# Bonnet Carré Spillway

New Orleans District

## Introduction

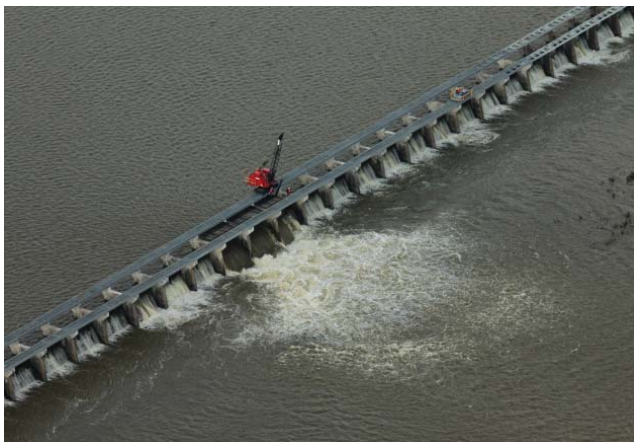
Map of Bonnet Carré Spillway (top), and aerial of the spillway in operation during the flood of 2011 (bottom).

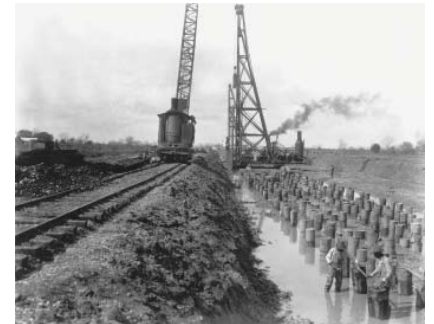
*Thousands of wooden pilings were driven to provide a reliable foundation for the spillway structure.*

Three separate studies were performed on-site. The first of these were site and foundation studies to determine the properties of the soil. Piling tests were undertaken to compare the qualities of wooden and concrete pilings. The tests indicated that long timber piles, in the range of 70 feet, would be adequate if sufficient numbers were driven under the structure.

Untreated piles were selected after examining the Robert E. Lee Monument foundation in New Orleans, which showed that such piles last indefinitely as long as they are kept below the water table. A temporary hydraulics laboratory was constructed on-site to determine the best shape of the weirs and to test various designs for dissipating the energy of water coming over the weir.

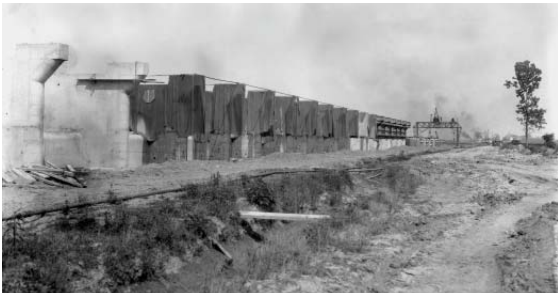
*High strength concrete used in the spillway was an engineering advancement.*

Because of the large quantity of concrete involved in the structure (135,000 cubic yards), it was essential that the concrete mixture produce strong, durable and economic concrete. The Corps established a concrete laboratory to determine optimal mixes of sand, gravel, cement and water quality for the spillway. Tests from the lab proved critical, resulting in a very high strength concrete in the neighborhood of 5,000 pounds per square inch. This was a significant advancement for the time, as typical concrete in the 1930s provided only 2,500 to 3,000 pounds per square inch compressive strength.

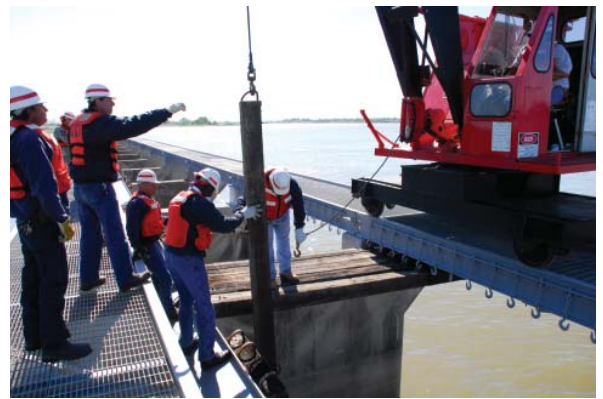
*In opening the spillway, each timber is individually lifted and placed atop the structure.*

Once the decision is made, actual operation of the structure is relatively simple. Two cranes, which move along tracks atop the structure, are used to individually lift each timber from the required number of bays. The timbers are raised from their vertical position across the weir opening (where together they serve as a dam against the high water) and are laid horizontally on top of the structure for later use in its closing. A complete opening of all 350 bays requires about 36 hours to lift the 7,000 wooden timbers in the structure. If a quicker opening of the structure is ever required, emergency procedures can release 20 timbers at a time and reduce the opening to three hours.

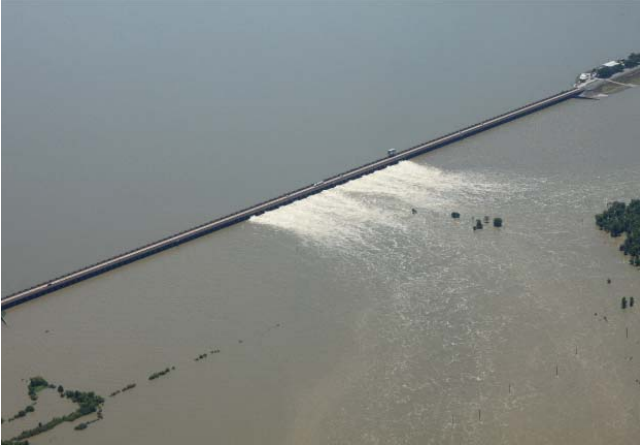
The Corps operated the Morganza Floodway for only the second time ever (and the first time for its intended purpose) in 2011 to divert excess Mississippi River water to the Atchafalaya River Basin and relieve pressure on the mainline Mississippi River levees.
