A history of buoys and tenders

by Amy K. Marshall

A history of buoys and tenders is a *Commandant's Bulletin* insert for November 1995. For information about the Coast Guard, visit your local library or write to the Coast Guard Historian's office at: Commandant (G-CP-4), 2100 2nd St., S.W., Washington, DC 20593-0001. Editing, design and layout by CWO3 Paul A. Powers. Photos courtesy of the Coast Guard Historian's office.

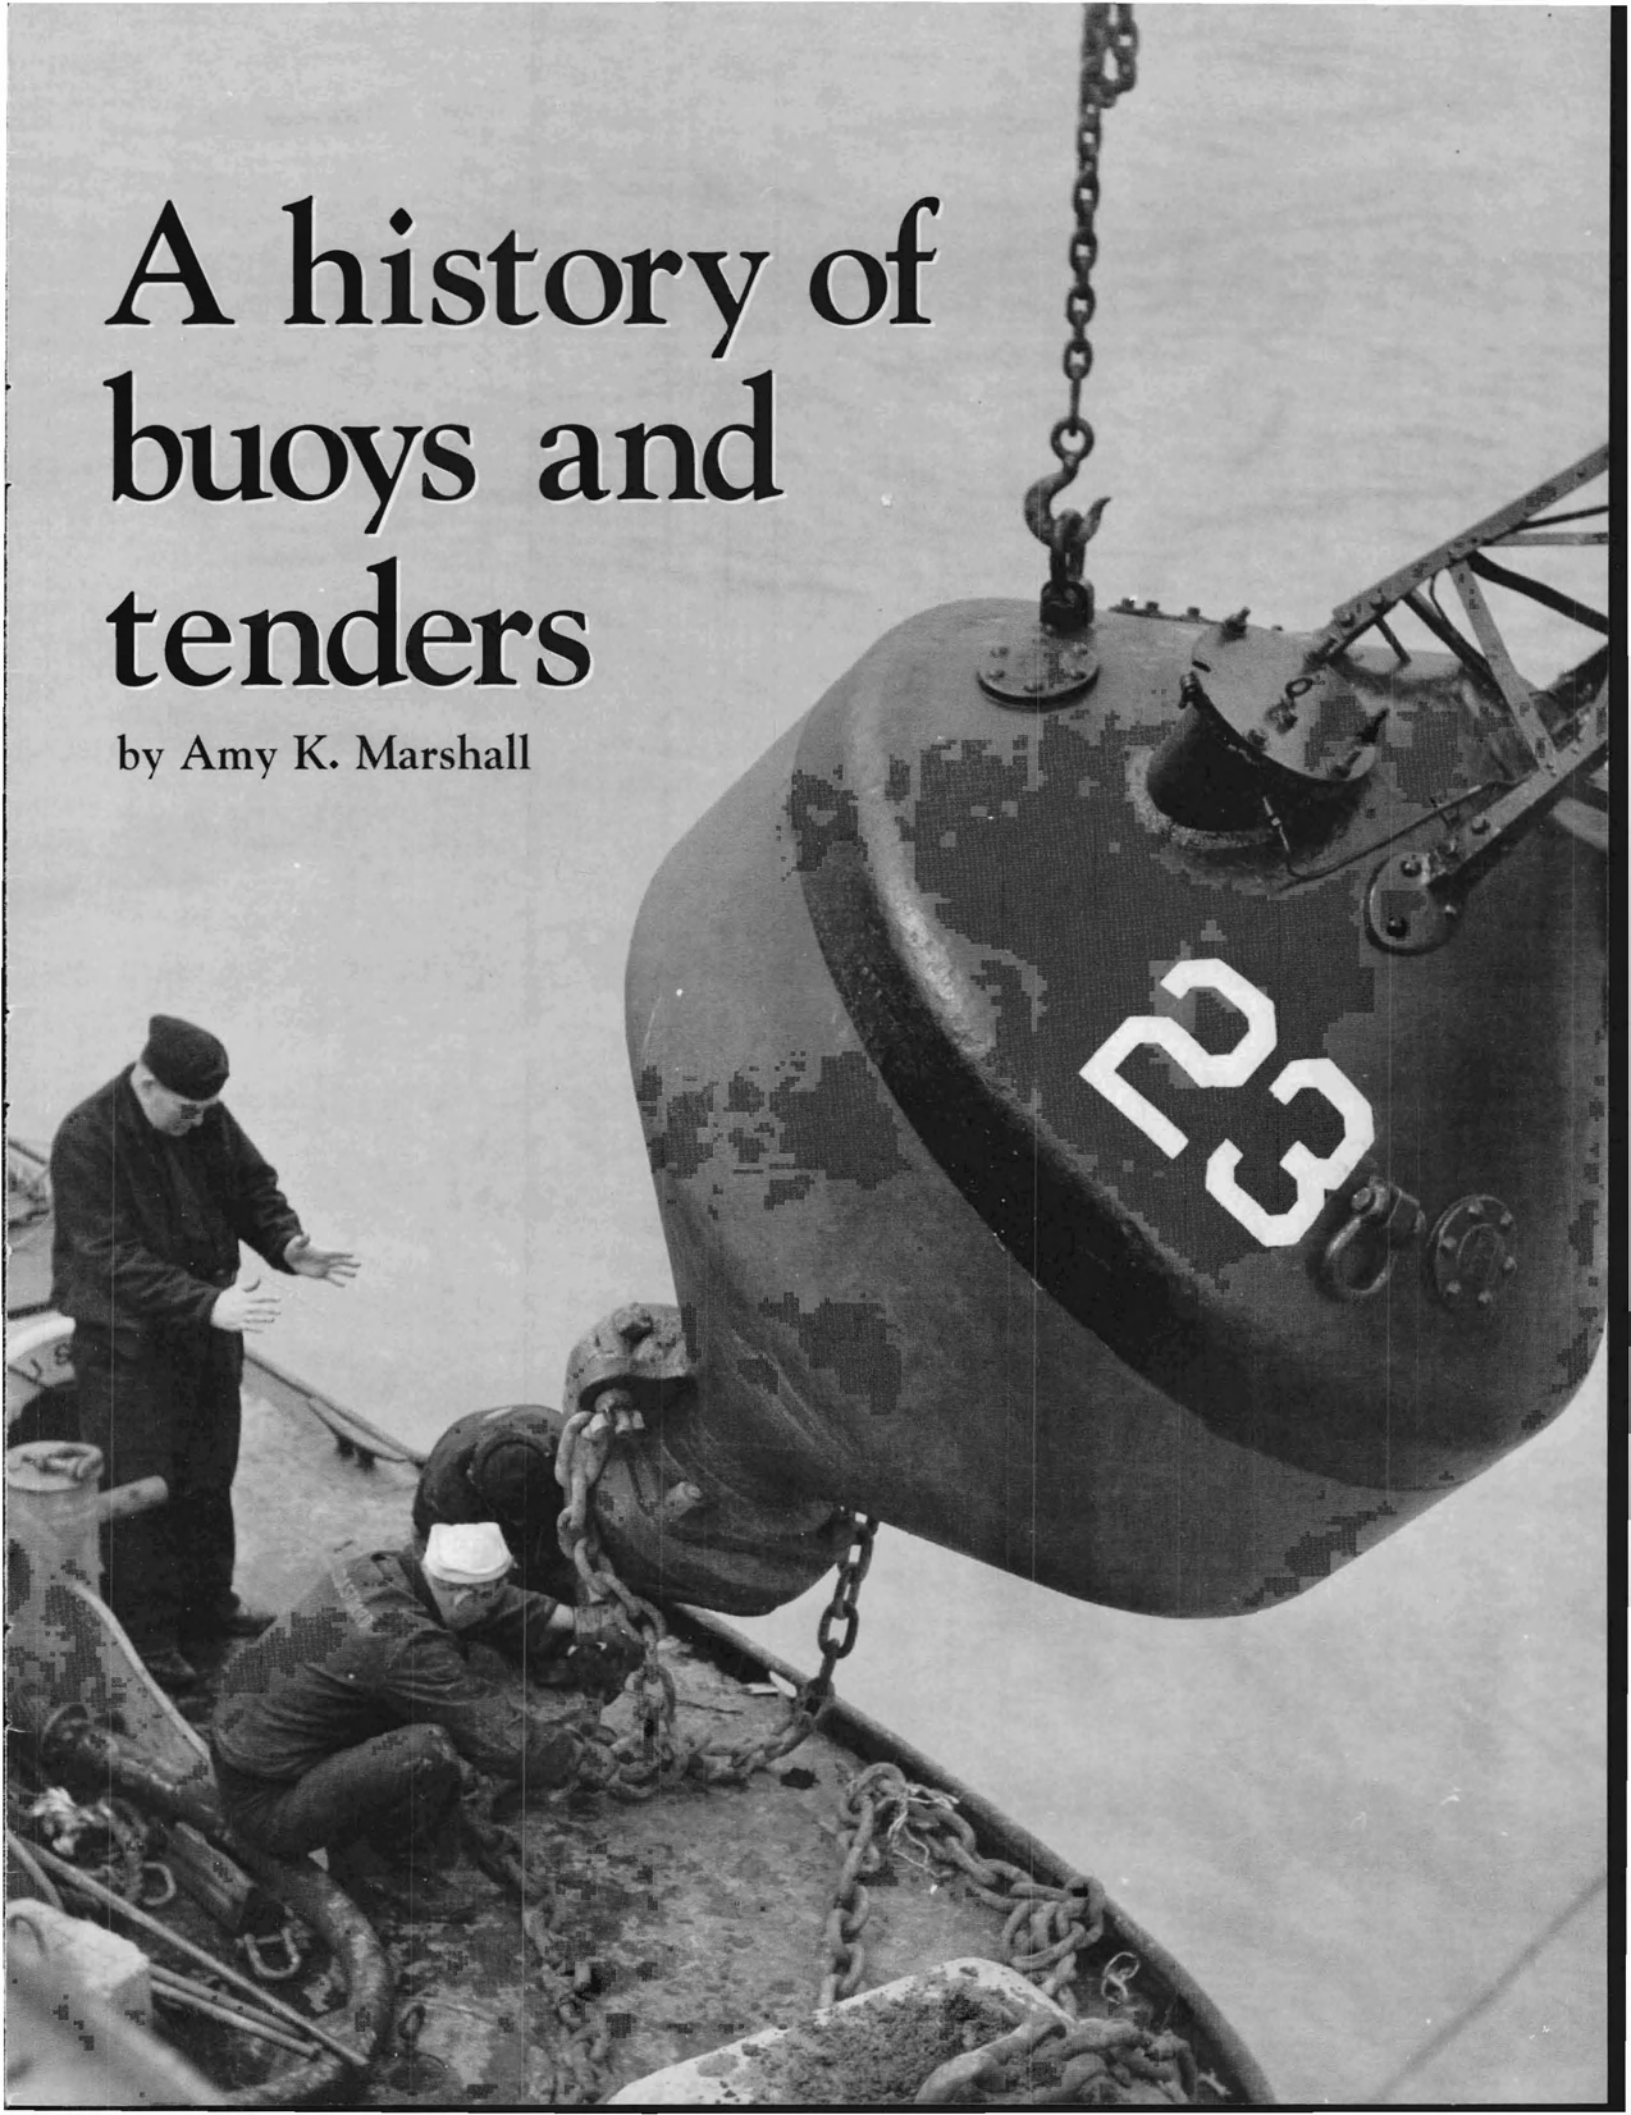
Front Cover: BMC Harley E. Johnson supervises the lowering of a buoy. Handling lighted buoys weighing more than 9,000 pounds and having a concrete sinker weighing 3,500 pounds is no easy task.

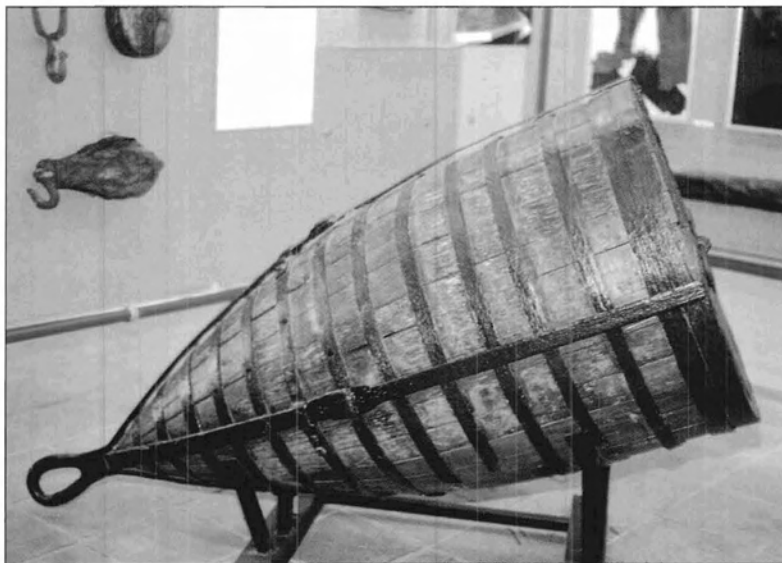
This cask buoy at the Rijksmuseum voor Scheepsarcheologie in Ketelhaven, Netherlands, is typical of the type found in northern Europe from the early 15th century until the late 18th century. This buoy marked an approach to the Hansa town of Kampen on the Zuider Zee.

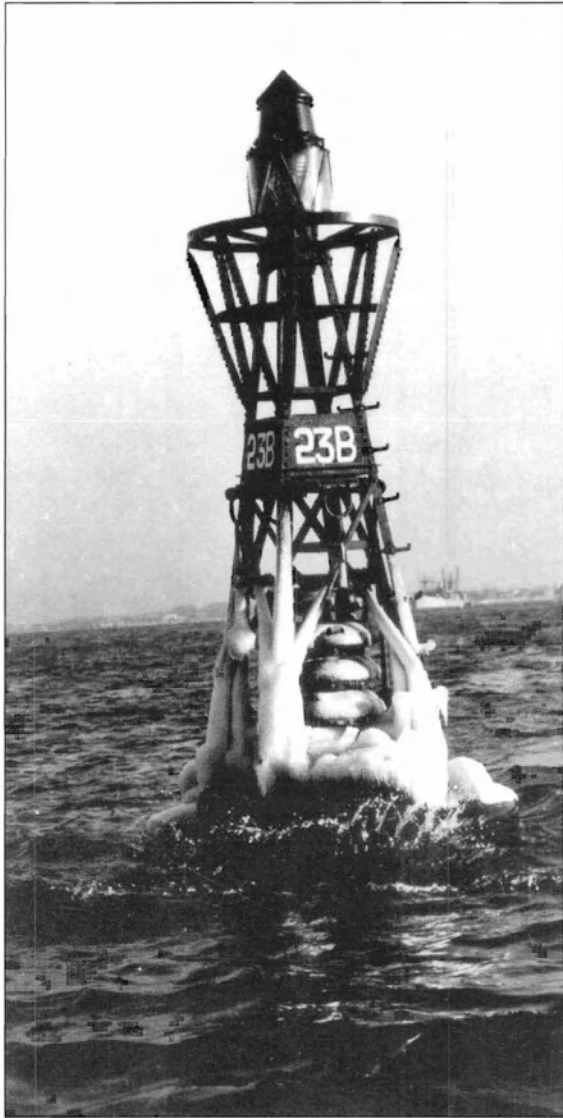
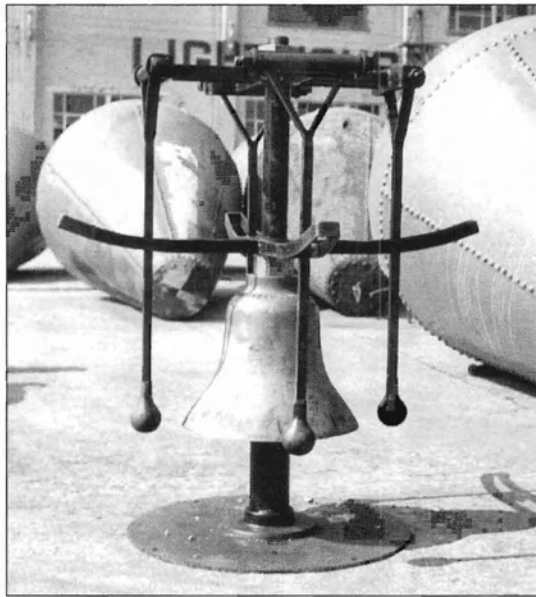
The Lighthouse Service continued to push for technological advances that would make America's sealanes the safest in the world. (Clockwise from upper left) The lighted gong buoy, with its distinctive three-note chime, was declared a success after extensive tests in 1922.

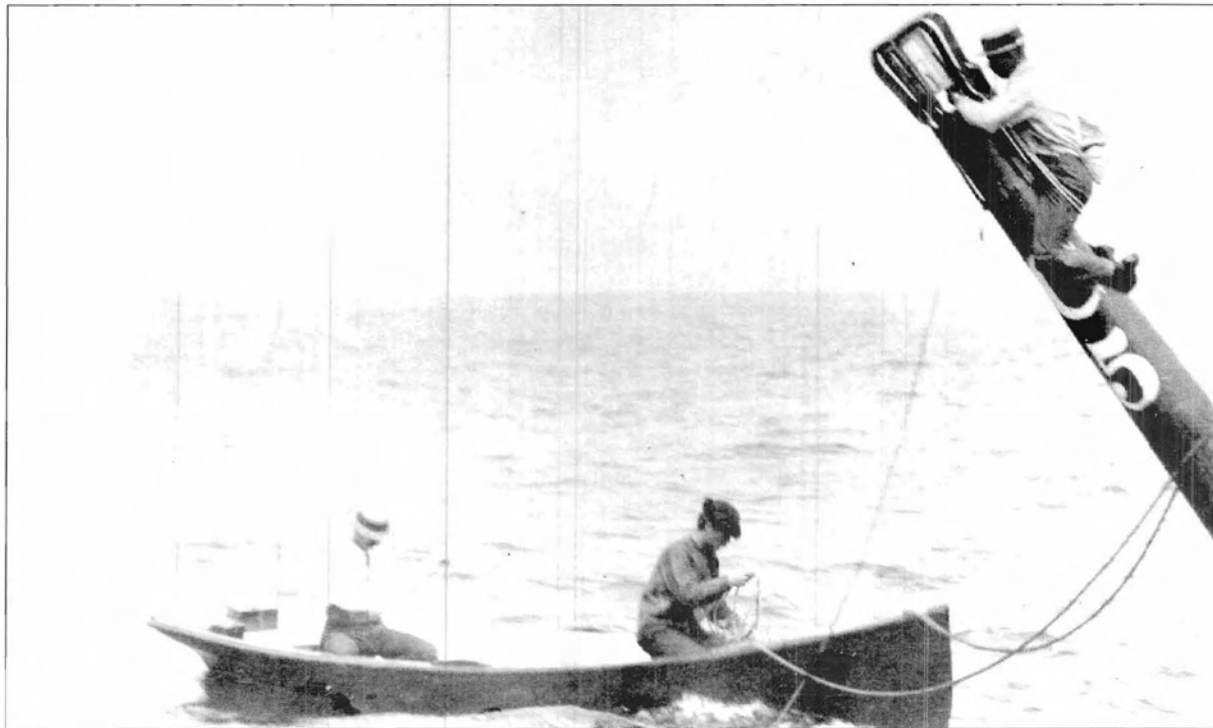
Experiments with electric light. A tender crewman straddles a lighted spar buoy in Gedney’s Channel, New York harbor. The buoy, one of a series of five, was connected by a cable to a generator on Sandy Hook, N.J. These buoys demonstrated that electric spars were unfeasible. Problems included the screws of deep-draft ships severing the power cable.

The first electrically-lit buoy tested by the board was a simple spar with a lantern housing and light on top. De-

ployed in Gedney's Channel, New York harbor, in 1888, a series of these buoys was lit by a cable running to a generator on Sandy Hook, N.J. These were removed in 1903.

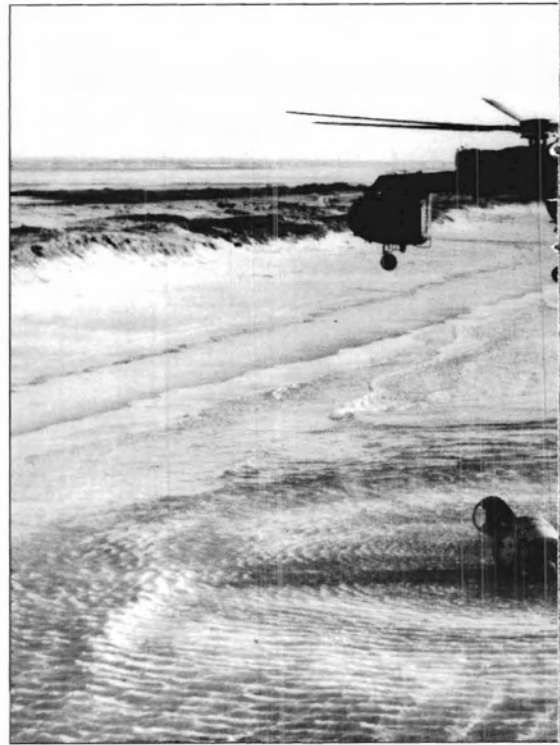
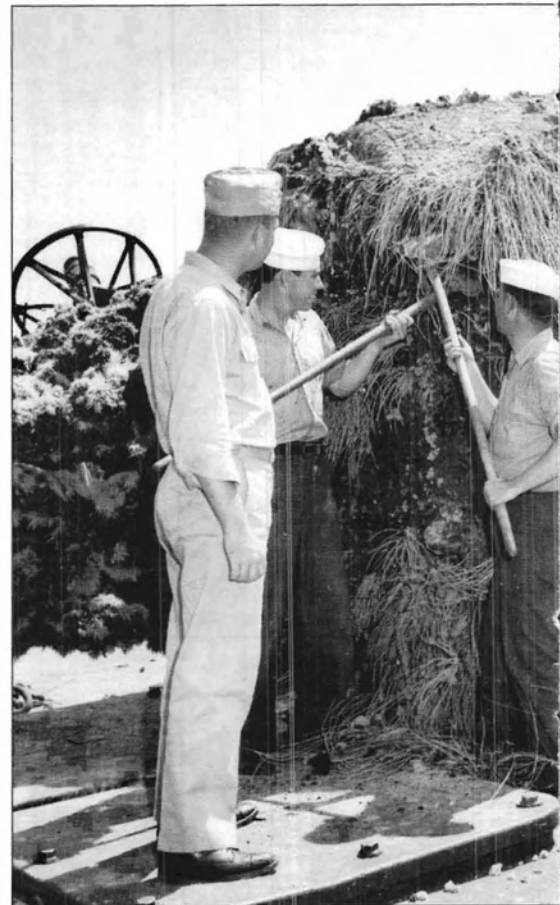
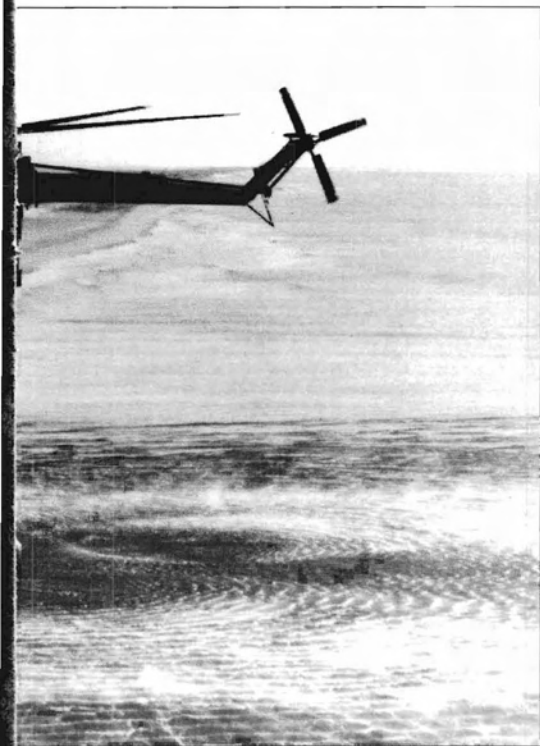
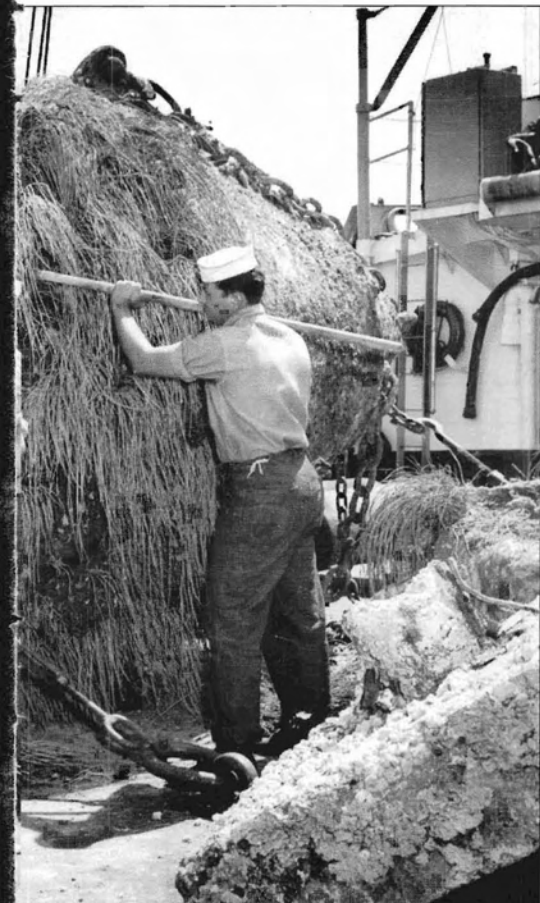
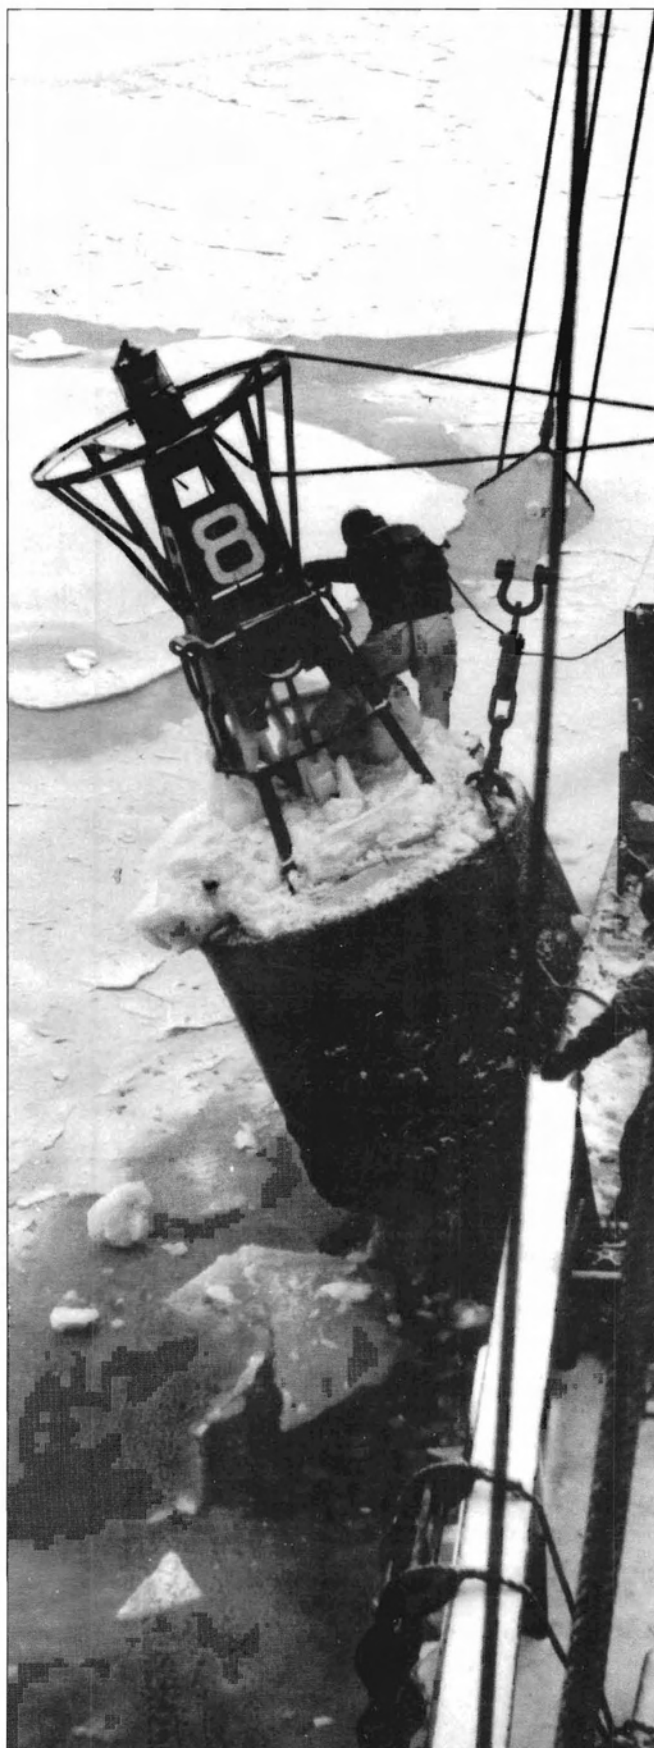
Broken moorings, snags, ice, collisions, marine growth — being a buoy is not all bobbing in the swells. A chance encounter with a snag (far left) left this light-bell buoy lanternless and with a twisted cage. A Chinook helicopter (top center) gives a lift to a buoy that had broken its moorings and washed up on a beach in a marine sanctuary. Foul work removing marine growth from a fouled buoy (bottom center). A ship in the James River (Virginia) struck this buoy and sank it. A Coast Guard tender recovered it six months later. (Left) As ice can jeopardize the stability of ships, it can also capsize and sink buoys. Here, the crew of a tender works to haul in and clean an ice-covered buoy.

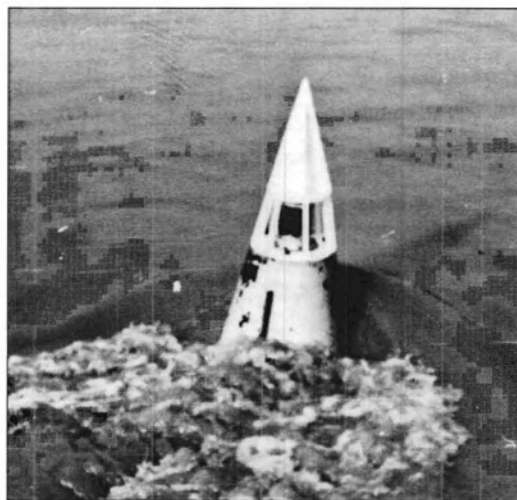
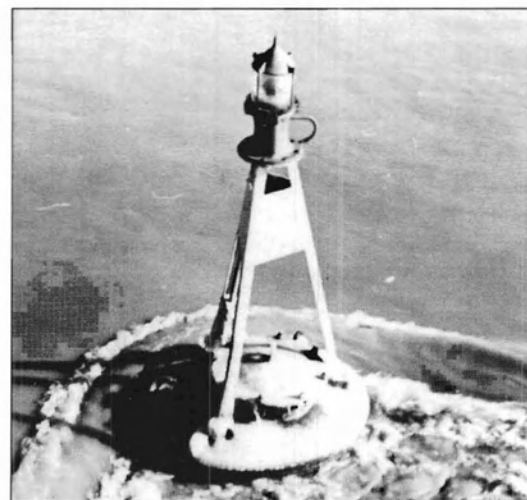
The Coast Guard continued the Lighthouse Service's tradition of experimenting with new buoy designs. In the 1940s and '50s, companies like Wallace and Tiernan and American Gas Accumulator provided prototype buoys for testing in swift-current environments. Four of these test buoys are pictured at right.

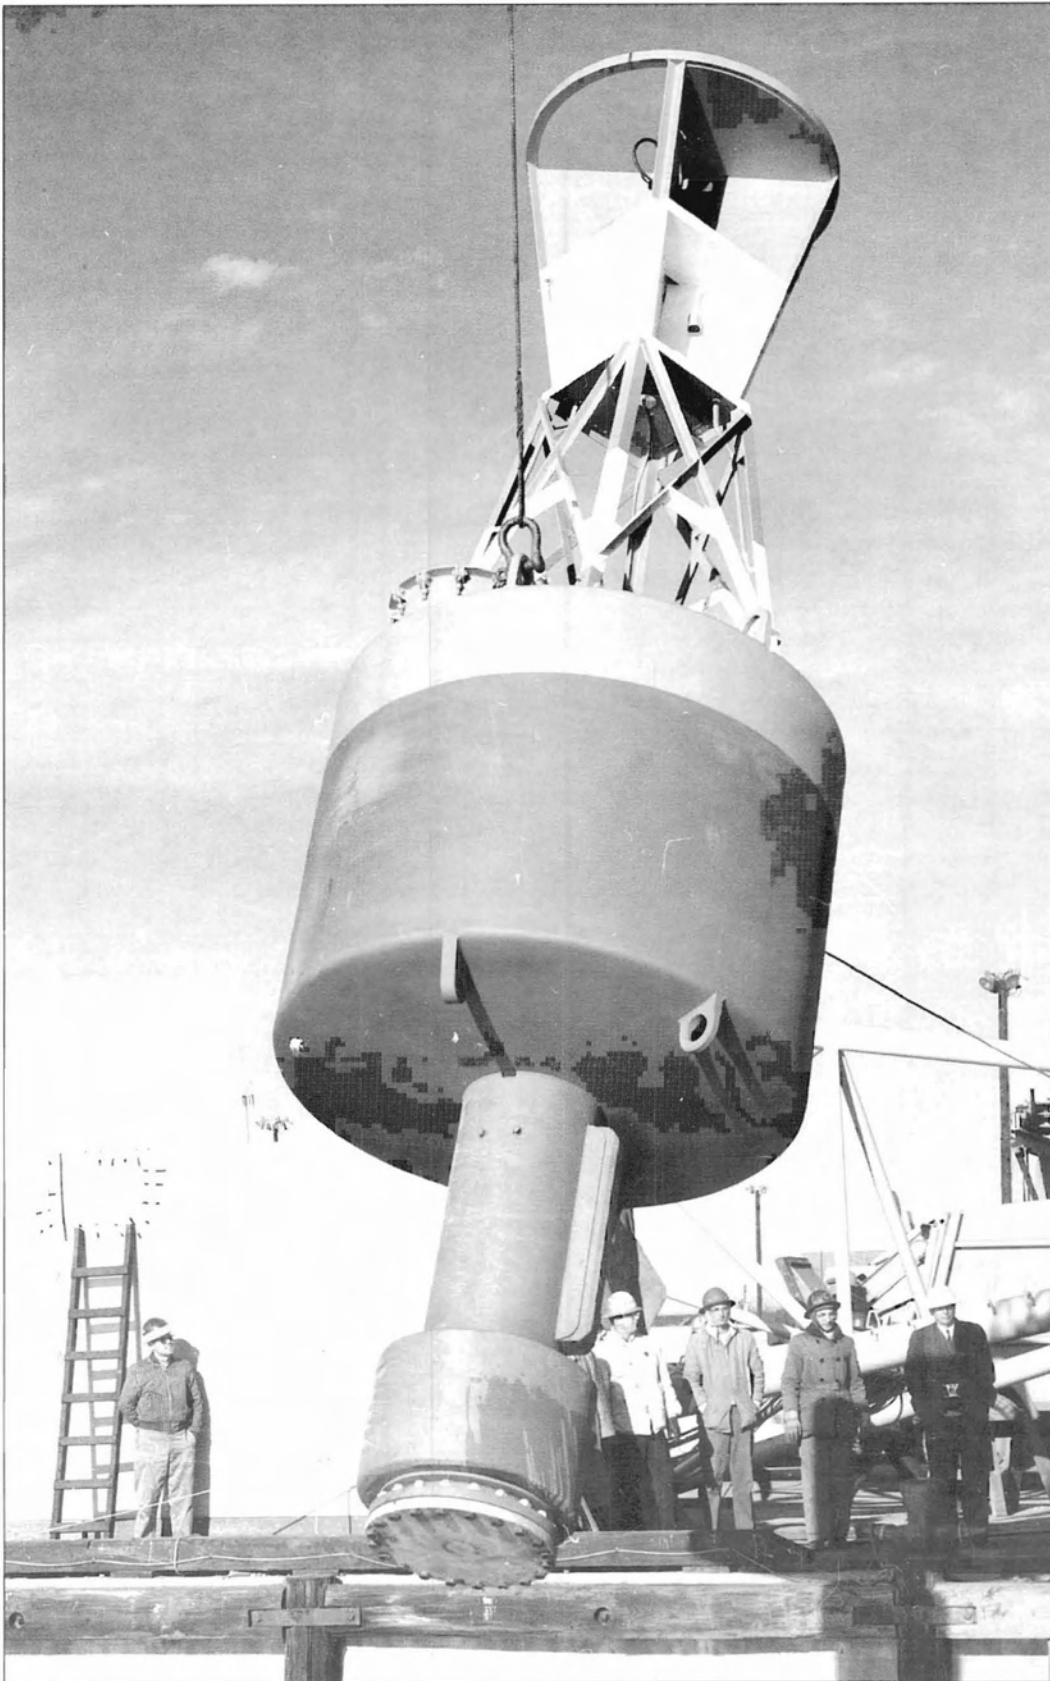
The Atomic Buoy was tested in Baltimore Harbor in 1961. It came complete with a SNAP-7A Strontium 90 generator. The buoy received world-wide attention and was presented as a model for the peaceful use of nuclear power. The generator, however, failed to keep the buoy lit. It was never deployed to its permanent station.

The Coast Guard embraced the promise of atomic power with the induction of its "Ensign Peaceful Atom." This buoy, and its cartoon personification, was touted by the media and the Coast Guard as the new wave in powering navigational aids. It was tested in Baltimore Harbor in 1961 and was quietly removed in 1966 after reports that the nuclear generator failed to keep the buoy lit. Later reports on the atomic buoy experiment admitted that it was a dismal failure.

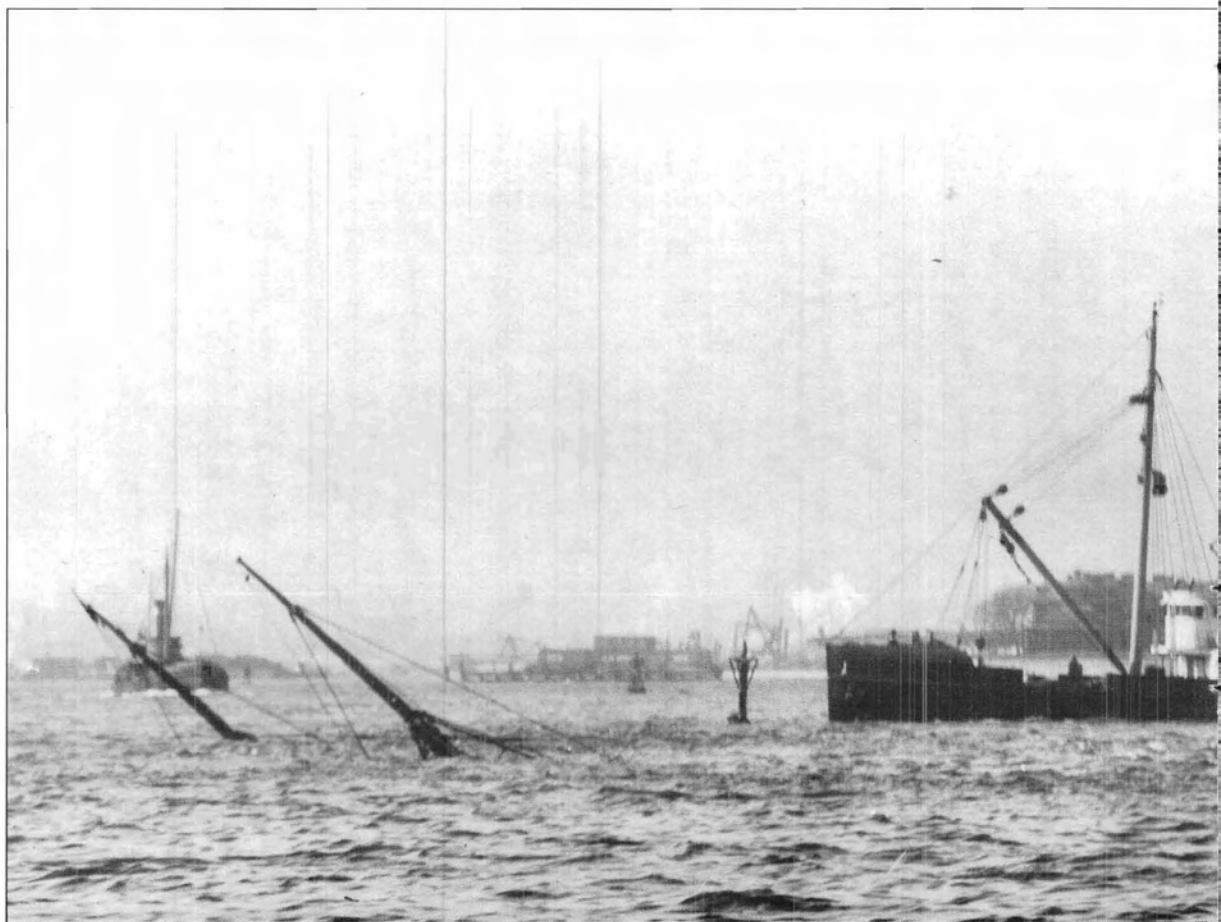
A wreck within sight of the Statue of Liberty, in New York harbor, is visited by a tender with an assortment of buoys. Captains of tenders take responsibility for marking wrecks and other temporary hazards to navigation in addition to their work marking shoals and rocks.

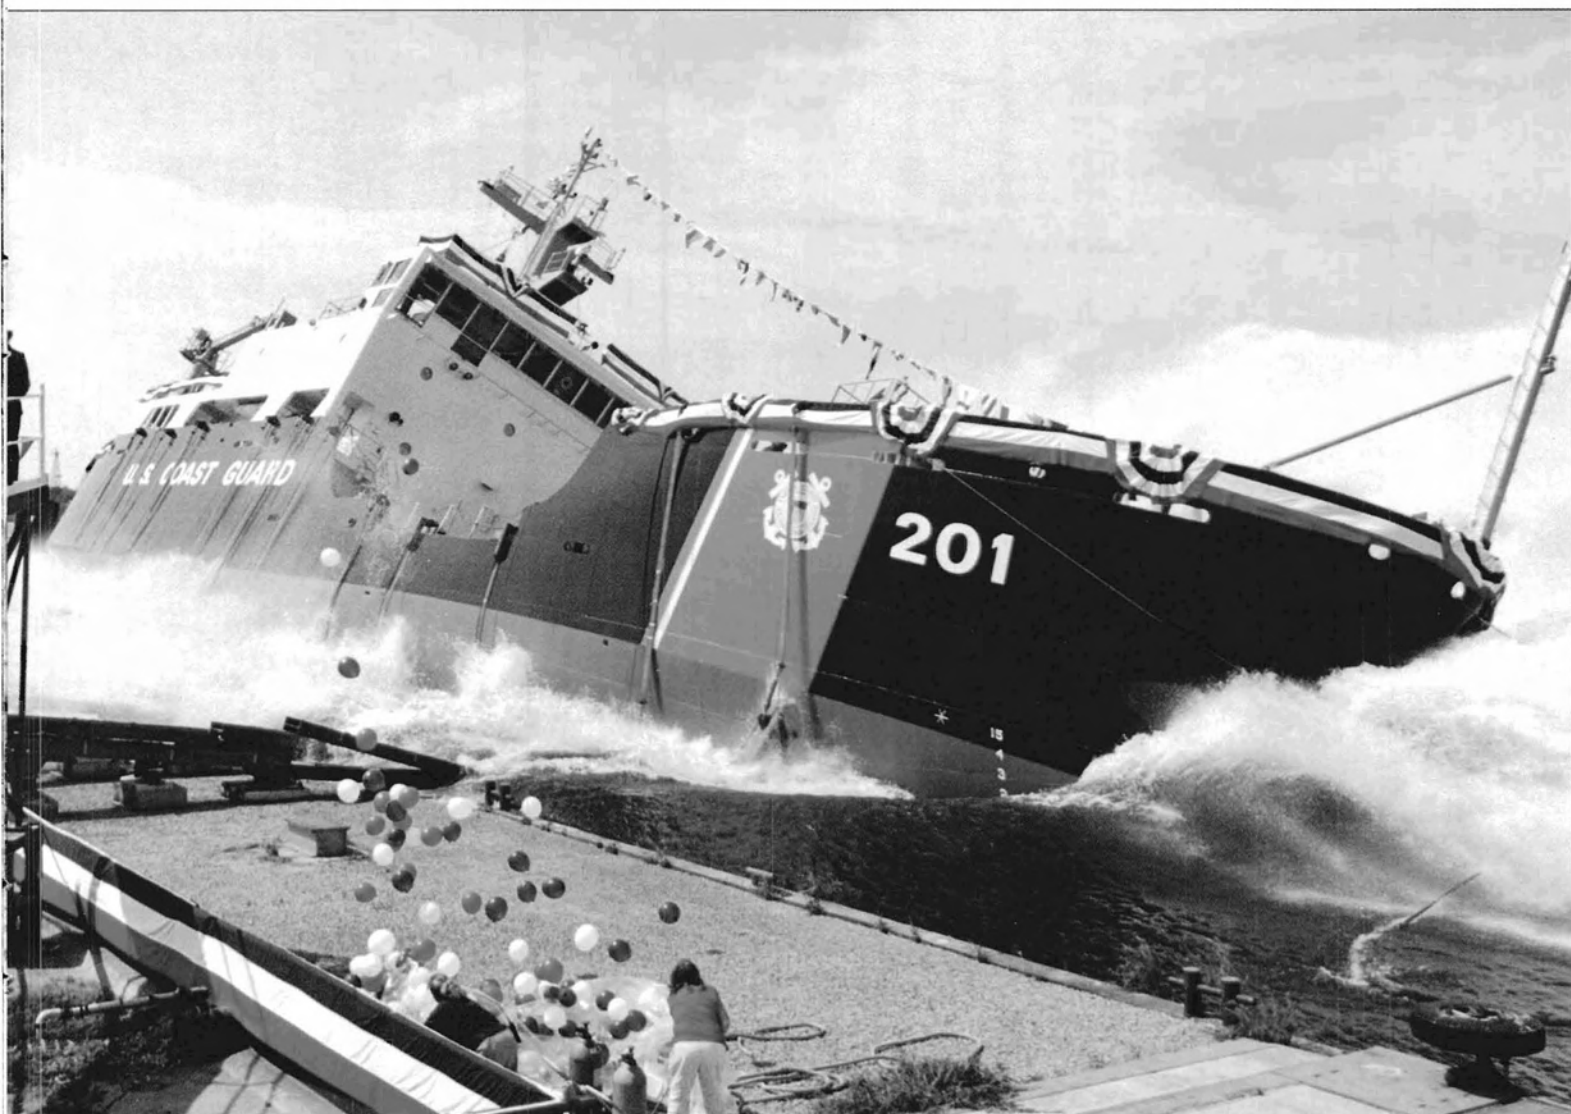
The new Juniper-class tender will lead the Coast Guard's tender fleet well into the 21st century.

Perhaps the most important advancement is the use of a new Dynamic Positioning System. DPS uses the Differential Global Positioning System to fix a position. Using this technology, the crew of the *Juniper* will be able to maintain the vessel's position within a 10-meter circle in conditions including winds of up to 30 knots with waves up to 8 feet. When setting buoys with this new technology, the *Juniper's* margin of error should be near zero percent.

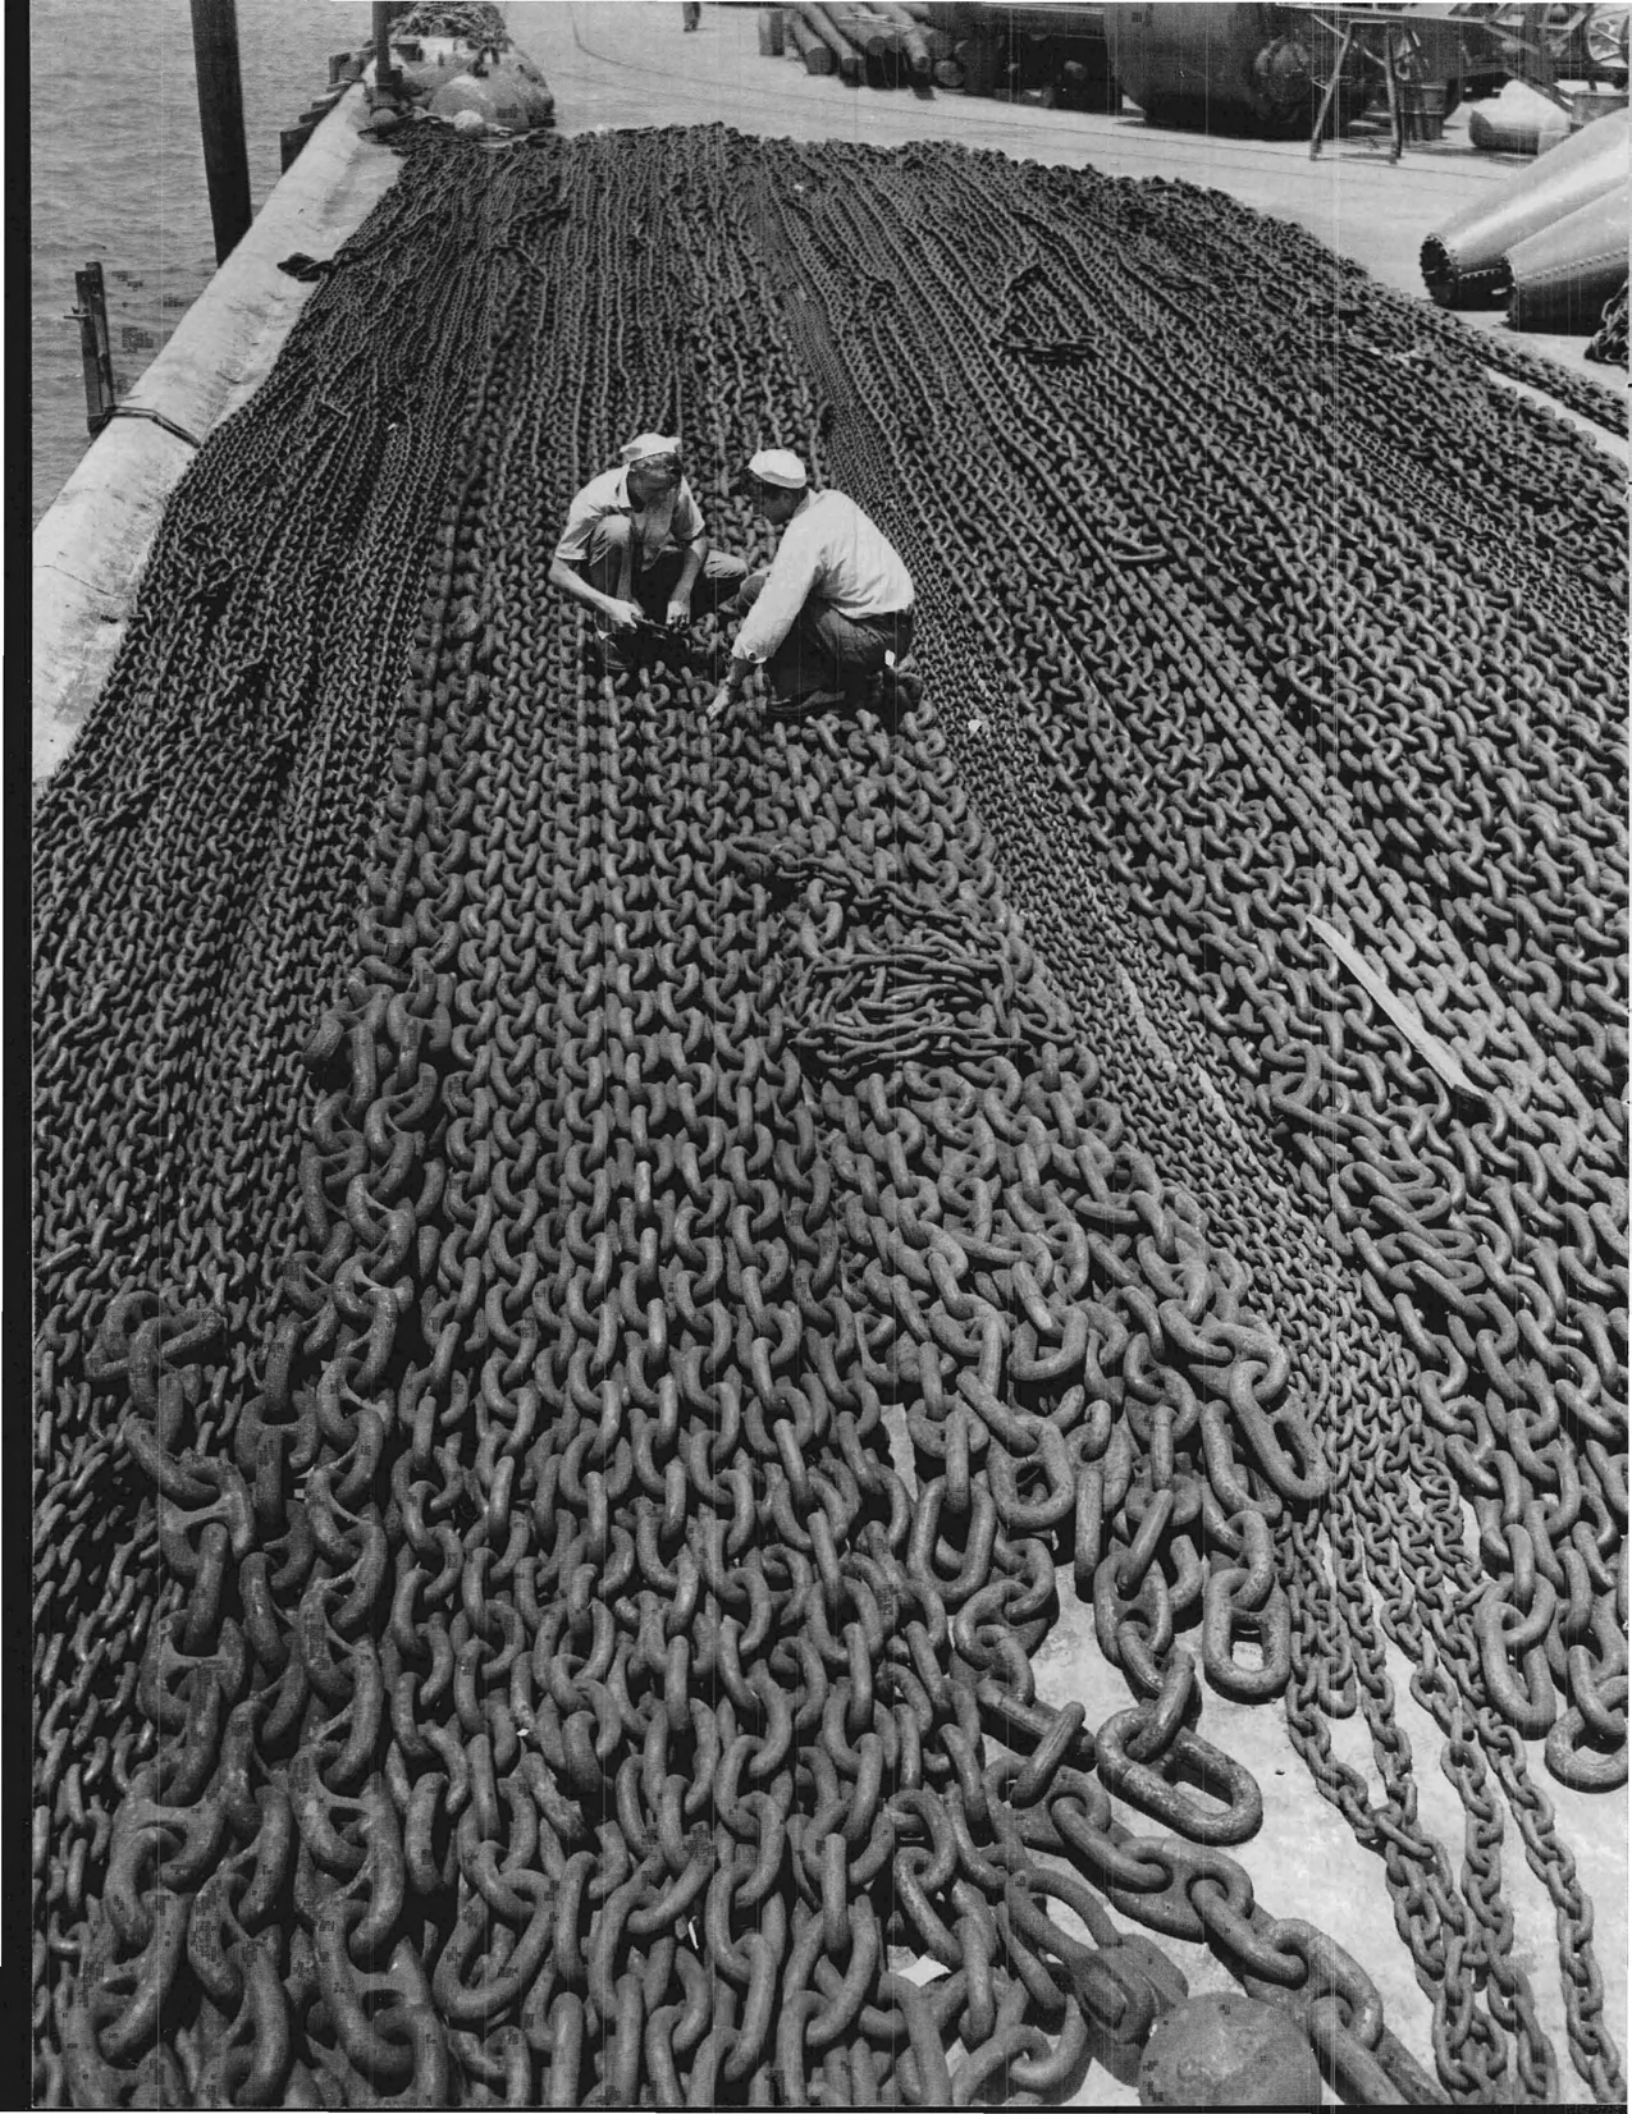
Back Cover: Lightship and buoy mooring chain lies ready for inspection at the Coast Guard Navigation Depot, Charleston, S.C. Two Coast Guardsmen are busy looking for a different kind of missing link.
