# **Memorandum: Rep. McGovern CODEL to Ecuador: Oil-Contaminated Communities Summary – November 9 - 10, 2008**

This memorandum presents summary information on the sites visited during the two-day (November 9 and 10, 2008) Congressional Delegation trip to the oilfields in the Napo Concession, Ecuador.

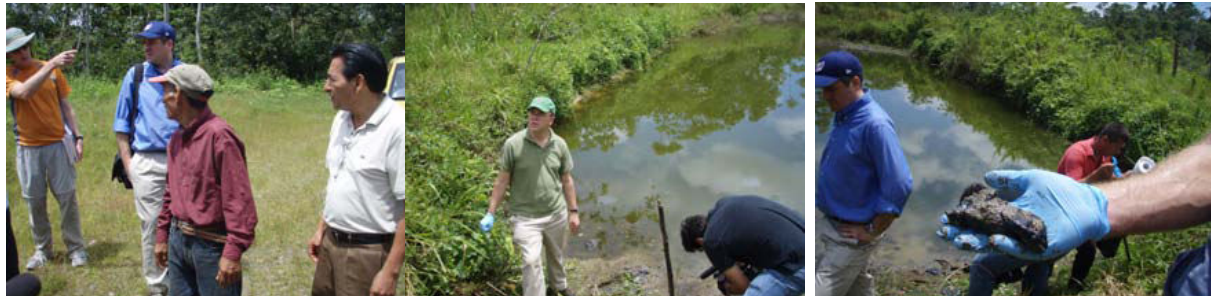
### **1. Oil Well Site Yuca 4**

At this site, we visited a relatively small open pit with standing water and oil in the pit soils. We also spoke with a farmer who had lived near the well site and pits for many years and has lost many head of cattle because of the contamination in the pits.

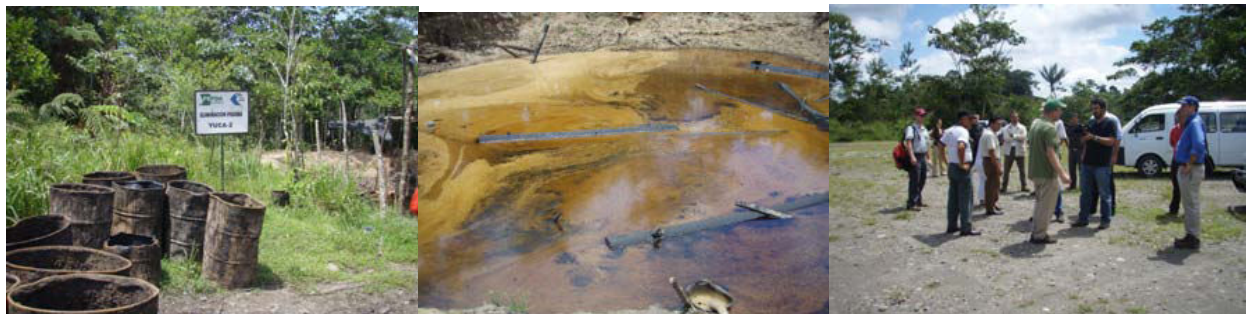
## 2. Oil Well Site Yuca 5 (incorrectly marked as “Yuca 2”)

At this oil well site we saw a pit where Petroecuador has been conducting cleanup operations for at least one year using very primitive methods. The operation consists of skimming off oil that floats to the top of water that is added to the pit. We also saw the pipe built into the side of the pit that discharged pit contents into the rainforest, and followed the flow of oil and contaminated soils from the pit outlet toward the nearby stream.

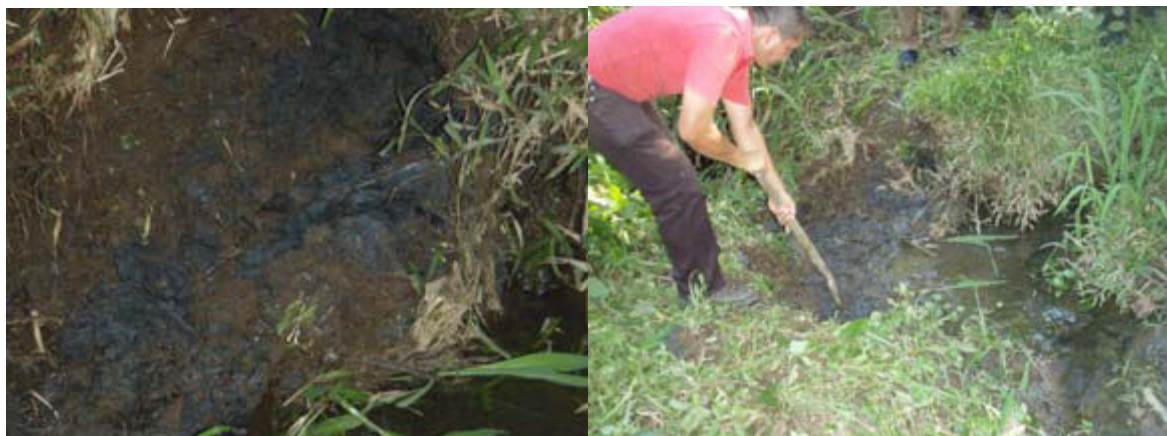
## 3. Processing Station Sacha Sur

We visited with Maria Garafola, who lives in San Carlos across the road from the Sacha Sur processing station. She and her daughter both suffer from cancer. We also inspected the small stream behind her house where Texaco dumped formation water and oil from the processing station. Oil was evident in the stream and stream banks a few centimeters beneath the surface.

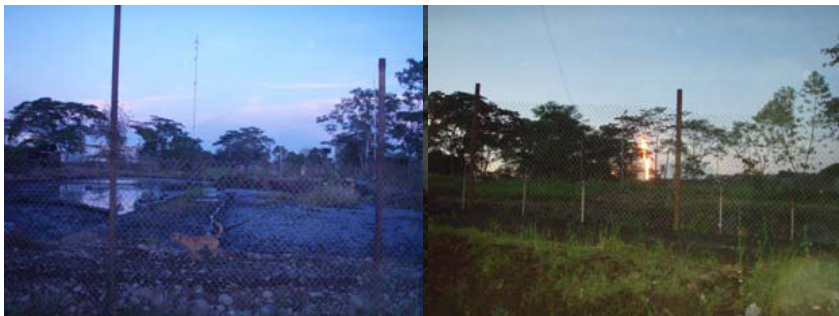
#### 5. Processing Station Sacha Central

At this large processing station, we saw the cascade of waste pits and the large pipes that were used by Texaco to dump billions of gallons of formation water into the nearby stream. Petroecuador now reinjects formation water back into the underground formation, and no longer dumps the formation water into the stream.

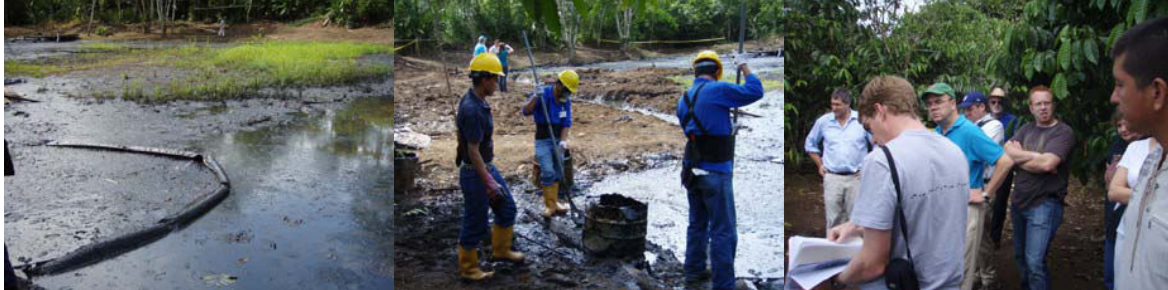
#### 6. Oil Well Site Shushufindi 38

This site includes two pits, one relatively large, immediately behind the house of the Salinas family. Petroecuador is currently conducting some cleanup actions at the larger pit, which is an open pit covered in oil. This site was sampled by the plaintiffs and by Chevron during the trial's Judicial Inspections. The plaintiffs reported high contamination with petroleum, whereas all of Chevron's samples were non-detect for petroleum contamination.

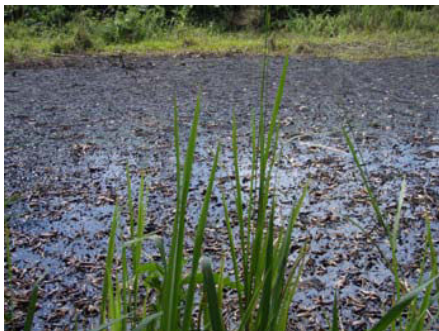
### **7. Oil Well Site Shushufindi 61**

This well site has an open oil pit that was not cleaned up by Texaco. This site was investigated by the Court Expert during the trial, and he found high petroleum contamination around the pit and along the stream into which the pit drains.
