Patient Safety Advisory

Sequence # 02 - 001

February 27, 2002

Item: **Potential for incorrectly attaching Allegiance Irrigation Kit (Catalog # 3T4121) caps to Foley catheters**

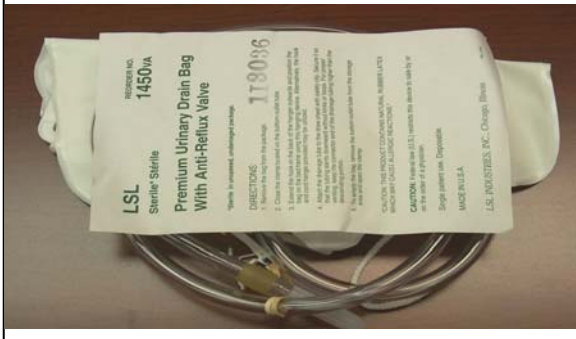
Standardized LSL Bedside bag with large cap

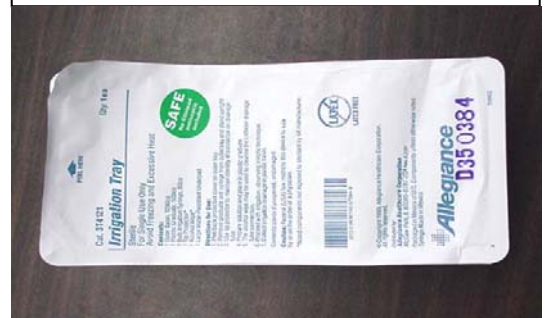
Non-Standardized Allegiance Irrigation tray (Cat. # 3T4121)

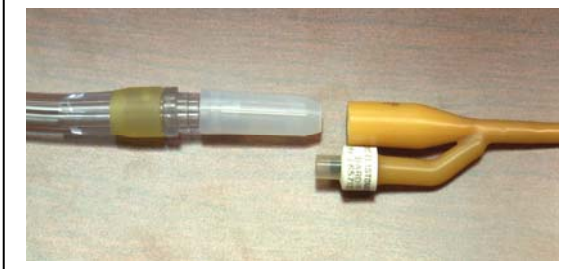
Cap packed with LSL kit cannot be accidentally inserted into Foley

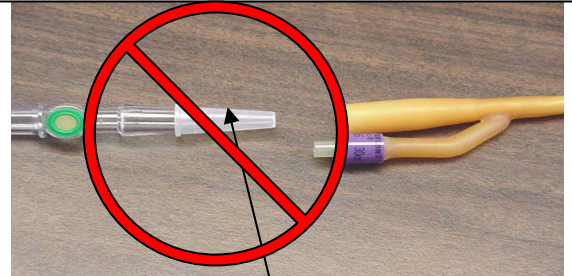
General Information: The tubing **cap** of the Allegiance irrigation kit is small enough to fit into a Foley catheter, resulting in an obstructed Foley catheter. The manufacturer of the kit informed us by letter that they “*designed the cap to cover the tip of the syringe when the syringe is not in use. Any other use of the cap is neither recommended nor endorsed*”. Refer to the attached photographs for further clarification and information.

Cap packed loose in Allegiance Irrigation tray can be incorrectly inserted into Foley causing blockage

- 1. Use only standardized irrigation kits identified by the Medical /Surgical Users Group; acquire from LSL Industries purchased under (BPA) Blanket Purchase Agreement # VANAC90NP-00-035 with Foley catheters.**
2. Check with Materials Management to determine if Allegiance Irrigation kits are present in your facility. If so, alert all clinical staff of this possible problem and the manufacturer’s intended use and design of the cap. Make copies of the attached **WARNING** sheet and distribute with Allegiance irrigation kits. Place signs in areas where this product is used to remind staff to remove cap from urinary bag tubing (if it is their practice to cap the bag tubing), prior to reinsertion to Foley catheter.

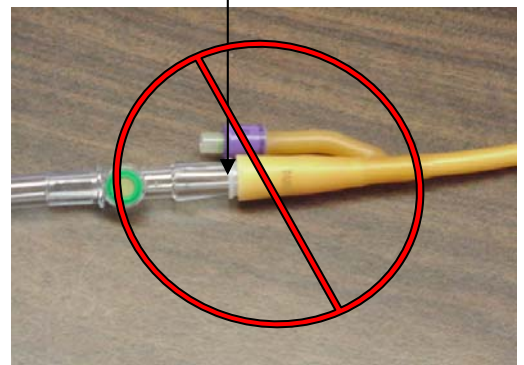
Note: Cap fits inside the Foley. Do not insert with cap in place.

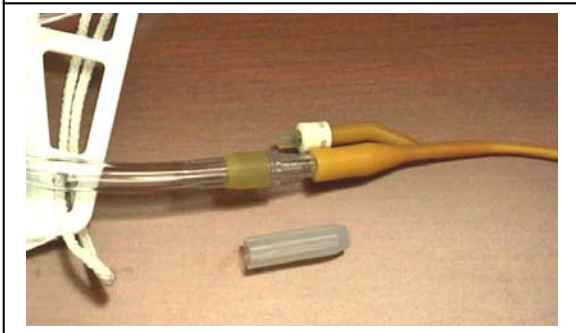
Large cap forces one to remove cap prior to insertion

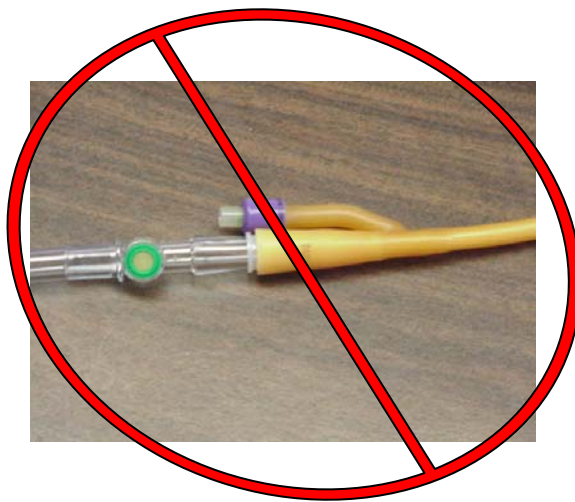
WARNING

CAP IN KIT IS DESIGNED TO CAP THE SYRINGE WHEN THE SYRINGE IS NOT IN USE.

**DO NOT
CAP TUBING OF DRAINAGE BAG
OR THE FOLEY CATHETER.**
