## Abstract

Photomicrographic images that are submitted to *Toxicologic Pathology* for the purpose of documenting scientific findings range in quality from the good and the bad, to the impossible. Some of the most common problems with manuscripts submitted to *Toxicologic Pathology* are uneven illumination, out of focus photomicrographs, overexposed immunohistochemistry and inappropriate labeling. Examples of various common errors in submissions will be presented along with possible solutions achieved by the utilization of an image-processing program, such as Photoshop®. Some worst-case scenarios of "impossible" images will also be examined.

## Examples of The Possible and The Impossible

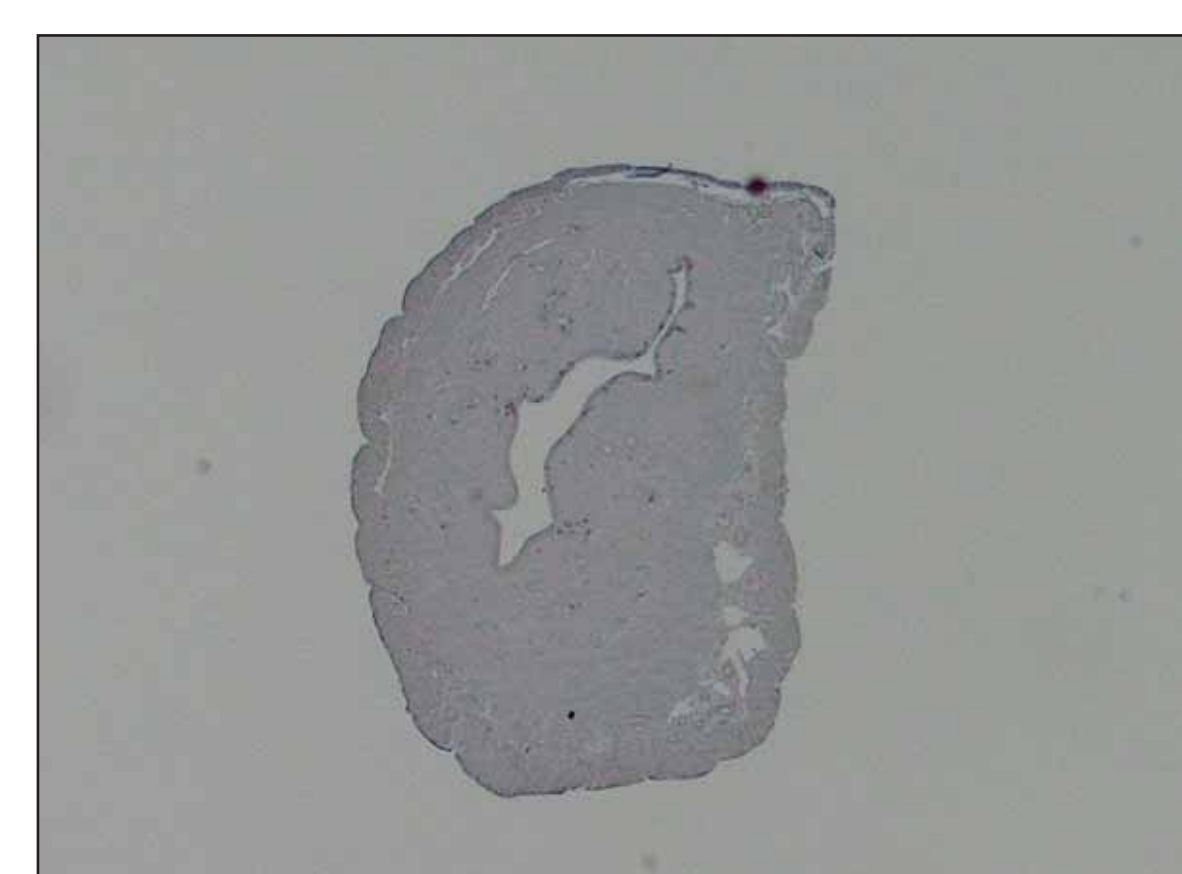
Figure 2A represents an image where the specimen was not properly illuminated.

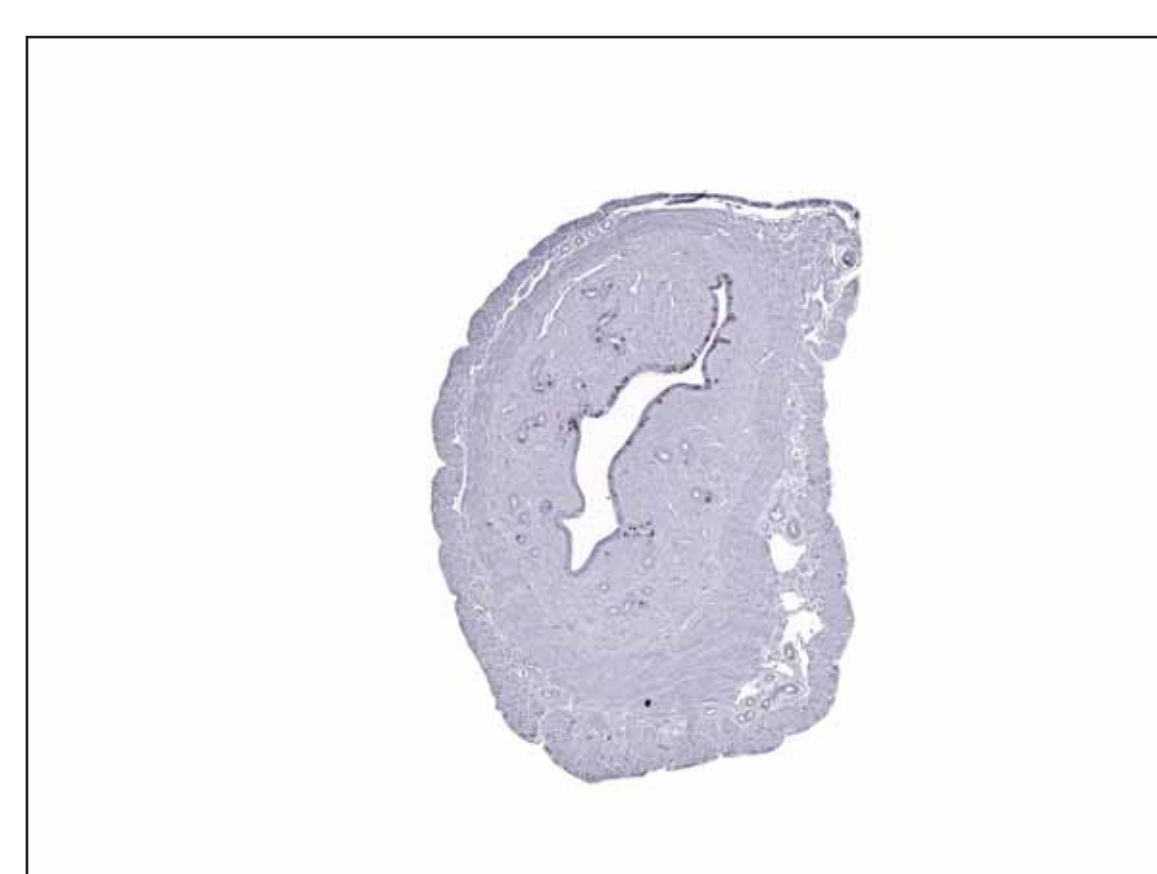
Figure 2B represents an image where the light source has been optimally adjusted.

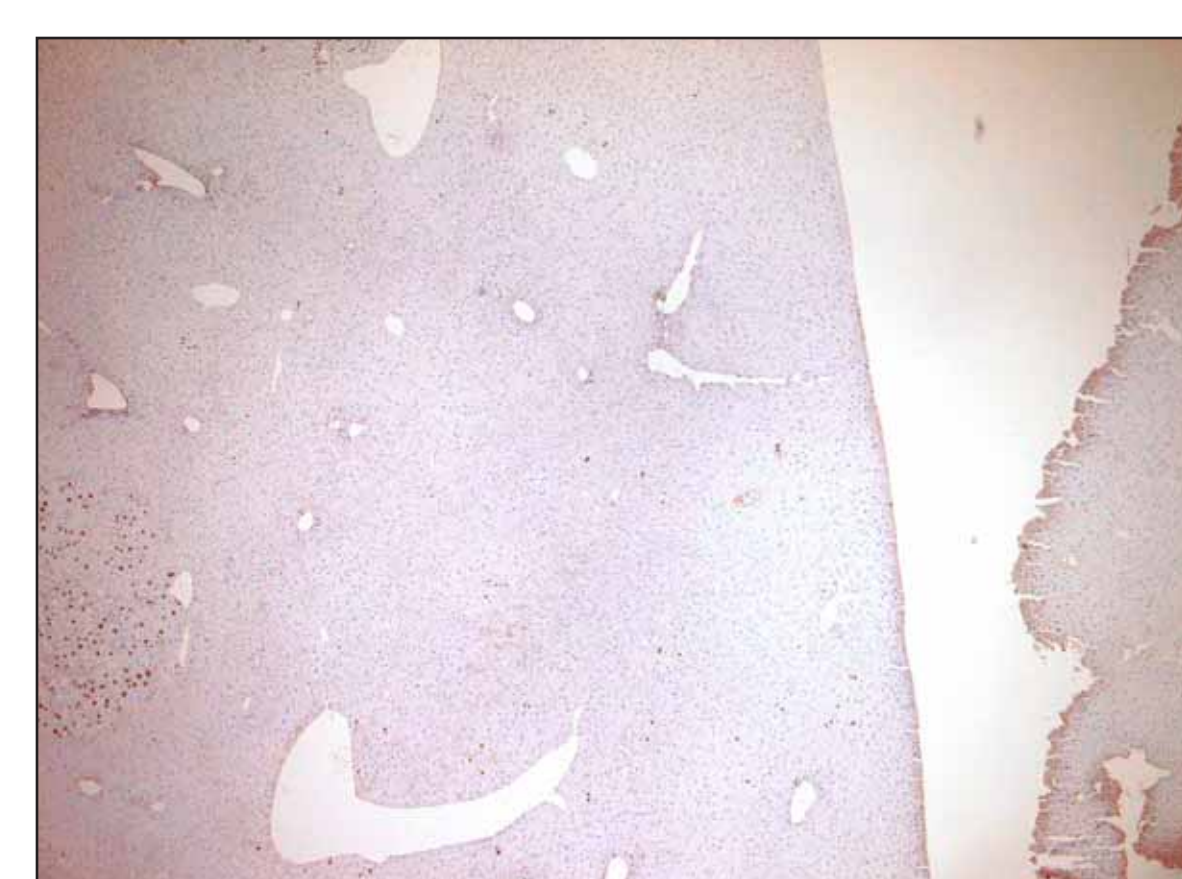
Figure 3A represents an image where the field diaphragm has been closed beyond the visual field.

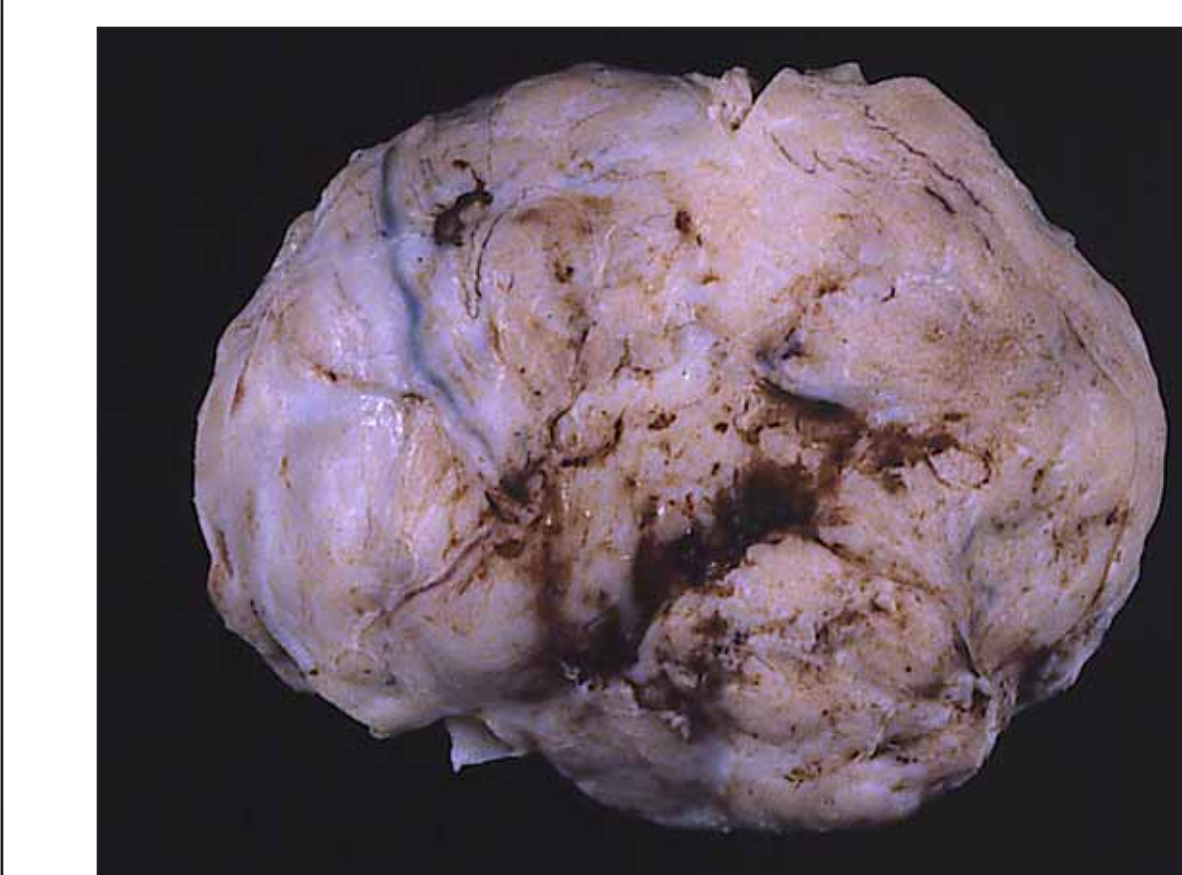
Figure 9A represents a digital scan of a 35mm kodachrome slide with poor illumination and a color caste.

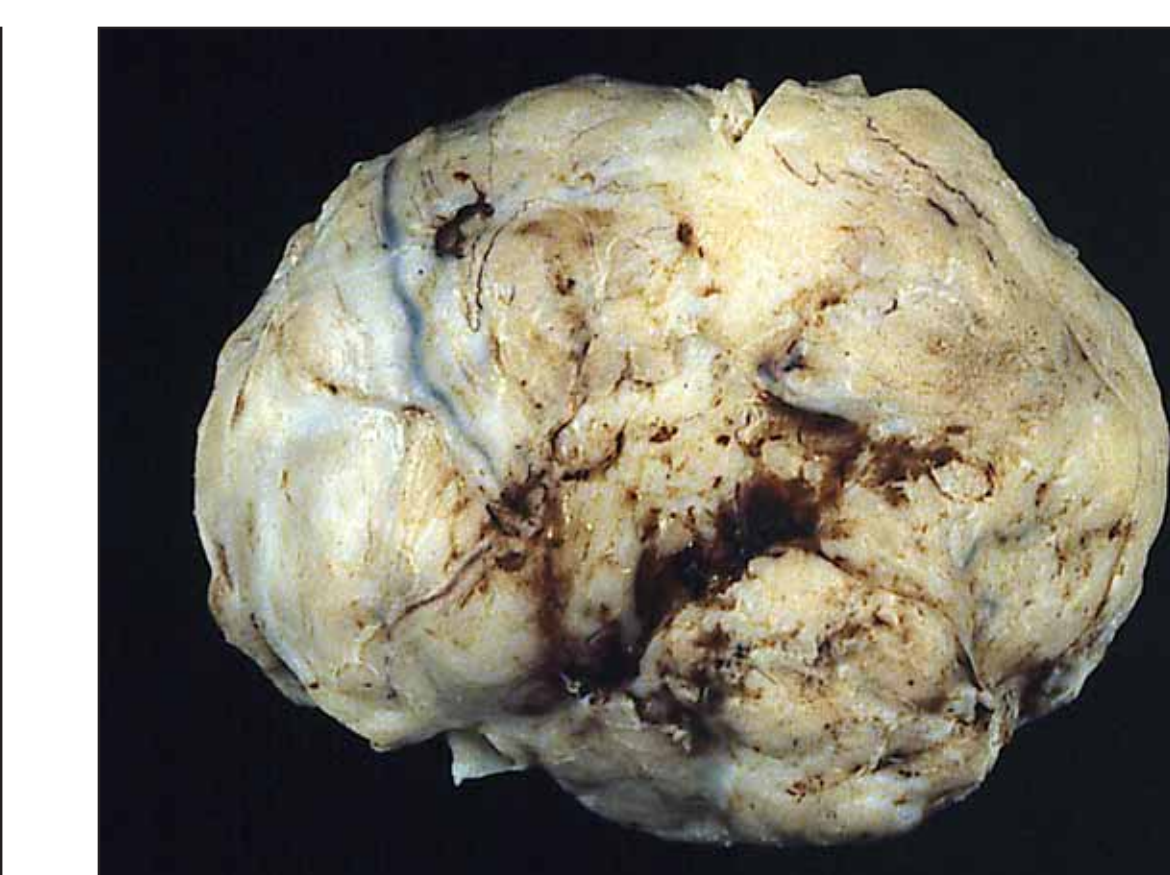
Figure 9B represents image 9A that has been adjusted by cropping the border, adjusting the illumination and setting the white point in Photoshop®. This image is acceptable for submission to *Toxicologic Pathology*.
