**PROCEDURES FOR US ARMY AND US AIR FORCE AIRFIELD
PAVEMENT CONDITION SURVEYS**

HEADQUARTERS, DEPARTMENTS OF THE ARMY

July 1989

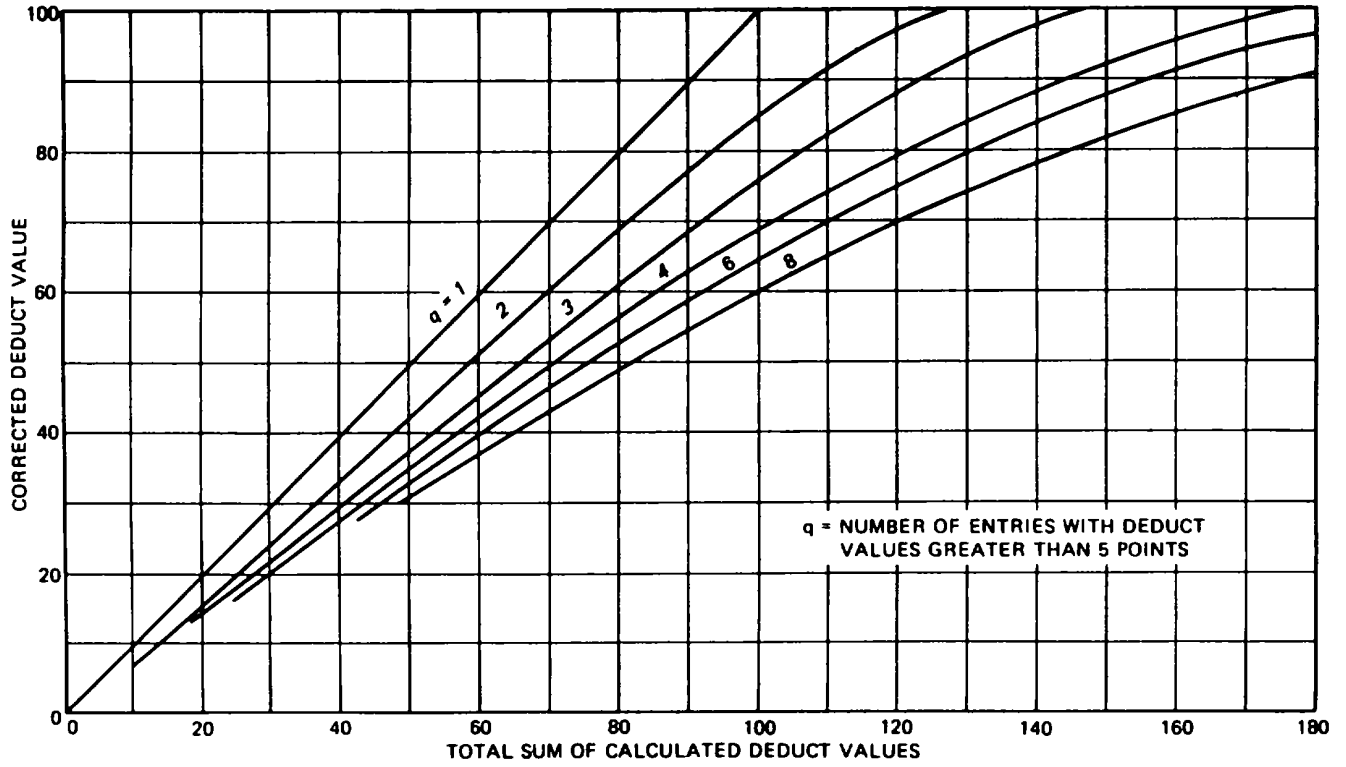
Figure 5-17. Corrected deduct values for jointed rigid pavements.

5-3. Sample unit PCI. Noting the number of individual deduct values that are greater than 5, one must consult figure 5-17 to obtain the CDV. The PCI is then calculated and the rating (from fig. 5-18) is entered on the jointed rigid pavement survey data sheet (fig. 5-1). If the CDV for a sample unit is less than the highest individual distress value, the highest value should be used in determining the PCI.

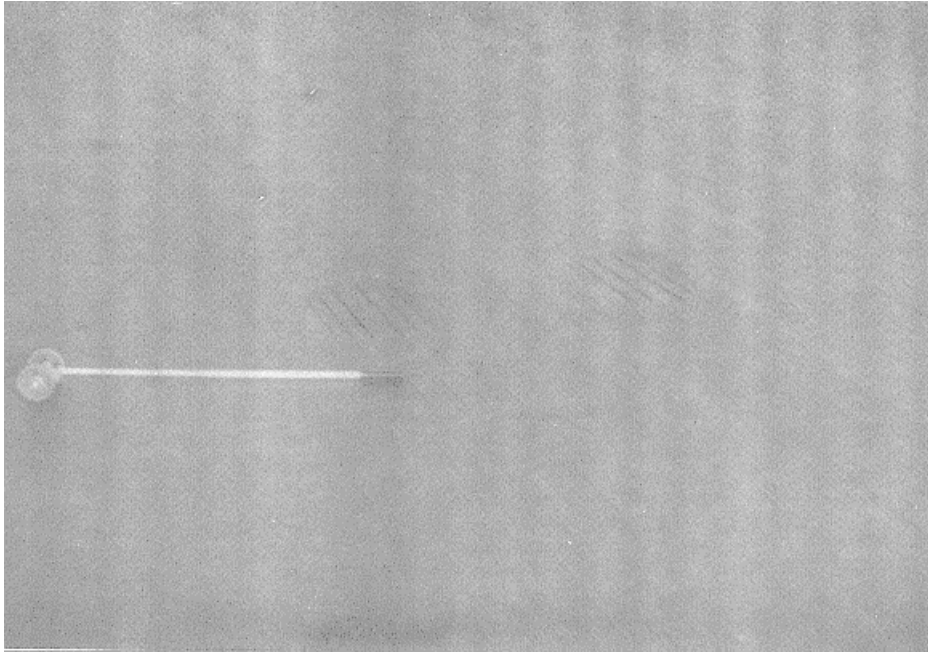
Figure A-7. Bleeding.

(2) *Severity levels.* No degrees of severity are defined. Bleeding should be noted when it is extensive enough to cause a reduction in skid resistance (figs A-7).

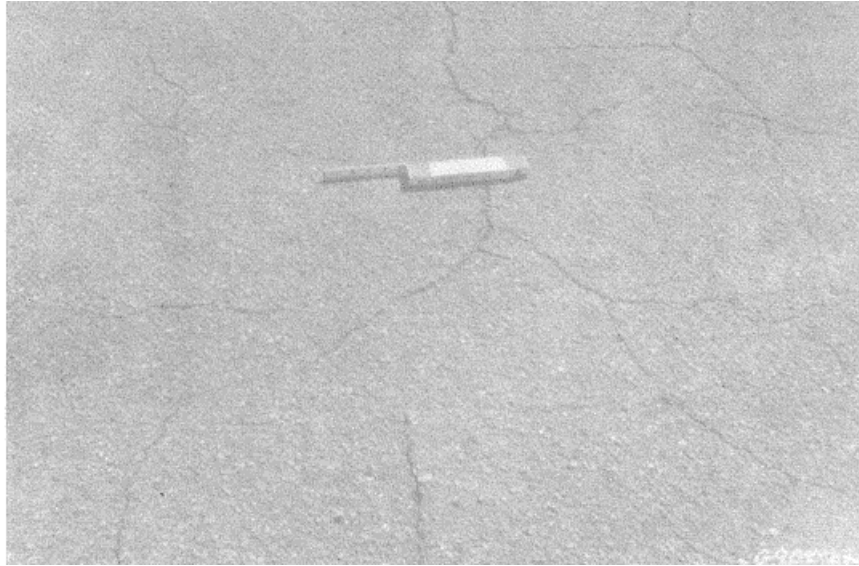
Figure A-8. Low severity block cracking, case 1.

(a) *Low severity level (L).* Blocks are defined by cracks that are nonspalled (sides of the crack are vertical) or only lightly spalled with no loose particles, causing no foreign object damage (FOD) potential. Nonfilled cracks have 1/4 inch or less mean width, and filled cracks have a filler in satisfactory condition (figs. A-8 through A-10).

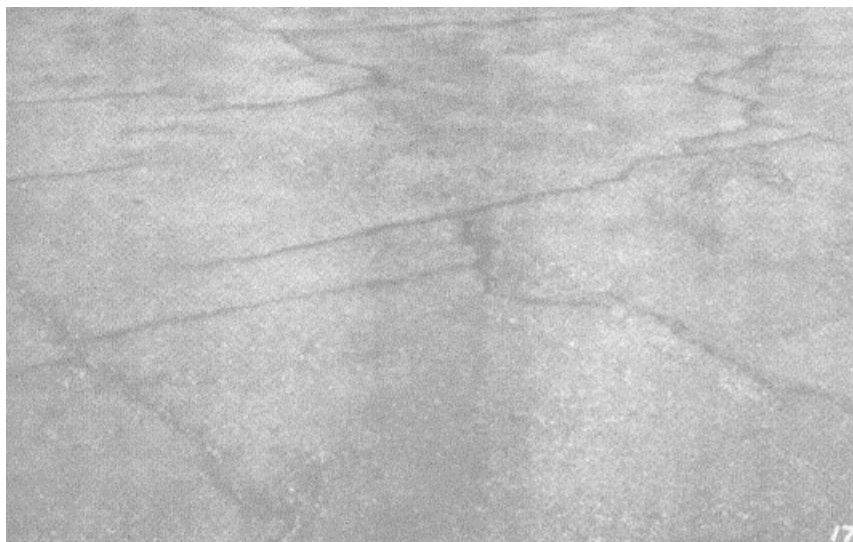
Figure A-11. Medium severity block cracking, case 1.

- (b) *Medium severity level (M)*. Blocks are defined by one of three different ways.
- Filled or nonfilled cracks that are moderately spalled with some loose particles (some FOD potential).
 - Nonfilled cracks that are not spalled or have only minor spalling with few loose particles (some FOD potential), but have a mean width greater than approximately 1/4 inch.
 - Filled cracks that are not spalled or have only minor spalling with few loose particles (some FOD potential), but have filler in unsatisfactory condition (figs. A-11 and A-12).

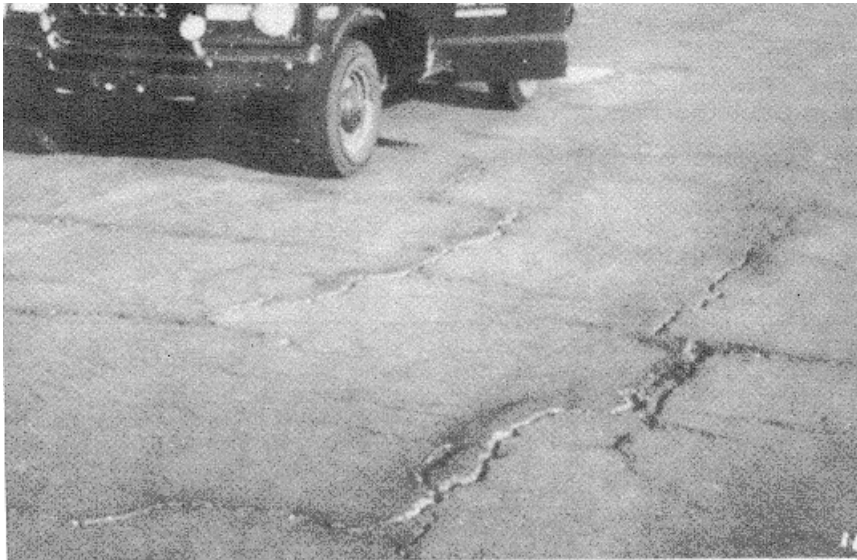
Figure A-13. High severity block cracking case 1.

(c) *High severity level (H).* Blocks are well defined by cracks that are severely spalled with loose and missing particles, causing a definite FOD potential. Such an example is show in figures A-13 through A-14.

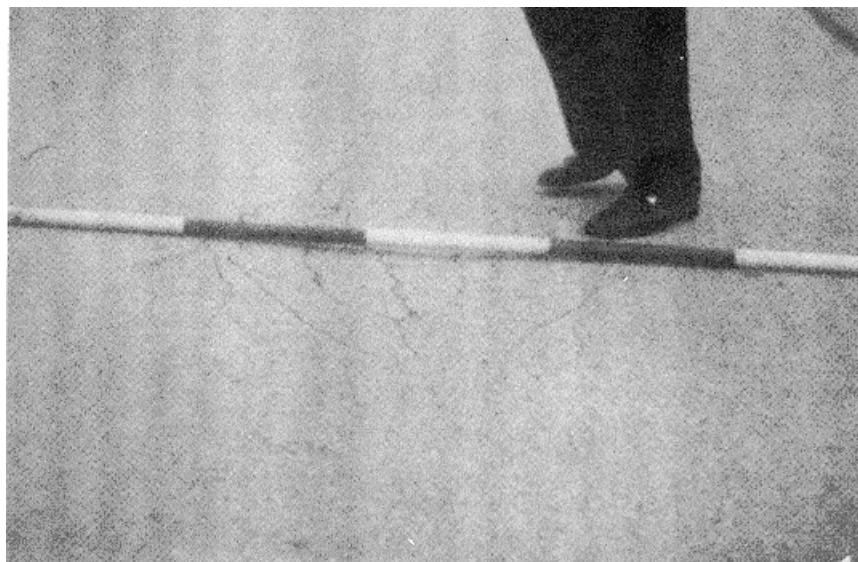
Figure A-18. Medium severity depression, case 1.

(b) *Medium severity level (M)*. The depression can be observed, moderately affects pavement riding quality, and causes hydroplaning potential on runways (see measurement criteria below) (figs. A-18 and A-19).

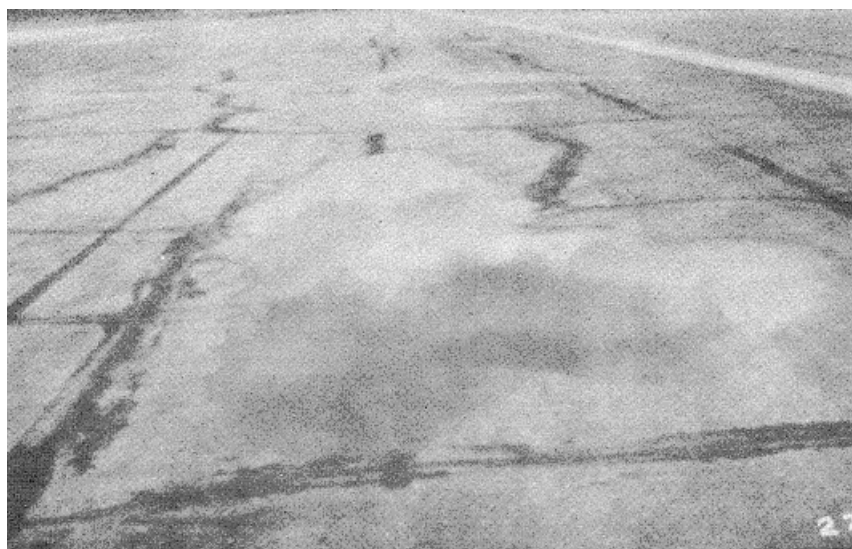
Figure A-20. High severity depression

(c) High severity level (H). The depression can be readily observed, severely affects pavement riding quality, and causes definite hydroplaning potential (see measurement criteria below) (fig. A-20).

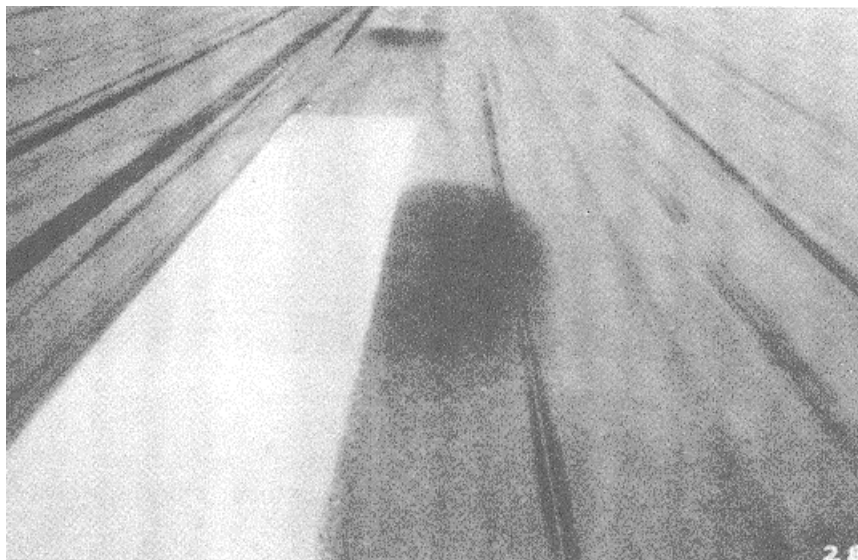
Figure A-21. *Jet blast erosion, case 1.*

(2) *Severity levels.* No degrees of severity are defined. It is sufficient to indicate that jet blast erosion exists (figs. A-21 and A-22).

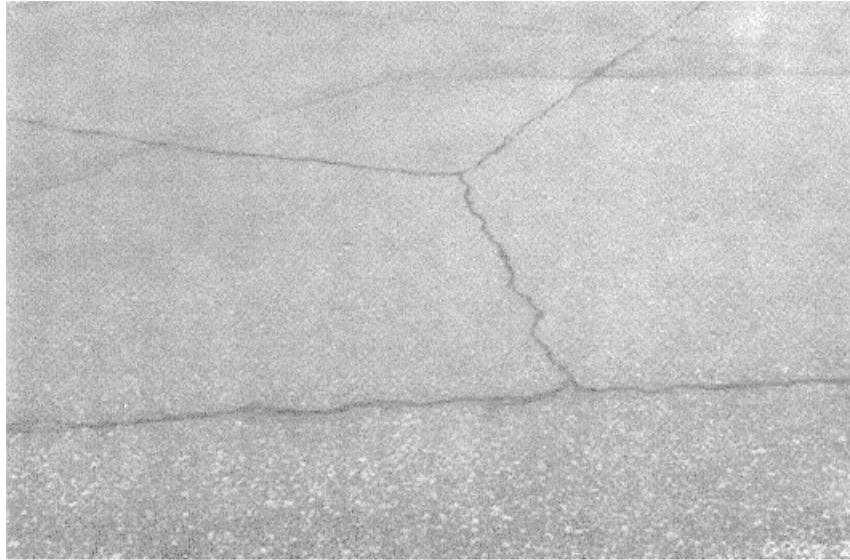
Figure A-23. *Low severity joint reflection cracking.*

(a) *Low severity level (L).* Cracks have only light spalling (little or no FOD potential) or no spalling and can be filled or nonfilled. If nonfilled, the cracks have a mean width of $\frac{1}{4}$ inch or less. Filled cracks are of any width, but their filler material is in satisfactory condition (fig. A-23).

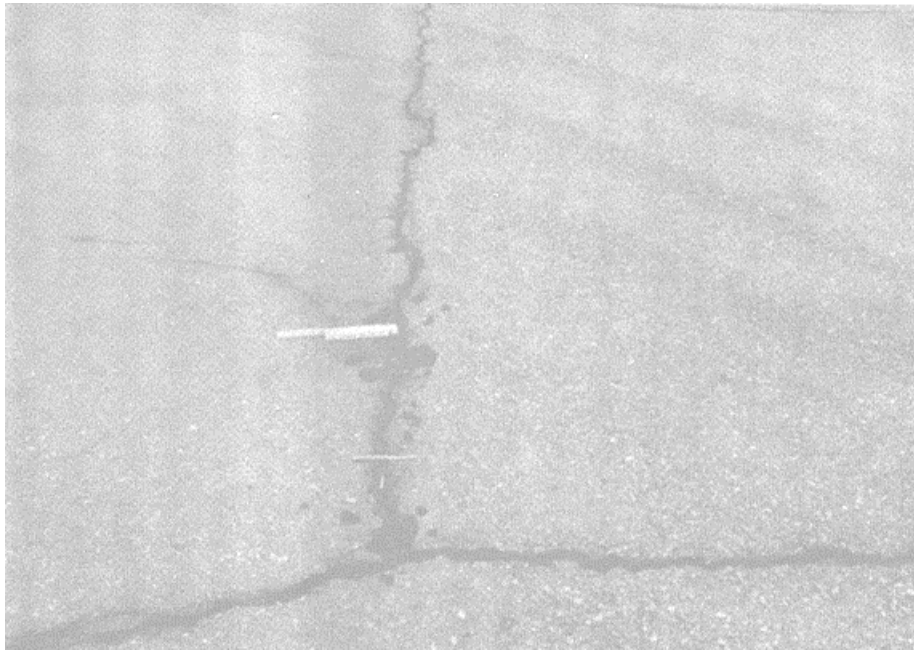
Figure A-24. Medium severity joint reflection cracking case 1.

- Cracks are moderately spalled with some loose particles (some FOD, potential) and can be either filled or nonfilled and of any width.
- Filled cracks are not spalled or are only lightly spalled, but the filler is in unsatisfactory condition.
- Nonfilled cracks are not spalled or are only lightly spalled, but the mean crack width is greater than $\frac{1}{4}$ inch.
- Light random cracking exists near the crack or at the corners of intersecting cracks (figures A-24 through A-25).

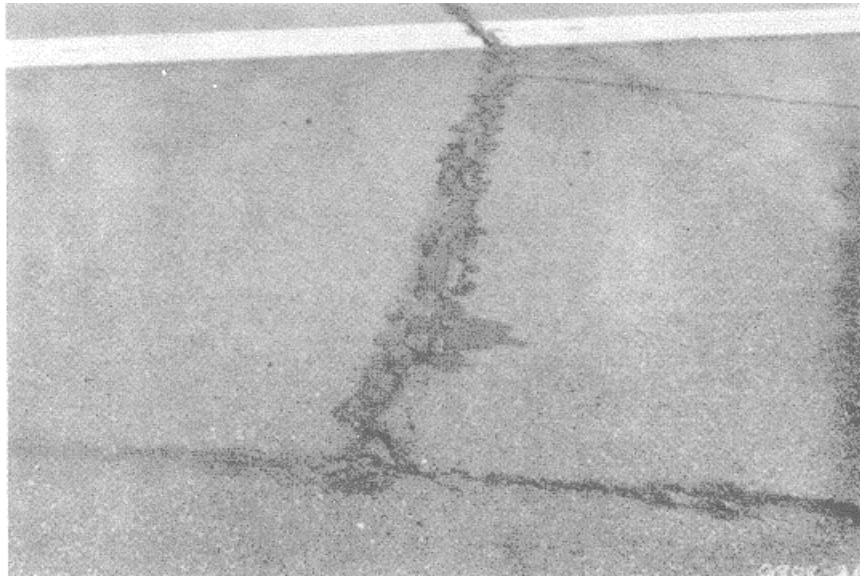
Figure A-26. High severity joint reflection cracking.

(c) *High severity level (H)*. Cracks are severely spalled with loose and missing particles (definite FOD potential) and can be either filled or nonfilled and of any width.

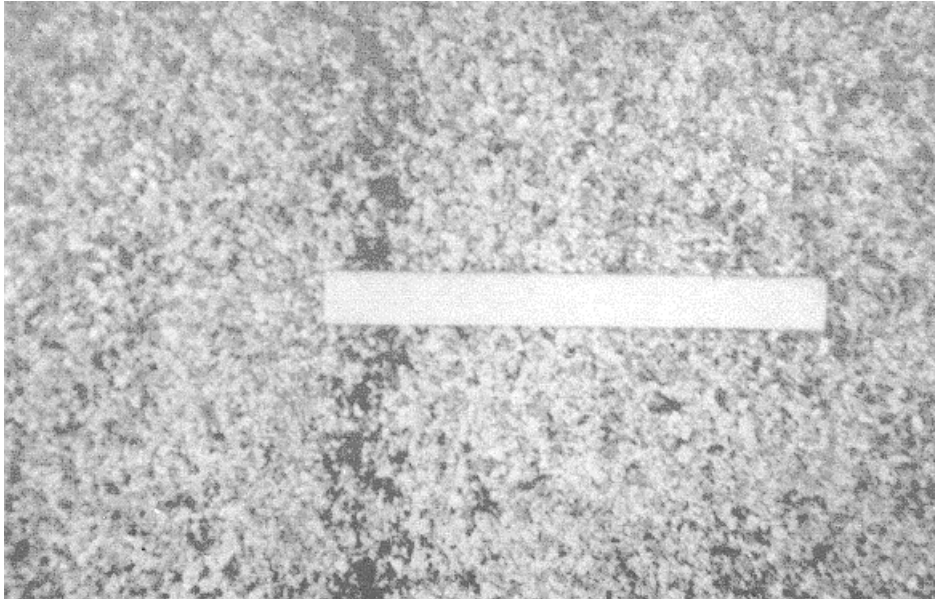
Figure A-29. Low severity crack, porous friction course pavement.

- Cracks have either minor spalling with no loose particles (little or no FOD potential) or no spalling. The cracks can be filled or nonfilled. Nonfilled cracks have a mean width of 1/4 inch or less. Filled cracks are of any width, but their filler material is in satisfactory condition (figs. A-27 and A-28).
- For porous friction courses, the average raveled area around the crack is less than 1/4-inch wide (fig. A-29).

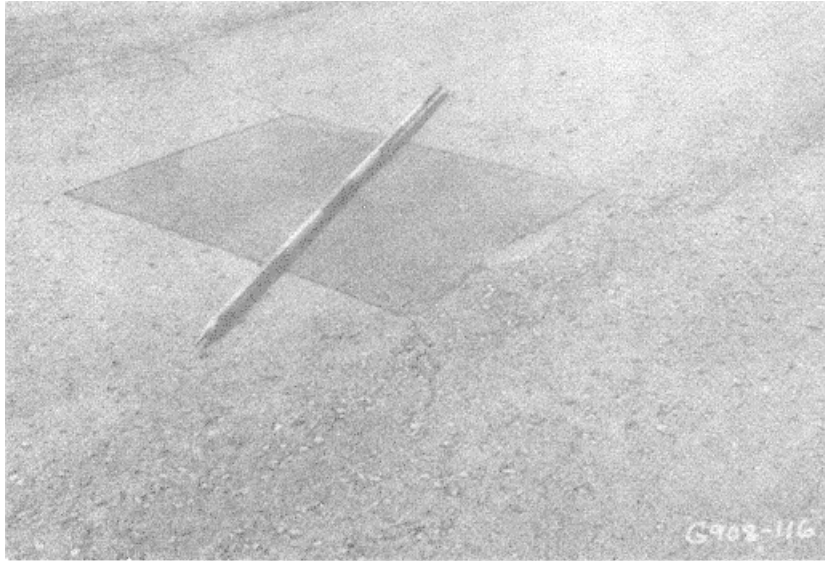
Figure A-37. Low severity patch, case 1.

- Patch is in good condition and is performing satisfactorily (figs. A-37 and A-38).
- For porous friction courses. The use of dense-graded AC patches in porous friction surfaces causes a water damming effect at the patch, which contributes to differential skid resistance of the surface. Low-severity dense-graded patches should be rated as medium-severity due to the differential friction problem.

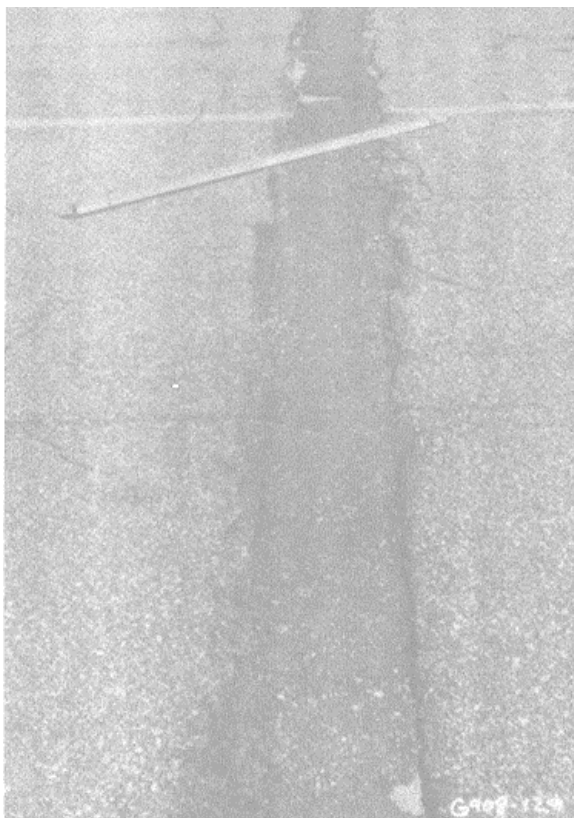
Figure A-39. Medium severity patch.

(b) *Medium severity level (M)*. Patch is somewhat deteriorated and affects riding quality to some extent (fig. A-39).

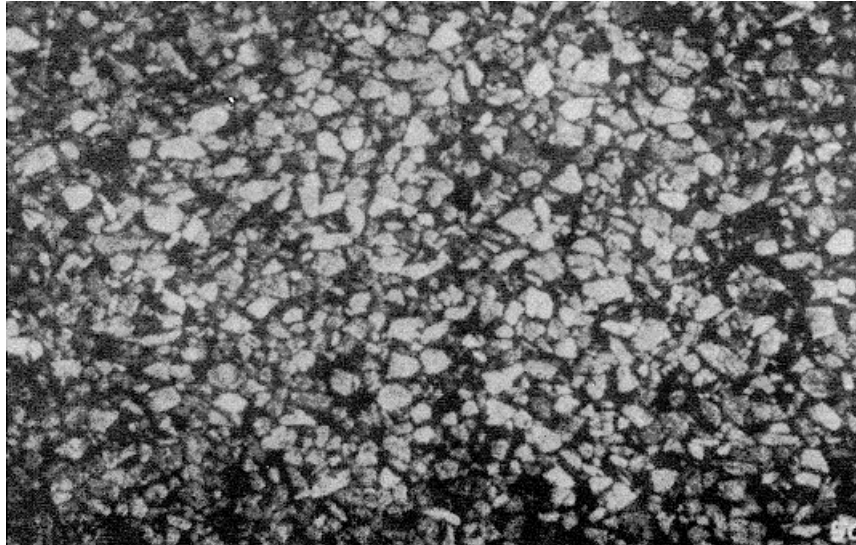
Figure A-41. Polished aggregate.

(2) *Severity levels.* No degrees of severity are defined. Polished aggregate should not be counted unless detected on a runway or high speed taxiway and the degree of polishing should be significant before it is included in the condition survey and rated as a defect (fig. A-41).

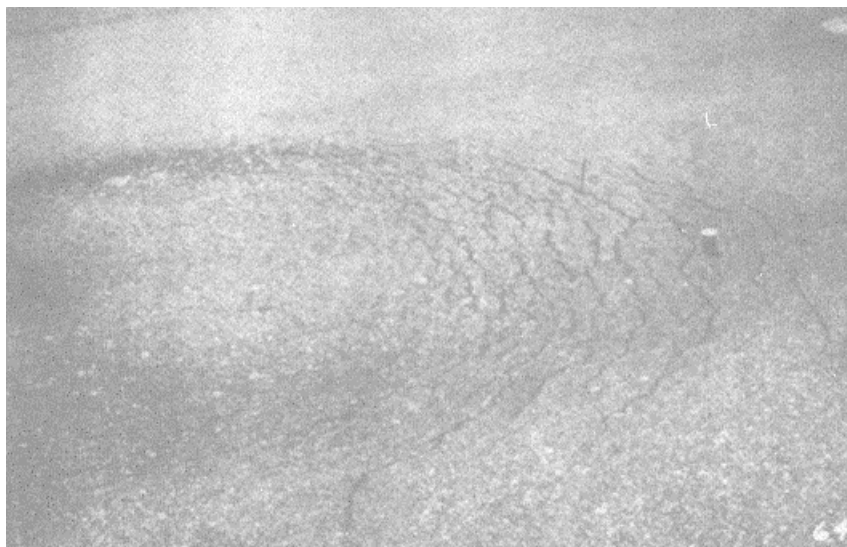
Figure A-60. Slippage cracking, case 1.

(2) *Severity levels.* No degrees of severity are defined. It is sufficient to indicate that slippage crack exists (figs. A-60 and A-61).

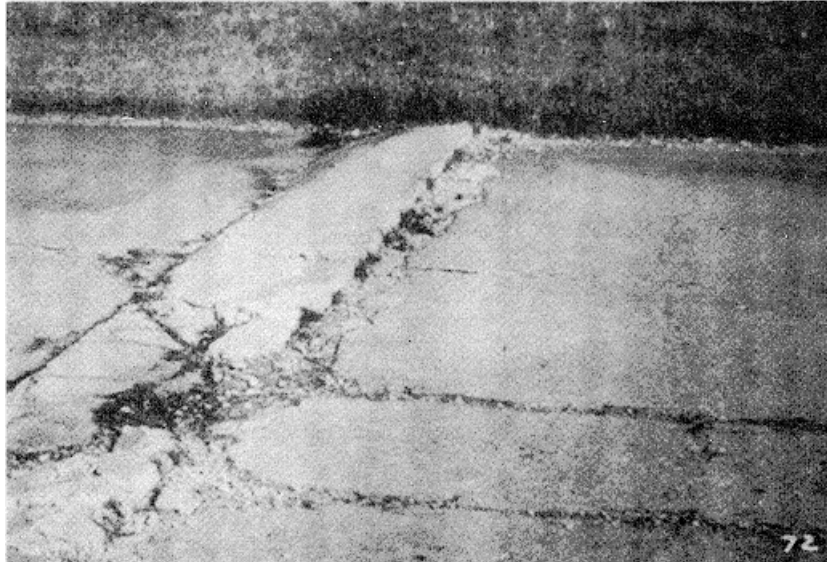
Figure A-68. High severity blowup.

(c) *High severity level (H)*. Buckling or shattering has rendered the pavement inoperative (fig. A-68). For the pavement to be considered operational, all FOD material caused by the blowup must be removed.

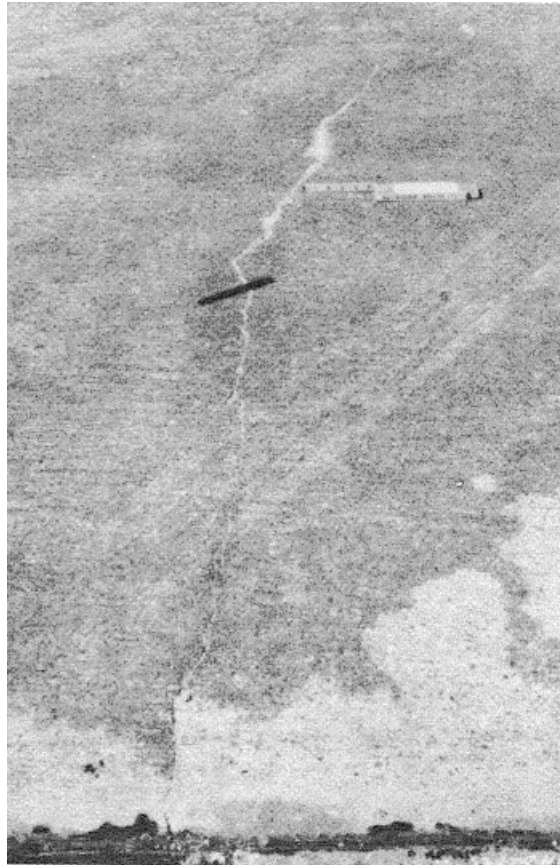
Figure A-74. Low severity longitudinal crack.

- Nonfilled cracks less than 1/8-inch wide with little or no spalling and no loose particles (no FOD potential) (figs. A-74 and A-76).
- Filled cracks of any width but filler material must be in satisfactory condition with no faulting or spalling and no FOD potential (fig. A-75).

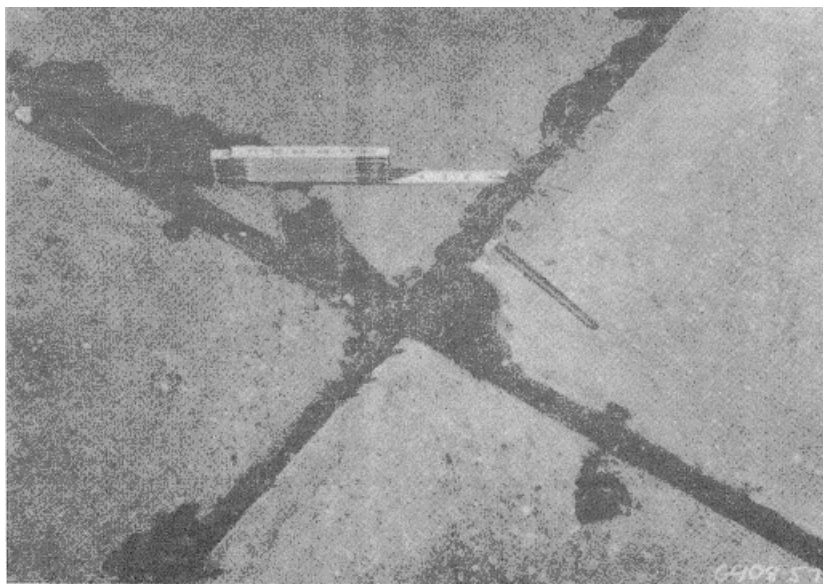
Figure A-89. High severity joint seal damage.

replacement (figs. A-89 and A-90). There is a complete loss of sealant, and joint is filled with incompressible material (fig. A-89).

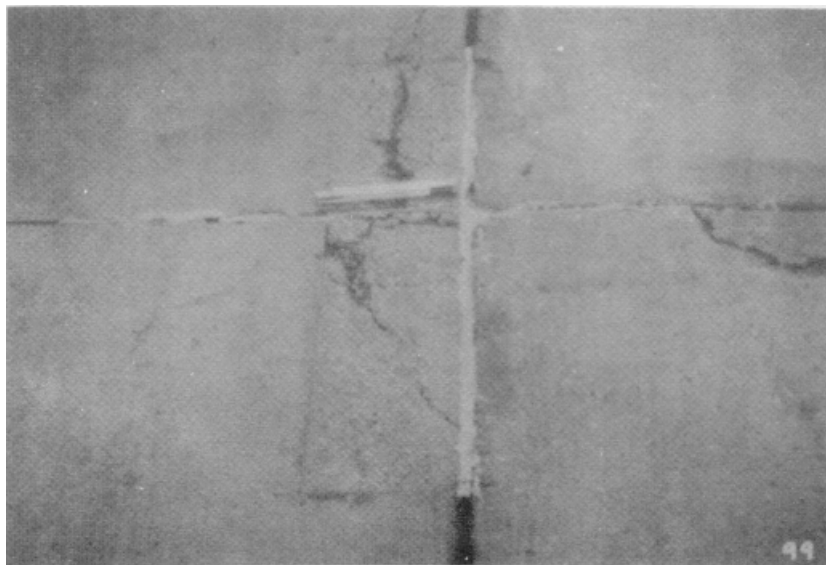
Figure A-95. High severity small patch.

(c) *High severity level (H).* Patch has deteriorated, either by spalling around the patch or cracking within the patch, to a state which warrants replacement (fig. A-95).

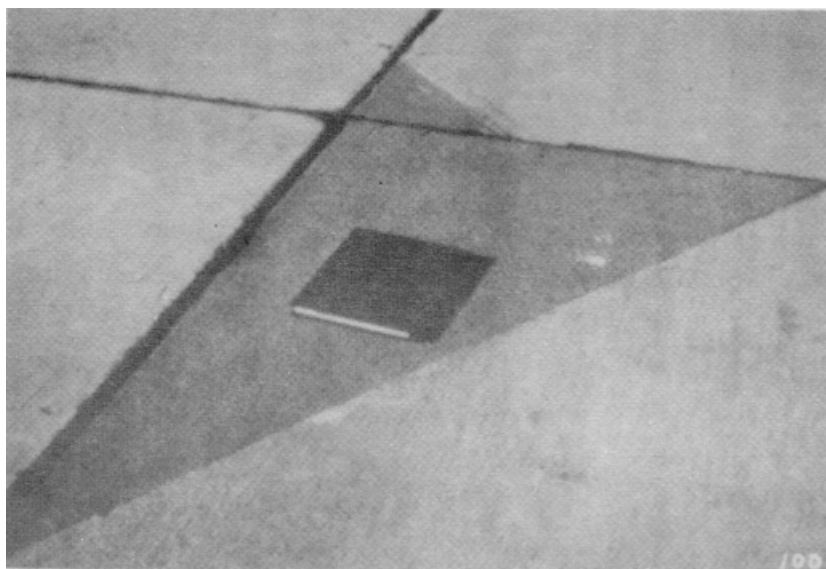
Figure A-96. Low severity patch, case 1.

(a) *Low severity level (L).* Patch is functioning well with very little or no deterioration (figs. A-96 through A-98).

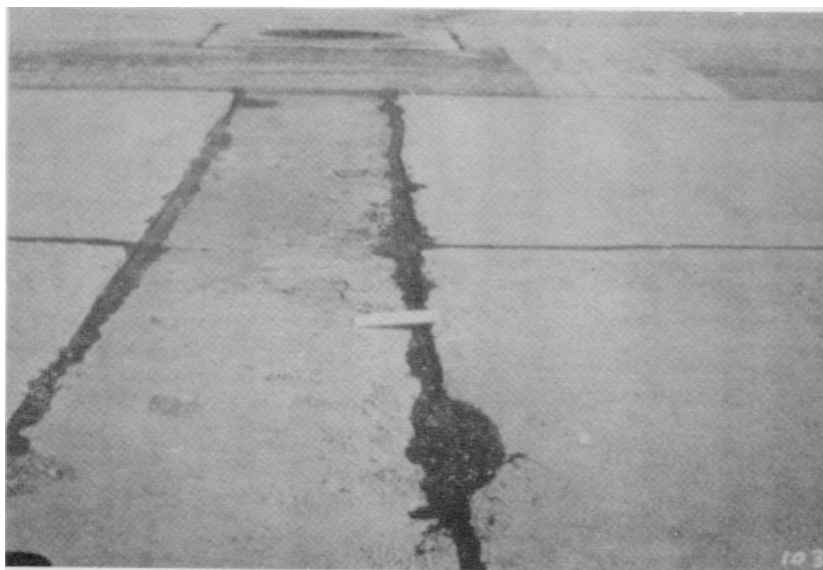
Figure A-99. Medium severity utility cut.

(b) *Medium severity level (M)*. Patch is deteriorated and/or moderate spalling can be seen around the edges. Patch material can be dislodged with considerable effort causing some FOD potential (fig. 99).

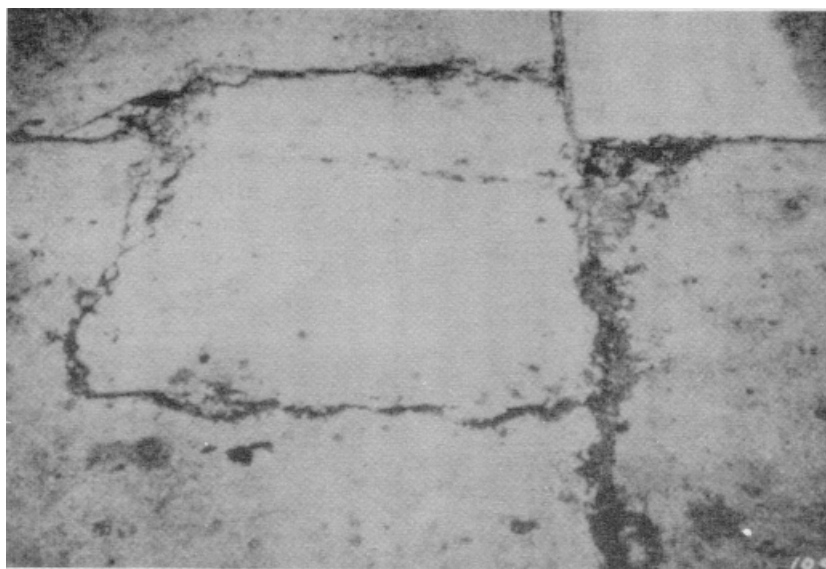
Figure A-100. High severity patch.

(c) *High severity level (H)*. Patch has deteriorated to a state which causes considerable roughness with loose or easily dislodged material (high FOD potential). The extent of the deterioration warrants replacement of the patch (fig. A-100).

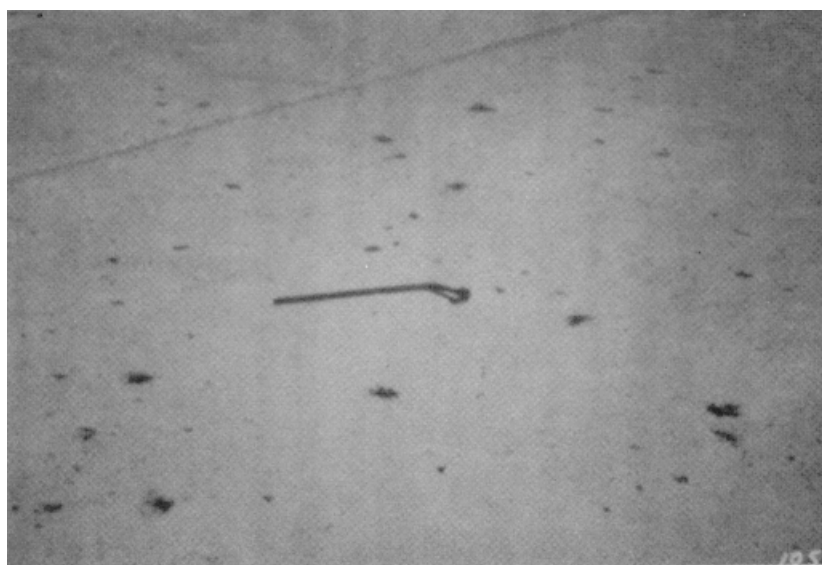
Figure A-102. Pumping.

(2) *Severity levels.* No degrees of severity are defined. It is sufficient to indicate that pumping exists (figs. A-102 through A-105). Fine material on surface that has been pumped out causing corner break, stains on pavement, and close-up of fine materials collecting in a joint are show in figures A-102 through A-105, respectively.

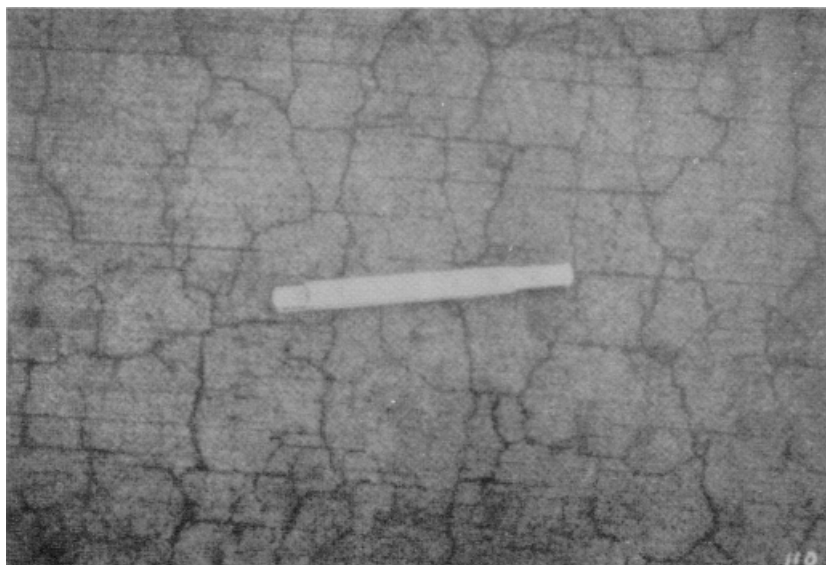
Figure A-107. Low severity crazing.

(a) *Low severity level (L).* Crazing or map cracking exists over most of the slab area. The surface is in good condition with no scaling (fig. A-107). The low severity level is an indicator that scaling may develop in the future. A slab should be counted only if in the judgment of the inspector scaling is likely to occur within a few years.

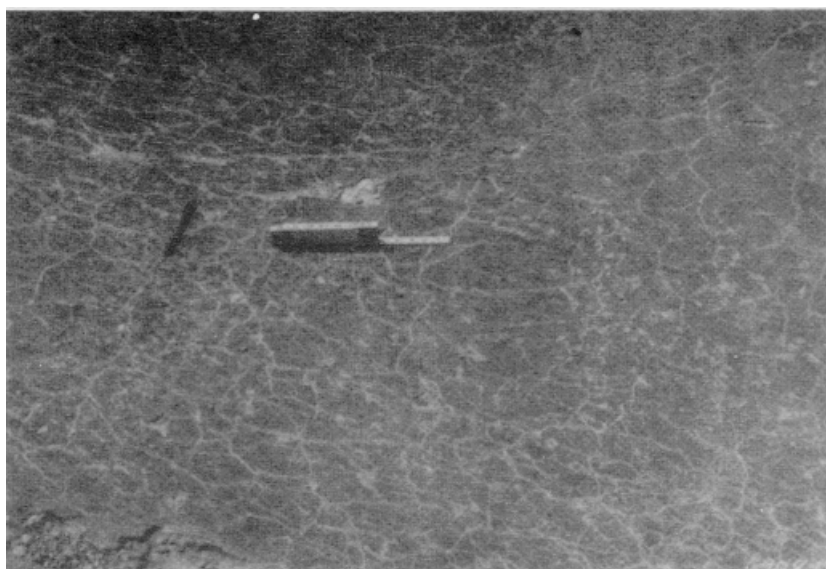
Figure A-108. Medium severity scaling.

(b) *Medium severity level (M)*. Slab is scaled over approximately 5 percent or less of the surface with loose or missing material causing some FOD potential (fig. A-108).

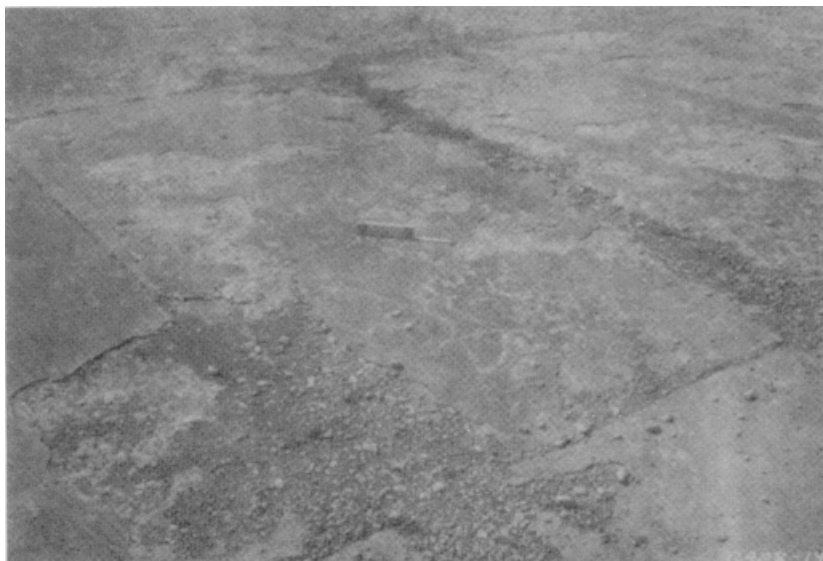
Figure A-109. High severity scaling.

(c) *High severity level (H)*. Slab is severely scaled with a large amount of loose or missing material causing a high FOD potential. Usually more than 5 percent of the surface is affected (figs. A-109 and A-110).

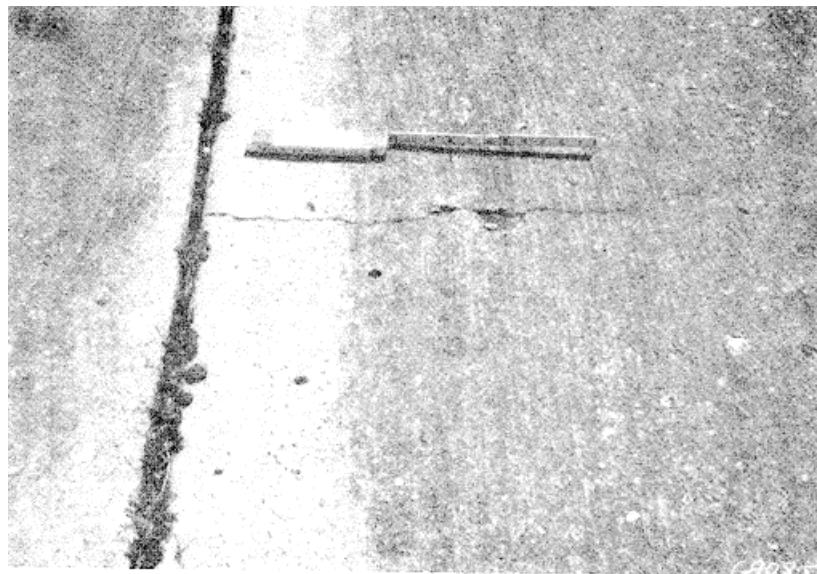
Figure A-122. Shrinkage crack, case 1

(2) Severity levels. No degrees of severity are defined. It is sufficient to indicate that shrinkage cracks exist (figs. A-122 and A-123).
