Project Title: Colville Confederated Tribes Substation Construction

Document Title: Final Technical Report

CIPV Substation Operations Manual

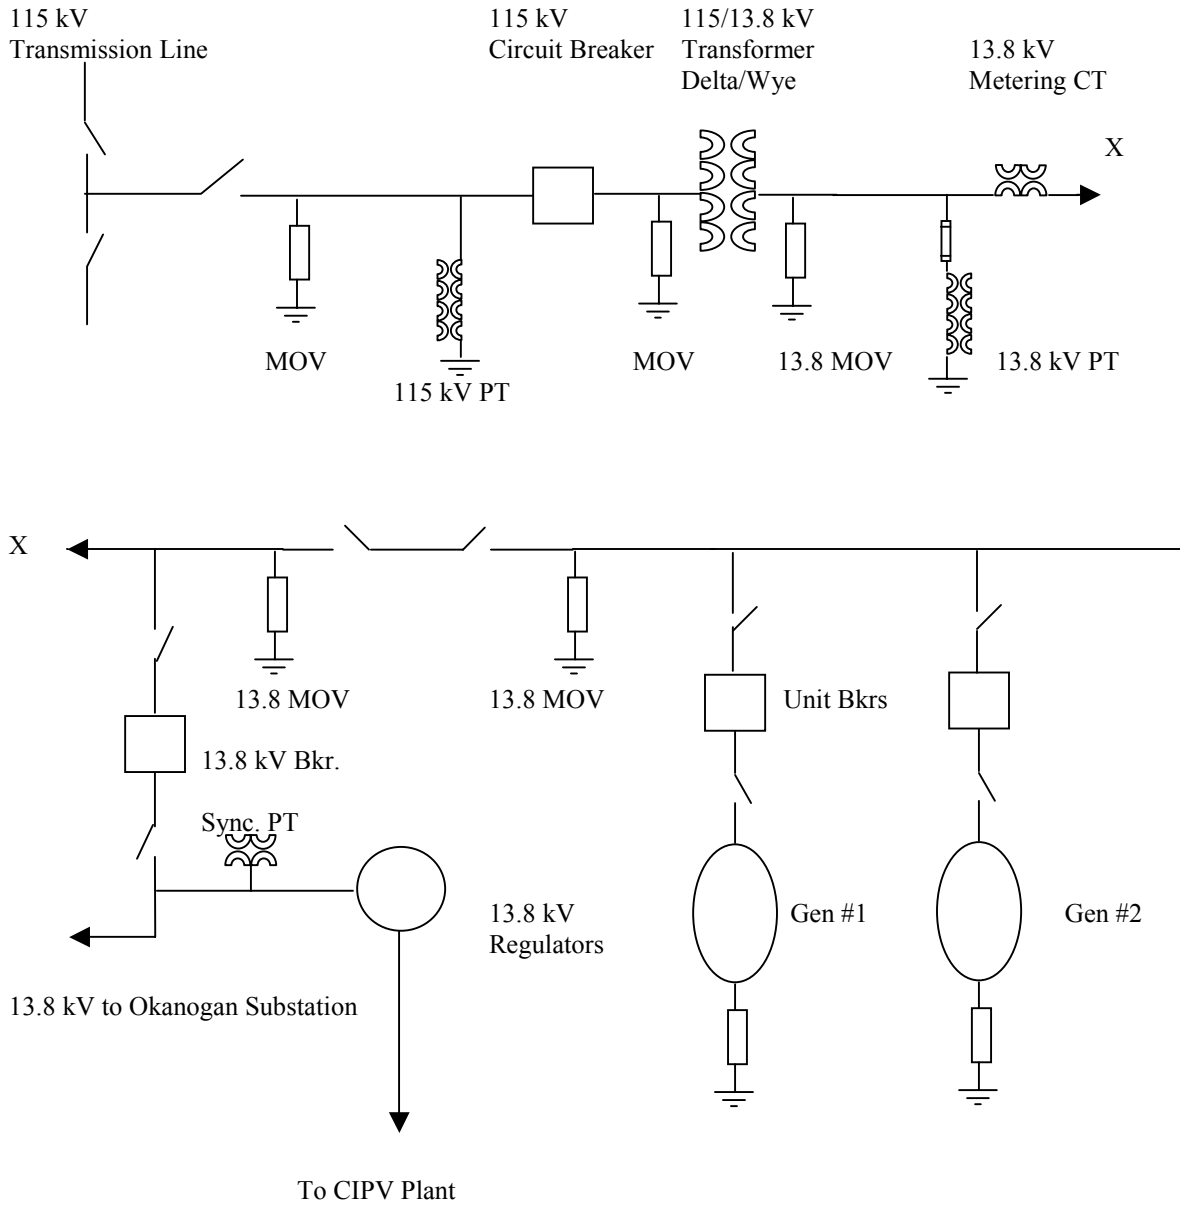
CIPV Substation
Simplified One Line Diagram:

The CIPV substation is connected to the Omak-Okanogan 115 kV transmission line owned and operated by Okanogan PUD. Two 115 kV disconnect switches have been installed in series with the line on CIPV property. The midpoint of the switches has been tapped and connected to the 115 kV substation entrance structure. A 115 kV disconnect switch is included on the entrance structure to provide a local visible opening of the 115 kV supply.
