Fact Sheet

June 2010

Site Investigation of the February 2009 Jet Fuel Pipeline Leak

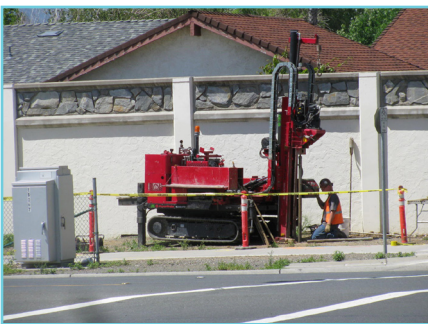
A drilling specialist positions a track-mounted drill rig to install a test boring. Soil samples from the boring were inspected to characterize subsurface soil conditions.

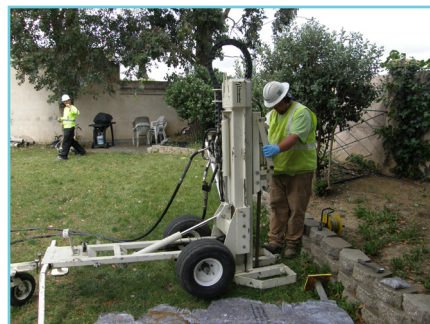
A drilling specialist uses a mobile Geoprobe drill rig to collect soil samples. This type of sampling equipment works well in confined spaces and areas with limited access.

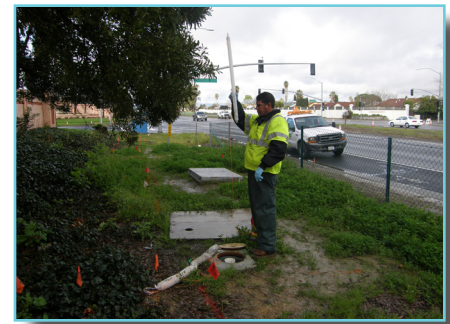
A field technician inspects a groundwater sample in a bailer. Visual inspections of water samples from monitoring wells identified the presence of fuel on the water table.

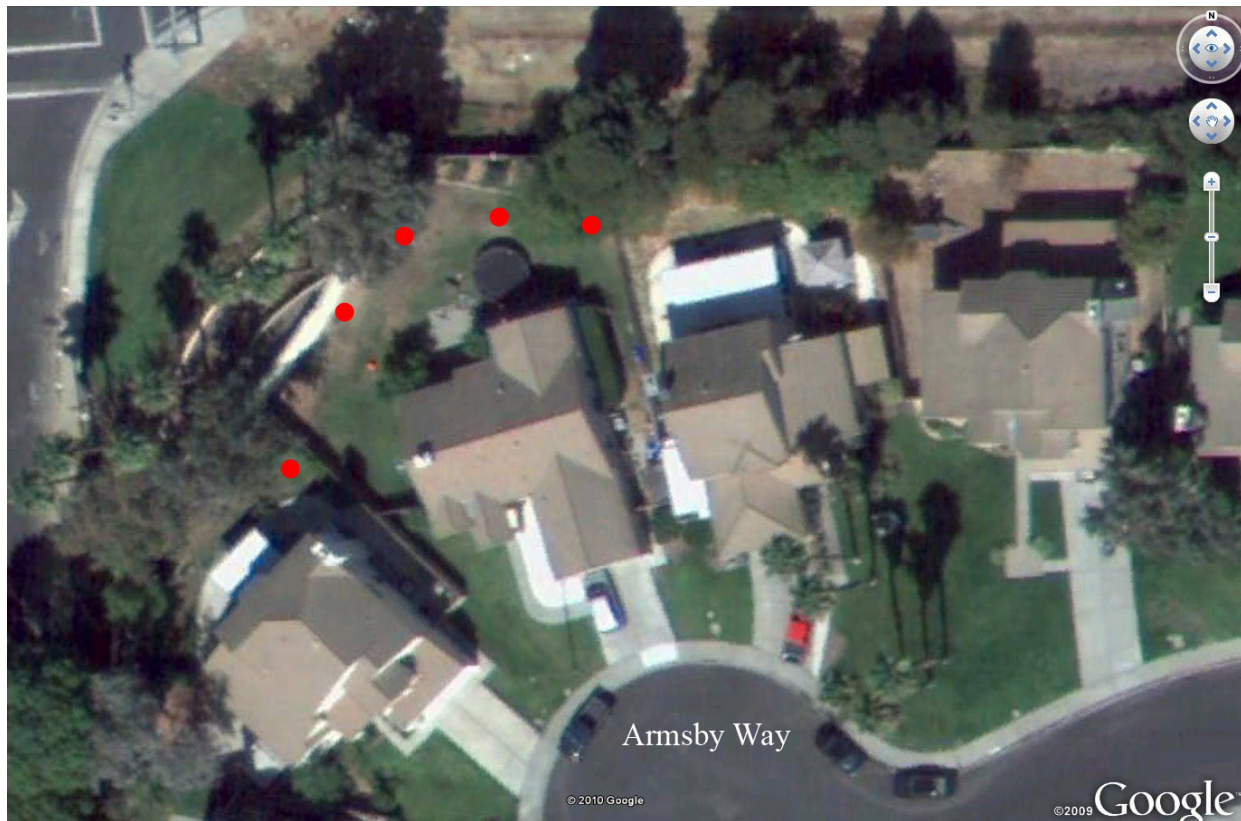
The results from the soil and groundwater sample analysis currently show that the fuel has migrated beneath the back yards of three homes in Lawler Ranch. The northern boundary of the fuel contamination has been established, but the southern boundary has yet to be determined.

Overhead view of the southern part of the Jet Fuel Leak Area. The red dots represent the highest fuel concentrations found in subsurface soil samples.

After reviewing the results of the Site Investigation field and laboratory data, Travis AFB and SCDRM decided that an additional round of sample collection and analysis are needed to complete the Site Investigation and select the appropriate cleanup strategies. Often, an environmental investigation is conducted in phases to fill in data gaps and completely identify the nature and extent of contamination. New sample locations, based on the results from previous sample locations, have been identified and will be approved by all interested parties before the next sampling round takes place.

In addition, the field team will collect soil vapor samples from several locations to evaluate the presence of vapors from JP-8. Over the next few months, Travis AFB will coordinate a second round of field work with SCDRM and property owners. This
