# Restoring the Black River

December 2010

## Project Description

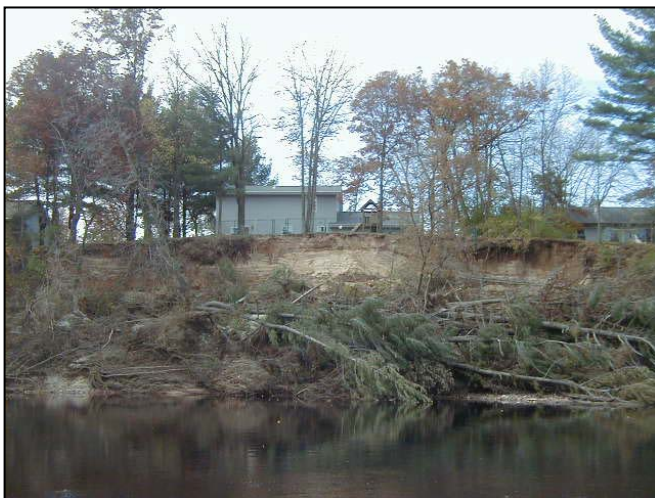
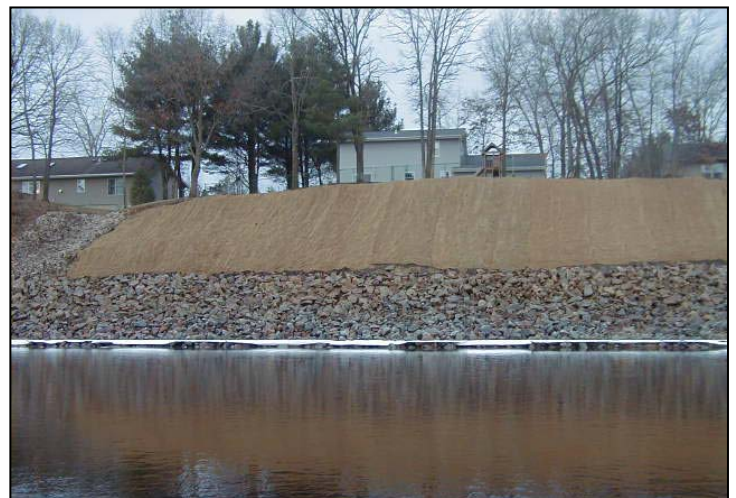
A major storm on Sept. 22-23, 2010, with significant rains caused the Black River in Jackson County, Wisconsin, to rise rapidly. The swift moving currents severely eroded and undercut the streambank along the river as it winds through the city of Black River Falls. The erosion jeopardized the stability of five homes situated along river, which would pose an immediate threat to life and property in the event of additional rains.

Through the Emergency Watershed Protection (EWP) Program, a plan was developed to stabilize the homes and alleviate the danger of additional damage. Rock riprap was used to stabilize the base of the slope. Earth fill was placed, seeded and covered with an erosion control matt.
