MEMORANDUM FOR THE RECORD

SUBJECT: Deep Sea Recovery of HEXAGON Recovery Vehicle 1201-3

Analysis of Recovered Takeup

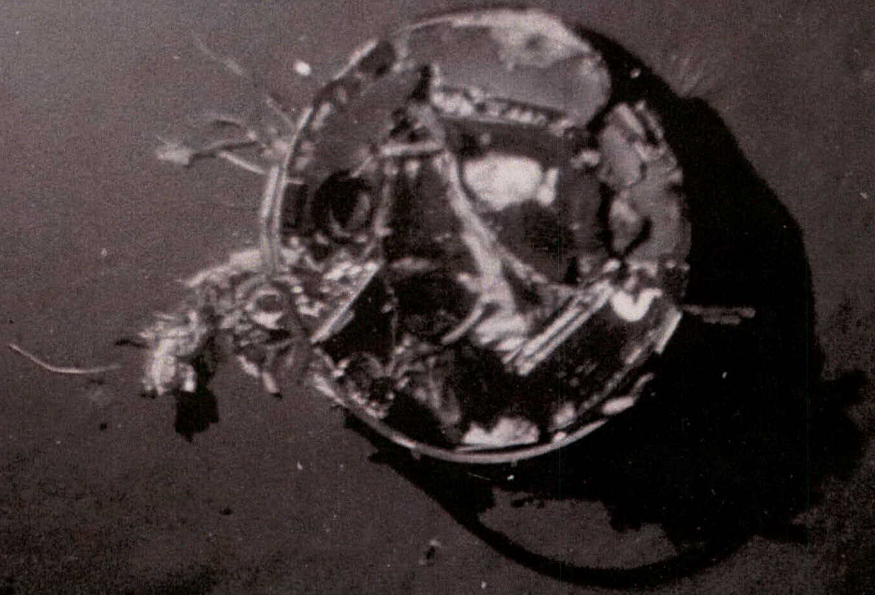
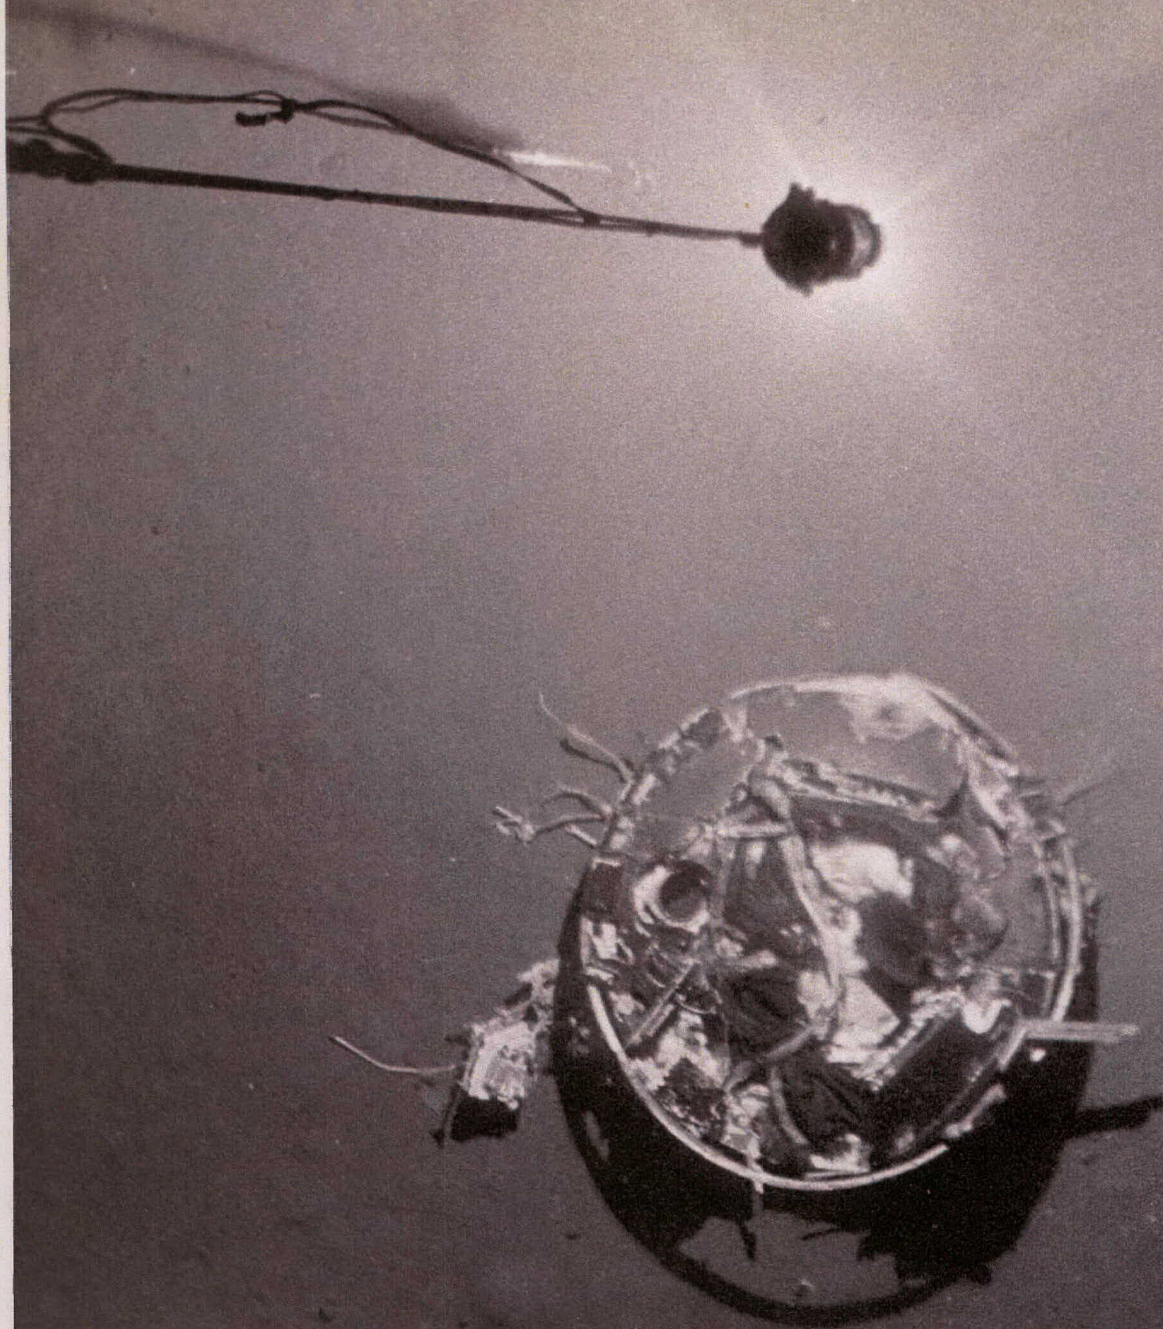
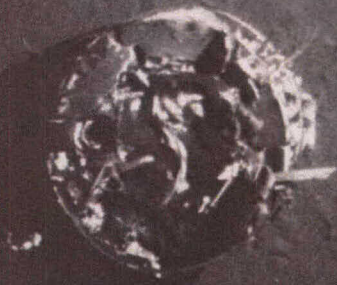
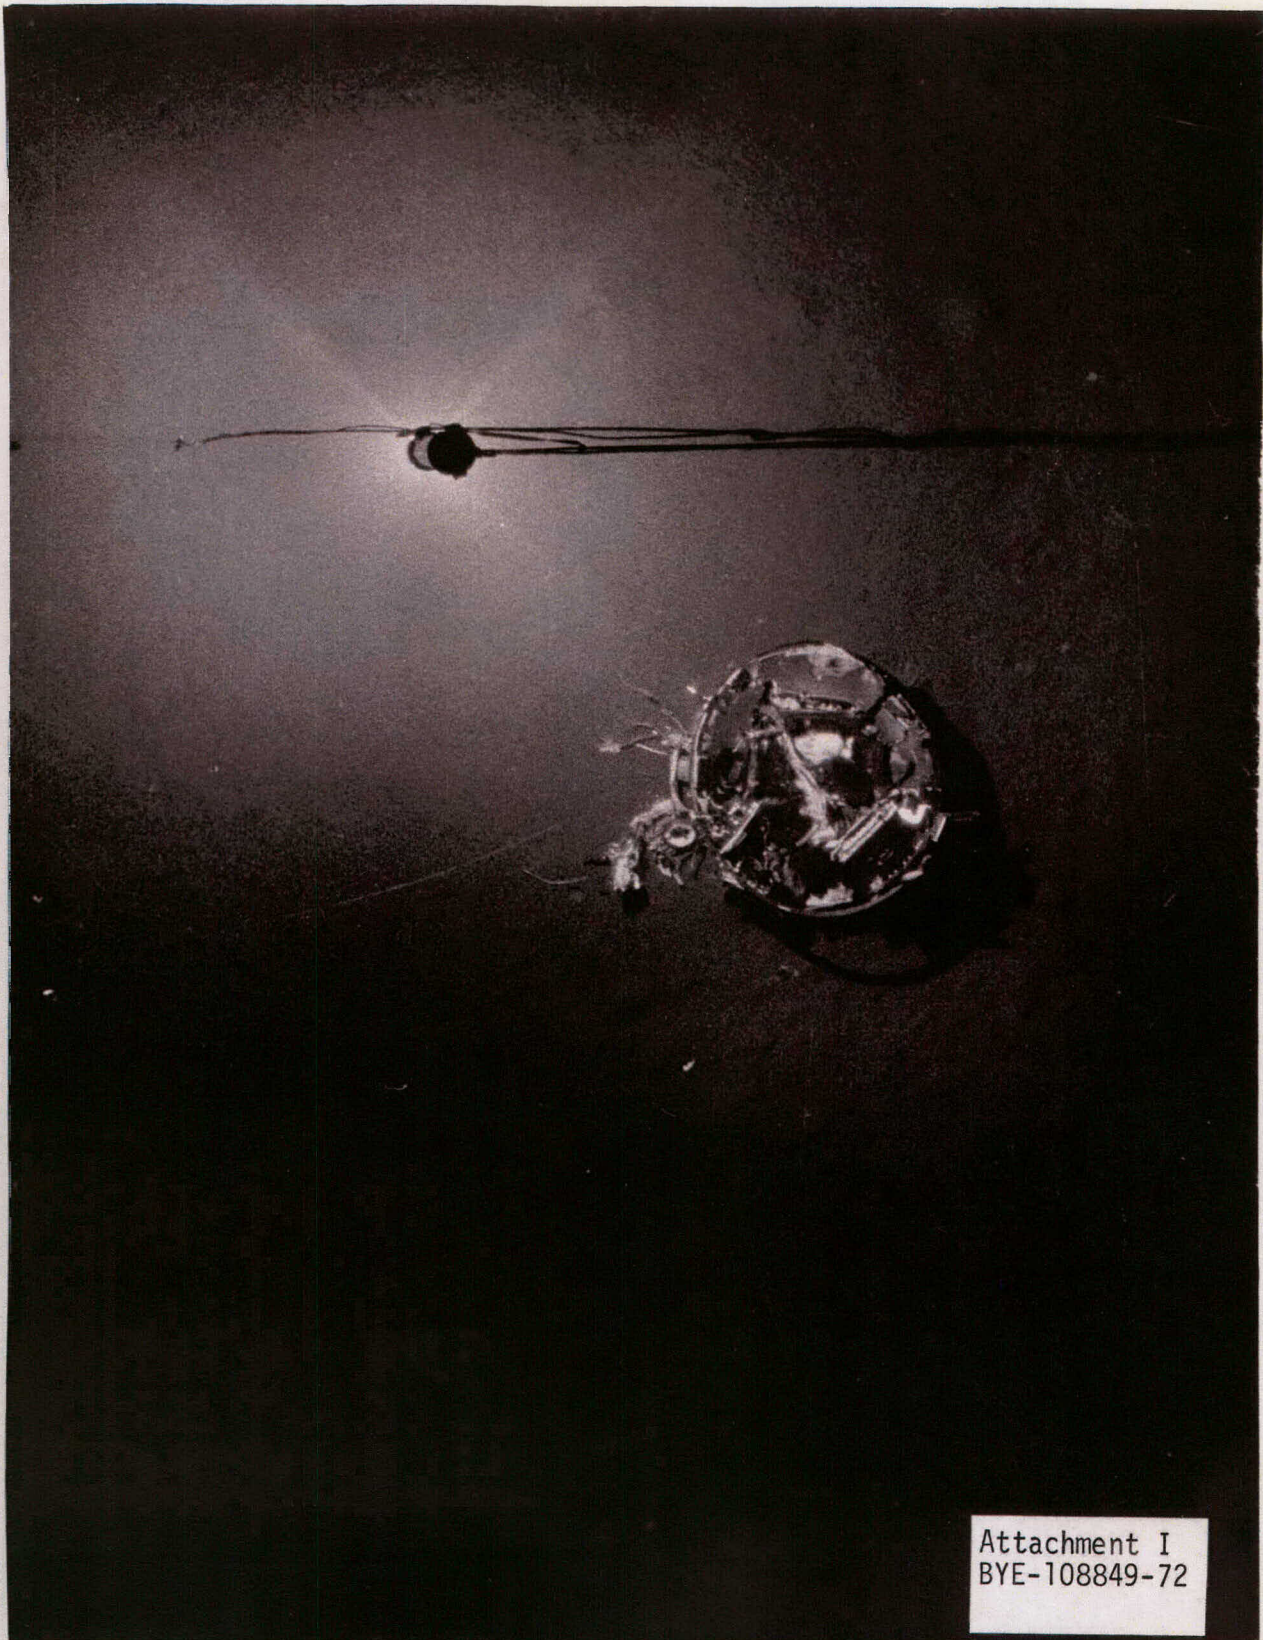
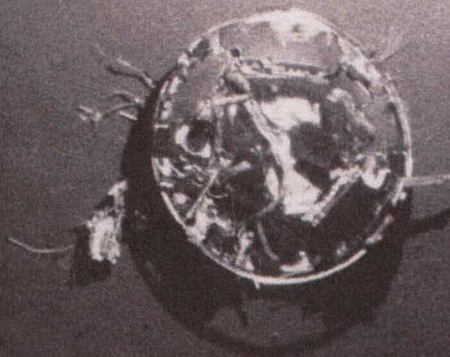
Attachment I
BYE-108849-72

3. The USNS De Steiger, under the direction of Dr. Fred Spiess, arrived in the search zone on 8 October and, after two weeks of search, located and successfully photographed the recovery vehicle. Attachment I has several of the photographs obtained from the search fish.

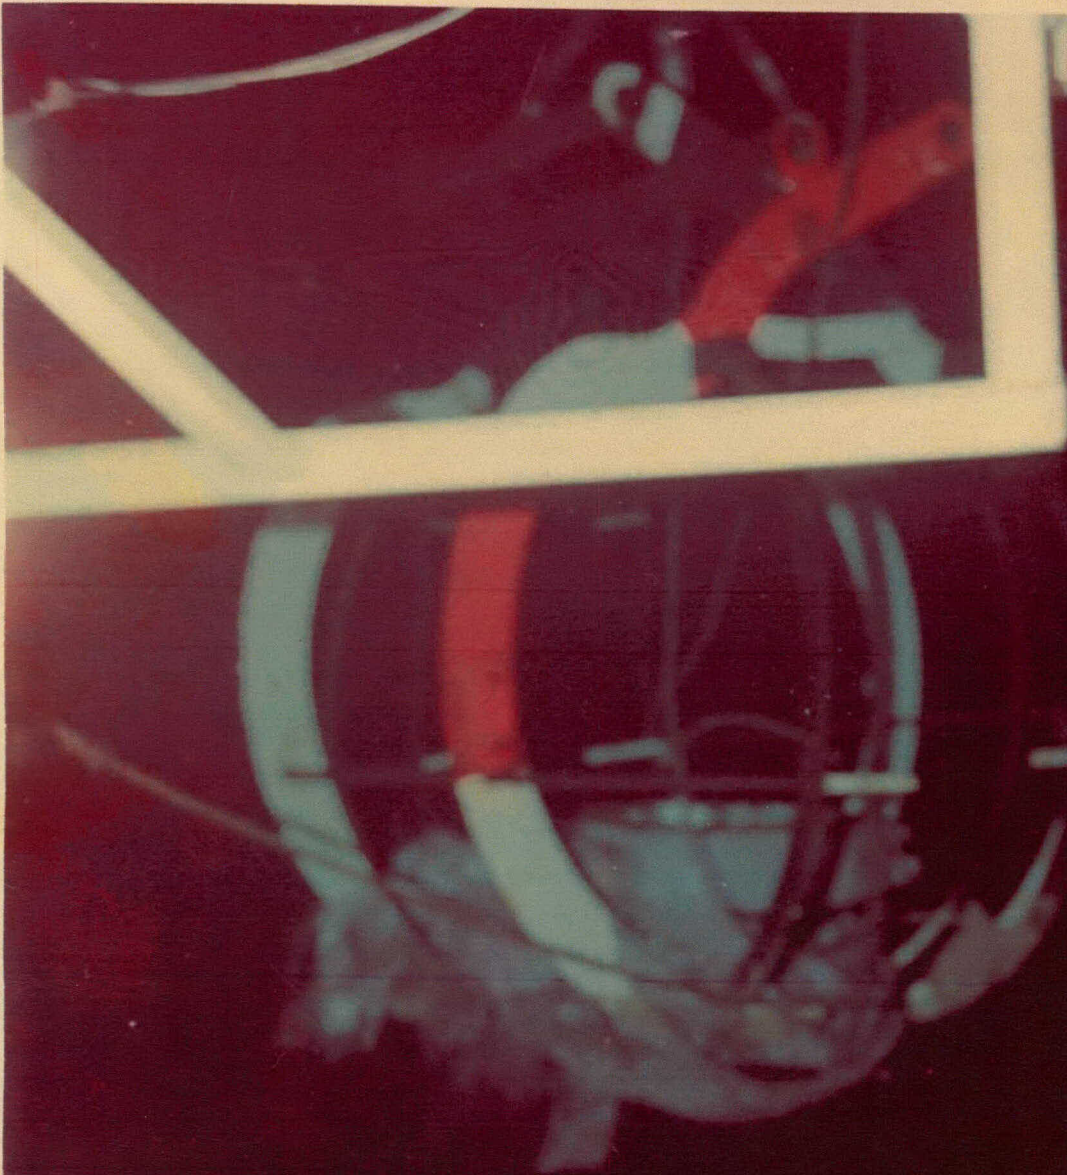
FIGURE IV E

Figure IV E shows that the stacks were recovered intact but Figure IV F shows them disintegrating as they are brought to the surface. Eastman Kodak analyzed the 25 feet of film that was recovered. They found that all of the physical properties had remained the same, but that the film had torn into 5 pieces, about one half the diameter of the core. This implies that the spokes between the A and B film stacks had cut into the film during impact, resulting in tears in the stacks that cannot be seen in the photographs. As the Trieste surfaced, pieces of the film flaked off due to the reduction of pressure and floated away.

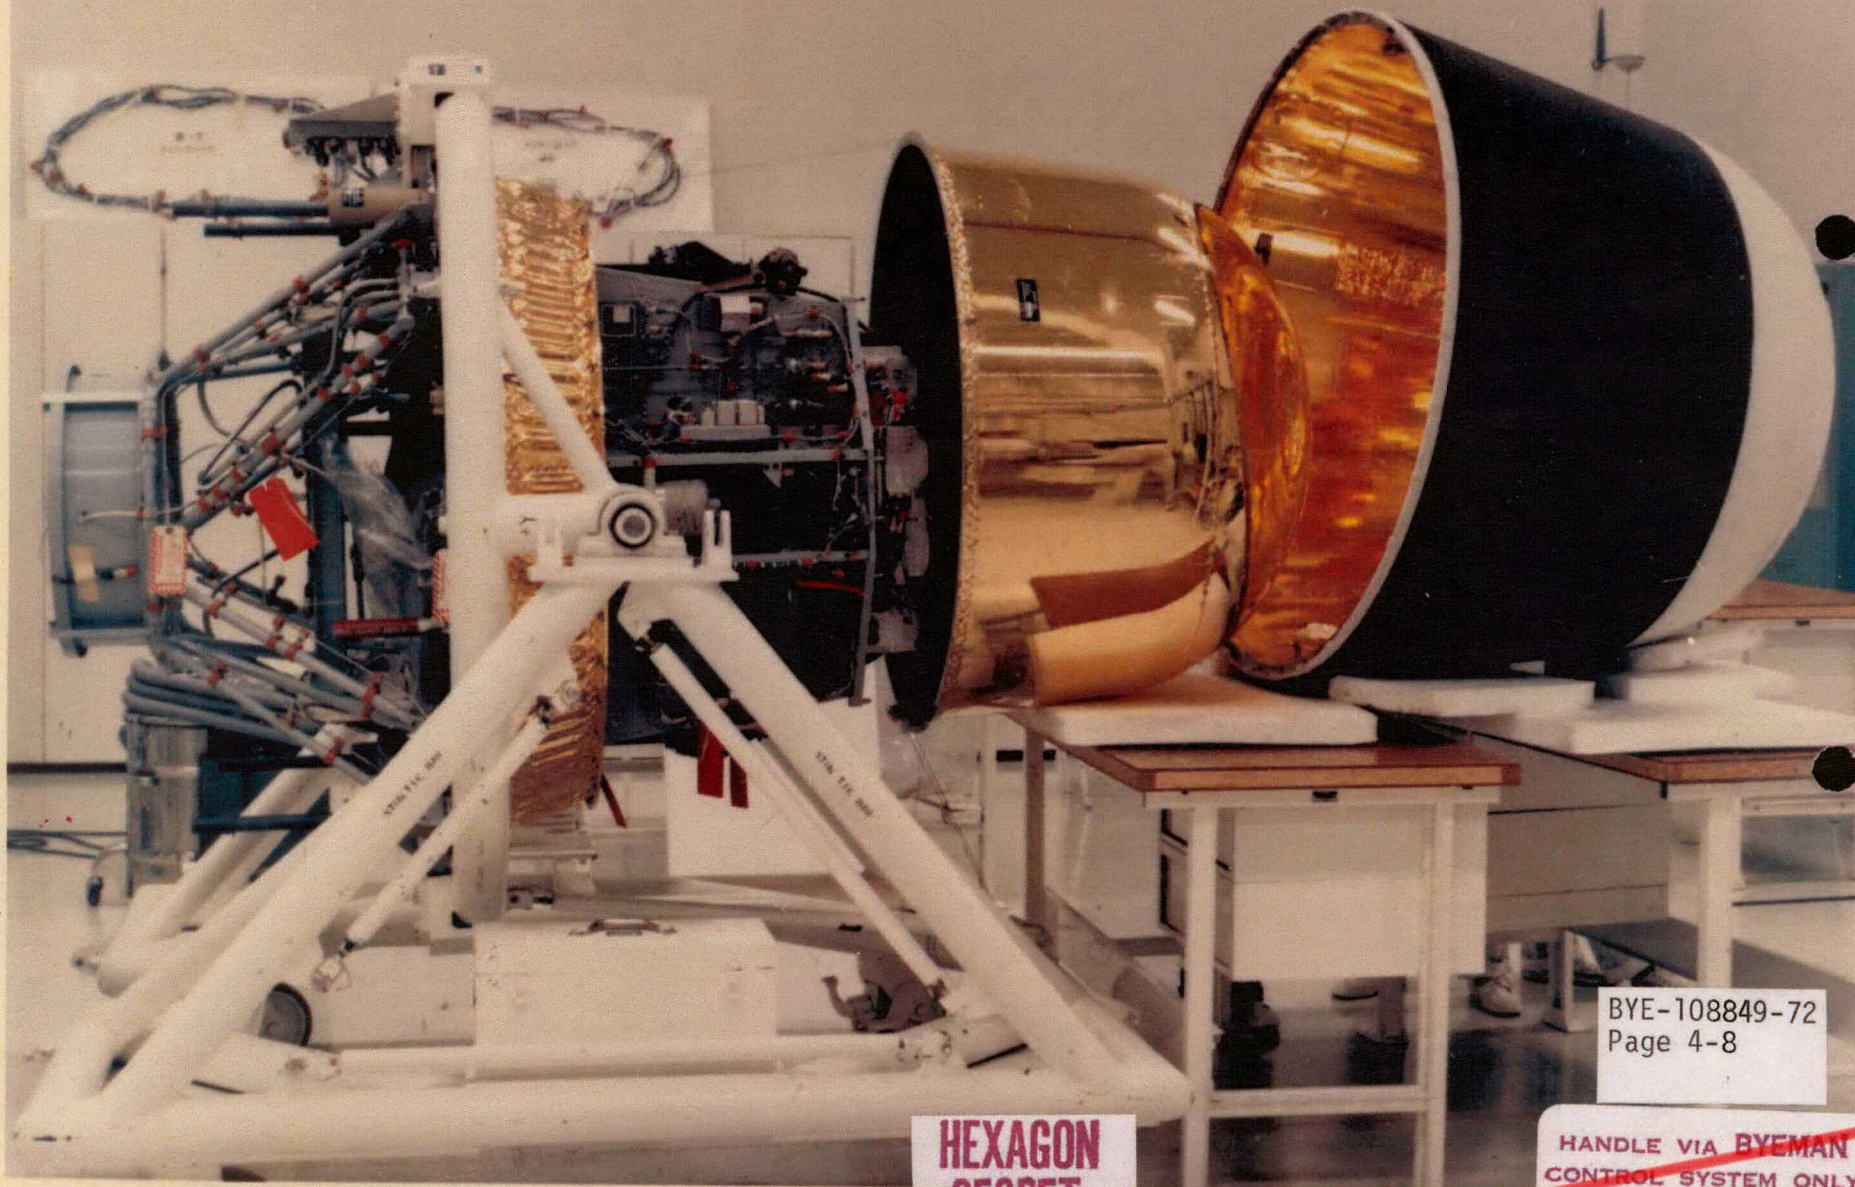
FIGURE IV G

The photographs obtained by the Trieste II showed several pieces of debris and the film spools. Figures IV G and H show the original RV and takeup configuration. The gold foil of the canister is evident in several of the photographs. Figure IV A was the first piece of debris that was sighted. It appears to be a piece of the gold canister and part of the grey RV support pallet. Figure IV B was sighted next. Several of the black takeup support arms can be seen. The main portion of the gold canister is evident in Figure IV C as well as the film spools. Figure IV D is an outstanding picture of the film stacks, looking down at the stacks. The encoder (Figure IV I) and the A1 motor drive electronics (Figure IV J) can be identified. The white lettering which is the part serial number can be seen on the encoder. The beryllium takeup core is shattered and in pieces, though some of the machine finish is still shiny. The cables going from the motor drive electronics to the motor can be seen. The shaft broke off flush with the edge of the stack, probably at impact with the water. The upper RV structure that was seen in the Dr. Spiess photographs is a separate piece and is still on the ocean bottom.
