USS Vulcan

HISTORIC AMERICAN ENGINEERING RECORD

USS *VULCAN* (AR-5)

HAER No. VA-129

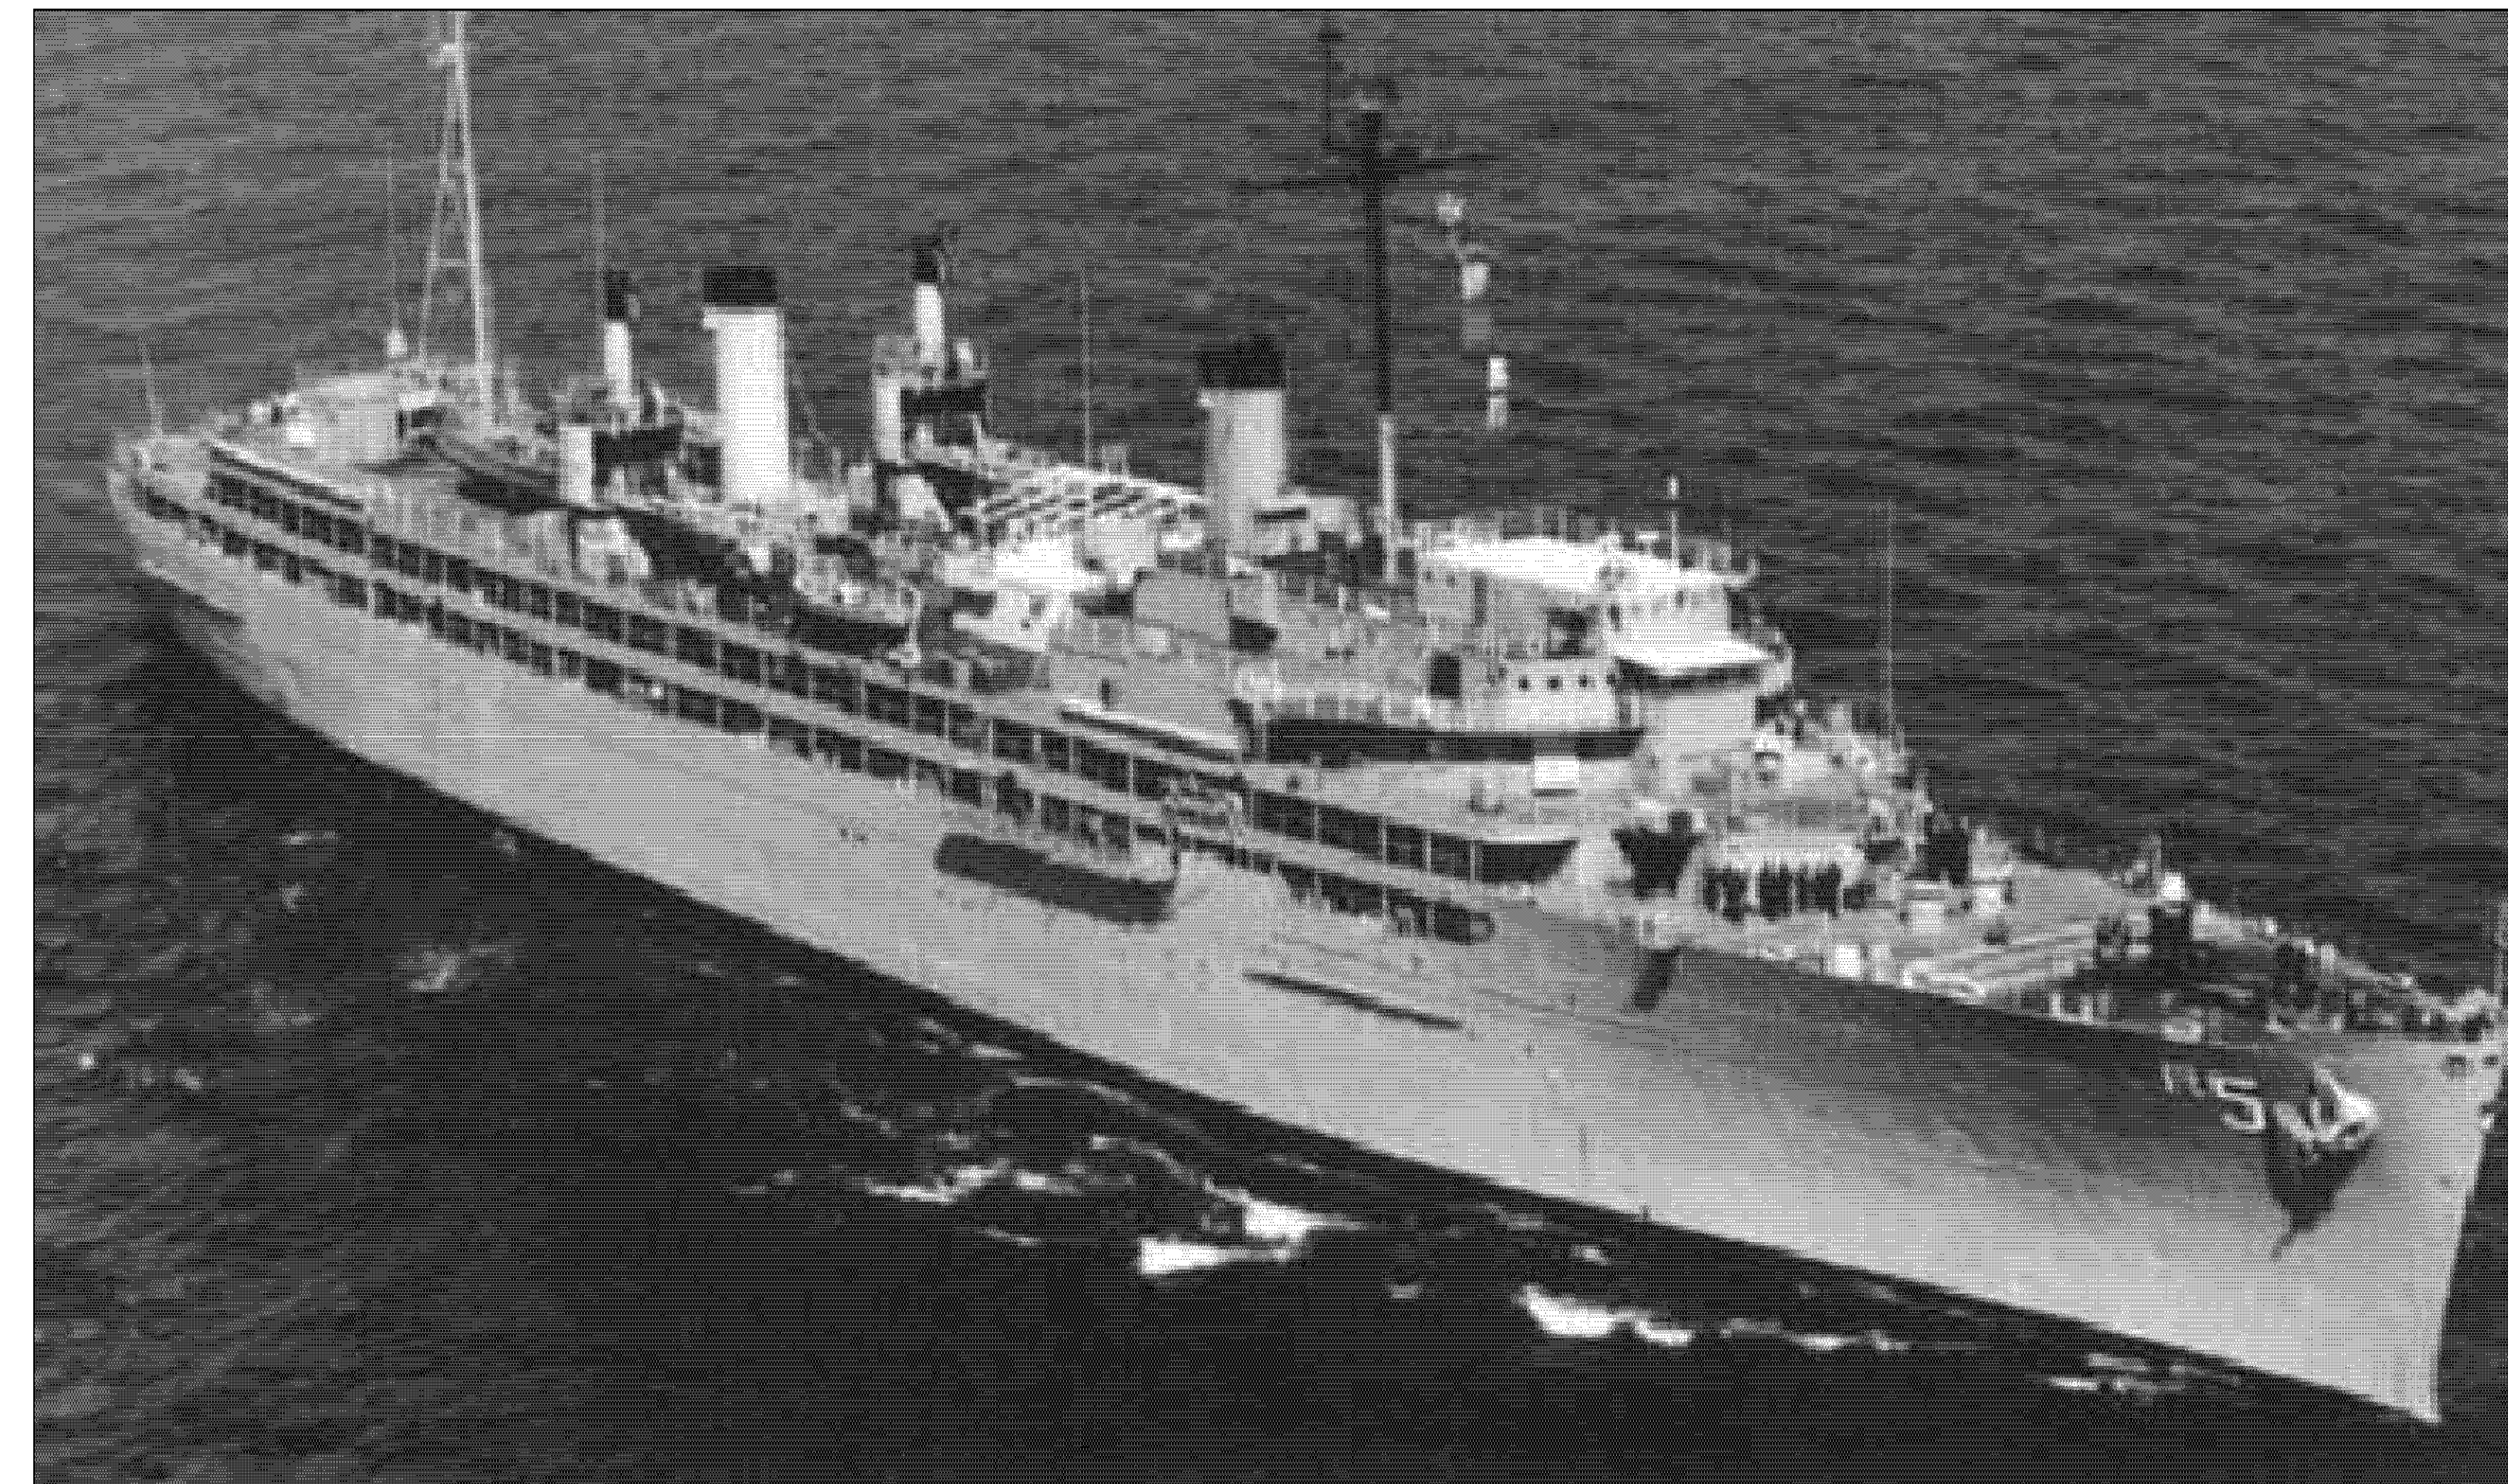
NAVY REPAIR SHIP *USS VULCAN*, CIRCA 1941.

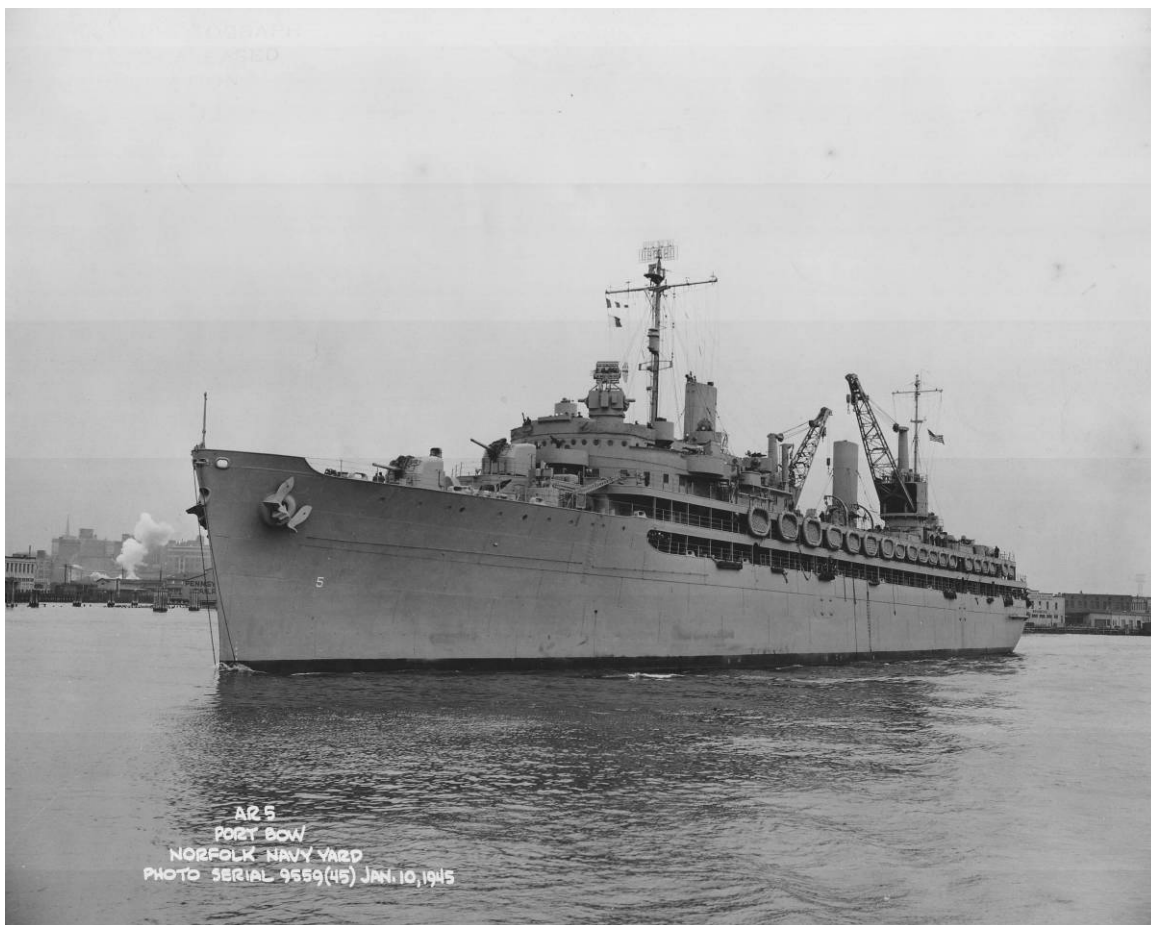
Figure 1: Caption reads: AR 5, Port Bow, Norfolk Navy Yard, Photo Serial 9559 (45), Jan. 10, 1945. From Photographic Section, Naval History & Heritage Command, Washington, DC.

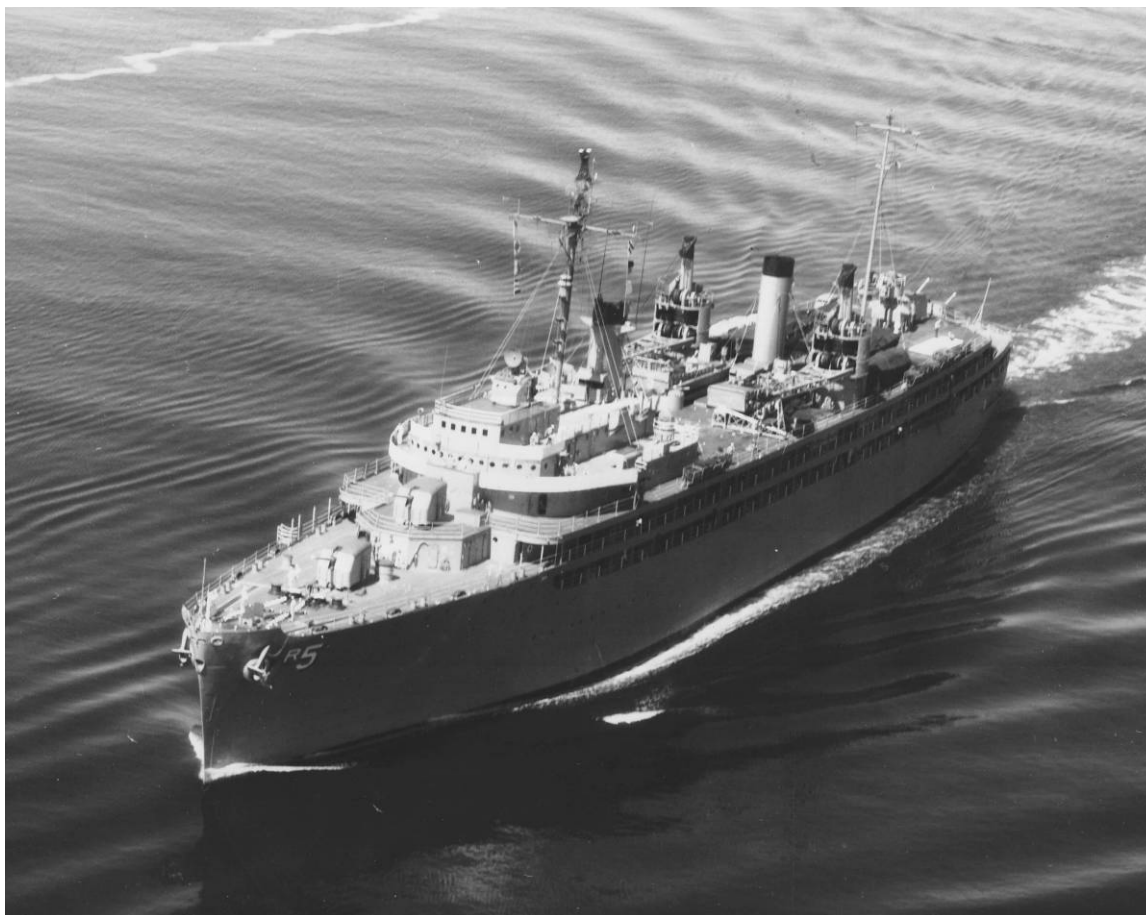
Figure 2: No caption or date. Photograph shows the *Vulcan* underway. From Photographic Section, Naval History & Heritage Command, Washington, DC.

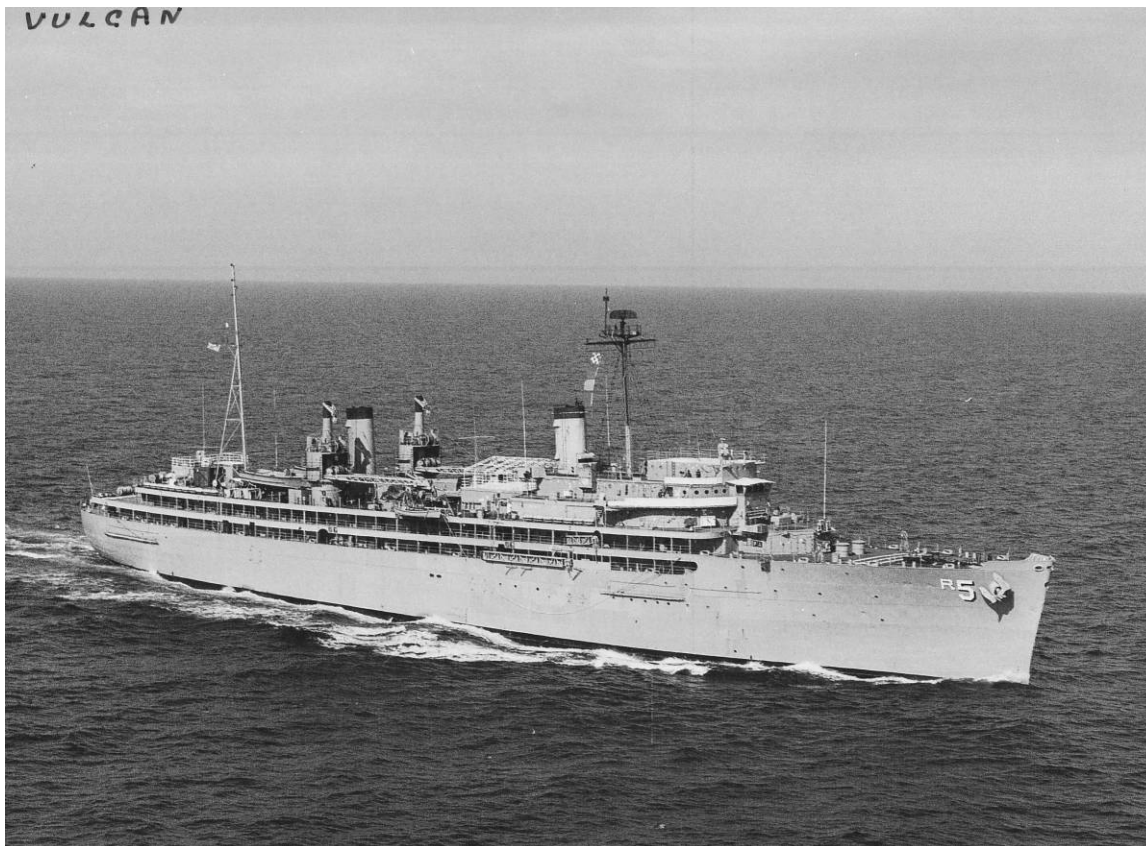
Figure 3: No caption or date. Photograph shows the *Vulcan* underway. From Photographic Section, Naval History & Heritage Command, Washington, DC.
