THE JOSEPH A. HOLMES SAFETY ASSOCIATION

BULLETIN

JANUARY/FEBRUARY 2003

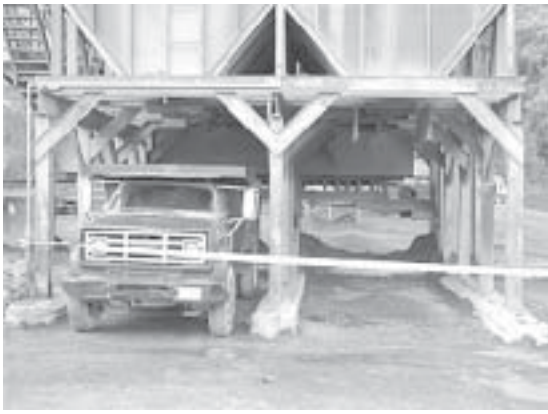
Another thing that safety training cannot always overcome is work place design. The photograph shows two side-by-side load-out bins. A truck is parked beneath one of them, facing the camera. A conveyor directly behind the bins requires truck drivers to back under the bins to load material. Tape across the entrances to the two load-out areas is there to mark the scene of a fatal accident.

Photo of the side-by-side load-out bins.

The truck driver died after being run over by a truck that backed into the space under the other load-out bin. The victim was standing

outside his truck on the driver's side to activate controls to release material from the bin. He had spent more time than usual outside the truck because material inside the bin had bridged and was not flowing properly.

The plant operator had gone up the walkway access level of the bin to find out why the material had bridged. The victim was standing between the two loading bays when the plant operator saw the other truck backing under the other bin. The plant operator yelled for the victim to watch out, but the right rear dump bed struck the victim. The driver continued backing until he felt the tire hit a bump. He then pulled forward, got out of the truck, and found the victim lying on the ground.
