INDUCED POLARIZATION AND SEISMIC 3D IMAGING OF LANDSLIDES

Publication No. FHWA-CFL/TD-11-006

September 2011

The objective of this study was to develop an understanding of new, state-of-the-art, applications of two geophysical methods – induced polarization (IP) and three-dimensional (3D) seismic refraction – for imaging landslides.

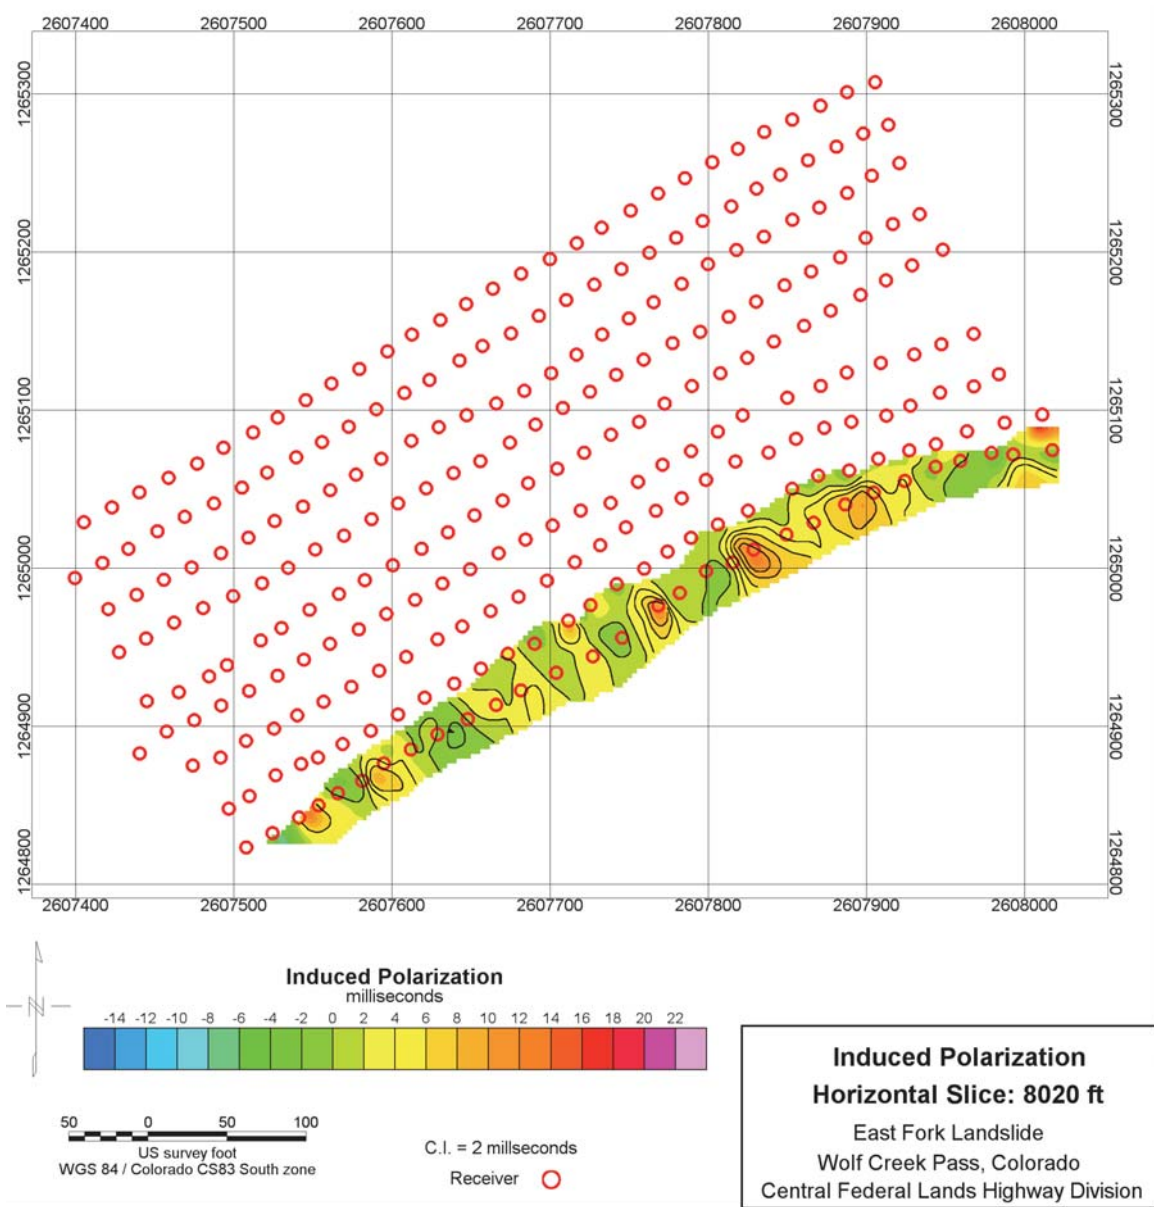
Figure 26. Map. Horizontal slice through East Fork Landslide IP volume at elevation 8020 feet.

The horizontal slice at an elevation of 8020 feet, shown in Figure 26, just clips the highest elevations found within the survey area. The strip of IP data reflects the shallow response to the transmitted signal. The features in the data vary rapidly (spatially) but are small amplitude.

The following series of 2D plan maps, presented in Figures 26 through 30, are horizontal slices through the 3D IP data volume starting at the highest elevation and working downward at 30-foot depth increments. The IP slices show values that are a chaotic mix of low amplitude anomalies that apparently have no pattern which would relate to geology or features of the slidemass. The haphazard pattern may reflect the response of clay minerals that have been jumbled during travel down the slope. Appendix A contains horizontal and vertical slices through the IP data volume; a CD is included with this report that has a 3D PDF file of the IP volume image results which can then be viewed in 3D using the Adobe 3D viewer.

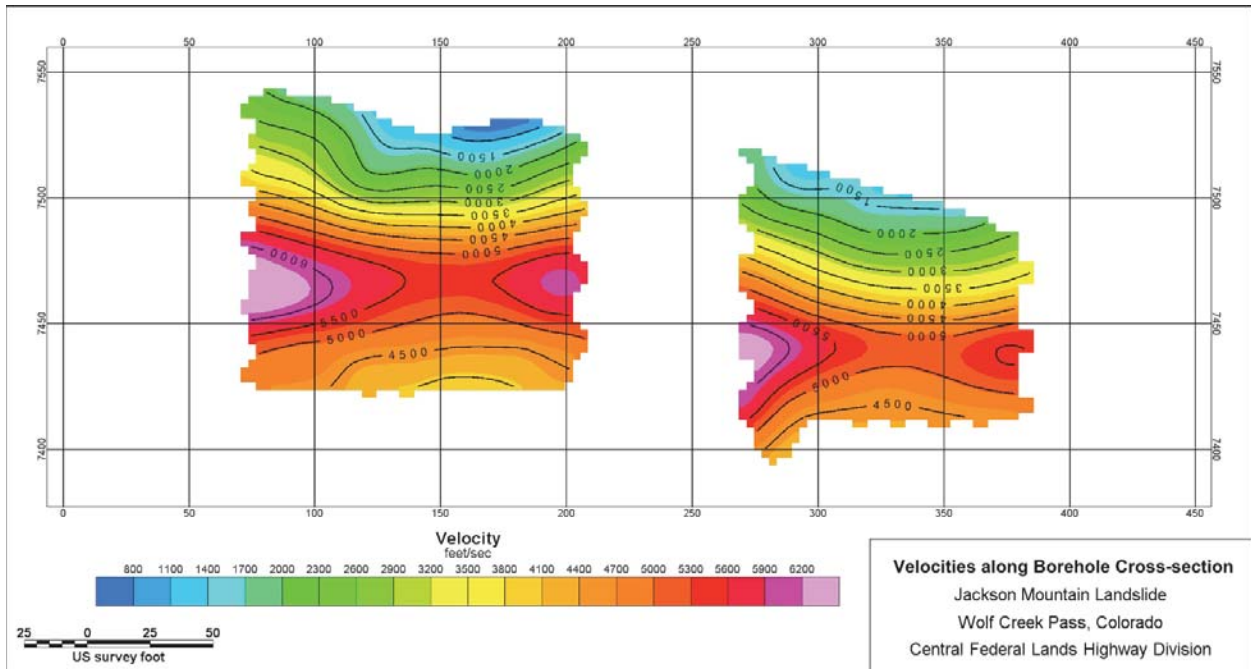
Figure 94. Model. Same cross-section as presented in Figure 92 showing only velocities below the surface where geophones were located.

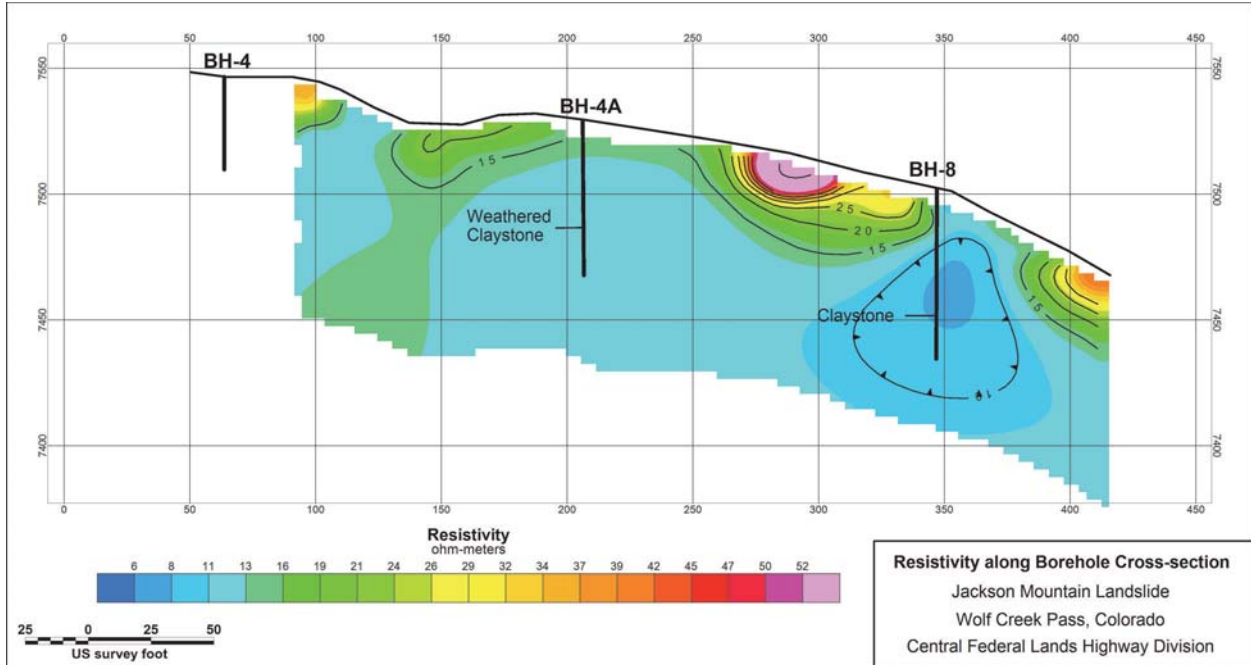
Figure 105. Diagram. Resistivity Cross-section through Borehole Locations on Jackson Mountain Landslide.
