**RANGE CONDITION ASSESSMENT REPORT**

**NAVAL SURFACE WARFARE CENTER,  
DAHLGREN LABORATORY RANGES**

**DAHLGREN, VIRGINIA**

**SEPTEMBER 2010**

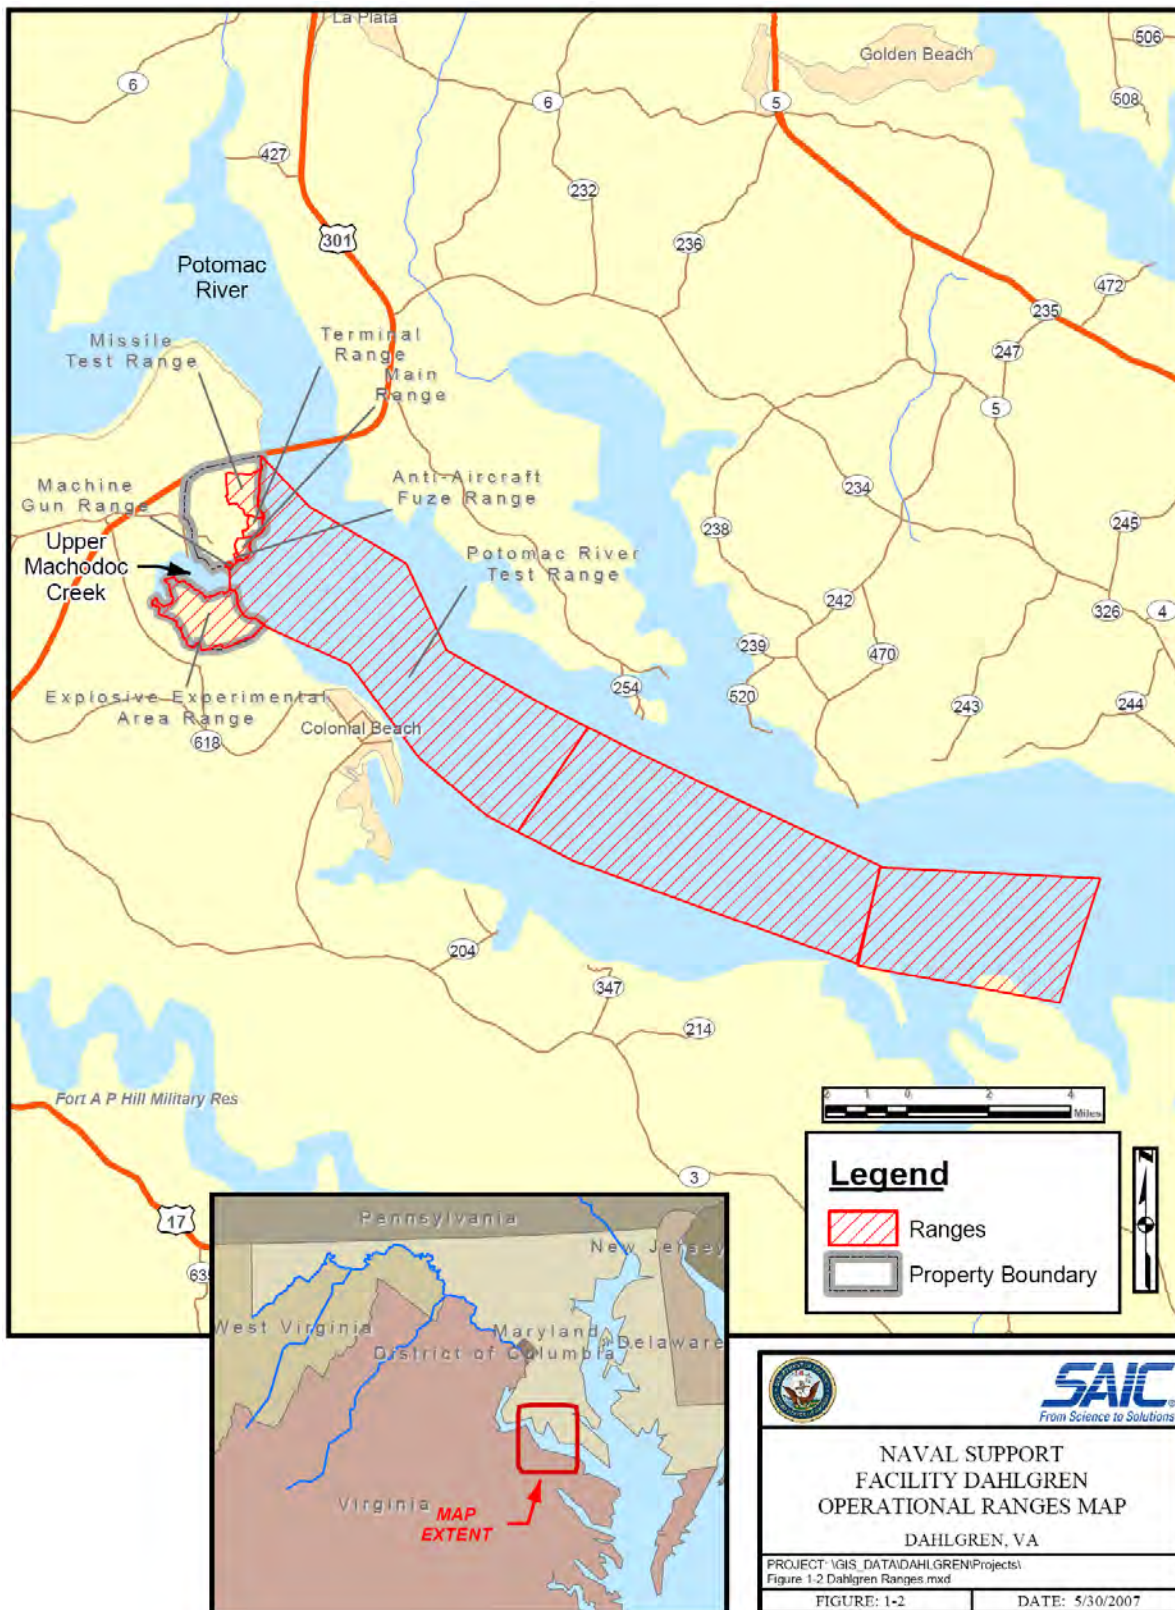
FIGURE 1-2. NAVAL SUPPORT FACILITY DAHLGREN OPERATIONAL RANGES MAP

To address these questions, the RCA assessed the following six land-based ranges as shown in Figure 1-1 where munitions operations are conducted: Anti-Aircraft (AA) Fuze Range, Explosive Experimental Area (EEA) Range, Machine Gun Range, Main Range, Missile Test Range, and Terminal Range. This synopsis does not address the Potomac River Test Range (PRTR), which is a water-based range as shown in Figure 1-2.

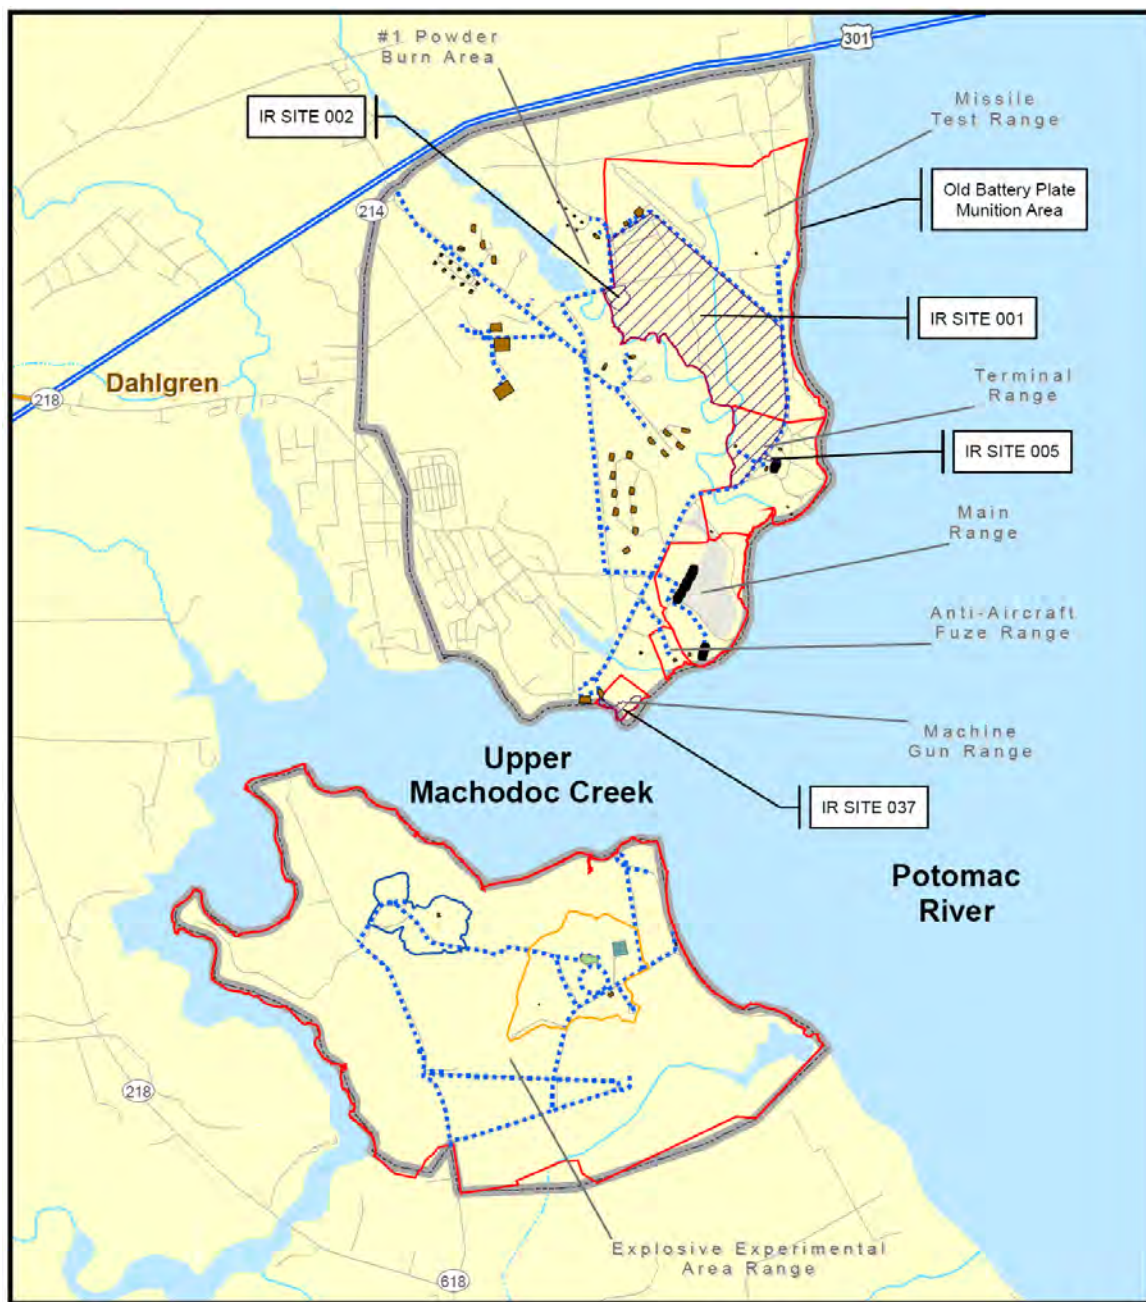
FIGURE 5-2. NAVAL SUPPORT FACILITY DAHLGREN LOCATIONS OF MUNITIONS-RELATED ACTIVITIES

Munitions-Related Activity	Primary Source	Location
Troop Training	<i>Combat Range</i> – Areas used for combat maneuvers	Not applicable
	<i>Bivouac and Encampment Areas</i> – Troop living areas (bivouacs are short-term areas, encampments are long-term, more permanent installations)	Not applicable
Defensive Positions	<i>Minefields</i> – Areas containing buried or surface placed anti-personnel or anti-tank mines	Not applicable
	<i>Gun Emplacements</i> – Areas where defensive weapons (e.g., anti-aircraft guns) are located	Not applicable
Sanctioned and Unsanctioned Munitions Disposal	<i>Mass Burial/Landfills with Munitions</i> – Areas where quantities of munitions were abandoned in place or disposed of by burial, prior to 1980.	<ul style="list-style-type: none"> <li>• Missile Test Range – Fenced Ordnance Burial Area (IR Site 2), World War I Munitions Mound (IR Site 47A)</li> <li>• Terminal Range – Projectile Disposal Area (IR Site 5) and Gambo Creek Projectile Disposal (IR Site 61B)</li> <li>• Not Located on Operational Ranges – Disposal/Burn Area (IR Site 9, west of Missile Test Range), 1400 Area Landfill (IR Site 17, north of Missile Test Range), Rocket Motor Pit (IR Site 44, west of Missile Test Range), and Shell House Dump (IR Site 57, west of Missile Test Range)</li> </ul>

<i>Open Burn/Open Detonation (OB/OD)</i> – Areas where ordnance was consolidated and treated by either burning or detonation	<ul style="list-style-type: none"> <li>• EEA Range – RCRA Permit for the Thermal Treatment of Explosive Hazardous Waste by OB/OD</li> <li>• Located on Inactive Operational Ranges – Burn Area (IR Site 3/44)</li> </ul>
	<i>Bomb Jettison Area</i> – Areas where bombers jettison bombs prior to landing	Not applicable

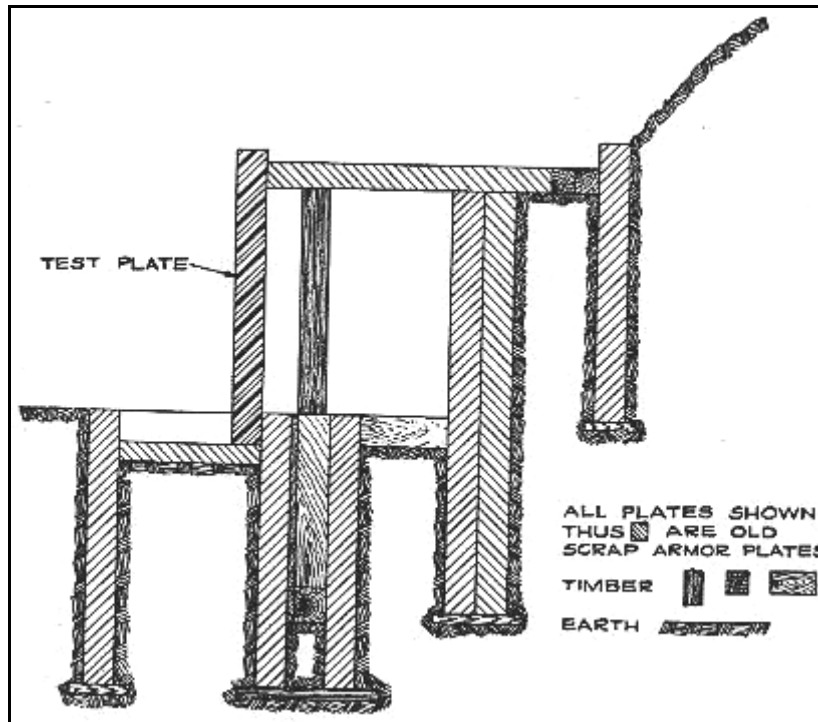
FIGURE 5-4. CROSS-SECTION OF AN ARMOR PLATE BUTT

Temporary and permanent gun mounts are tested by firing projectiles into butts, armor plates, concrete blocks, or the PRTR. The butts are constructed using discarded armor plates (for testing projectiles) or experimental armor plates (for testing durability of armor material) secured to timbers. To recover projectiles, sand is often placed between the plates. Figure 5-4 illustrates the construction of an armor plate butt used for testing projectiles (Slover 1937). Thus, the materials comprising the armor plate target butts are not likely to be a concern for RSEPA.

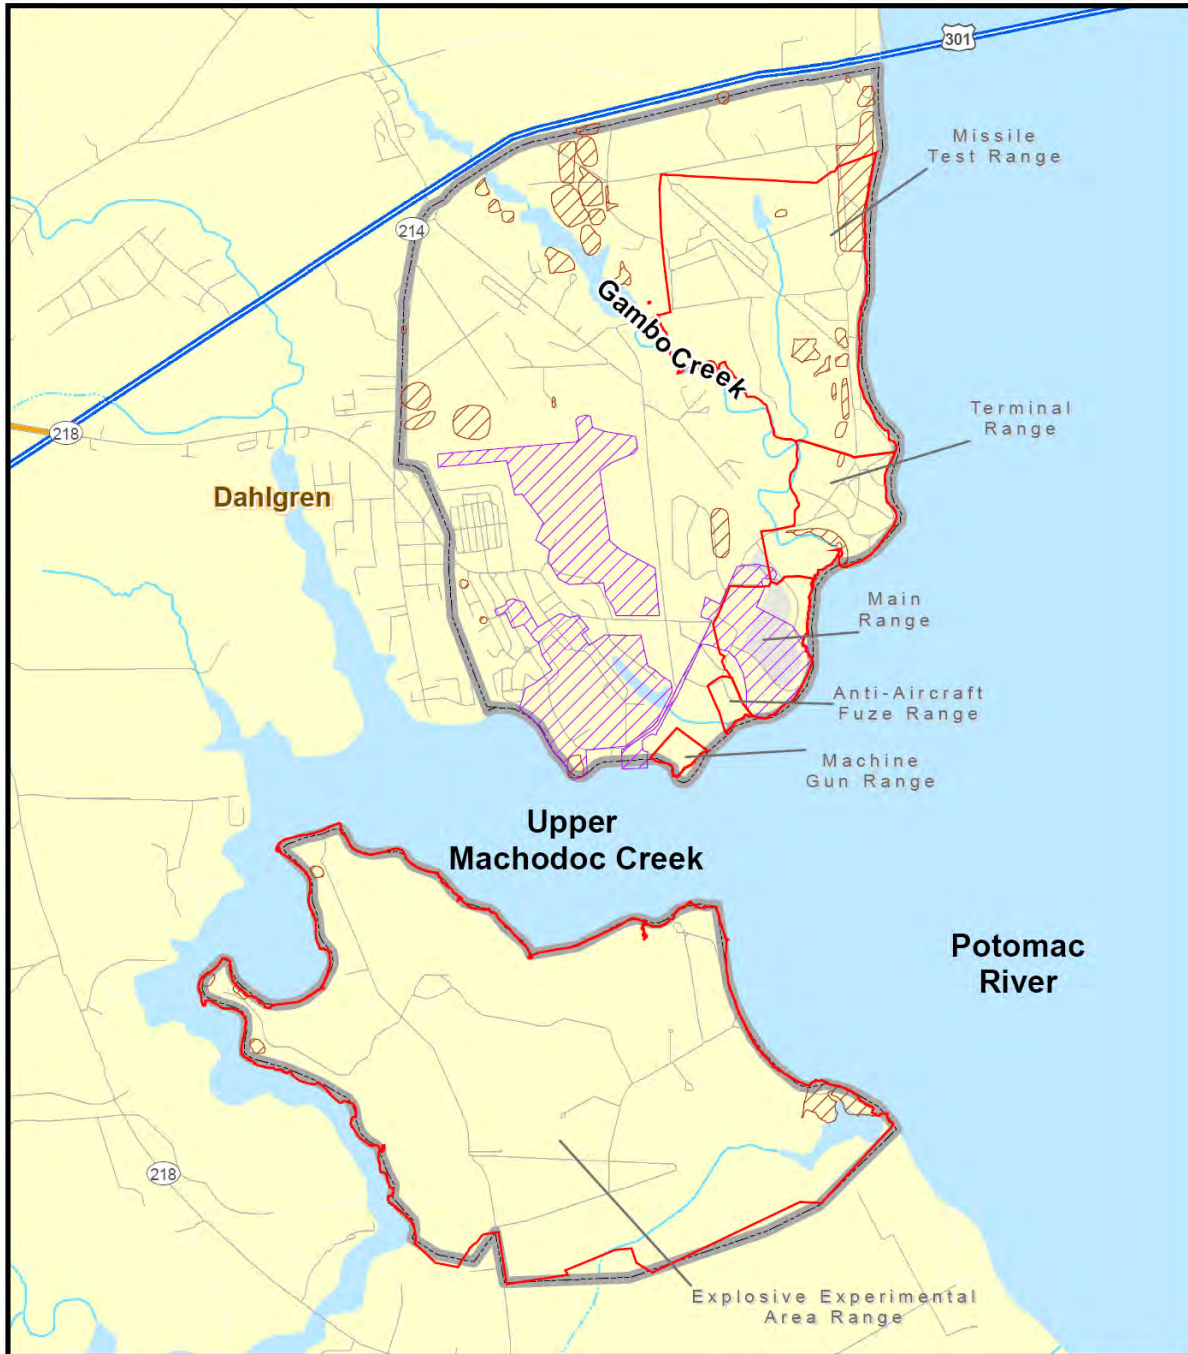
FIGURE 5-8. NAVAL SUPPORT FACILITY DAHLGREN CULTURAL RESOURCE LOCATIONS

Four historic architectural districts also exist on Mainside (NSFD/NAVFAC 2007b) and are shown in Figure 5-8. Early Dutch colonial architecture mixed with more modern architecture occurs in these districts. The four districts include the airfield (including the airstrip and associated aircraft facilities), the main battery (including the primary major caliber gun emplacements), the residential area (including the majority of historical installation residences), and the wharf area (including the historical docking area along Upper Machodoc Creek linking the waterway with the Main Battery via rail and road).

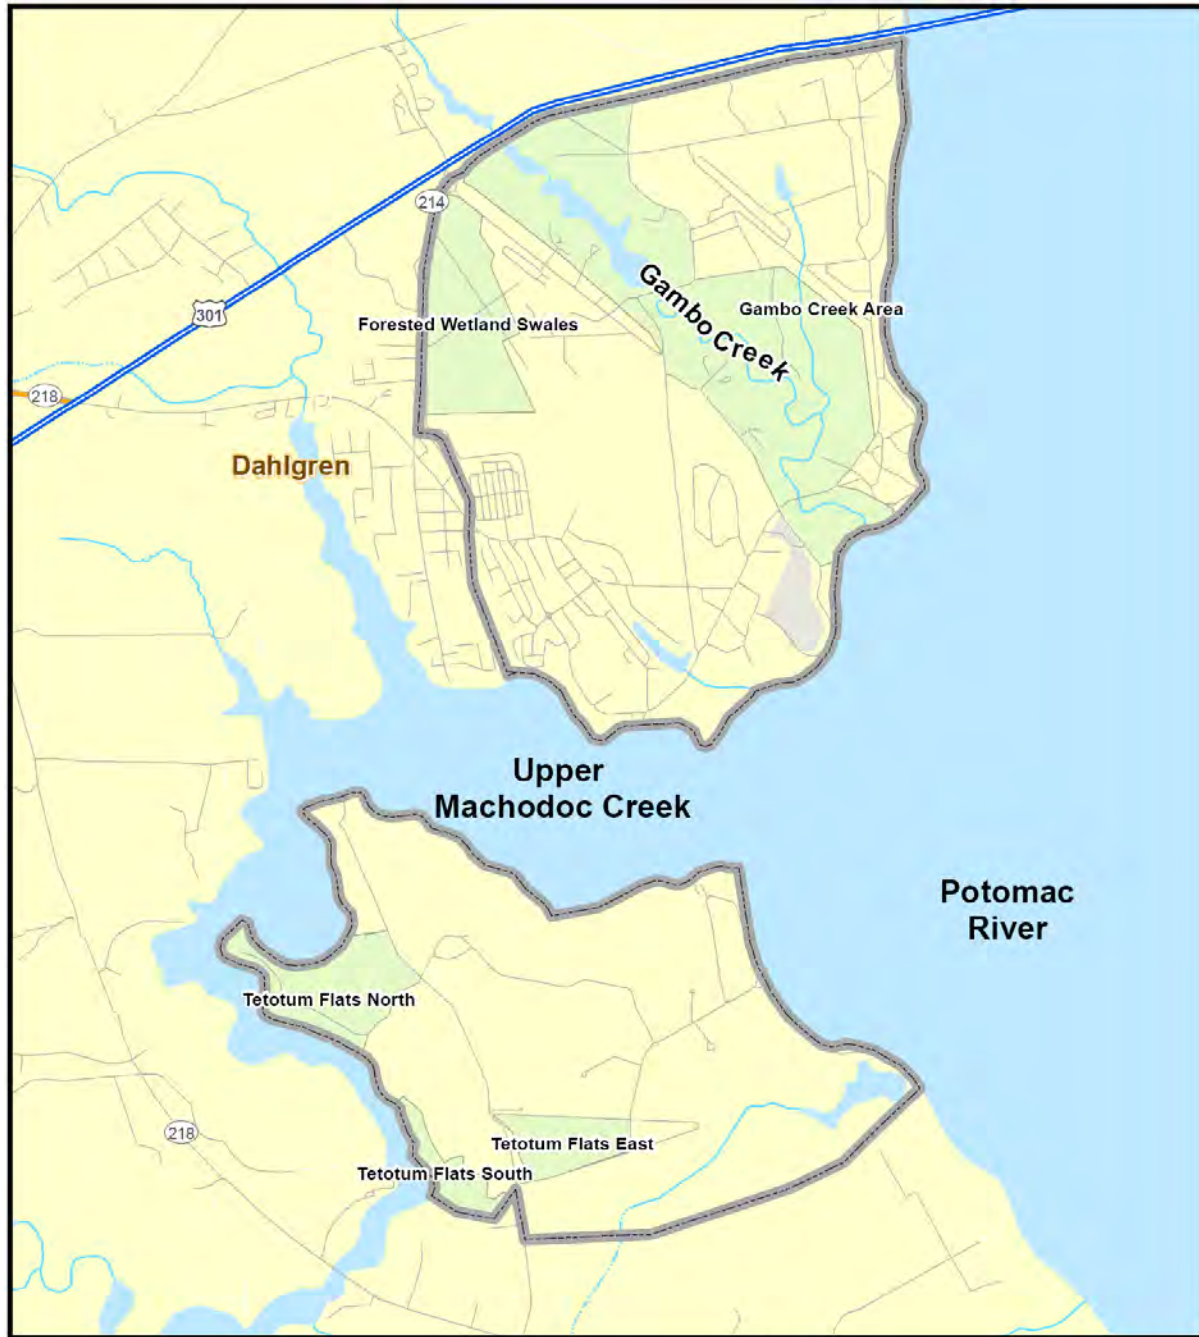
FIGURE 5-9. NAVAL SUPPORT FACILITY DAHLGREN SPECIAL INTEREST AREAS

There are five Special Interest Areas (SIAs) at NSFD, which represent areas with unique ecological characteristics and/or high-quality habitat for rare species. Three of these SIAs were established based on the inventory conducted in 1991 and 1992. The original boundaries were updated and new SIAs were established in 2001 based on new information and changing conditions (e.g., new bald eagle nesting sites). Two SIAs totaling 810 acres occur on the Mainside Ranges and three SIAs totaling 223 acres occur on the EEA Range. The SIAs (Forested Wetland Swale, Gambo Creek, Tetotum Flats North, Tetotum Flats South, and Tetotum Flats East) are discussed below:

- The Forested Wetland Swale is 167 acres in the northwestern portion of Mainside that provides rare invertebrate habitat. The swales drain toward the north end of the airfield and the northern border of swales are adjacent to County Route 614. Rare invertebrates are no longer documented in this SIA.

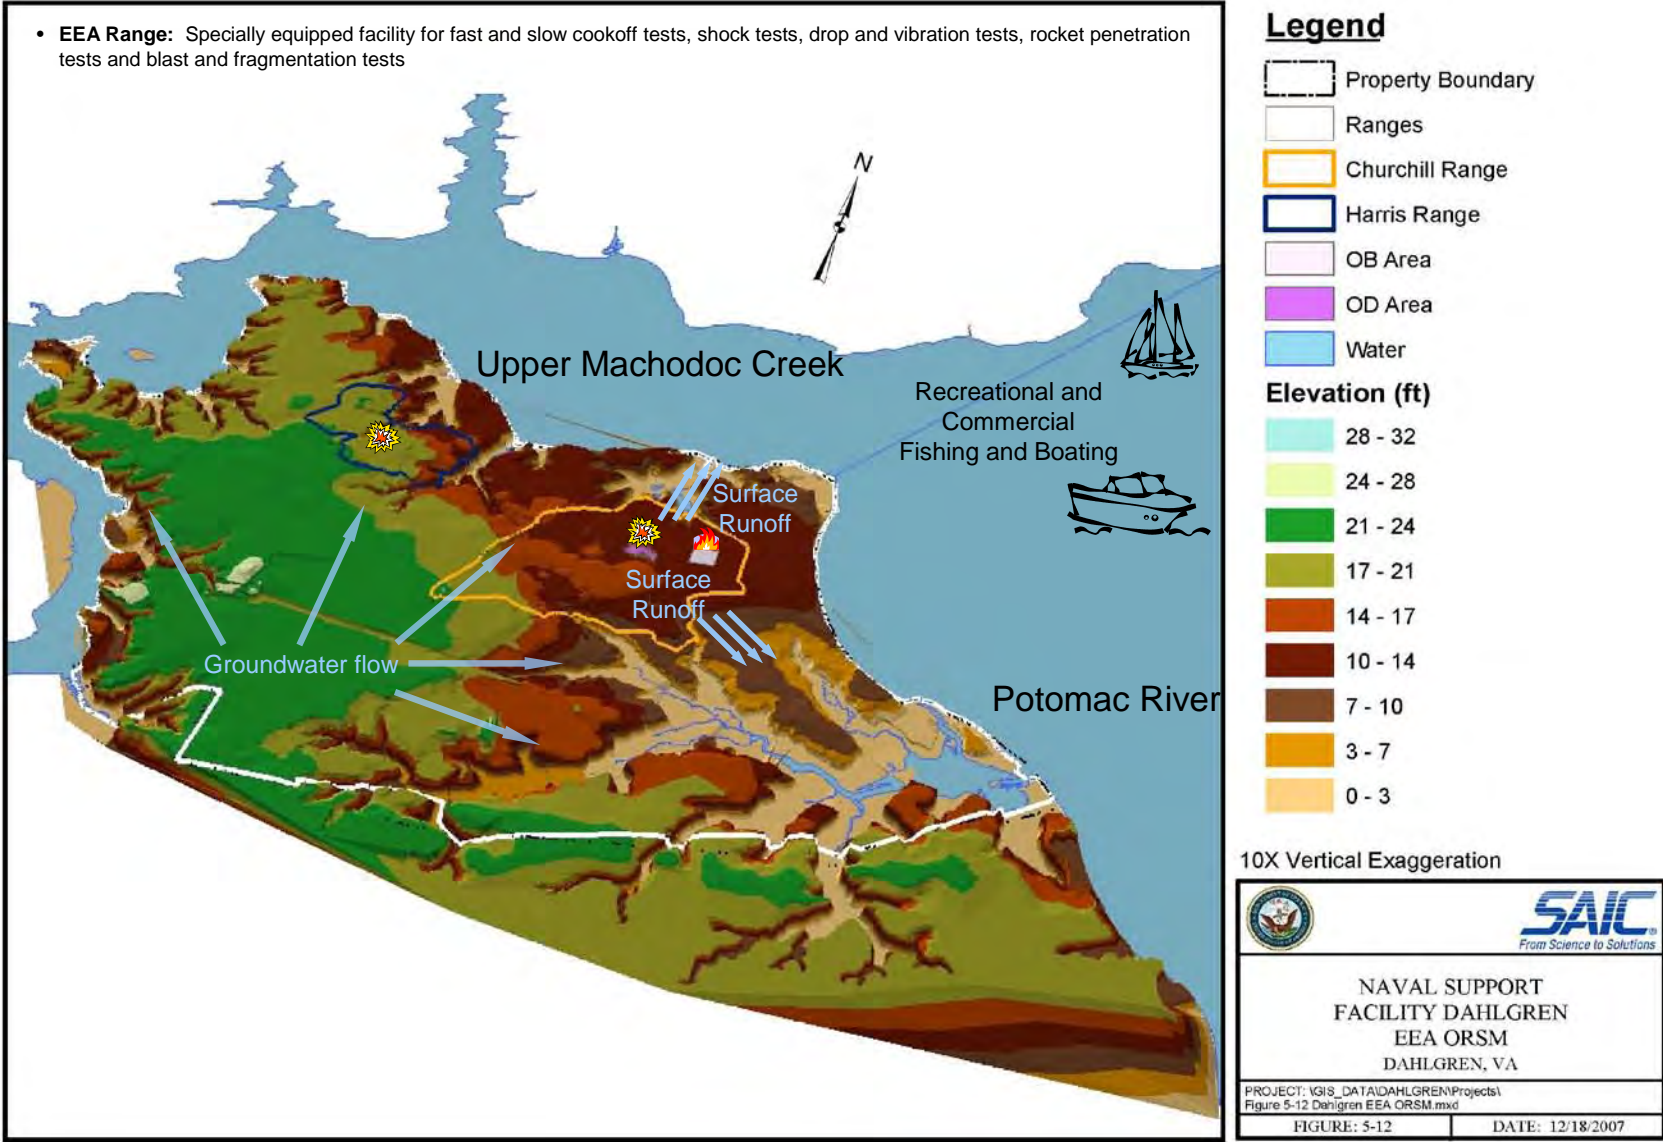
FIGURE 5-12. NAVAL SUPPORT FACILITY DAHLGREN EEA ORSM

- **Operational**—The OB/OD units located on the EEA include current operations. However, because constituents have been detected and the levels of those detections, the site is conducting monitoring to comply with the RCRA permit requirements.
- **Environmental**—Like Mainside, EEA is characterized by low relief and steeper slopes located along sections of installation watercourses and shorelines. There are three SIAs at EEA representing areas with unique ecological characteristics and/or high-quality habitat for rare species. Groundwater monitoring has detected explosives and perchlorate in wells, but these wells are in a shallow aquifer not used or suited for drinking water.

- **Land Use**—NSFD is open to installation personnel and guests only (NSFD/NAVFAC 2007b). Although there are a variety of recreational activities available on Mainside, few of these opportunities occur at EEA. There are four game compartments for hunting at EEA, but the open hunting areas can be subject to change based on testing and bald eagle nesting activities. No fishing is permitted on EEA due to potential UXO issues and range activities. Recreational and commercial boating does occur within the waters off the coast of the range.

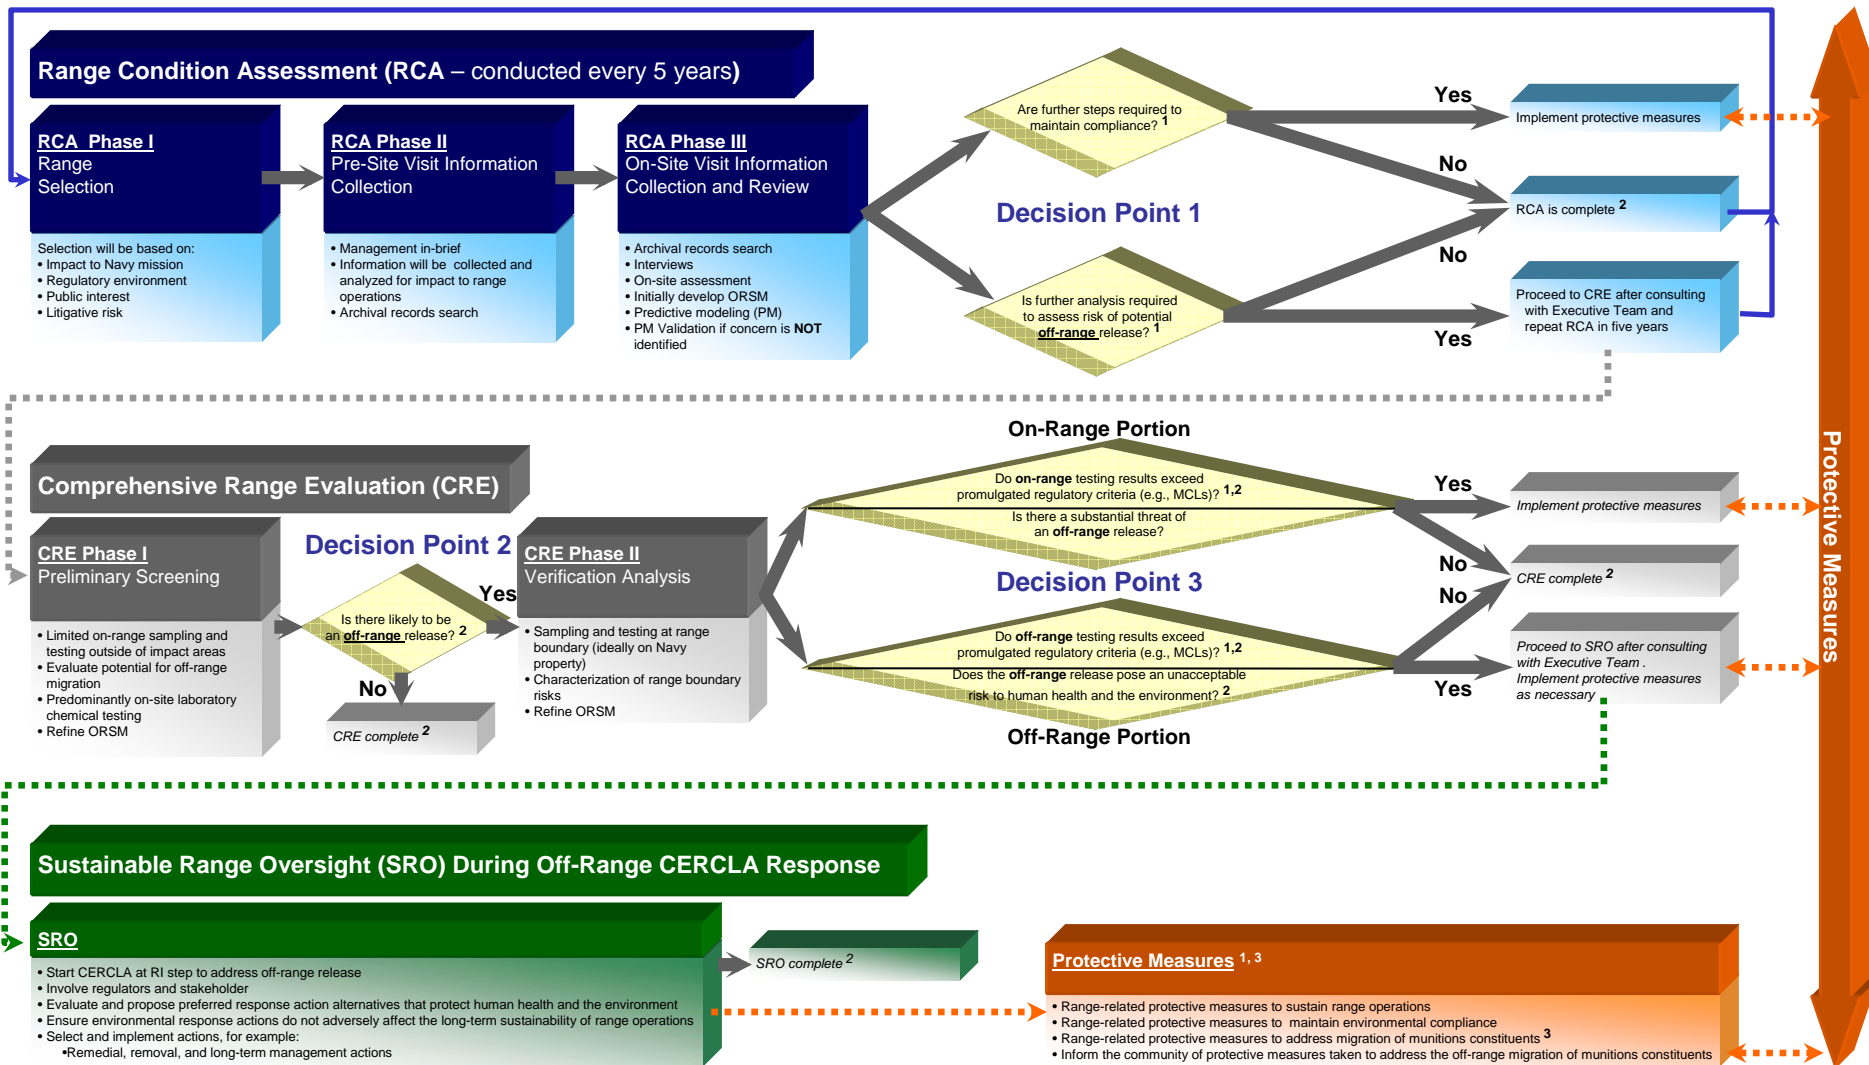
## Process Overview

- Notes:**
1. Protective measures can be implemented at any point in the process
  2. RCA will be repeated every 5 years regardless of whether a CRE and/or SRO are conducted
  3. Implement concurrently with CERCLA response when applicable

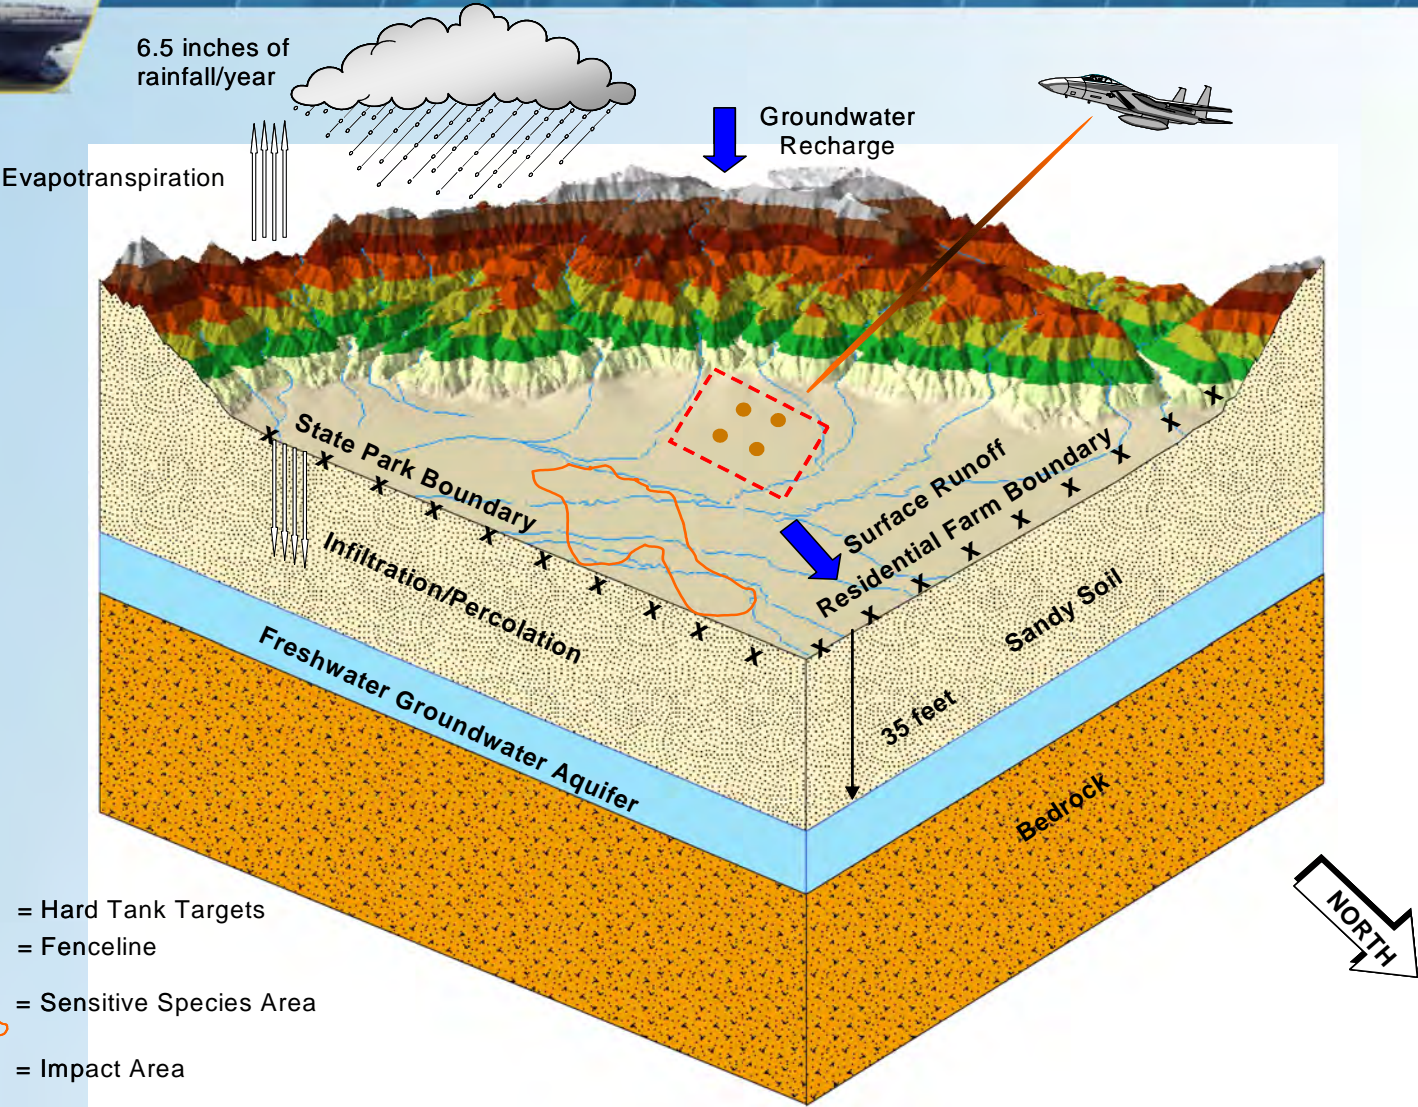
# Example ORSM

- = Hard Tank Targets
- x x x = Fenceline
- = Sensitive Species Area
- = Impact Area
