**2008/2009 Annual Inspection
Report**

**CLEAR MARAIS SHORE
PROTECTION PROJECT
(CS-22)**

State Project Number CS-22
Priority Project List 2

October 2, 2008
Cameron Parish

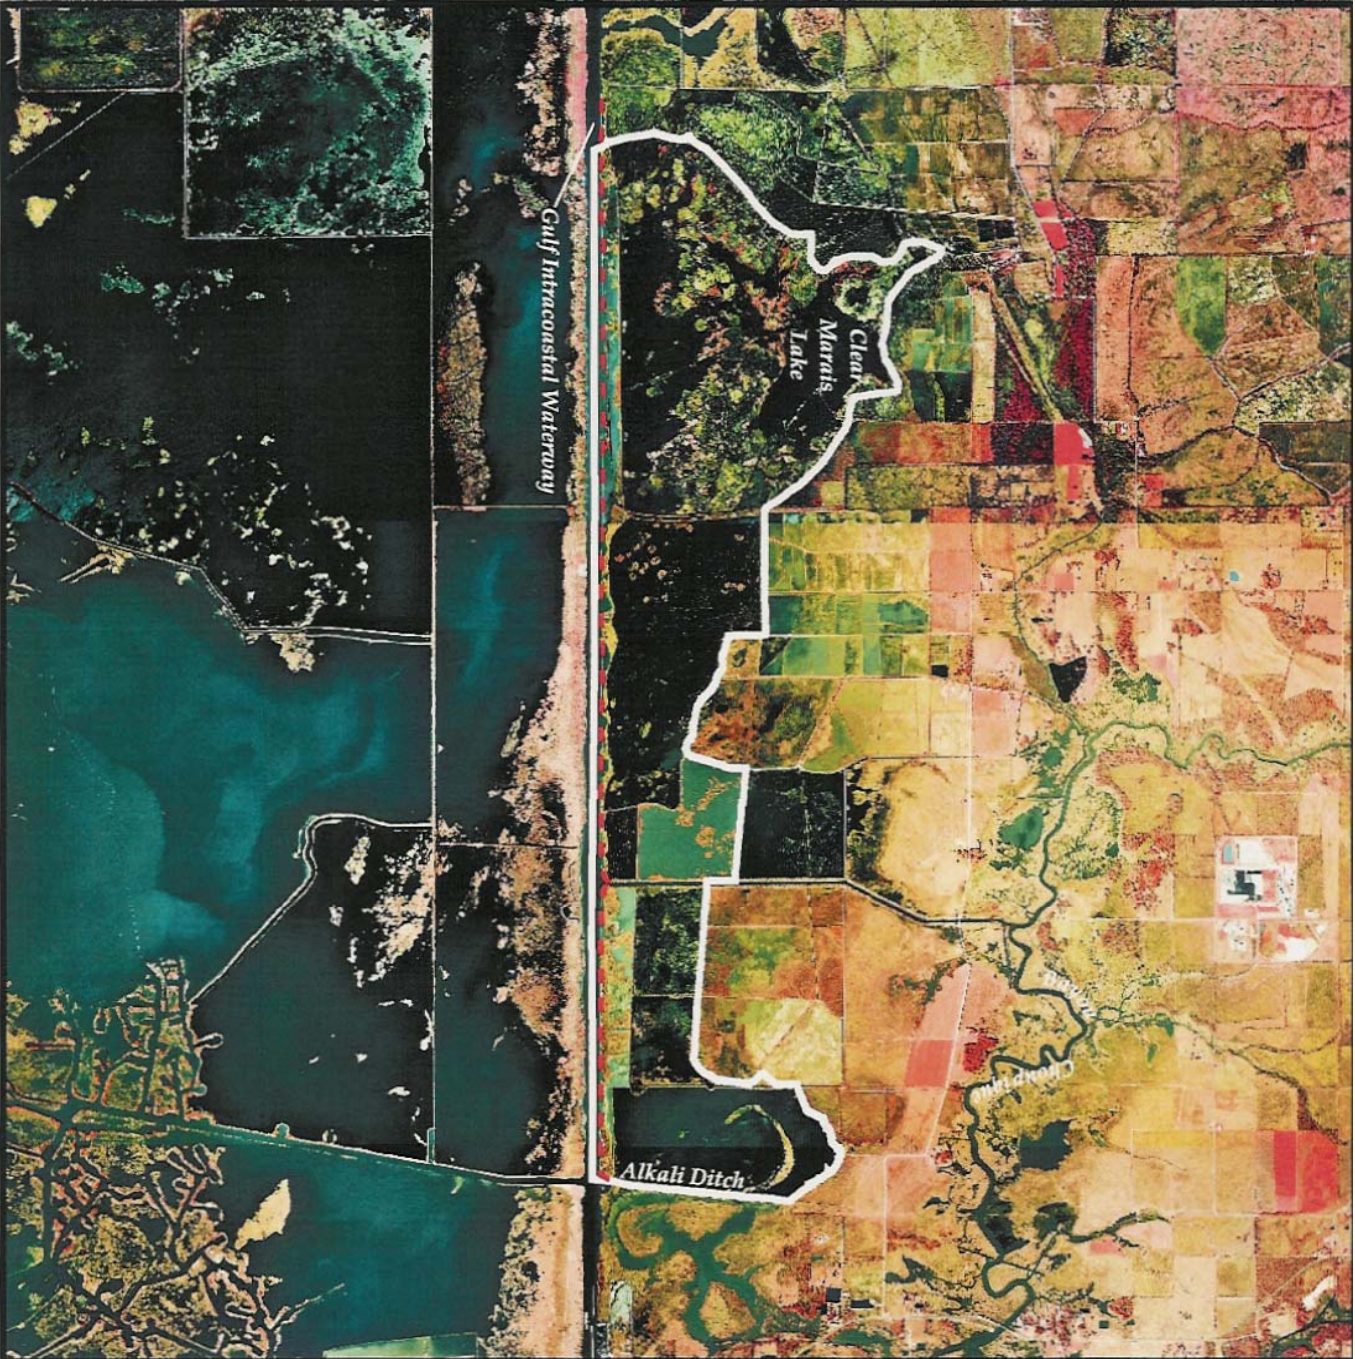
Appendix A
Project Features Map

Clear Marsh Bank Protection (CS-22)

Shoreline Protection

Project Boundary

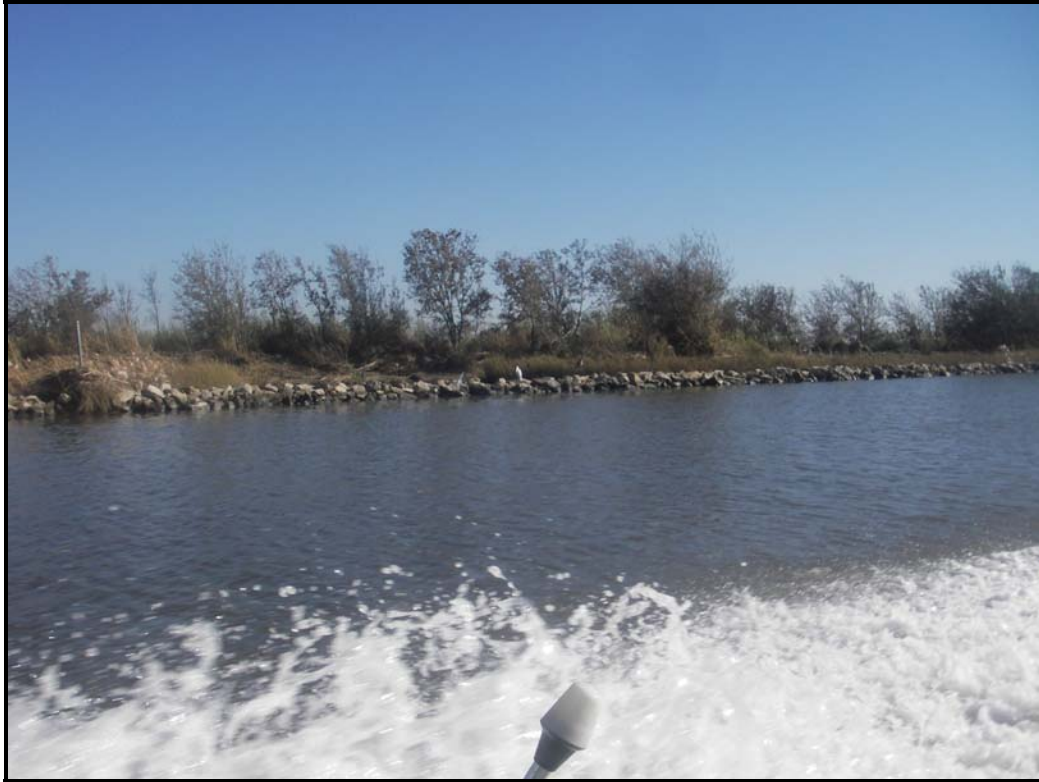
Photo No. 1, Typical rock dike

The dike is in fairly good condition and does not appear to have suffered any damages from Hurricane Ike. Wrack deposition was observed on the bank of the GIWW and between the foreshore dike and shoreline. The organic portions of the wrack (vegetation and soil) may aide in the in-filling of open water area and expand land area. As observed from the GIWW, the vegetation appeared mildly stressed and recovering. As noted on previous inspections, approximately 4,000 to 5,000 linear feet of dike is slightly below constructed elevation. This appears to be the result of slight settlement rather than displacement. Several of the settlement plates placed during construction are broken/leaning/damaged/ etc. and are no longer useful. One section of dike, approximately 0.5 miles from the Alkali Ditch, has apparently been removed by hunters and or fishermen. This section is only about 4 feet wide with rock removed to an approximate +0.5 NAVD elevation. It has been noted in previous inspections and has not worsened. Three other sections appear to have been displaced by barges nosing up on the bank. This is a problem noted on several other rock dikes along the GIWW. A staff gauge will need to be installed in the vicinity. No apparent need for any other maintenance at this time. (Photos: Appendix B, Photos 1-2)
