**DOT/FAA/AR-02/81**

# **Reduced Approach Lighting Systems (ALS) Configuration Simulation Testing**

July 2002

Final Report

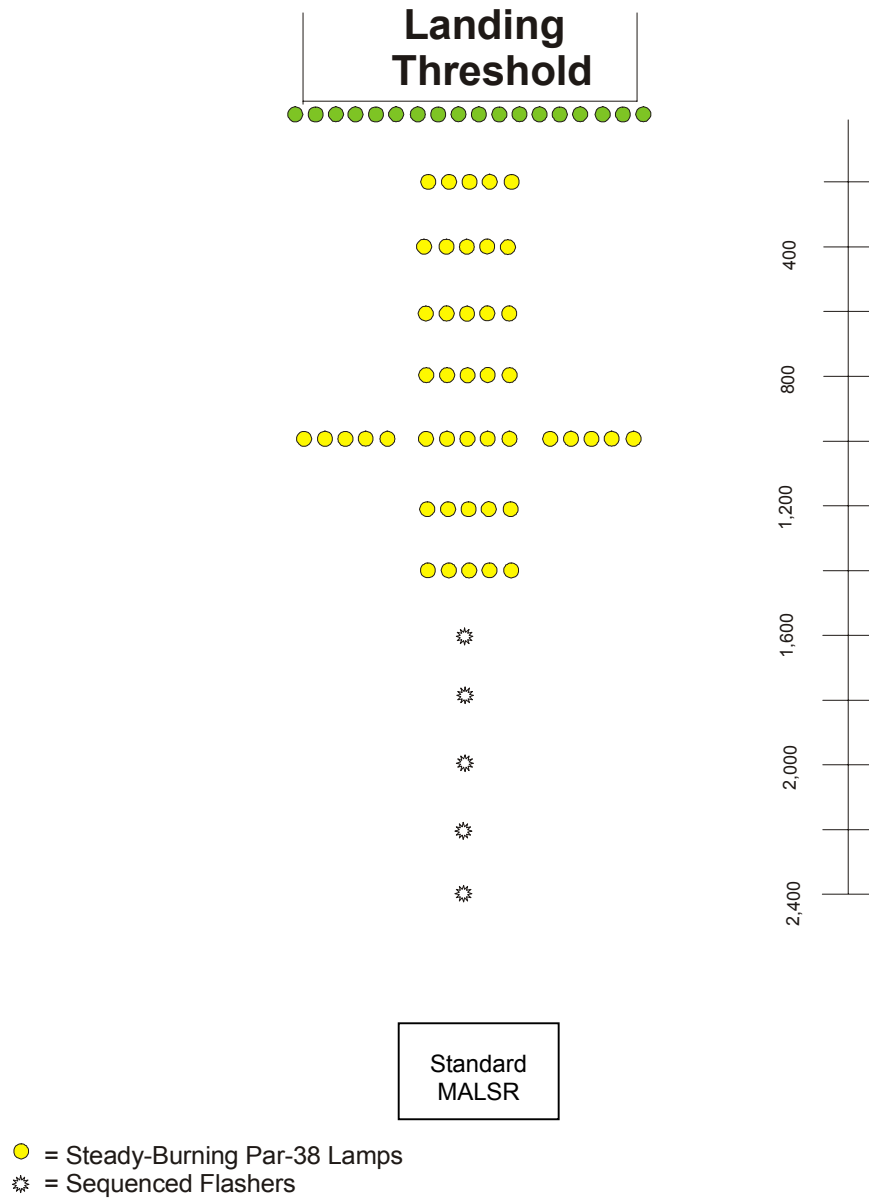
FIGURE 1. STANDARD MALSR SYSTEM

The evaluation effort described herein can certainly be considered as a follow-on investigation of the extent to which the widely used MALSR system (figure 1) may be made more cost efficient through a reduction in the number of components such as light barrettes, flasher units, and associated equipment. These savings might be amplified even further, in some instances, by concomitant reductions in the land areas needed for a reduced configuration. Indeed, such modifications would even permit system installations in locations previously deemed unsuitable.

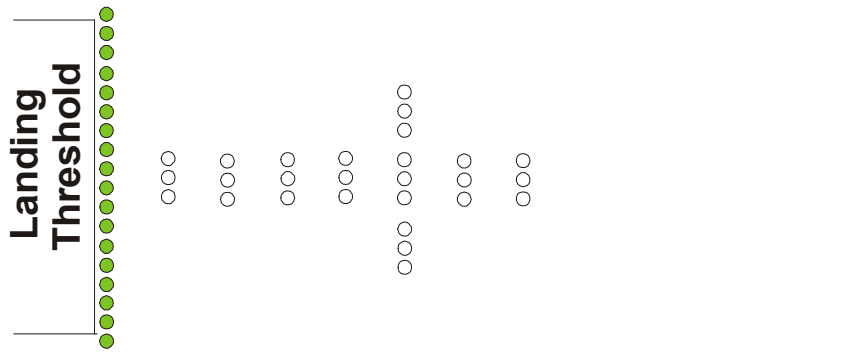
FIGURE 2. CONFIGURATION C

SSALS  
Config. C

- = Steady-Burning High Intensity Par-56 Lamps
- ✱ = Sequenced Flashers

Note: All of the above configurations are variations of the MALSR system except the first, configuration C, which is the SSALS system.

It should be noted additionally that configuration C, which is basically the SSALS without any strobe lights in the outer portion of the system, has been proposed by Flight Standards for use in adjusted minima of 3200-foot (5/8-statute mile) visibility. This was the shortest (1400 feet) configuration evaluated.

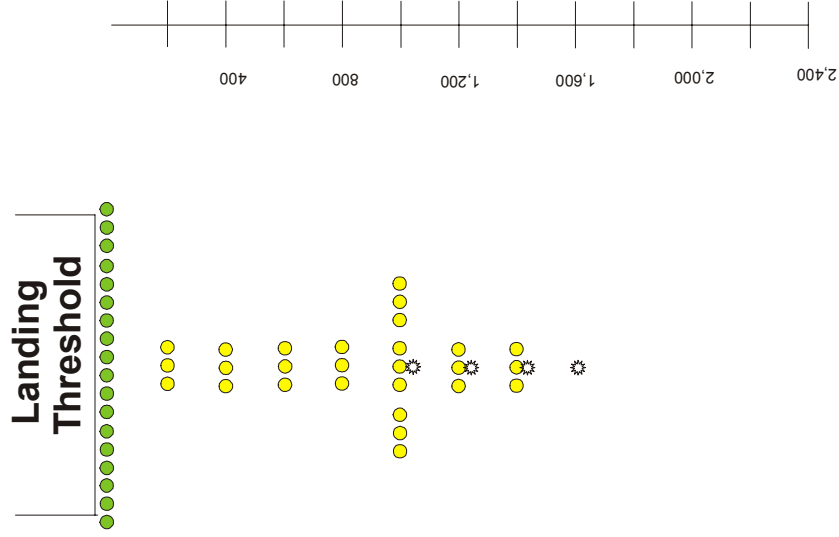
4 Strobes 1,000 to 1,600 feet  
Config. A

- = Steady-Burning Par-38 Lamps
- ✱ = Sequenced Flashers

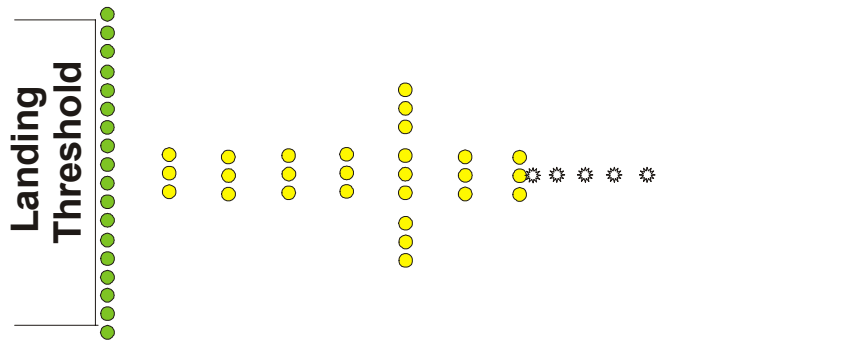
FIGURE 6. CONFIGURATION J

5 Strobes 1,400 to 1,800 feet  
@ 100 foot spacing  
Config. J

- = Steady-Burning Par-38 Lamps
- ✱ = Sequenced Flashers

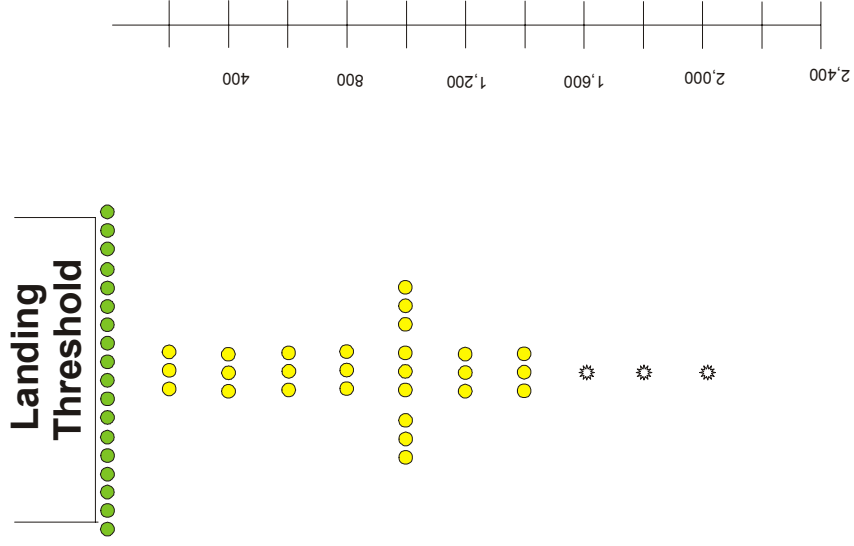
FIGURE 7. CONFIGURATION G

3 Strobes 1,600 to 2,000 feet  
Config. G

- = Steady-Burning Par-38 Lamps
- ✱ = Sequenced Flashers

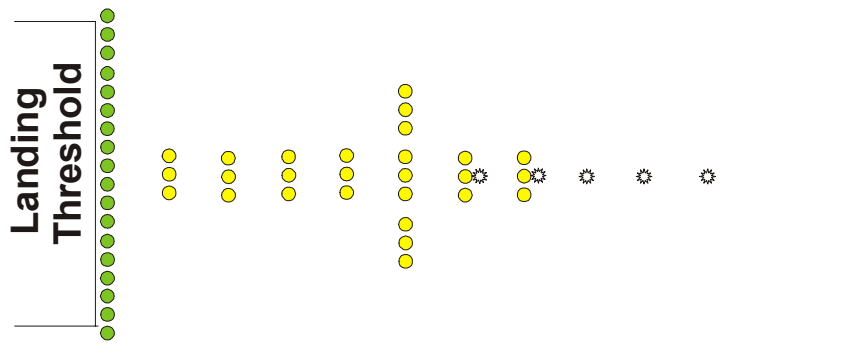
FIGURE 8. CONFIGURATION D

5 Strobes 1,200 to 2,000 feet  
@ 100 foot spacing  
Config. D

- = Steady-Burning Par-38 Lamps
- ✱ = Sequenced Flashers

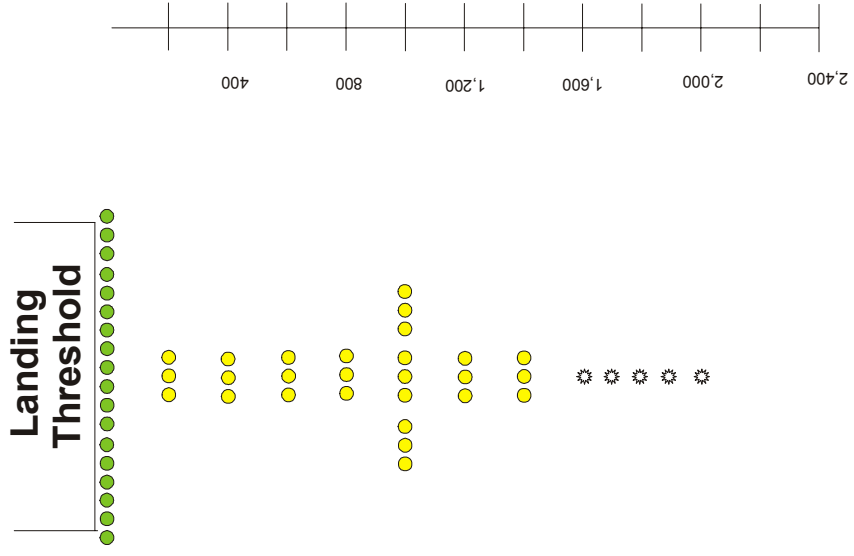
FIGURE 9. CONFIGURATION K

5 Strobes 1,600 to 2,000 feet  
@ 100 foot spacing  
Config. K

- = Steady-Burning Par-38 Lamps
- ✱ = Sequenced Flashers

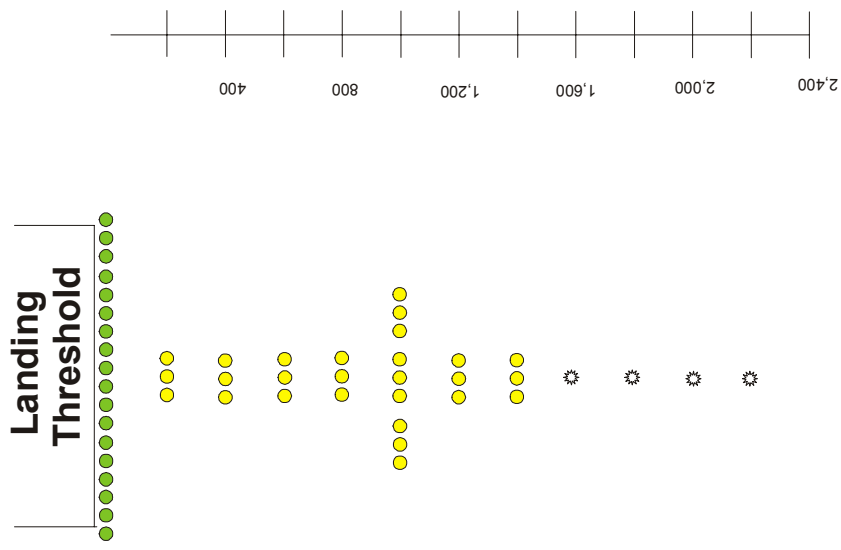
FIGURE 10. CONFIGURATION H

4 Strobes 1,600 to 2,200 feet  
Config. H

- = Steady-Burning Par-38 Lamps
- ✱ = Sequenced Flashers

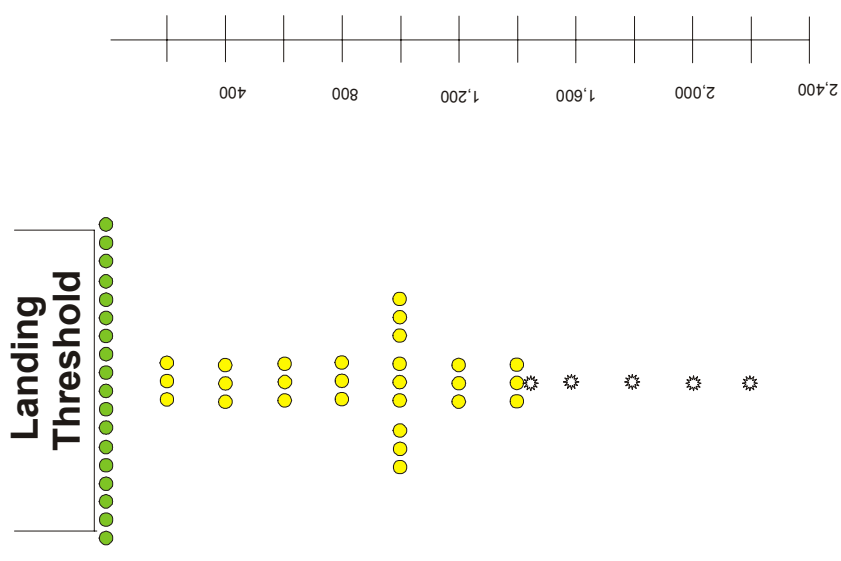
FIGURE 11. CONFIGURATION E

- Configuration E (figure 11)—Reduced density CAT I with three lights per centerline barrette and five strobe lights on 200-foot spacing from the 1400-foot point to 2200 feet from T/H. Total system length of 2200 feet.

5 Strobes 1,400 to 2,200 feet  
Config. E

- = Steady-Burning Par-38 Lamps
- ✱ = Sequenced Flashers

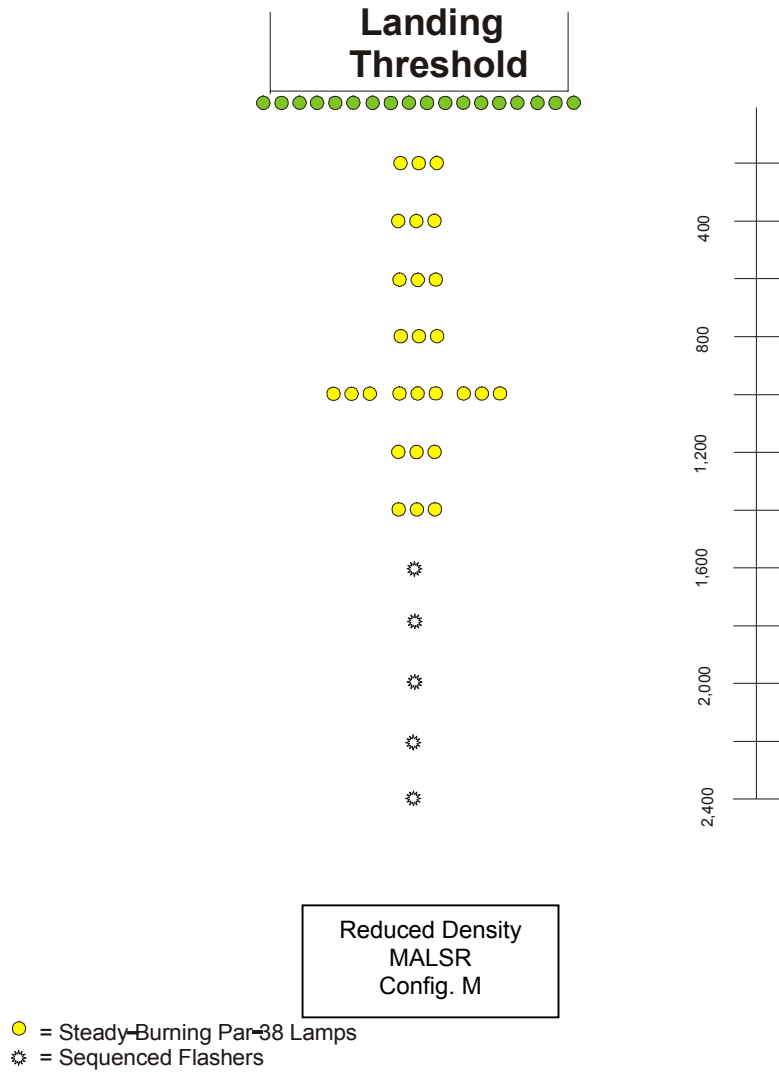
FIGURE 12. CONFIGURATION M

- Configuration M (figure 12)—Reduced Density CAT I with three lights per centerline barrette and five strobe lights on 200-foot spacing from the 1600-foot point to 2400 feet from T/H. Total system length of 2400 feet.

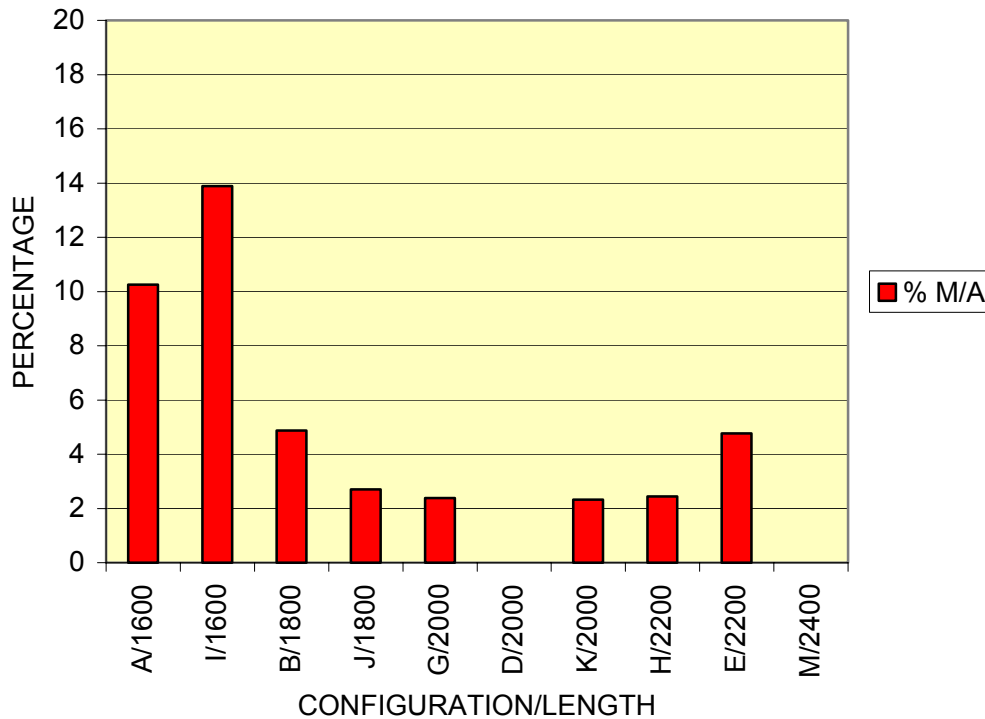
FIGURE 14. MISSED APPROACH FREQUENCY

Occurrences of missed approaches, expressed as percentages of total approach attempts, for each of the ten CAT I configurations are depicted graphically in figure 14. Missed approach frequency for the configuration C SSALS system will be shown and discussed separately.

All but two of the configurations tested produced missed approach frequencies of 5% or less, with configuration D (2000-foot overall length) and M (2400-foot overall length) showing the lowest values of 0%. If the total number of approaches accomplished for each of these configurations is considered, the results are shown in table 1.

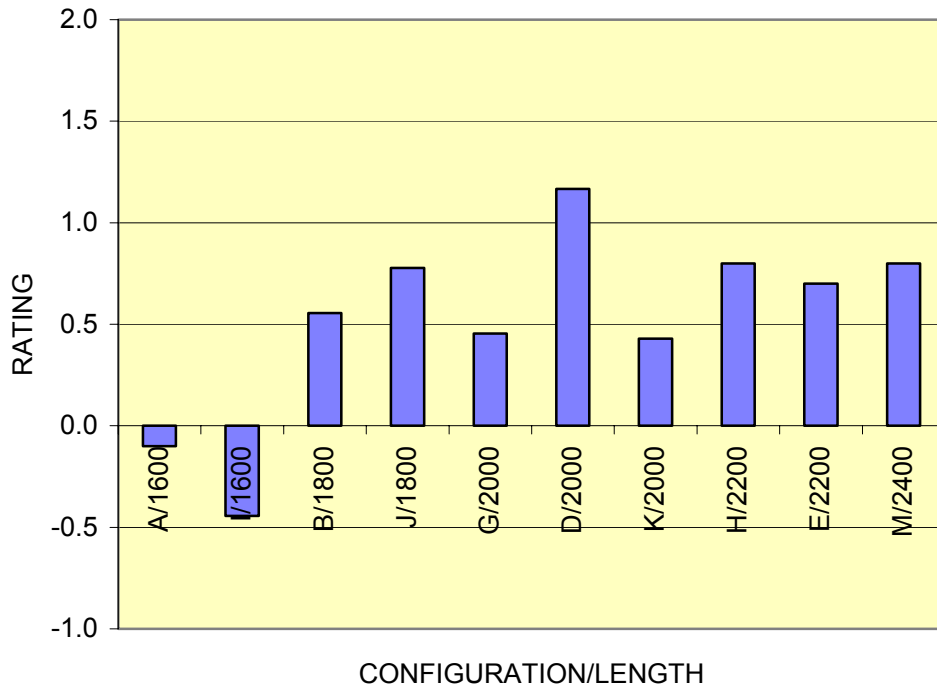
FIGURE 15. QUESTION 1—FINDING THE RUNWAY

The total of the numerical ratings were then averaged to obtain the results depicted on the graphs.

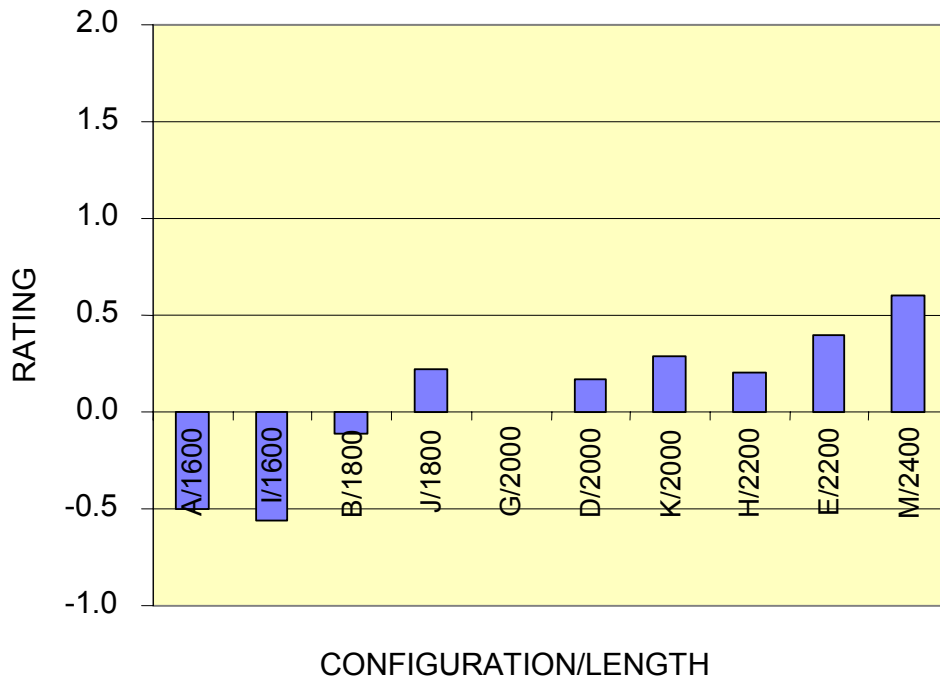
FIGURE 16. QUESTION 2—AWARENESS OF ALTITUDE

Question 2. Question 2 (figure 16), concerning altitude awareness, shows an even more pronounced subject preference for the longer system lengths. Here again, the probable reason for this is that the resultant earlier acquisition provides a longer time period for interpretation of available guidance.

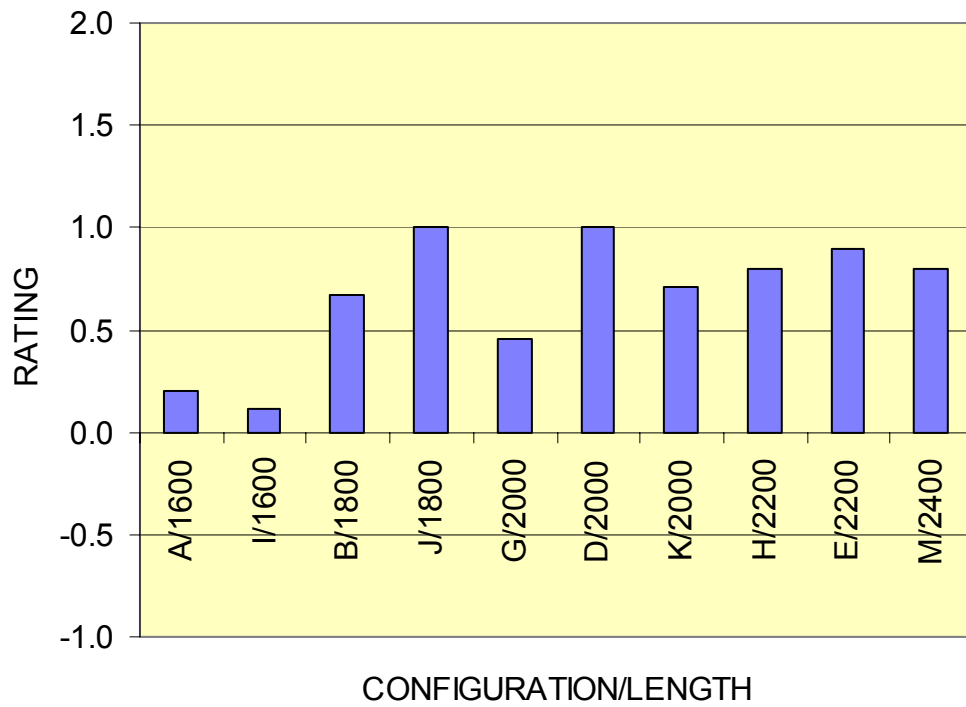
FIGURE 17. QUESTION 3—LATERAL ALIGNMENT

Question 3. The affect of system length variation is not quite so evident when viewing the results of question 3 (figure 17), which addressed the quality of tracking guidance. One must realize that tracking guidance depends upon retention, in the mind’s eye, of a series of objects (lights) that define the line representing the runway centerline extended. Sequenced flashing lights, the sole variable in each of the different configurations, do not serve this purpose very well. The 1400 feet of steady-burning light barrettes are the major ALS component performing this function, however, and their appearance is constant and uniform throughout the variety of configurations under test. Taking this into consideration, it should not be expected that there would be much difference in the subject pilot’s opinion as to the effectiveness of the tracking guidance capability.

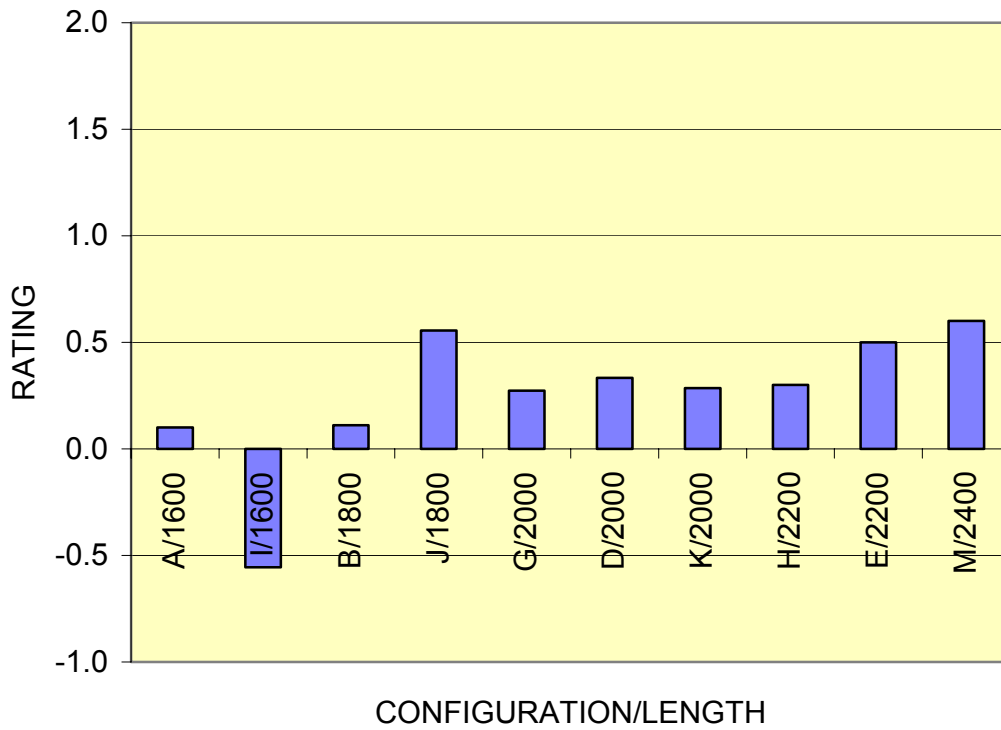
FIGURE 18. QUESTION 4—ROLL GUIDANCE

Question 4. With regard to results for question 4 (figure 18), concerning roll guidance, it is again a rather marked increase in effectiveness is seen as system length is increased. This is rather surprising, since many subject pilots in the past have expressed the opinion that ALS systems provide very little in the way of roll guidance, and that the subject pilot derives most of his “wings level” information from cockpit instruments and not from the lights. The results here would seem to contradict this.

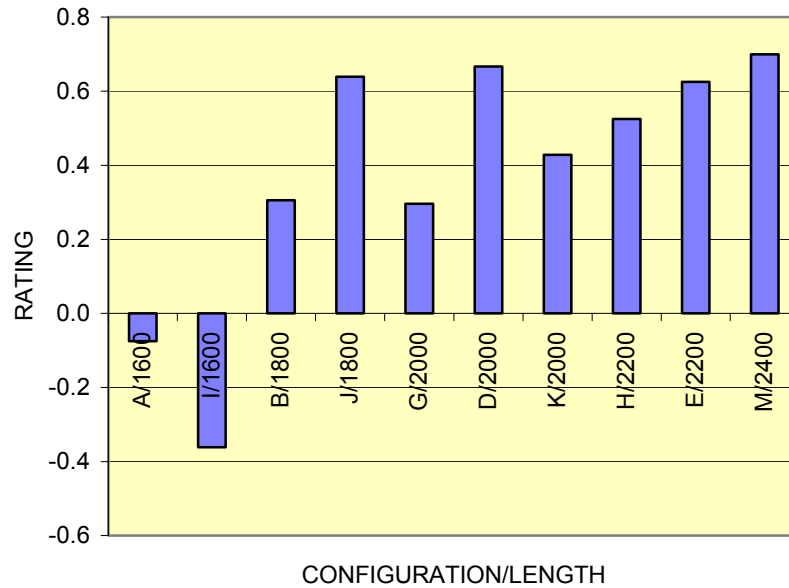
FIGURE 19. OVERALL RATINGS

Overall, or composite, ratings are graphically presented in figure 19. They were obtained by adding the configuration rating values for all four questions and then dividing by four. This, of course, presumes equal importance for each of the four guidance categories but does provide some measure of comparative general effectiveness for the configurations.

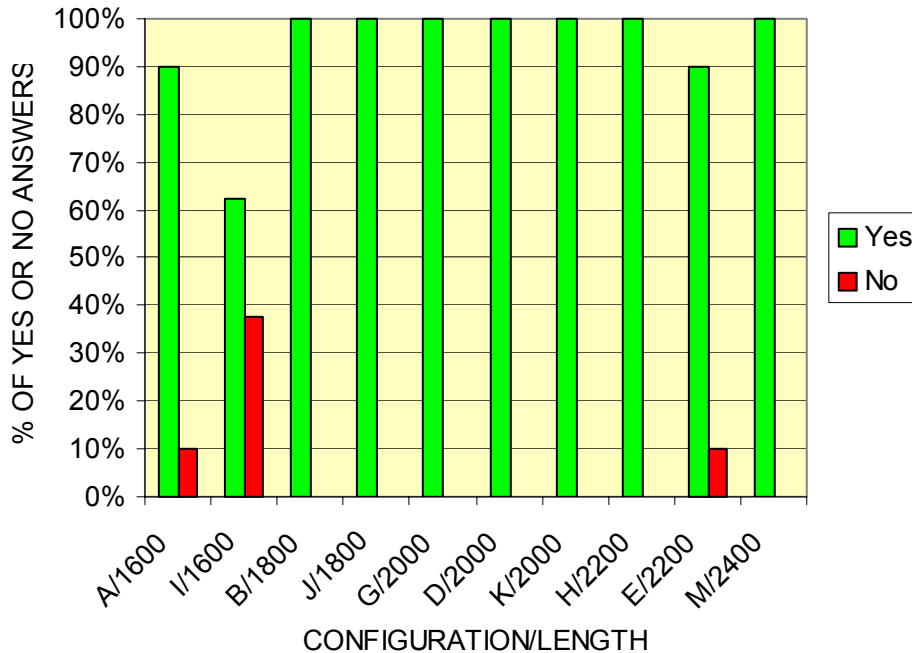
FIGURE 20. OVERALL GUIDANCE SUFFICIENCY

Questions 5 and 7 involved subject pilot opinion as to whether the particular configuration provided sufficient overall visual guidance to permit a safe approach and landing (question 5) and as to whether the configuration merited further consideration as a suitable replacement for the standard MALS (question 7). Responses, as a ratio of yes to no answers, are shown graphically in figures 19 and 20.

Question 5. Answers to question 5 (figure 20), dealing with sufficiency of overall guidance, would indicate that all but the shortest (1600 feet) configurations provided at least the minimum amount of visual guidance necessary for completing the approach and landing safely. Looking back to figure 14, virtually the same results are found reflected in the much higher rate of missed approaches for the two shortest configurations. Both subjective and objective data agree in this case and would seem to validate the subject pilots’ opinion that configurations as short as 1800 feet may provide at least the minimal required guidance.

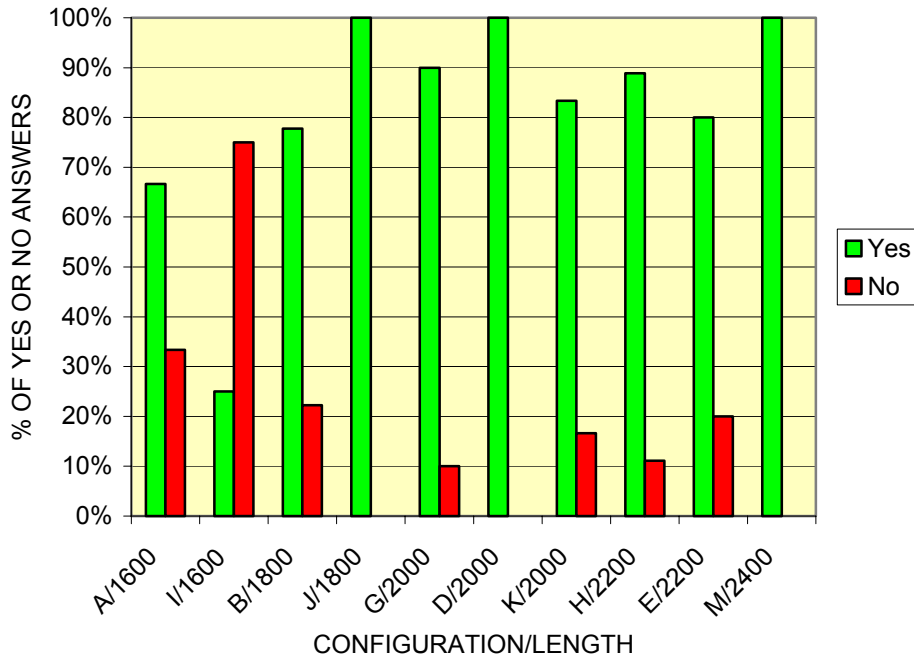
FIGURE 21. FURTHER TESTING WORTHWHILE

Question 7. Results of question 7 (figure 21), addressing the issue of whether any of the configurations evaluated warrant further consideration, show no clear cut preference for any of the patterns with overall lengths of 1800 feet or more. Here once again, it is seen that a rather marked subject dissatisfaction with the two shortest 1600-foot configurations, reflected in the opinion that no further testing of such minimum length systems would be worthwhile.

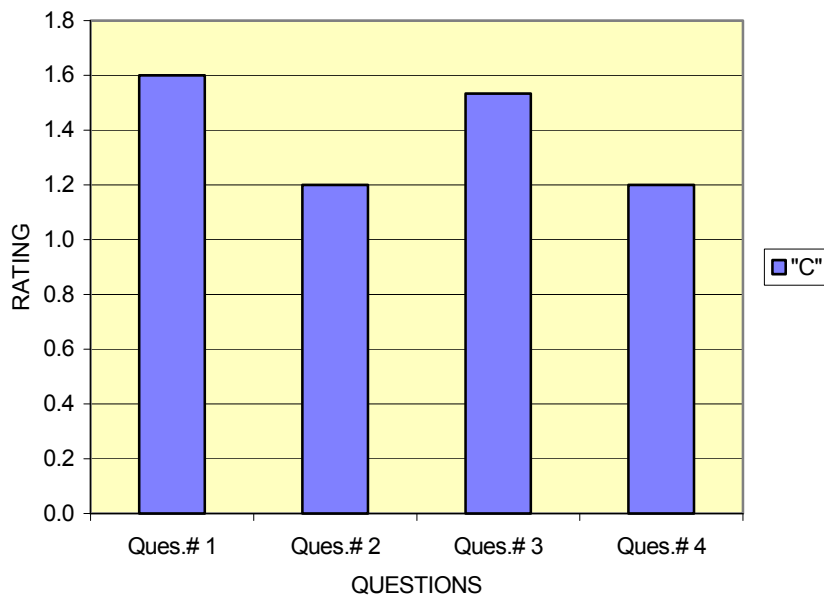
FIGURE 22. CONFIGURATION C—QUESTIONS 1 THROUGH 4

Configuration C, the SSALS of 1400-foot length, was evaluated under 3200-foot RVR conditions and is discussed separately at this point. Referring to figure 22, it can be seen that it was very favorably considered in providing all four guidance characteristics and the numerical values indicate average ratings by all subjects of good to excellent.
