Final Site Observational Work Plan for the UMTRA Project Site at Shiprock, New Mexico

September 1999

Prepared by the
U.S. Department of Energy
Grand Junction Office

UMTRA Ground Water Project

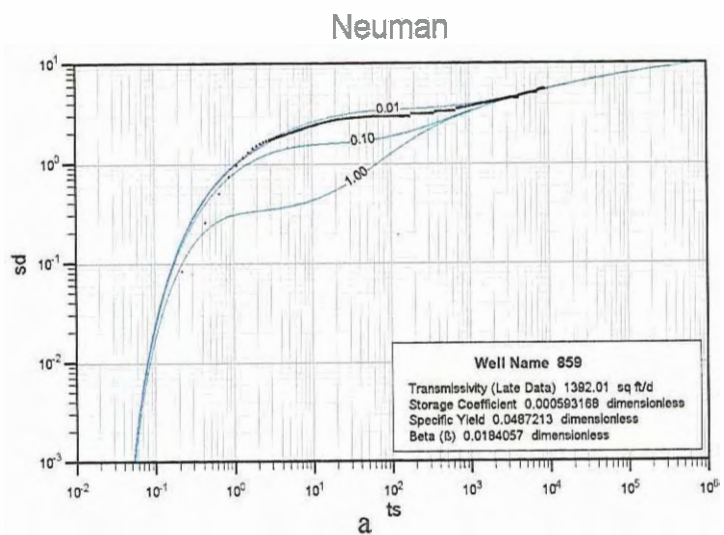
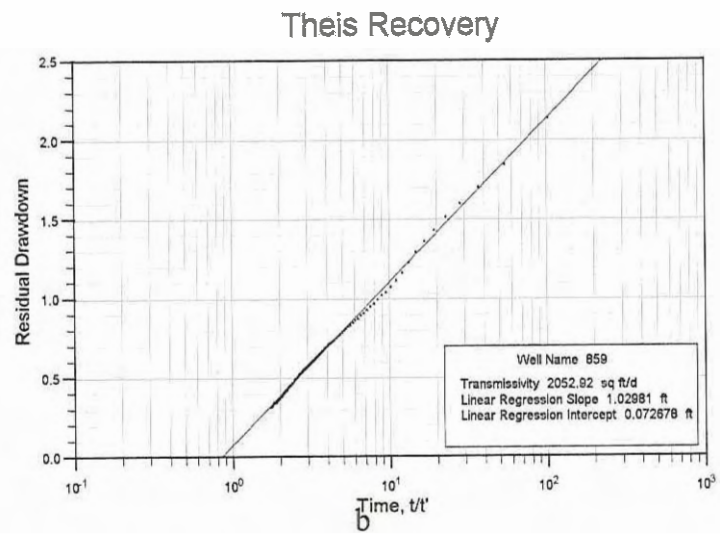
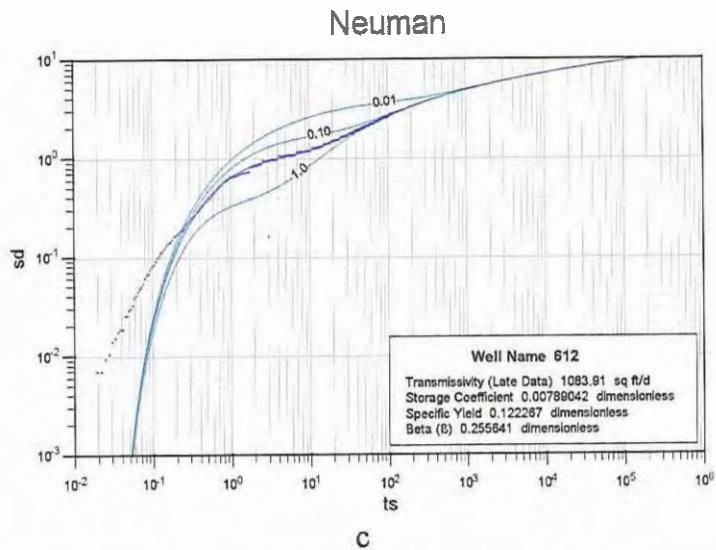
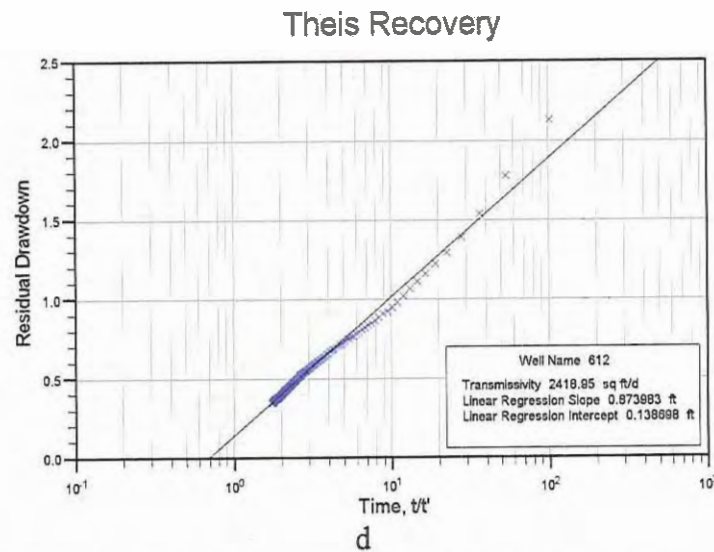
Figure 4-11 presents the drawdown-versus-time records for the aquifer tests in the floodplain alluvium. The transmissivity measured during the pumping phase was between 1,100 and 1,400 square feet per day (ft^2/day); during the recovery test it ranged from 2,100 to 2,400 ft^2/day . The average of these data is approximately 1,800 ft^2/day . Saturated thickness in the area of the test is approximately 16 ft. Therefore, the hydraulic conductivity, defined as the transmissivity divided by initial saturated thickness, is computed to be 110 feet per day (ft/day).

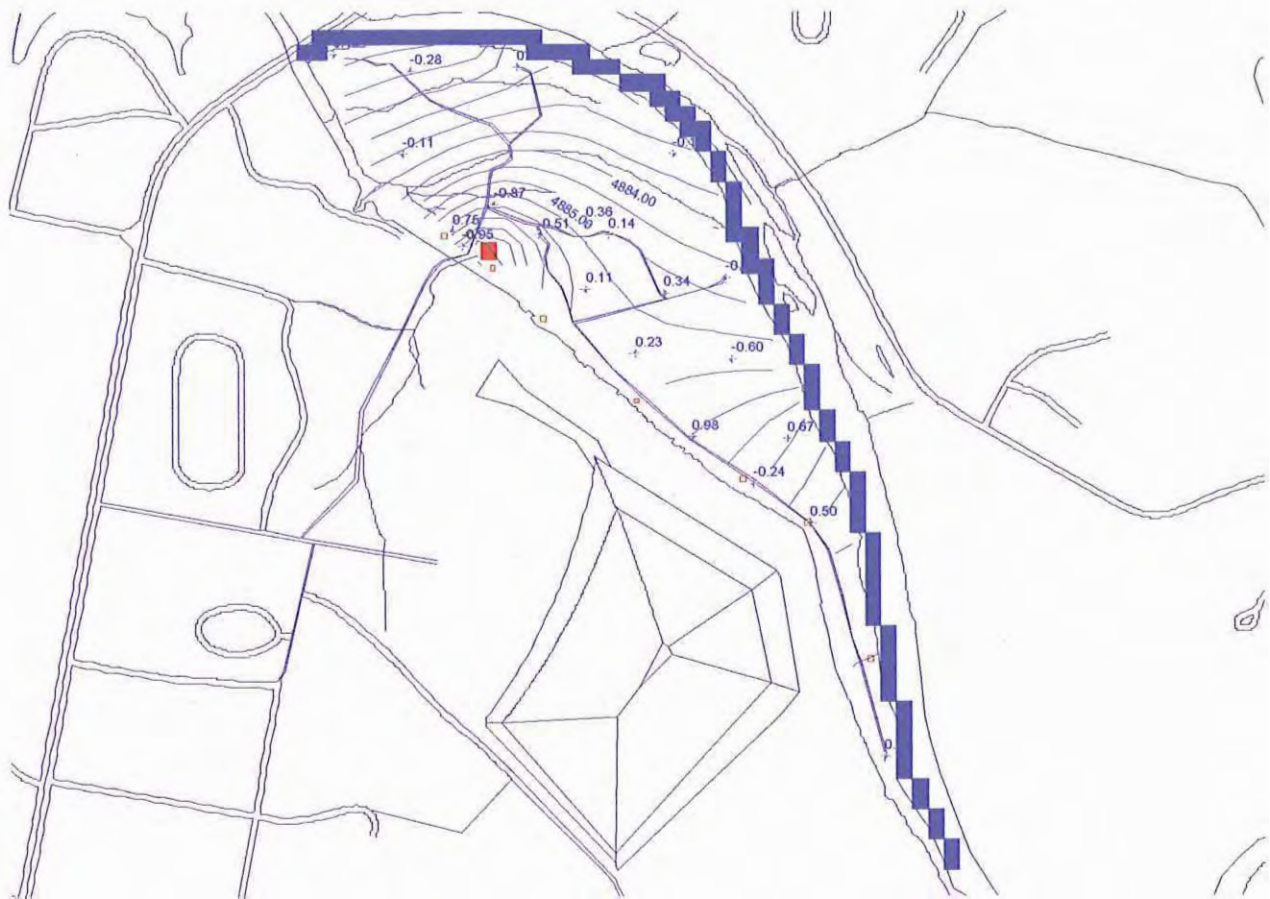
Figure 4-45. Hydraulic Head and Residuals from Calibrated Flow Model of Floodplain Alluvial Aquifer at the Shiprock, New Mexico UMTRA Site

Figure 4-45 presents a schematic of the output from the flow model, consisting of the simulated water table and a posting of the residuals. The head distribution from this flow model was saved and used for additional simulations of particle tracking and mass transport. One of the striking features of the simulation is the tremendous effect that Bob Lee Wash imparts to the flow system. This effect is increasingly obvious as the model is developed through particle tracking and transport.

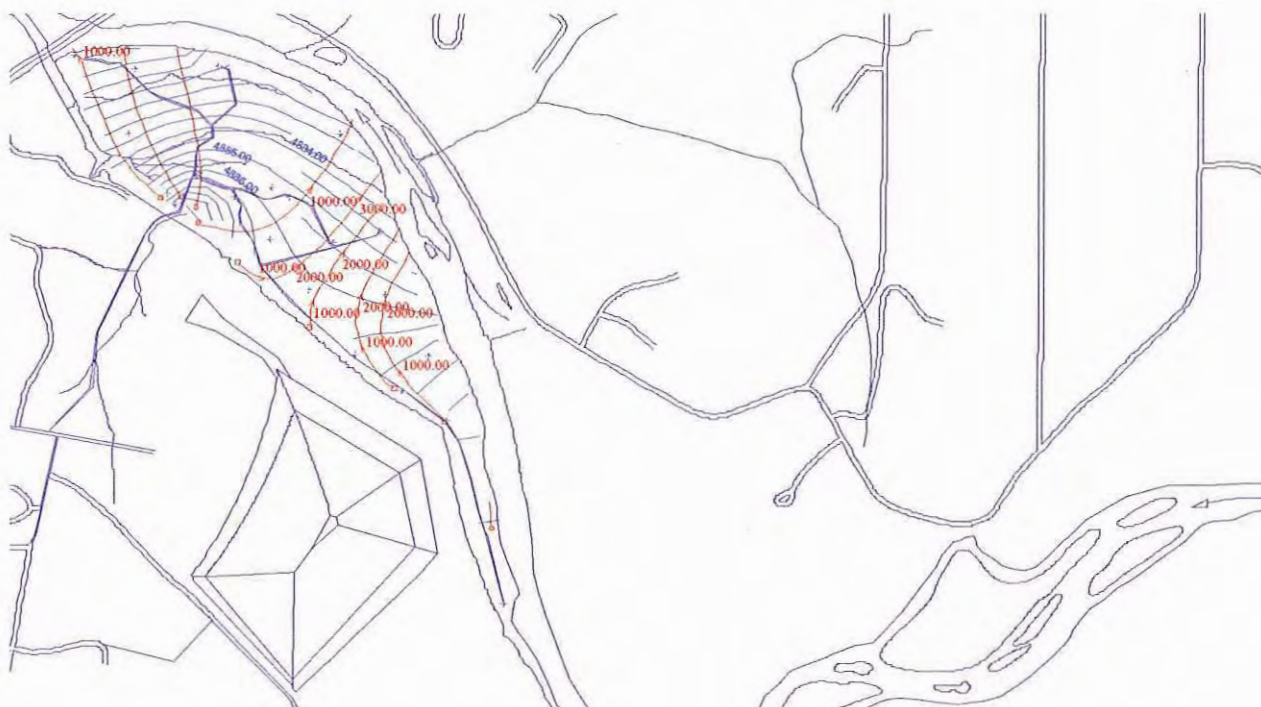
Figure 4-46. Results of Particle Tracking Simulation for Floodplain Alluvial Aquifer, Shiprock, New Mexico UMTRA Site. Arrowheads Indicate 1,000-Days Travel Time For Fluid Elements.

Flushing would be slower along the mixing zone where flow converges between water from artesian well 648 and water from the San Juan River. In this region, 1 pore volume of flushing might be expected to require between 3,000 and 4,000 days (8 to 11 years). High concentrations of contaminants have existed throughout this region since 1984. The presence of these high concentrations in this area for more than 30 years suggests that a continuing source of contamination feeds this area of the floodplain.
