# The St. Louis Sites

Formerly Utilized Sites Remedial Action Program • Summer 2009

## St. Louis Downtown Site

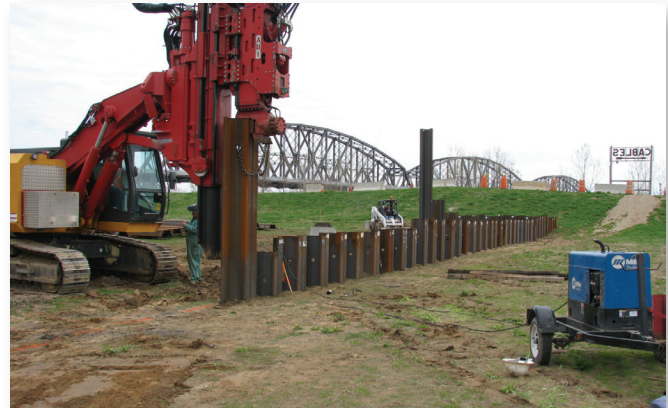
*Heavy pile-driving equipment is used to initiate the sheet pile protection for the City Property Vicinity Property at SLDS.*

Sheet piling consists of long sheets of interlocking half-inch-thick steel. The purpose of the sheet pile is to form a wall around the excavation to keep surrounding soil from falling into the excavation. As seen in the photos, sheet pile is driven into the ground before excavation begins. The installation of sheet pile will facilitate remediation activities in this area which include the removal of approximately 5,200 cubic yards of contaminated soil, an abandoned MSD 30-inch-diameter sewer line, and nearby sewer support structures.

The installation involved driving 168 pairs of sheet pile, approximately 506 linear feet, into the ground. The pairs of sheet pile varied in height from 29 to 44 feet, depending on the specific installation location and the planned depth of excavation in that area. The excavation itself may be as deep as 30 feet in certain places.

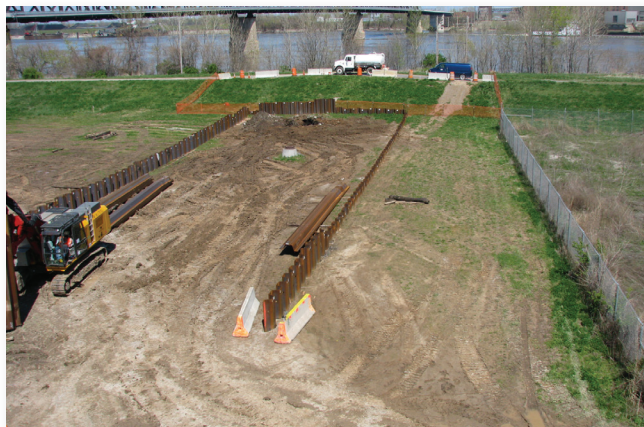
*Sheet pile protection system for the City Property excavation is shown nearing completion.*

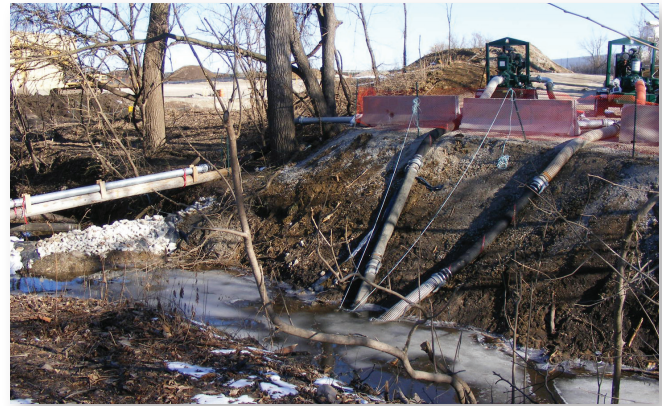
*Two large pumps divert Coldwater Creek flow around an excavation at the Norfolk Southern Vicinity Property in North County.*

The remediation of the Norfolk Southern area was particularly interesting from a technical standpoint. The FUSRAP team installed a temporary pump-around system in the tributary area to divert an estimated 1,500 gallons per minute of dry-weather flow around

the construction area. The system included portable diesel-powered pumps, temporary piping, check dams, and scour protection.

In addition to providing easier access to the tributary area, the system eliminated any possibility of Coldwater Creek contamination by diverting flow away from the area of remediation.
