The St. Louis Sites

Formerly Utilized Sites Remedial Action Program • Summer 2010

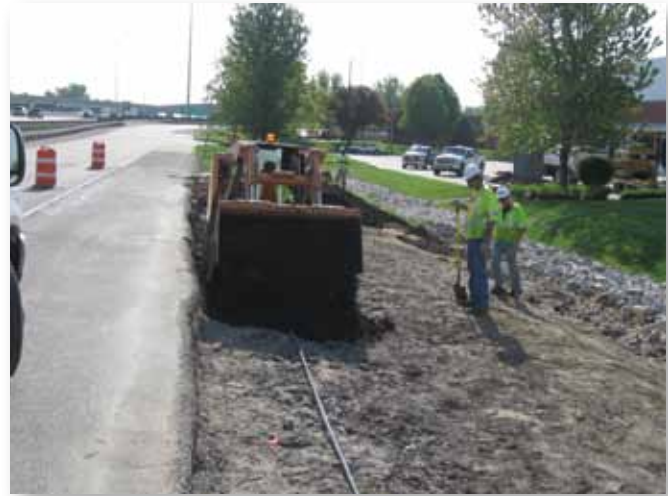
Restoration of VP-54 along Pershall Road

In February 2010, an RA was started using funds furnished by the American Recovery and Reinvestment Act (ARRA). Five properties are targeted for remediation under this RA. Most of the work is on road rights-of-way adjacent to Pershall Road and McDonnell Boulevard. To date, work has been completed at VP-63 (the old Ford Automobile Plant) off Lindbergh Boulevard, and remediation has been completed at three properties along Pershall Road (VPs-53, 54, and 55) and at VPs 3, 4, 5, and 6 off of McDonnell Boulevard. The last ARRA property to be remediated is VP-12, a property located on the northwest side of McDonnell Boulevard across from the St. Louis Airport Site (SLAPS). An estimated 706 bcys will be removed from VP-12. To date, approximately 864 cys of contaminated soil have been removed from the ARRA properties and shipped to an out-of-state licensed disposal facility. Final restoration of the ARRA properties is expected to be completed by the end of the summer.

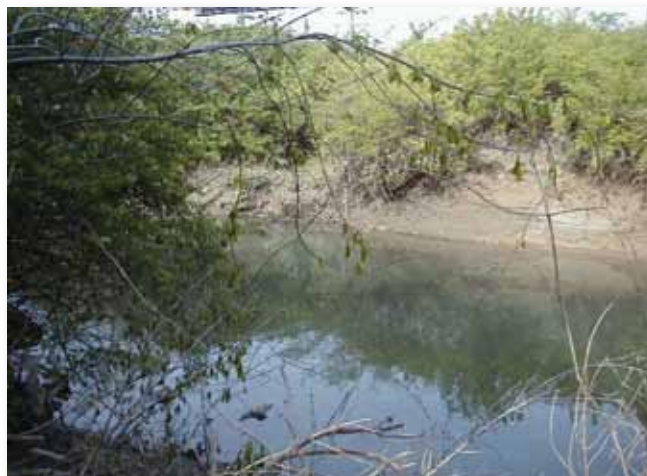
Coldwater Creek south of Pershall Road

approximately 450 cys of MED/AEC contaminated soils and sediments were removed from the creek and its banks. In 2004, the section of CWC adjacent to the SLAPS, between the Norfolk Southern railroad on the south, and the McDonnell Boulevard Bridge on the north, was also remediated as part of the SLAPS remedial activities. Approximately 11,230 cys of contaminated soils and sediments were removed from CWC and its banks. The remediation of CWC in this area culminated in the reconstruction of the channel and the armoring of the banks and creek bed with riprap.

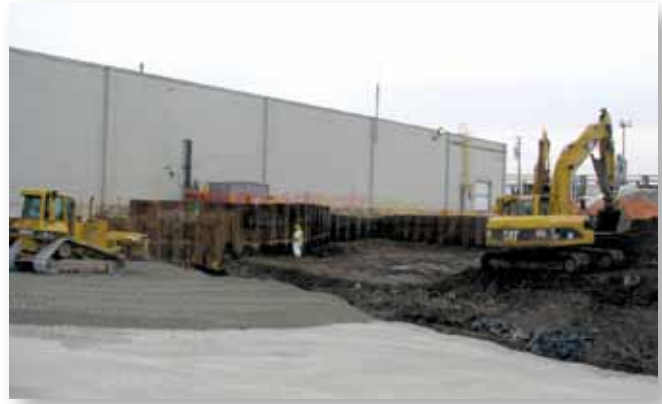
Plant 6-West Half Excavation

Excavation continues in Mallinckrodt Plant 6-West Half. The FUSRAP team previously remediated the southern portion of this plant area, and Mallinckrodt removed their source material from this area under a separate contract. Currently, remedial activities are being conducted adjacent to FUSRAP's Soil Storage and Load-out Facility in the northern area of Plant 6-West Half. Prior to initiating excavation, sheet pile shoring was installed along the eastern side of Building 101 and between some of the excavation areas to protect

the building foundation and to facilitate the staging of the various excavation areas. FUSRAP coordinated closely with Mallinckrodt, who removed additional source material from this area under a separate contract. All Mallinckrodt work has been completed in this area and it is anticipated that the FUSRAP remediation of Plant 6-West Half will be completed by this September. To date, FUSRAP has shipped about 35,000 cys of contaminated material from Plant 6-West Half to an out-of-state licensed disposal facility.
