Famous Building Stones of Our Nation's Capital

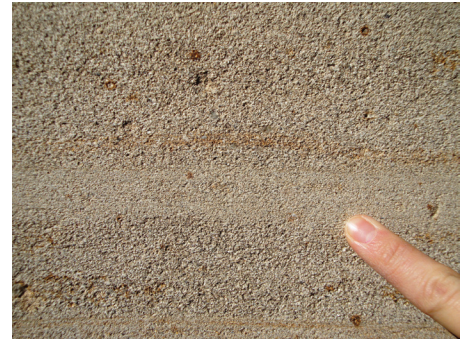
Aquia Creek sandstone

The Aquia Creek sandstone is of Early Cretaceous age (between 100 and 140 million years old). It is composed primarily of sand and pebble-sized quartz and clay pellets and is cemented with silica. Unlike many other sandstones, its matrix is harder than its crystals, which gives it a

quality of toughness without brittle hardness. In appearance, the coarse-grained stone is light gray or tan, and it is streaked or clouded with buff, yellow, or red colors that give it a warm tone.

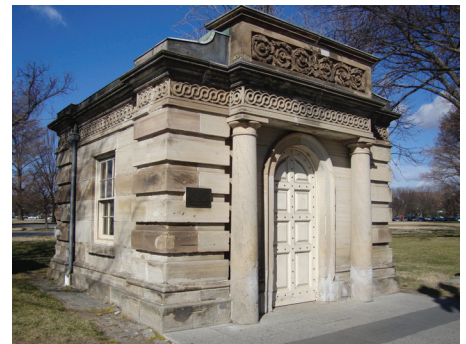
U.S. Capitol gatehouse

Unfortunately, the Aquia Creek sandstone proved to have quality-related flaws, and it weathered poorly. After the burning of the White House and Capitol buildings by British troops in 1814, the walls made of Aquia Creek sandstone suffered cracking and pitting. Both buildings were whitewashed and later painted to mask the damage and help protect the stone from weathering. As the defects of the stone became apparent, its use for exteriors declined. One of the last major exterior uses of the stone was at the U.S. Capitol gatehouses and gateposts (circa 1827). One of these gatehouses and three of the gateposts are located at 15th Street and Constitution Avenue NW, and another gatehouse is located farther west at 17th Street NW.

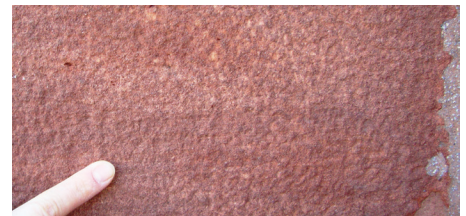
Seneca sandstone

During the “brownstone era,” from about 1840 to about 1880, red Seneca sandstone was an extremely popular building stone in Washington. This stone of Triassic age (more than 200 million years old) crops out along the Potomac River in the Triassic lowlands from Seneca, Maryland, to just east of Point of Rocks, Md. Red Seneca sandstone ranges from reddish brown to a deep purplish brown. It is brightly colored when cut but darkens and hardens on exposure to air. Seneca sandstone is generally fine-grained and uniform, and it does not easily scale when exposed to weather.

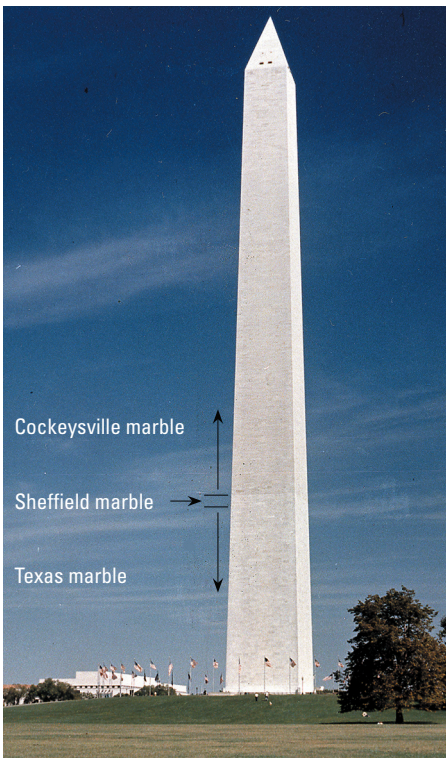
Washington Monument

Marble eventually replaced sandstone as the most popular building stone in Washington. Of particular note were the three different kinds of regionally metamorphosed marbles of late Precambrian to early Paleozoic age that were used in the construction of the Washington Monument. The first 152 feet of the monument, which was built between 1848 and 1854, is faced with marble from the quarry located at Texas, Md., just north of Baltimore in the Piedmont Province. Work stopped when funds ran out. When construction was about to resume in 1876, the builders discovered that the foundations were inadequate and that the monument was sinking and tilting. To straighten and stabilize the monument, wider subfoundations were constructed to a depth of nearly 37 feet. In 1879, work began again on the upward projection of the monument, and four courses, or rows, of white marble from Sheffield, Massachusetts, were laid above the Texas, Md., marble. Because of difficulties with timely delivery and quality control of the marble, however, the contract with the Sheffield quarry was

annulled in 1880. The extensive upper part of the monument was then finished with marble from a quarry located north of Baltimore in Cockeysville, Md. The monument was completed in 1884, reaching a height of 555 feet and 5 inches.

The three kinds of marble used in the monument can be distinguished by their differences in color. The lower section is the white, coarse-grained, nearly pure calcium carbonate marble from the Texas, Md., quarry. The upper section is built of fine-grained marble from the Cockeysville, Md., quarry. The Cockeysville marble is a clear white stone with a few pale streaks or bands, and its higher magnesium content gives it a pale gray sheen. Both marbles contain veins and pockets of mica and pyrite, which can stain the marble if it is exposed to the elements. In between these two marbles are four rows of a pronounced white marble from the Sheffield, Mass., quarry.

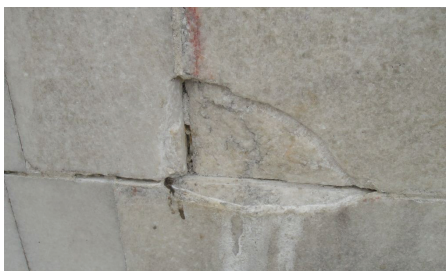
Cockeysville marble from the Washington Monument showing damage caused by the August 2011 earthquake.
