# Surviving disaster – The Titanic and SOLAS

In 1914, two years after the Titanic disaster of 1912, in which 1,503 people lost their lives, maritime nations gathered in London adopted the International Convention for the Safety of Life at Sea (SOLAS Convention), taking into account lessons learned from the Titanic. The 1914 version was superseded by SOLAS 1929, SOLAS 1948, SOLAS 1969 (the first adopted under the auspices of the International Maritime Organization) and SOLAS 1974. SOLAS 1974 is still in force today, but it has been amended and updated many times. The regulations relating to life saving appliances and arrangements, contained in chapter III of SOLAS, a new version of which entered into force on 1 July 1988, are intended to ensure that in the event of a catastrophe at sea, passengers and crew have the greatest chances of survival. Improved design and equipment, better fire protection, satellite communications, rescue planes and helicopters and trained personnel also contribute to improved safety at sea.

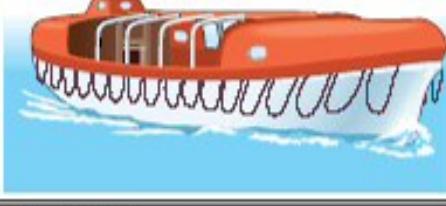
**Lifeboat design**  
Some people died from hypothermia in the Titanic lifeboats because they were open and gave no protection against the cold.  
Under SOLAS, lifeboats must be fully or partially enclosed. On passenger ships, partially enclosed lifeboats can be used as they are easier to get into, but they must have a collapsible roof to fold across.

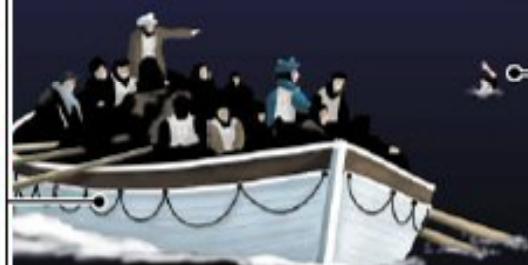
**Training of crew in lifeboat drill**  
The crew of the Titanic lacked training in loading and lowering the lifeboats and few knew which boat they were assigned to. Lifeboats were not filled to capacity because senior officers did not know the boats had been tested and were strong enough.  
Under SOLAS, every crew member must participate in regular practice drills and have easy access to training manuals.
