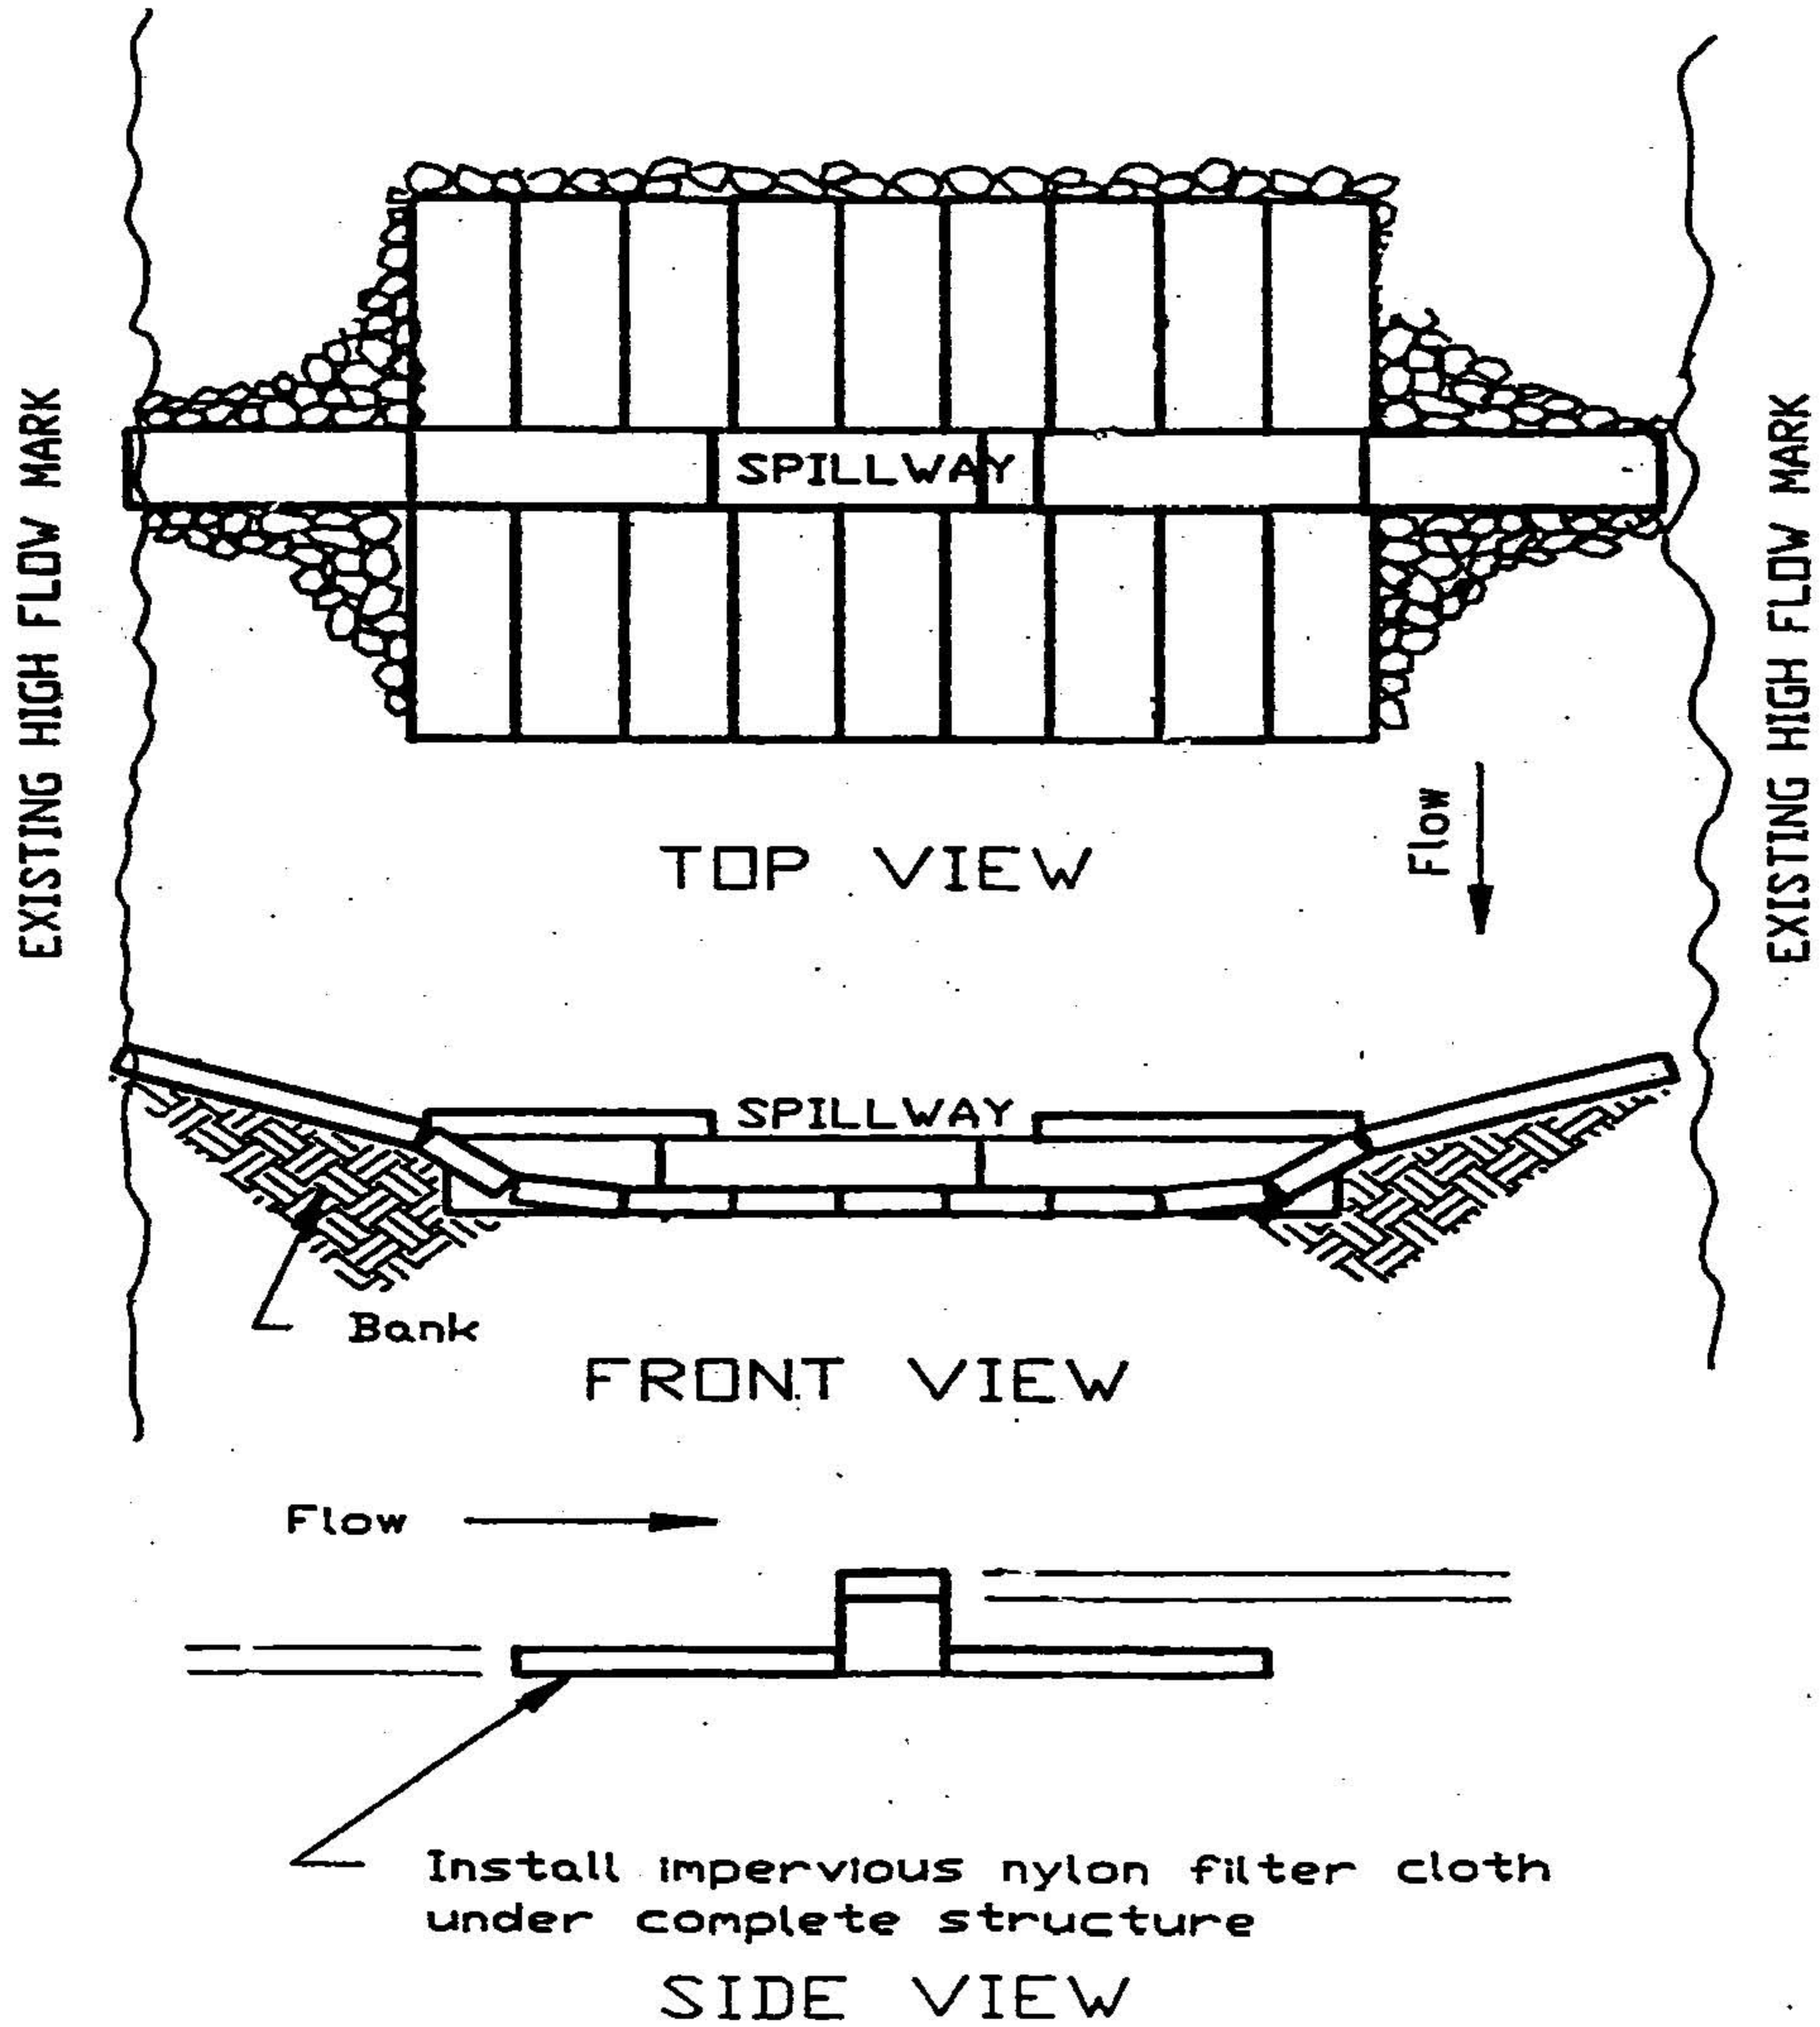
Large rock on corners to prevent high water from cutting around structure
