FINAL REPORT

Washington Metropolitan Area Transit Authority (WMATA)

Safety Management Inspection

Examination Dates: March 16 to April 3, 2015

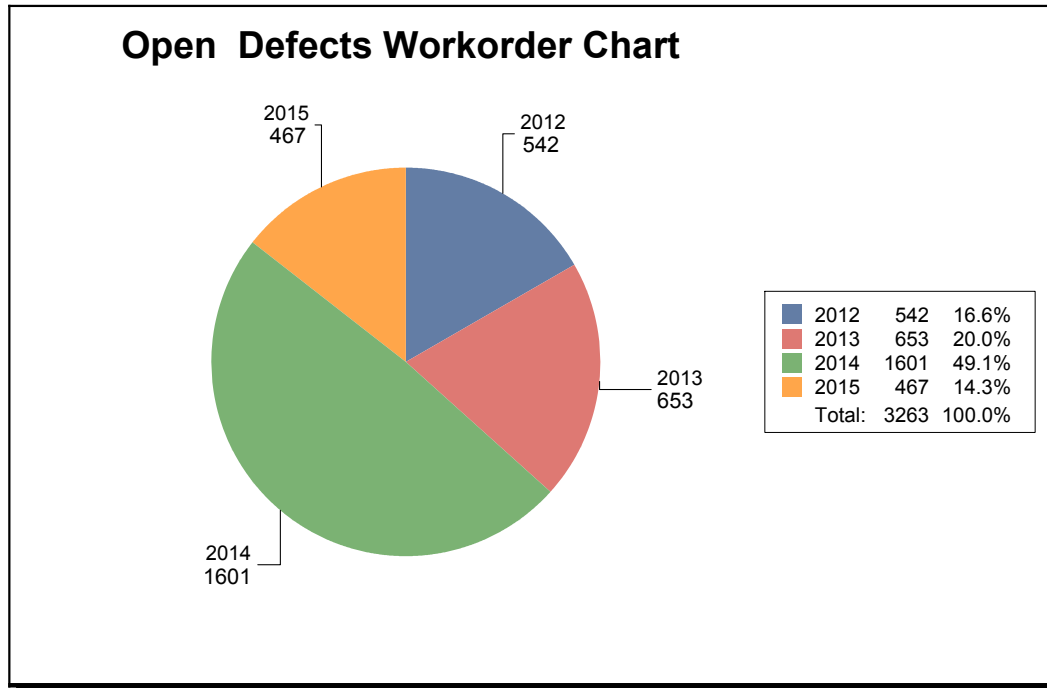
WMATA Track and Structures Open Work Order Defects, 2012 through 2015

Track and Structures management indicated that additional access to specific locations, provided through reductions in restrictions on single-tracking during off-peak service and late night hours, would enable track maintenance personnel to begin to address this backlog. On-going rail replacement (about 12 miles per year) also supports improvements in the condition of track.
