# Cooperative Intersection Collision Avoidance System Limited to Stop Sign and Traffic Signal Violations (CICAS-V)

## Subtask 3.4 Interim Report

## Human Factors Pilot Test of the CICAS-V

**September 30, 2008**

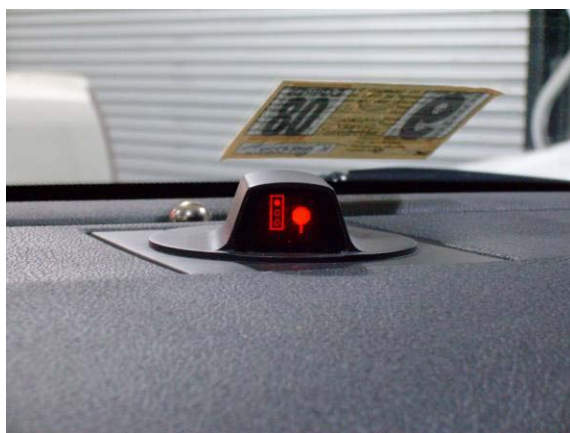
Figure 1 The visual display is located on the dash of the experimental vehicle.

The auditory warning consisted of a female voice stating "Stop Light" or "Stop-Sign", presented at 72.6 dBA via the front speakers, measured at the location of the driver's head. The visual warning (Figure 1) displayed a traffic signal and stop-sign icon from a high "head down" display located on top, center of the dashboard near the windshield. Finally, the haptic brake pulse warning consisted of a single 600 millisecond brake pulse (or vehicle jerk) presented in conjunction with the visual icon and an auditory warning.

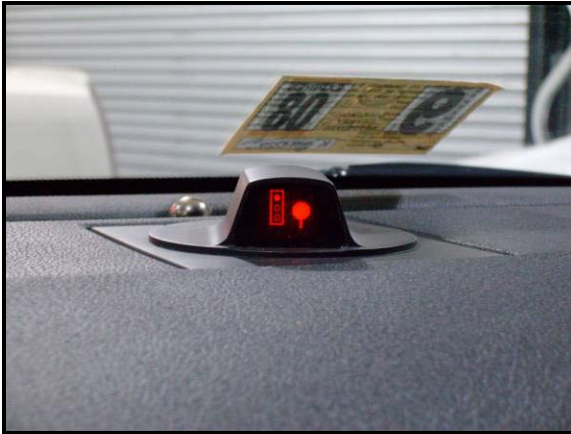
**Figure 3** The visual display is located on the dash of the experimental vehicle.

The visual warning is displayed by a dash-mounted icon (Figure 3) positioned at the vehicle centerline near the cowl of the windshield. As implemented in the vehicle, the visual icon was 11.6 mm (0.46 inches) high and 11.6 mm (0.46 inches) wide. It was illuminated as either steady, continuous blue (advisory) or flashing red (warning).

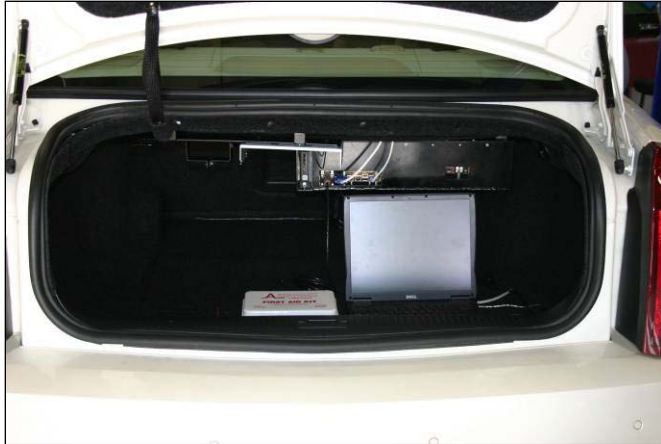
**Figure 5 DAS, installed in the vehicle trunk underneath the rear shelf.**

The vehicle DAS (Figure 5) was used to record digital video and kinematic data from multiple sources, and was composed of hardware, software, and data storage components.

The vehicle DAS hardware consisted of a main unit, a video system, front and rear radar, and a GPS unit. The main unit contained an Embedded Platform for Industrial Computing (EPIC) single-board computer, hard drive, CAN communication, battery backup system, and several VTTI-developed sensor modules. Four unobtrusive cameras installed in the passenger compartment captured the scene in and around the vehicle.

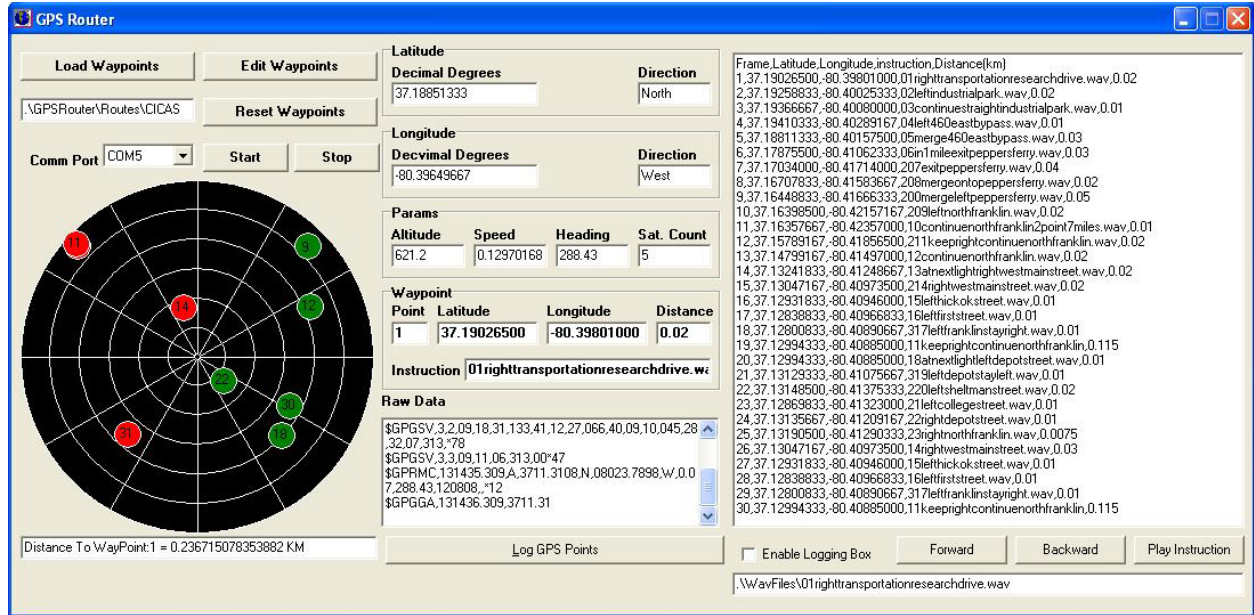
**Figure 6** GPS interface.

antenna. The navigation system interface is pictured in Figure 6. The system played auditory instructions over a speaker in the front of the vehicle based on the current position of the subject along the route. The custom software solution allowed the researchers to record the instructions to play and to guarantee the timing of the instructions so as to not distract the driver while approaching an equipped intersection.

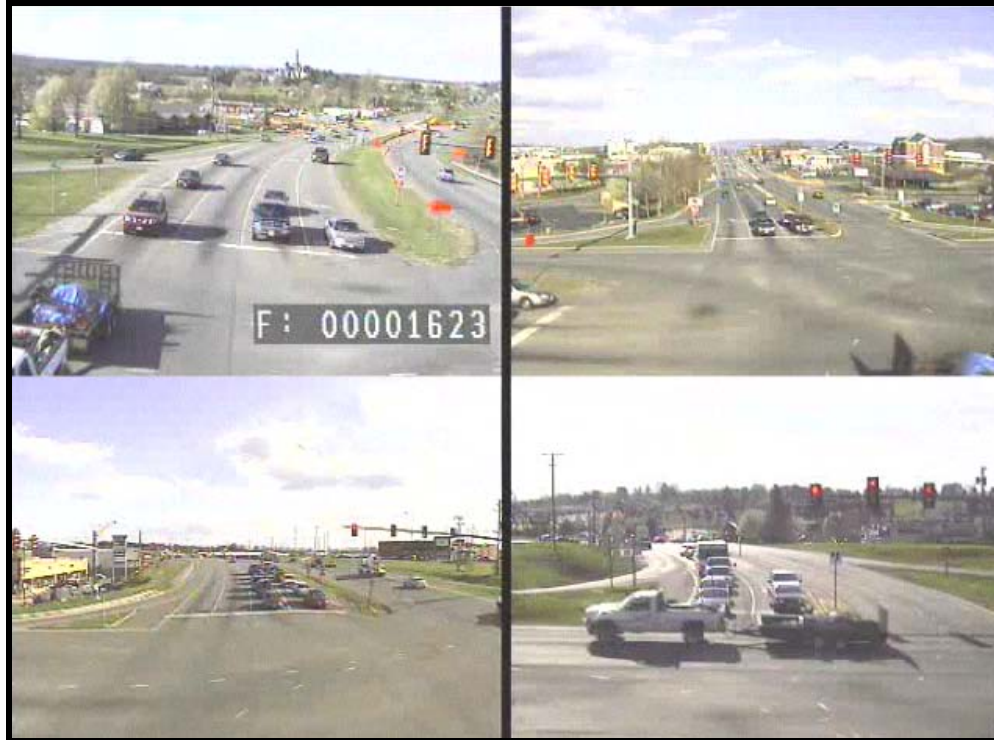
**Figure 9 Video quadrants from camera units mounted on intersection mast arms.**

As discussed in section 2.2.1, the RSE used a second WSU to perform the CICAS-V roadside tasks. The DAS was attached to the RSE via a CAN bus and received data packets containing the SPaT. A video camera was installed on each of the four traffic signal mast arms to provide an image of the entire intersection environment (Figure 9).

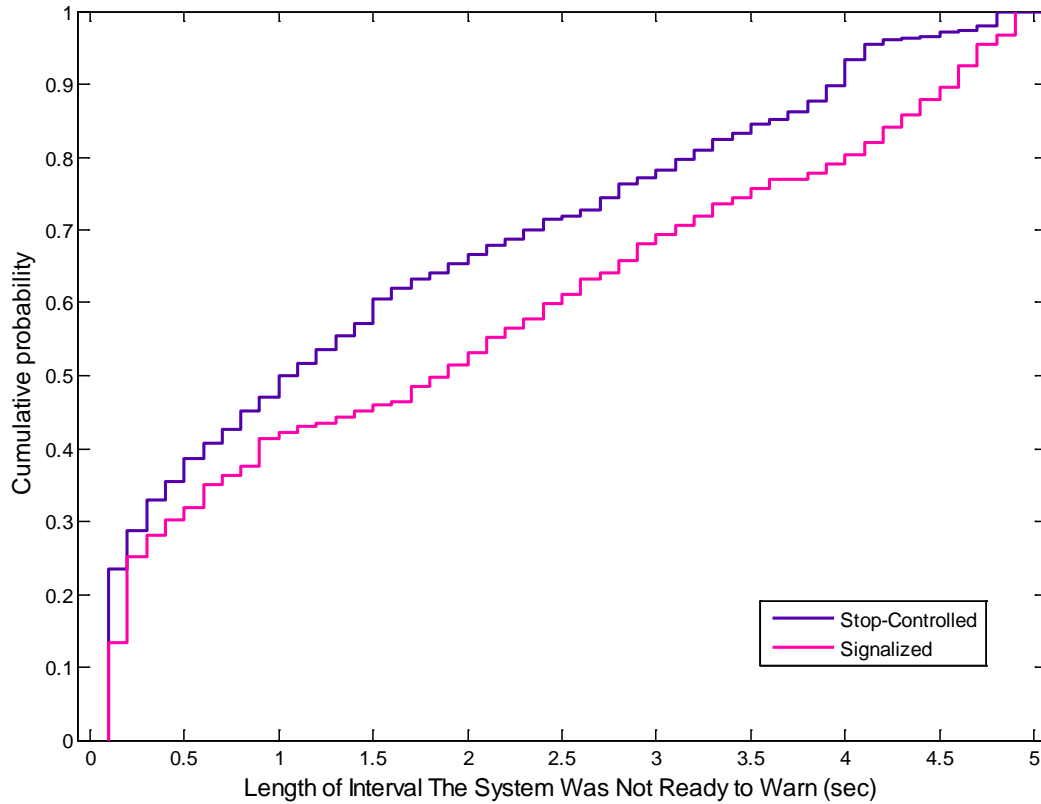
**Figure 17 Empirical cumulative probability distribution of the length of a disabled DVI period at stop-controlled intersections.**

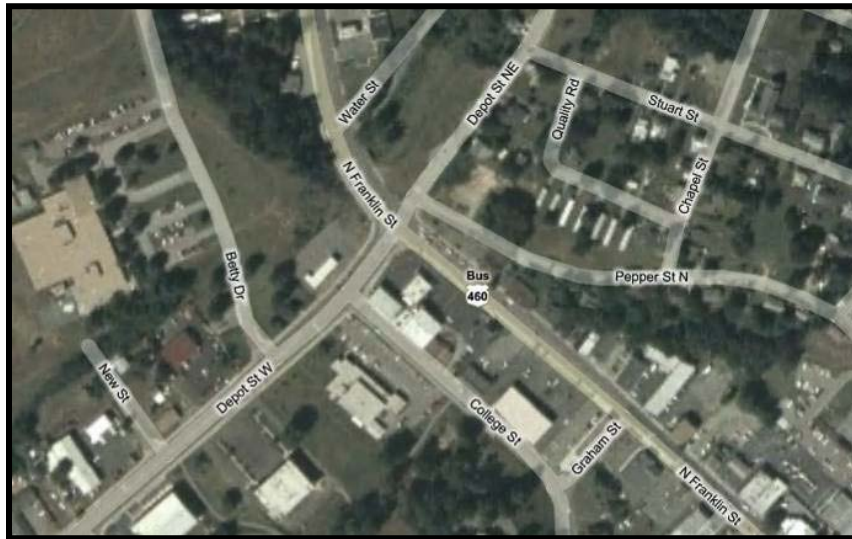
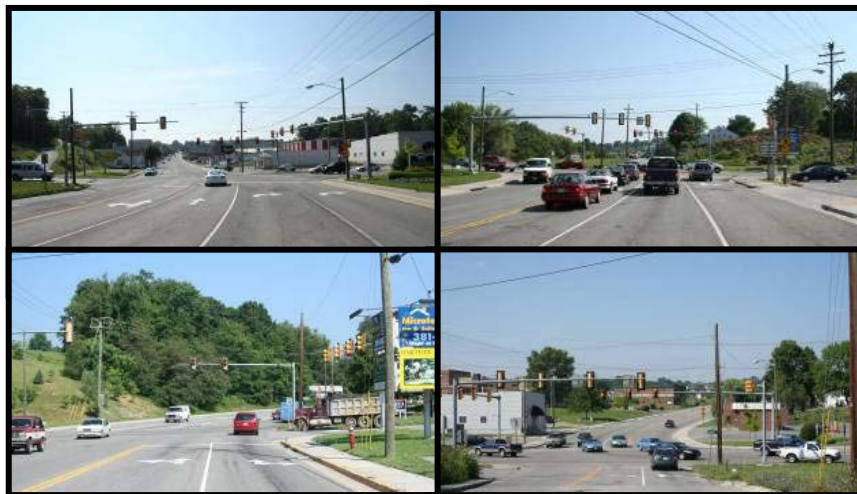
The intersection of Depot Street and Franklin Street (Intersection 6) is a four-way signalized intersection with a traffic light presented to vehicles traveling on both Franklin Street and Depot Street. The Franklin Street eastbound intersection approach has a 35 mph posted speed limit, while the westbound intersection approach has a 25 mph posted speed limit. The Depot Street intersection approach has a 25 mph posted speed limit going southbound and a 35 mph posted speed limit going northbound. An aerial view and ground images of Intersection 6 are presented in Figure 18 and Figure 19, respectively.

**Figure 18 Aerial view of Depot & Franklin intersection.**

**Figure 19 Ground images from Depot & Franklin intersection.**

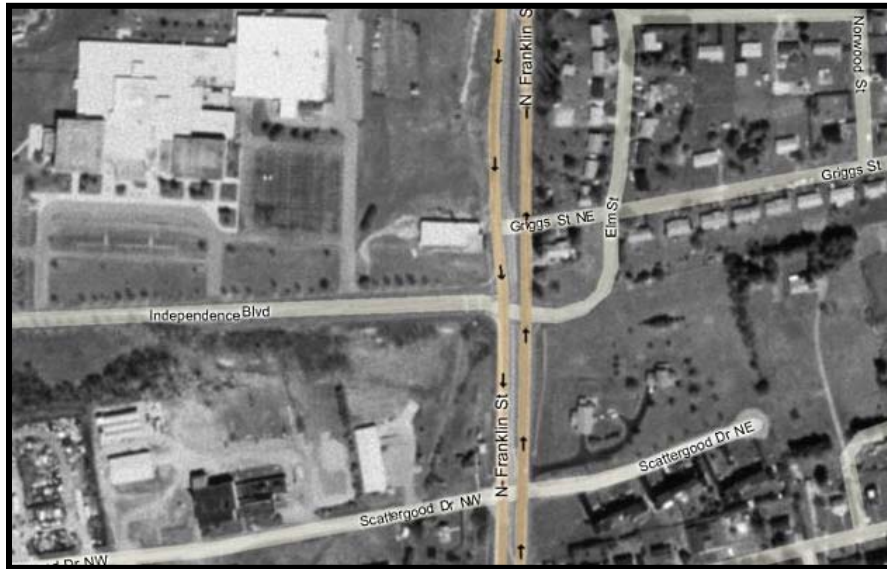
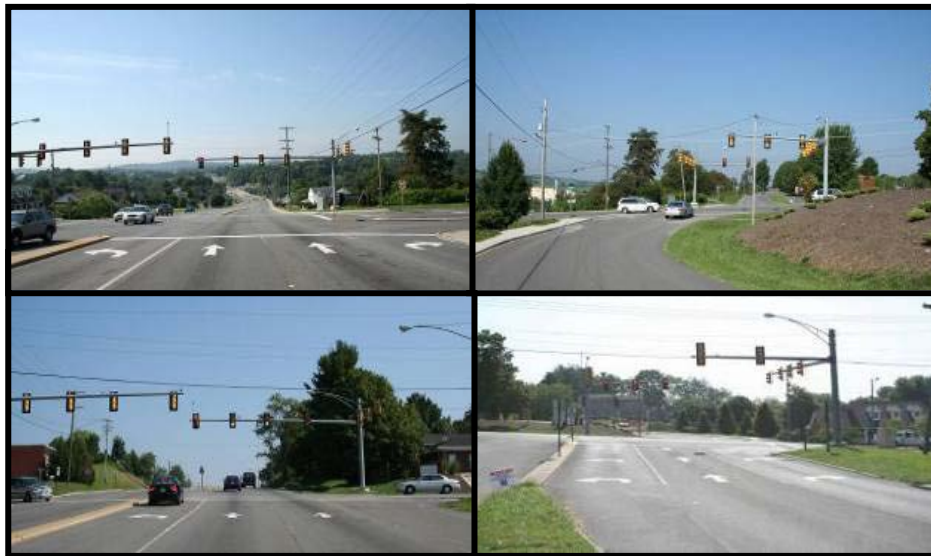
The intersection of Franklin Street and Independence Boulevard (Intersection 7) is a four-way signalized intersection with a traffic light presented to vehicles traveling on Independence Boulevard, Elm Street, and both directions on Franklin. The posted speed limits for Franklin Street, Independence Boulevard and Elm Street are 45 mph, 35 mph, and 25 mph, respectively. An aerial view (Figure 20) and ground images (Figure 21) of Intersection 7 are provided below.

**Figure 20 Aerial view Franklin, Elm & Independence intersection.**

**Figure 21 Ground images from Franklin, Elm & Independence intersection.**

For the valid warning, a middle-aged male approached the Independence by Franklin signalized intersection to make a straight-crossing maneuver (see Appendix E, Figure 20). He was in the right-most straight-through-lane following a vehicle with about a one-second headway. The signal became visible in the video at 53m (173 ft) and is in the yellow state. The driver does not show any indication of intending to brake until after the pre-warning process (a 500 ms process to initialize the warning) has started. Three-hundred ms later, the driver begins to brake. The pre-warning process finished and a warning is issued 200 ms after the braking began. The driver brakes safely to a stop before crossing the stop bar. Although it cannot be determined with certainty, the driver's braking prior to the warning likely indicates intent to stop. The driver did not show any visible expression in response to the warning. If the driver had not stopped, it appears a violation would have occurred, based on the location of the lead vehicle, which crosses over the stop bar as the signal turned red.

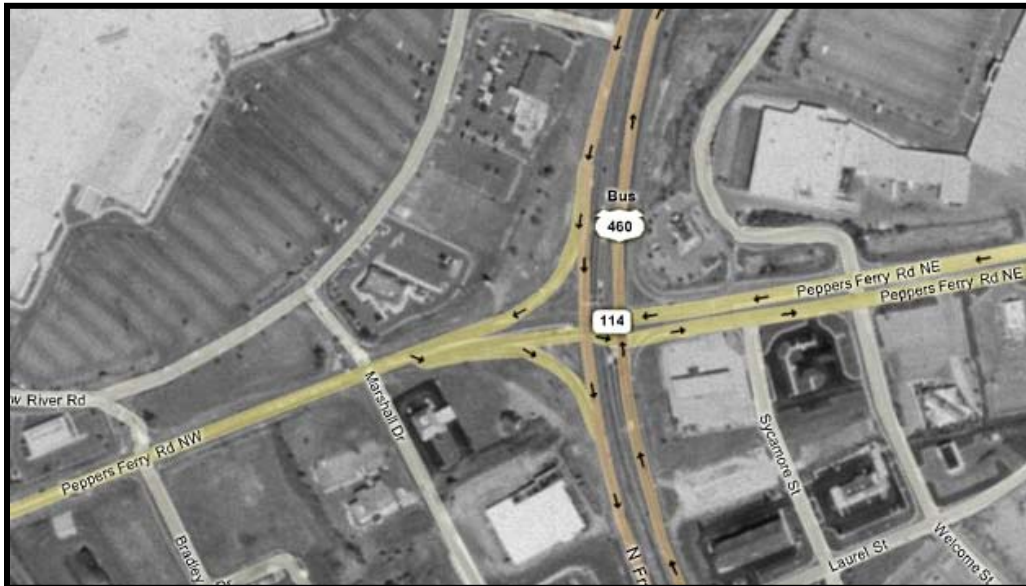
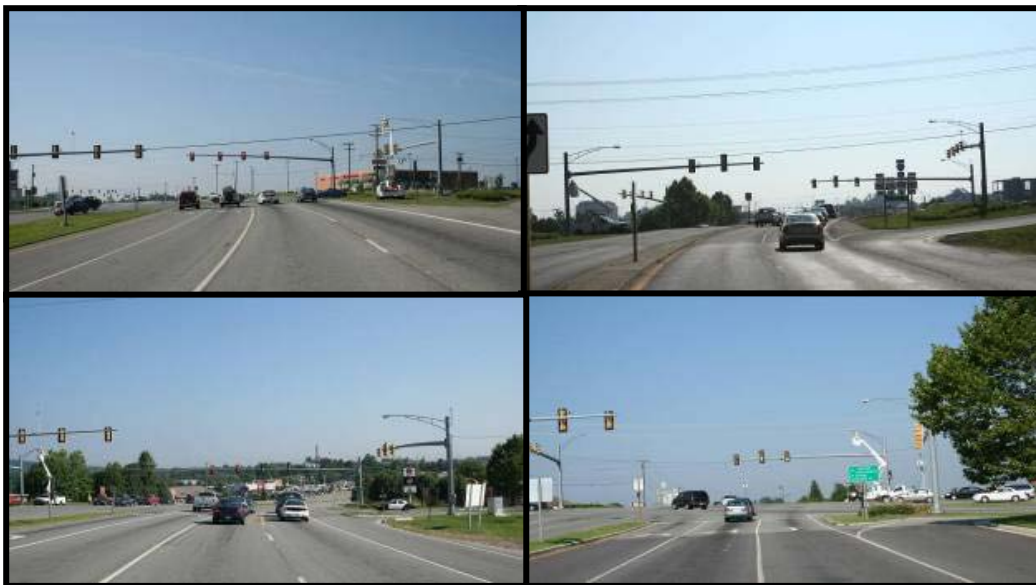
The intersection of Peppers Ferry and Franklin Street (Intersection 8) is a four-way signalized intersection with a traffic light presented to vehicles traveling on Peppers Ferry and Franklin Street. The Peppers Ferry intersection approach has a 35 mph posted speed limit in both westbound and eastbound directions. On Franklin there is a 45 mph posted speed limit in both northbound and southbound directions. An aerial view and ground images of Intersection 8 are presented in Figure 22 and Figure 23, respectively.

**Figure 22 Aerial view of Peppers Ferry (VA-114) & Franklin (Bus460) intersection.**

**Figure 23 Ground images from Peppers Ferry (VA-114) & Franklin (Bus460) intersection.**

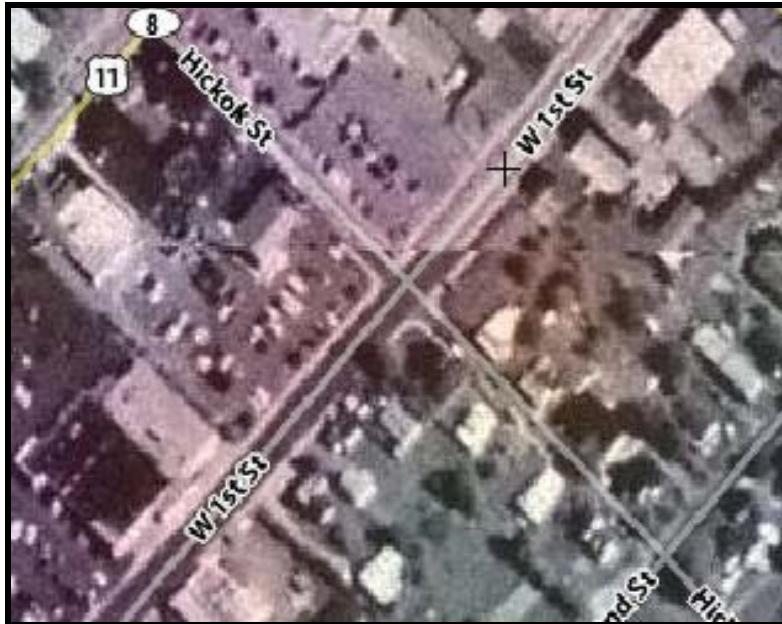
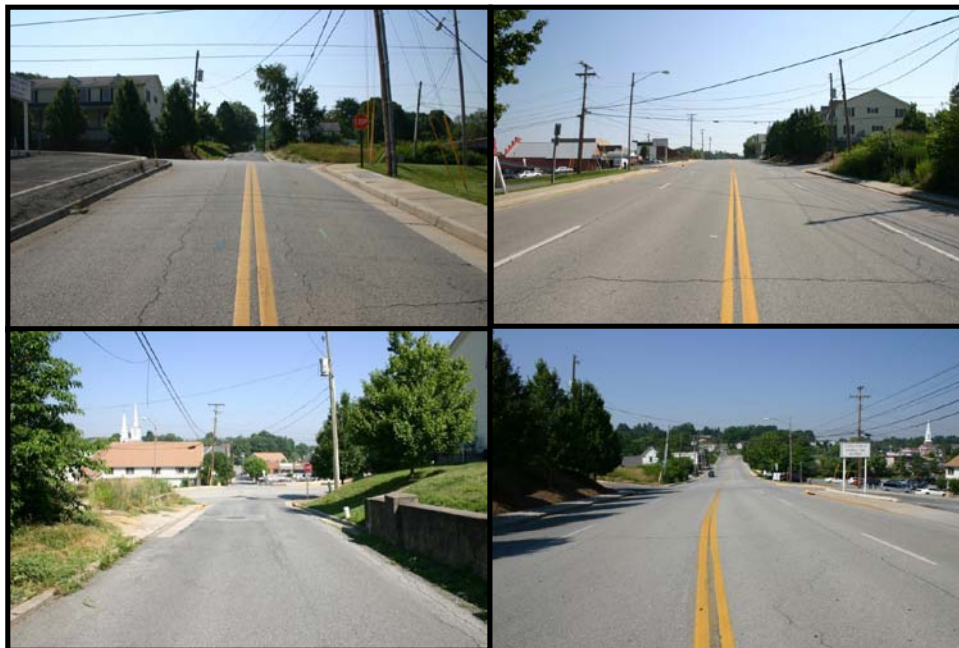
The intersection of Hickok Street and First Street (Intersection 12) is a four-way stop-controlled intersection with a single stop sign for vehicles traveling both directions on Hickok. The speed limit for traffic traveling on both Hickok Street and First Street is 25 mph. An aerial view and ground images of Intersection 12 are presented in Figure 24 and Figure 25, respectively.

**Figure 24 Aerial view of Hickok and First Street intersection.**

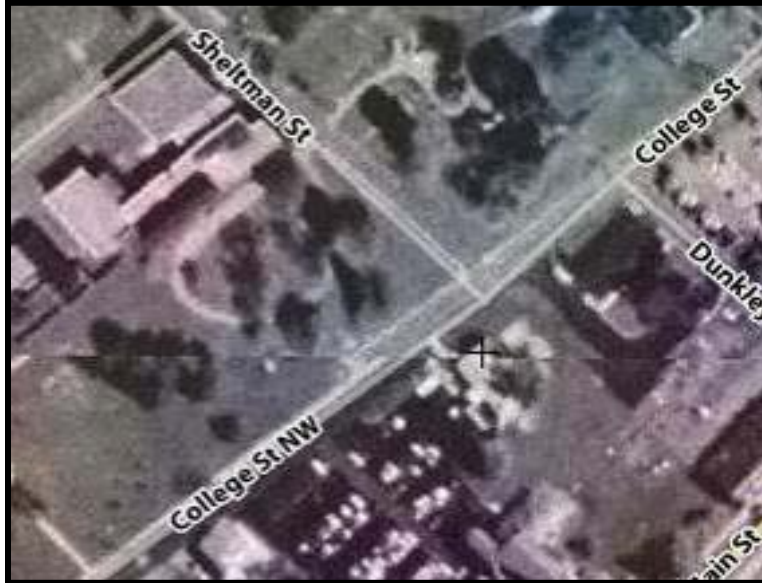
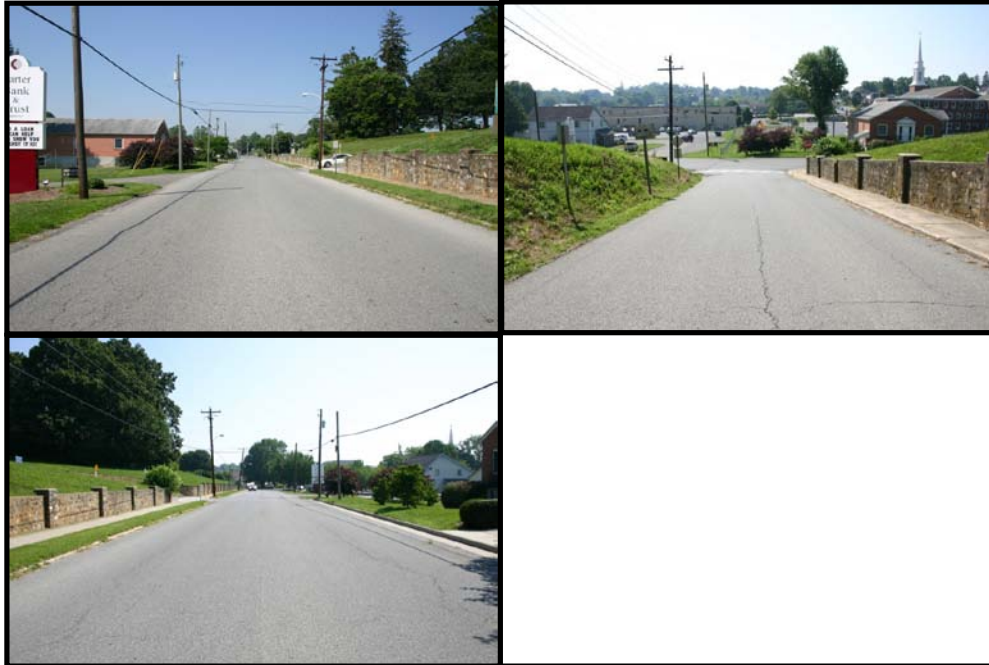
The intersection of Sheltman Street and College Street (Intersection 13) is a three-way stop-controlled intersection with a single stop sign for vehicles traveling on Sheltman Street. The speed limit for traffic traveling on both Sheltman Street and College Street is 25 mph. An aerial view and ground images of Intersection 13 are presented in Figure 26 and Figure 27, respectively.

**Figure 26 Aerial view of Sheltman & College intersection.**

**Figure 27 Ground images of Sheltman & College intersection.**

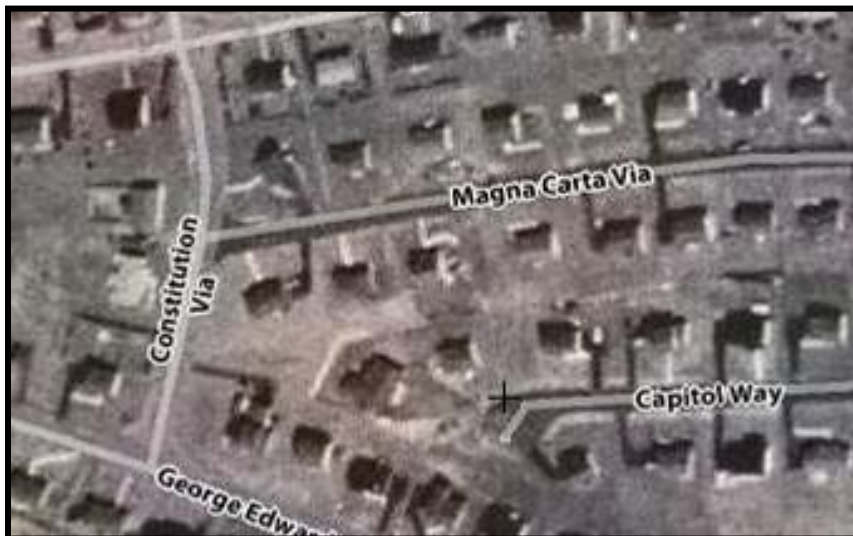
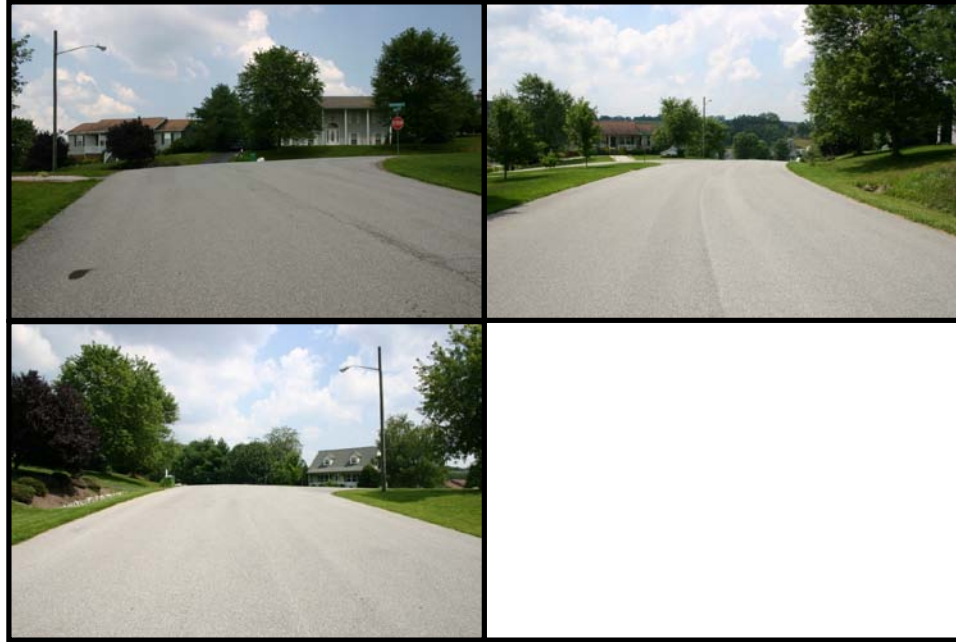
The intersection of Magna Carta Via and Constitution Via (Intersection 15) is a three-way stop-controlled intersection with a single stop sign for vehicles traveling on Magna Carta Via. The speed limit for traffic traveling on both Magna Carta and Constitution is 25 mph. An aerial view and ground images of Intersection 15 are presented in Figure 28 and Figure 29, respectively.

**Figure 28 Aerial view of Magna Carta Via and Constitution Via.**

**Figure 29 Ground images of Magna Carta Via and Constitution Via.**

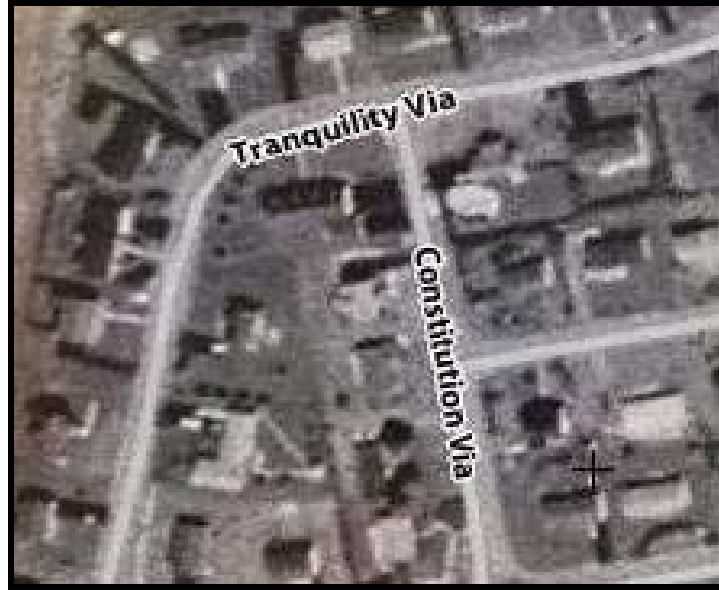
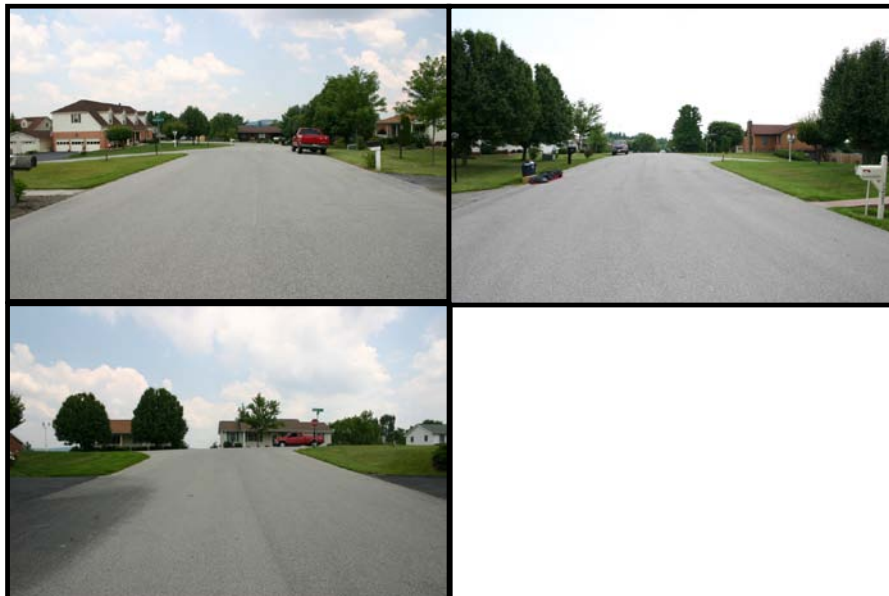
The intersection of Constitution Via and Tranquility Via (Intersection 17) is a three-way stop-controlled intersection with a single stop sign for vehicles traveling on Constitution Via. The speed limit for traffic traveling on both Constitution Via and Tranquility Via is 25 mph. An aerial view and ground images of Intersection 17 are presented in and Figure 31, respectively.

**Figure 30 Aerial view of Constitution Via & Tranquility Via intersection.**

**Figure 31 Ground images of Constitution Via & Tranquility Via intersection.**

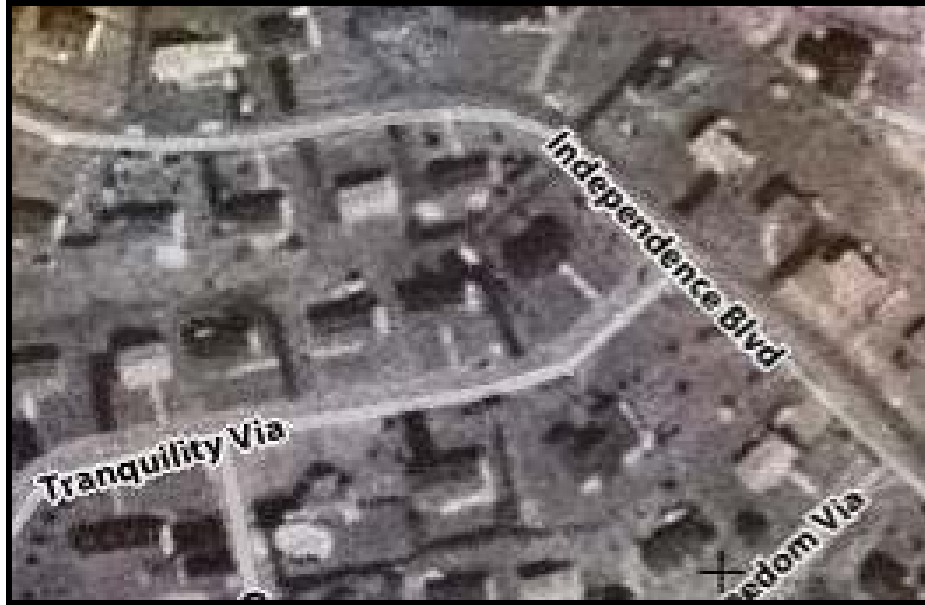
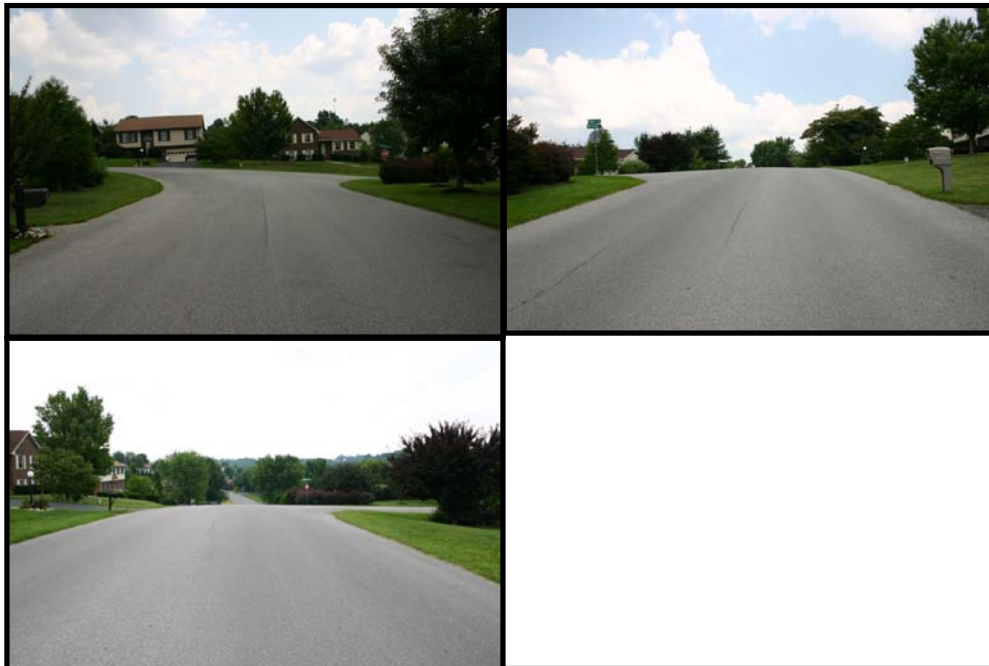
The intersection of Tranquility Via and Independence Via (Intersection 18) is a three-way stop-controlled intersection with a single stop sign for vehicles traveling on Tranquility Via. The speed limit for traffic traveling on both Tranquility Via and Independence Via is 25 mph. An aerial view and ground images of Intersection 18 are presented in Figure 32 and Figure 33, respectively.

**Figure 32 Aerial view of Tranquility Via & Independence intersection.**

**Figure 33 Ground images of Tranquility Via & Independence intersection.**

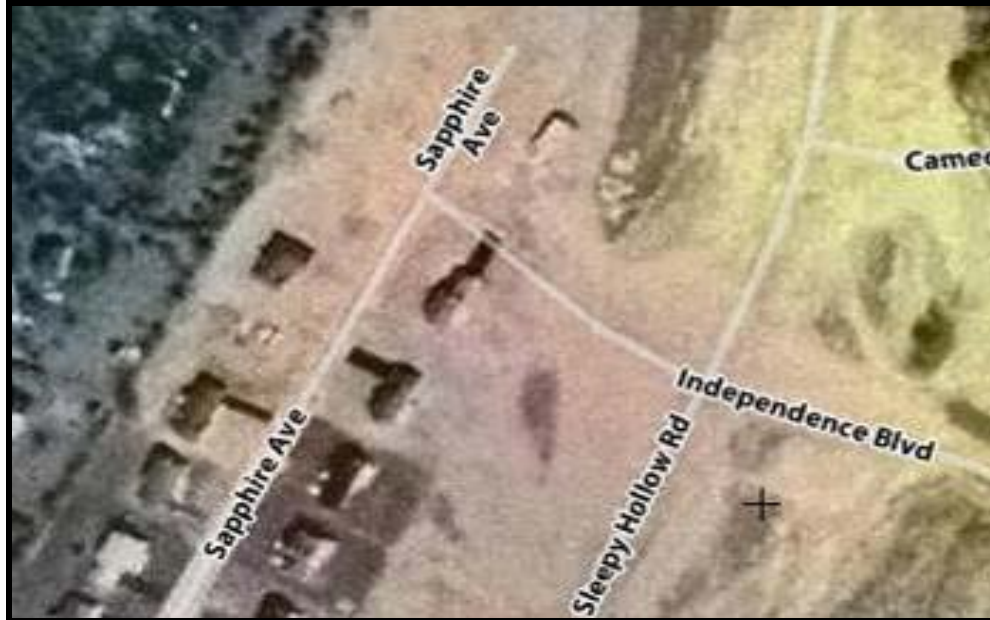
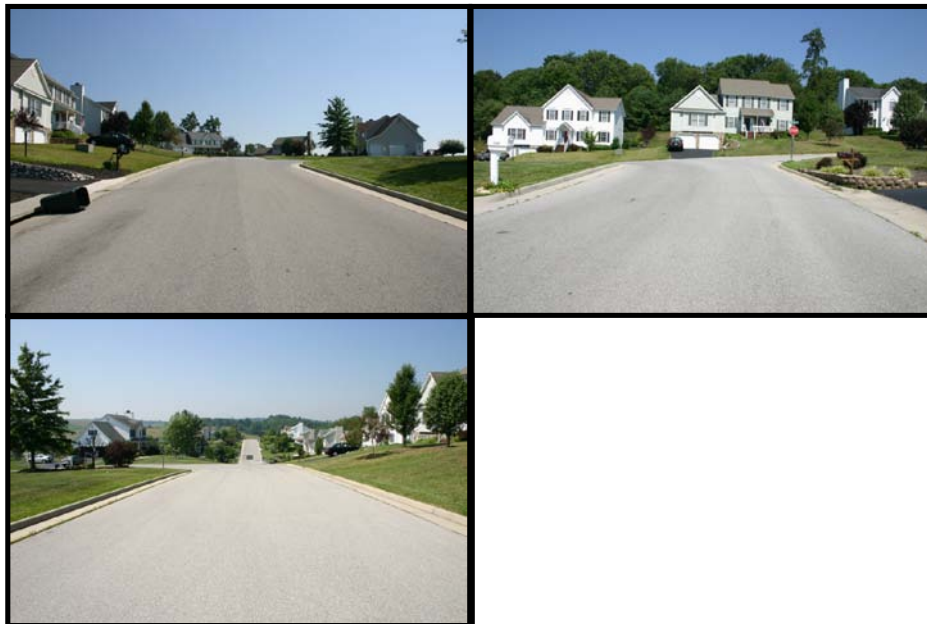
The intersection of Independence Blvd. and Sapphire Avenue (Intersection 19) is a three-way stop-controlled intersection with a single stop sign for vehicles traveling on Independence Blvd. The speed limit for traffic traveling on both Independence Blvd. and Sapphire Avenue is 25 mph. An aerial view and ground images of Intersection 19 are presented in Figure 34 and Figure 35, respectively.

**Figure 34 Aerial view of Independence & Sapphire intersection.**

**Figure 35 Ground images of Independence & Sapphire intersection.**

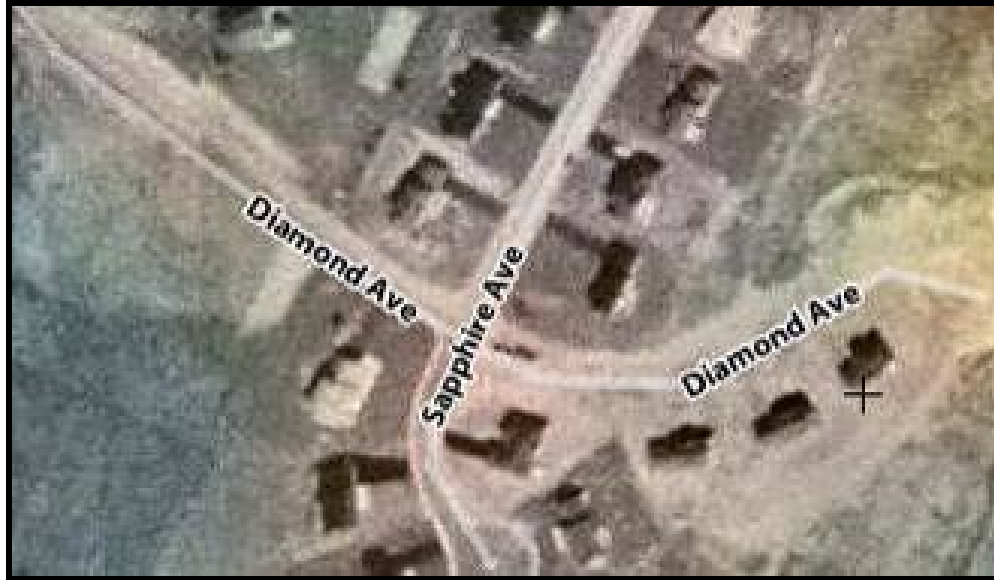
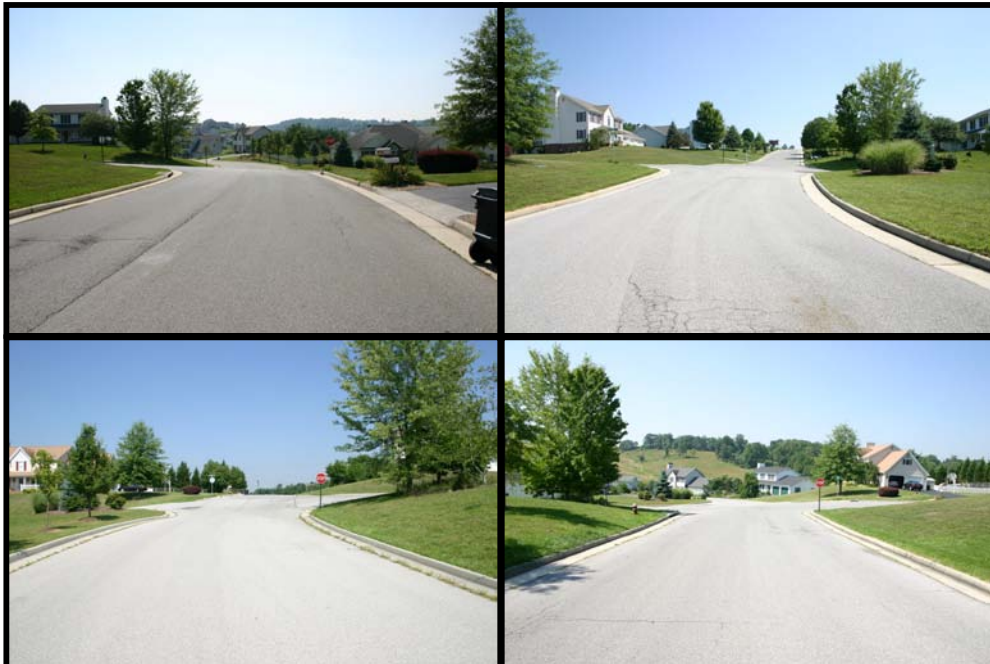
The intersection of Sapphire Avenue and Diamond Avenue (Intersection 20) is a four-way stop-controlled intersection with a single stop sign for vehicles traveling both directions on Sapphire Avenue and Diamond Avenue. The speed limit for traffic traveling on both Sapphire Avenue and Diamond Avenue is 25 mph. An aerial view and ground images of Intersection 20 are presented in Figure 36 and Figure 37, respectively.

**Figure 36 Aerial view of Sapphire & Diamond intersection.**

**Figure 37 Ground images of Sapphire & Diamond intersection.**

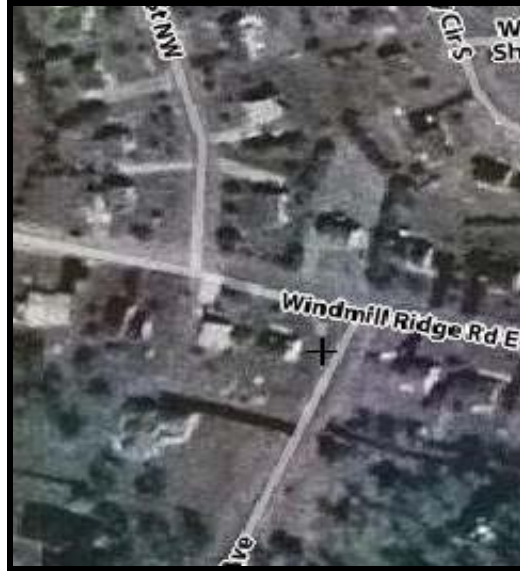
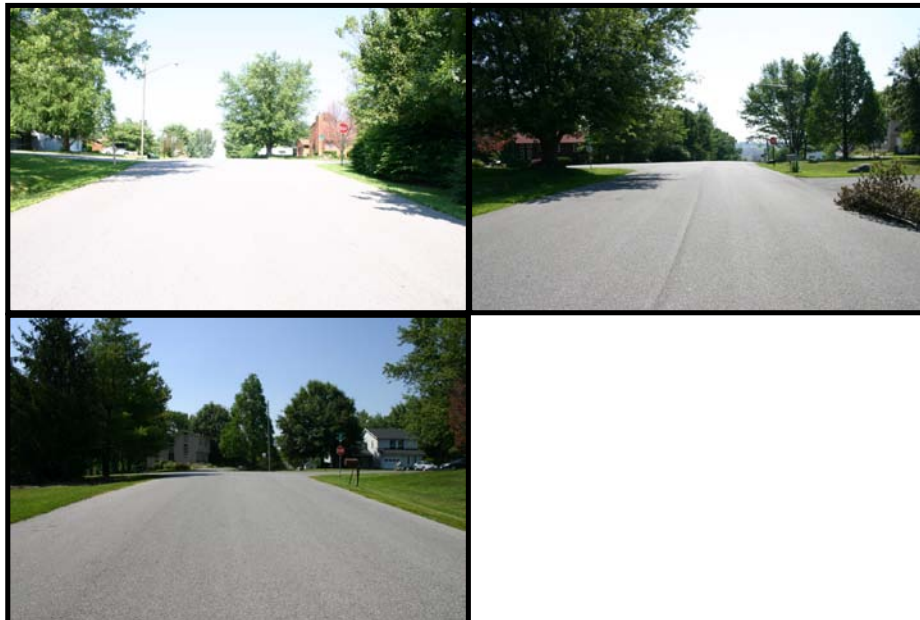
The intersection of Windmill Ridge Road and Cambria (Intersection 22) is a three-way stop-controlled intersection with a single stop sign for vehicles traveling both directions on Windmill Ridge Road and also on Cambria. The speed limit for traffic traveling on both Windmill Ridge Road and Cambria is 25 mph. An aerial view and ground images of Intersection 22 are presented in Figure 38 and Figure 39, respectively.

**Figure 38 Aerial view of Windmill Ridge & Cambria intersection.**

**Figure 39 Ground images of Windmill Ridge & Cambria intersection.**

All three warnings occurred at the same intersection while making the same straight-crossing maneuver: traveling west on Windmill Ridge Road through the stop-controlled intersection of Windmill Ridge Road and Cambria Street (intersection identification number 23; refer to Figure 11 for intersection location on the route and to Appendix E for a description of the intersections). The intersection is in the middle of a straight road with a stop sign that is partially occluded at longer distances. The violation warnings were provided to three different drivers: a younger male, a middle-aged male, and an older male. In all three cases, they did not show indications of intending to stop prior to the warning, yet stopped before entering the intersection box after the warning was issued. The drivers' peak decelerations ranged from 0.46 g to 0.6 g and the average decelerations ranged from 0.33 g to 0.41 g.

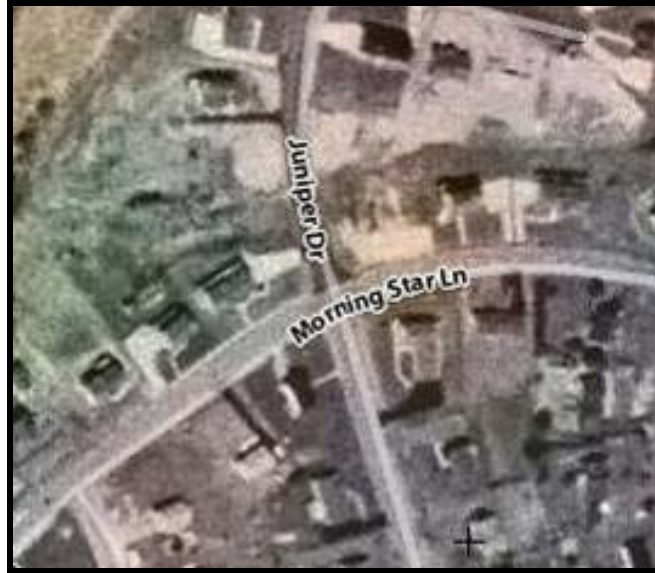
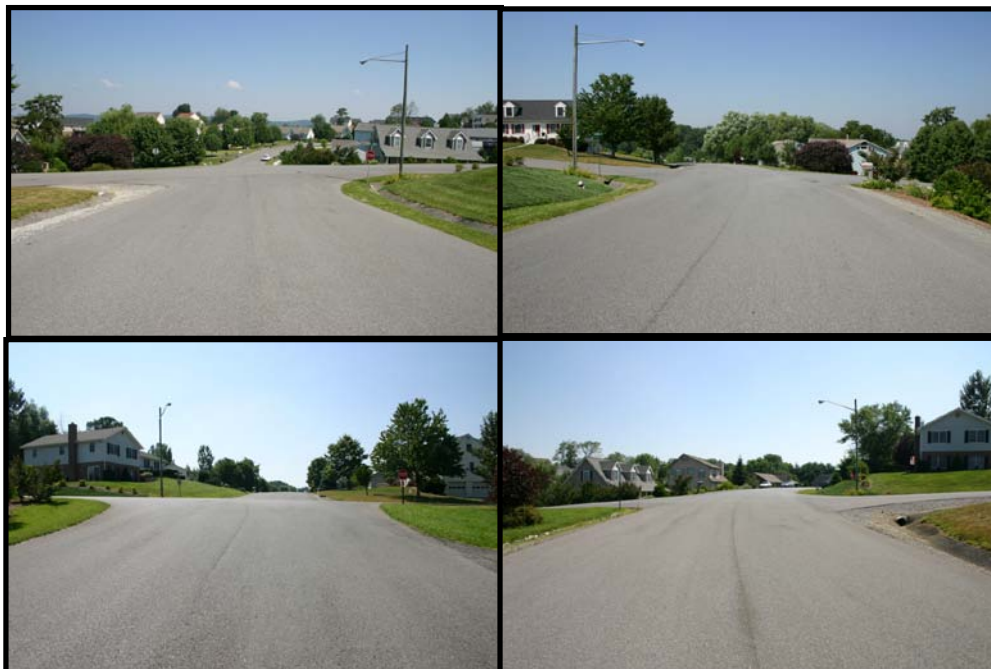
The intersection of Juniper Drive and Morning Star Lane (Intersection 23) is a four-way stop-controlled intersection with a single stop sign for vehicles traveling both directions on Juniper Drive. The speed limit for traffic traveling on both Juniper Drive and Morning Star Lane is 25 mph. An aerial view and ground images of Intersection 23 are presented in Figure 40 and Figure 41, respectively.

**Figure 40 Aerial view of Juniper & Morning Star intersection.**

**Figure 41 Ground images of Juniper & Morning Star intersection.**

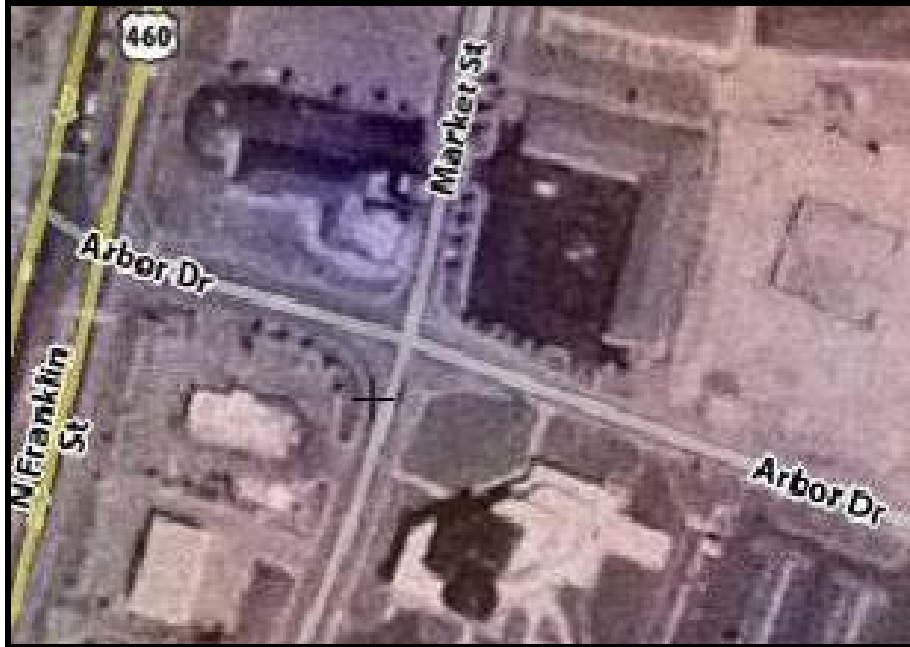
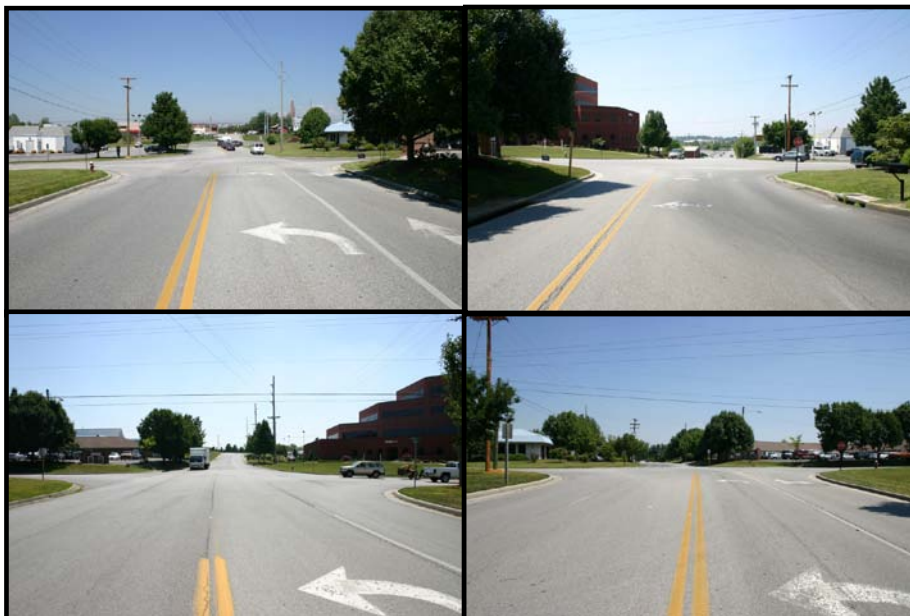
The intersection of Market Street and Arbor Drive (Intersection 25) is a four-way stop-controlled intersection with a single stop sign for vehicles traveling both directions on Market Street. The speed limit for traffic traveling on both Market Street and Arbor Drive is 25 mph. An aerial view and ground images of Intersection 25 are presented in Figure 42 and Figure 43, respectively.

**Figure 42 Aerial view of Market & Arbor intersection.**

**Figure 43 Ground images of Market & Arbor intersection.**

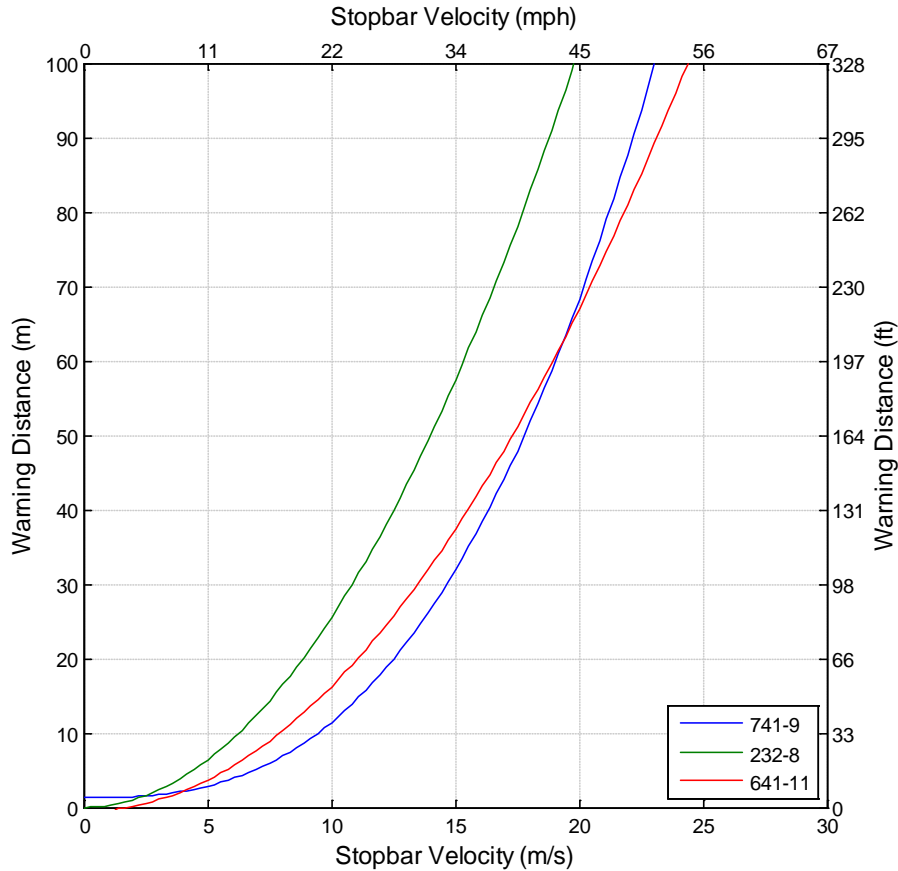
Figure 44 Graphical representation of the Subtask 3.4 algorithms.
