# Final Report:

## Vehicle Infrastructure Integration

### Proof of Concept

Submitted to the  
Research and Innovative  
Technology Administration,  
US Department of Transportation  
by  
The VII Consortium  
May 19, 2009

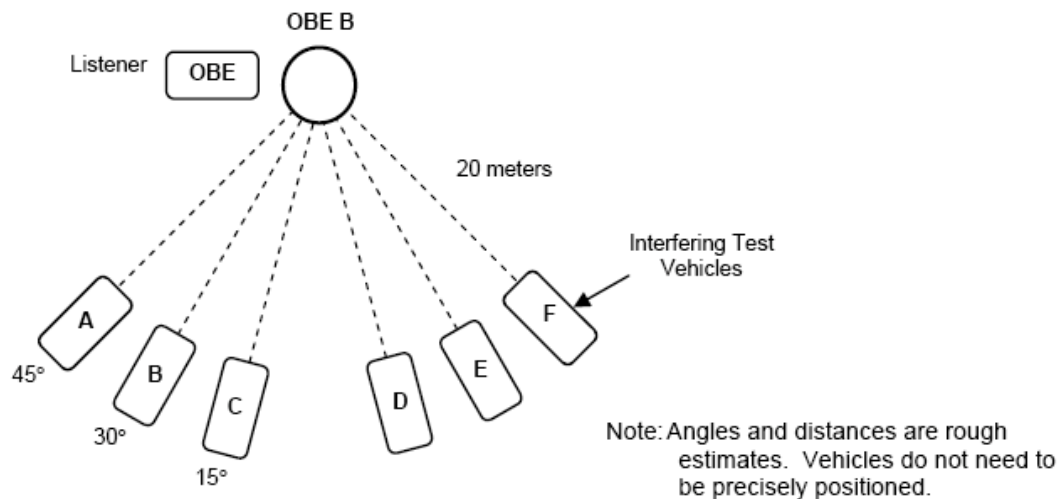
**Figure 4-7 DSRC-5b Test Setup**

This test is designed to verify V2V communication while operating at a series of static distances in an environment of mutual interference. The position of each test point is determined based on a percentage of the observed communication range corresponding to a 10% PER. This test was repeated for a total of 15 test points ranging from 10% to 150% of this range and the entire test was repeated for a total of four Heartbeat message rates of 10 Hz, 16 Hz, 25 Hz, and 50 Hz. The test setup is illustrated in Figure 4-7.

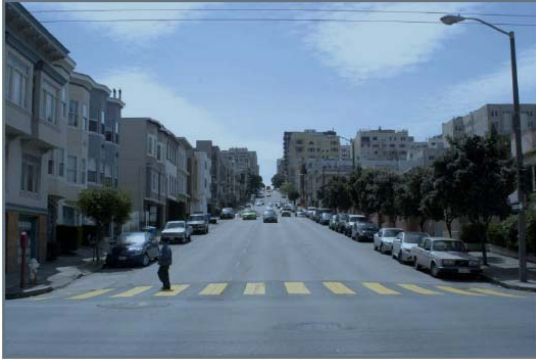
**Figure 4-8 Low Urban Canyon**

DSRC-1 through DSRC-4 testing was also performed in an urban canyon environment and evaluated and compared to the results collected from the open area testing to assess the impact of the urban setting on the performance of the DSRC communication link. The test sites are shown in Figures 4-8 to 4-10 below.

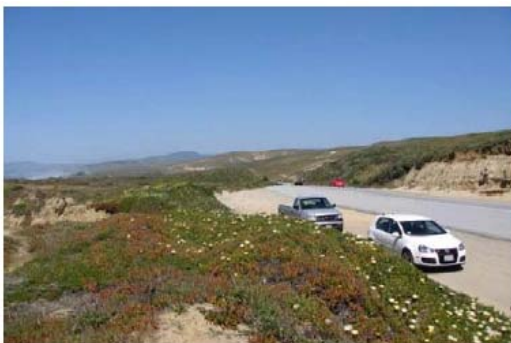
**Figure 4-11 Hilly Location #1**

The hilly terrain testing was performed on Highway 1, south of San Francisco, at three test locations representing various terrains, including occulted and crested hills and curves. The RSE was positioned at the side of the road at each location as shown in Figures 4-12 and 4-13.

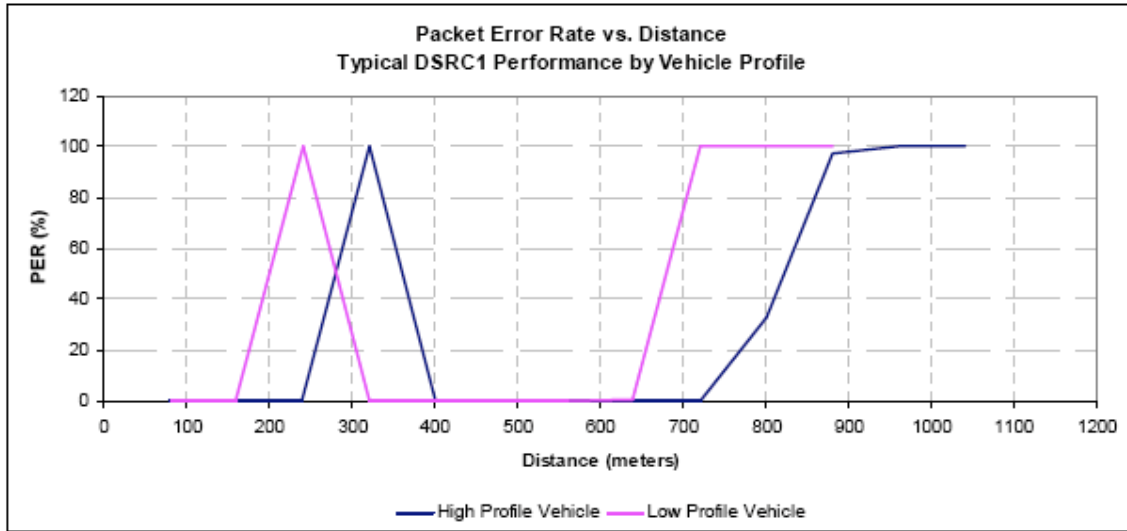
**Figure 4-14 V2I DSRC Range in Open Field Environment**

The height of the vehicle profile had a significant impact on the effective range of the DSRC communication link. It was found that the high-profile vehicles (Cherokee, Edge) had a reliable I2V communication range of about 800 m while the low-profile vehicles (Altima, Camry) had a range of about 600 m. This behavior can be seen in Figure 4-14.

The V2I and I2V range was found to significantly exceed original estimates. In open field conditions with no roadside furniture, the V2I range was found to exceed 800 m and the I2V range exceeded 1200 m using transmit powers of 11 dBm and 15 dBm, respectively and the low-profile vehicle dual antenna.

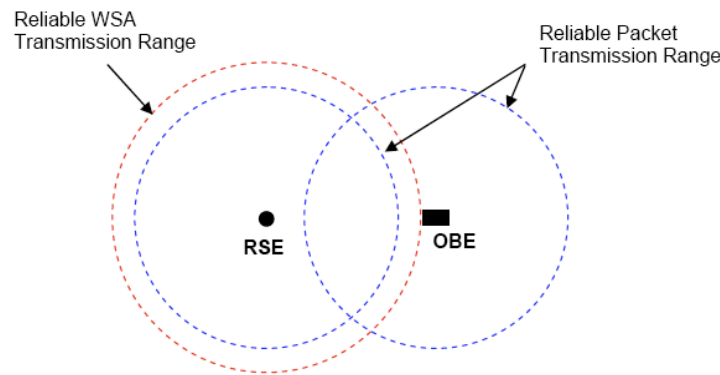
**Figure 4-16 RSE/OBE Link Imbalance**

An imbalance was observed between the transmission range for the WAVE Service Announcement (WSA) messages and the reliable range for two-way data exchanges. In this situation, a WSA is received by the OBE at an extreme range where reliable communication is not normally expected. With the right combination of the registered OBE application and advertised service, and since the reception of a single WSA is all that is required for the OBE to “join” the RSE service, the OBE joins and begins transmitting data. This can occur at long ranges because there is a finite chance that, for example, even at 99% PER, one WSA (out of one hundred broadcasts) will get through. However, the RSE has higher transmit power than the OBE, so at these long ranges, it is typically not possible for the OBE to successfully send packets back to the RSE. This is illustrated below in Figure 4-16.

The system worked well for those applications utilizing only broadcast messages, such as Signage. Without this problem being rectified, it is less suitable for applications requiring two-way communications. This issue also caused substantial problems in early application testing. The mechanism is well understood, and the radio protocols need to be revised, so that the radio does not join a service unless the quality of service is acceptable.

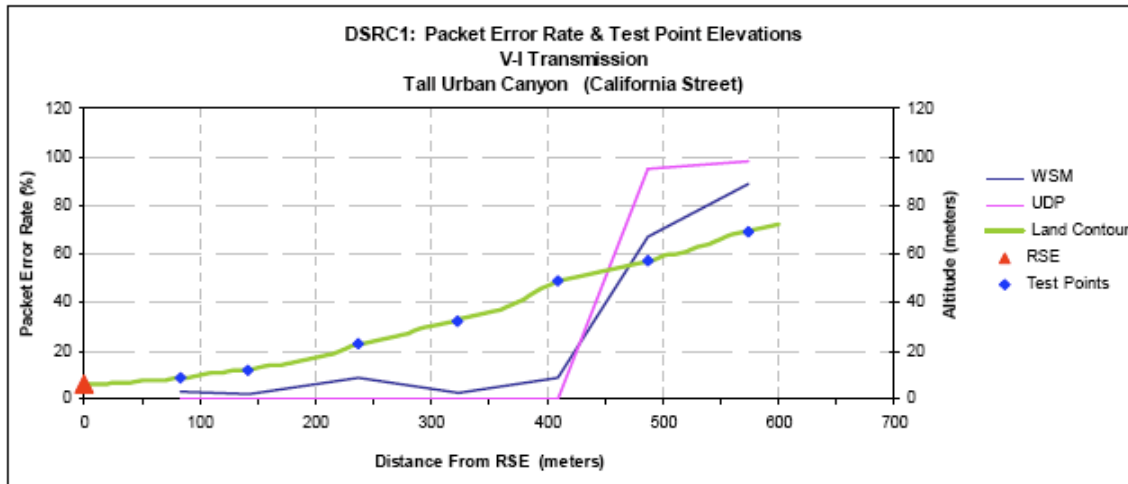
Various urban canyon heights were tested to assess the impact of the urban setting on the performance of the DSRC communication link. The chosen test sites presented challenges to this assessment, due to the impact on the test results from factors other than the urban setting such as grade elevation changes, traffic conditions, and non-baseline test vehicles. These other factors serve to cloud any conclusions based on a comparison with the open-area testing. However, the testing for the short, medium and tall urban canyons did indicate an apparent positive trend of increasing the effective I2V DSRC communication range while mitigating the effect of the RSE-OBE radio null as the height of the urban canyon increased. This appears to be a result of the larger number of scattered signal paths present in the urban canyon environment (many multipath sources). This results in the nulls effectively being “filled in” by radio energy scattered from other parts of the local environment. Effectively, the “two ray” multipath model does not hold in these environments. This phenomenon improves the short range communication capability while still providing adequate range for the urban environment. The results of V2I tests in short and tall urban canyon environments are shown in Figure 4-18 and 4-19.

Figure 4-18 DSRC V2I Range in Low Urban Canyon Environment

**Figure 4-19 DSRC V2I Range in Tall Urban Canyon Environment**

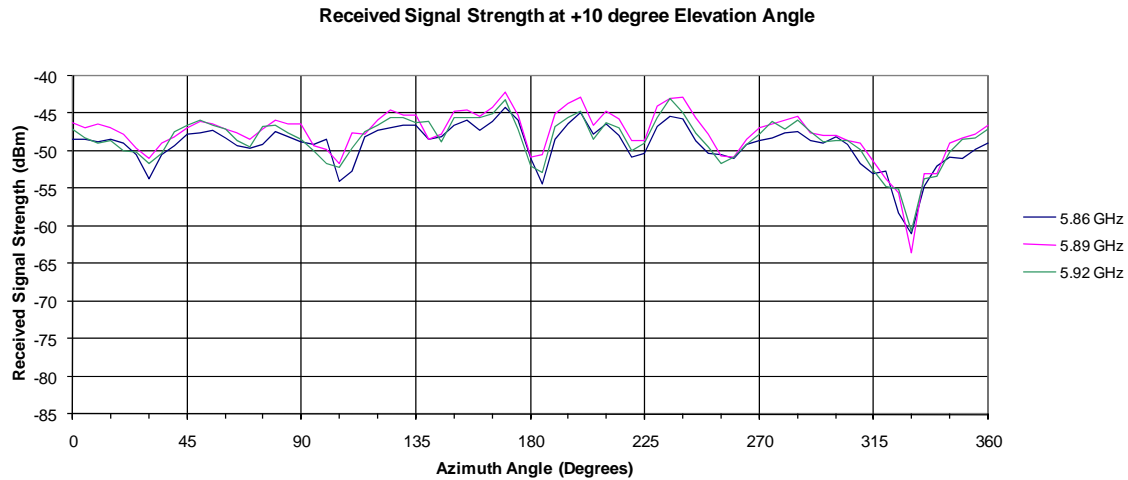
**Figure 4-22 Receive Signal Strength vs. Azimuth Angle**

The DSRC received signal strength performance of the Mark IV, combined DSRC and GPS antenna, varied considerably as a function of the link aspect angle. At the time the test was planned, it was expected that the variation would be less than 5 dB. The test results found that, in general, there was about a 10 dB variation between the maximum and the minimum values, but there were also specific aspect angles where the received signal strength dropped by more than 15 dB. The implication of this finding is that vehicles that are in motion with respect to the RSE may encounter link aspect angles with significantly less signal strength. This is particularly true at 30°, 105°, 190° and 330° azimuth angles. The data for this test are shown in Figure 4-22.

Similar effects were also observed during V2V Heartbeat Application testing. In those tests it was found that the antenna position on the roof of the vehicle had a significant impact on the reliability of V2V communications. It is clear that in order to assure reliable communications between a wide variety of different vehicles, it will be necessary to define a minimum required radio performance envelope for mobile elements (e.g. vehicles). This requirement will need to be defined in terms of minimum radiated power vs. azimuth within minimum and maximum elevation angles (for transmitters) and in terms of minimum sensitivity in azimuth and elevation.

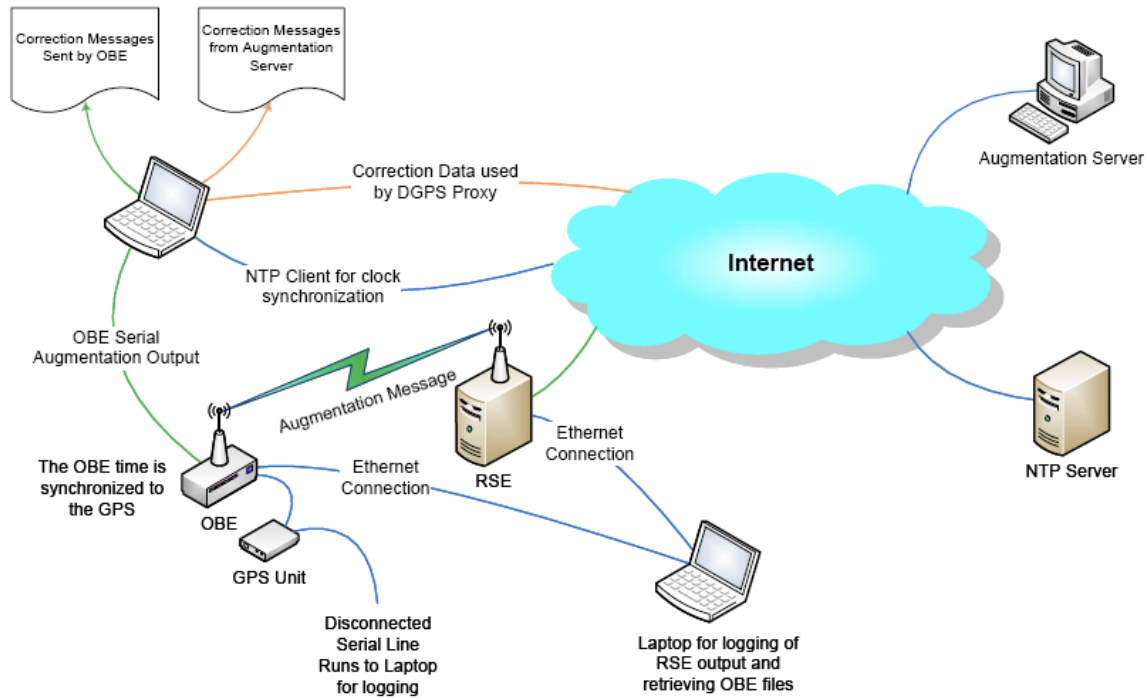
**Figure 4-23 Augmentation Latency Test Setup**

The goal of this test was to determine the time for position correction messages to travel from the server to the OBE via the RSE and from the OBE to the external positioning unit. The augmentation latency tests were conducted in the VIIC garage using a stationary vehicle. The test setup used is shown in Figure 4-23.

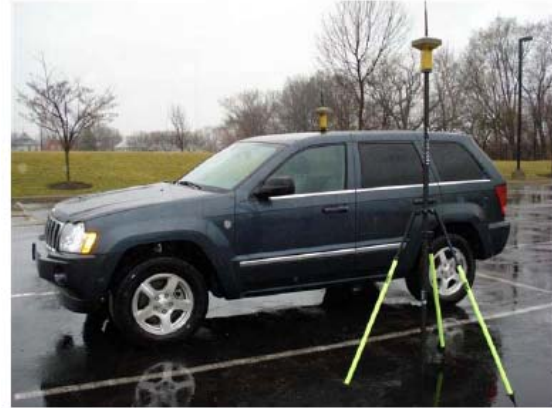
**Figure 4-25 Topcon Survey System**

Since the tests required knowledge of the absolute position of the vehicles (in order to assess the accuracy of the various elements), a survey grade positioning system was used as a “Truth” sensor. The Topcon GR-3 is a geodetic roving tracking system and combines three satellite position systems: GPS, Global Navigation Satellite System (GLONASS) and the European Galileo system. The Topcon system has a static accuracy of 3 mm and Real-Time Kinetic (RTK) accuracy of 10 mm. The unit is shown attached to the test vehicle in Figure 4-26.

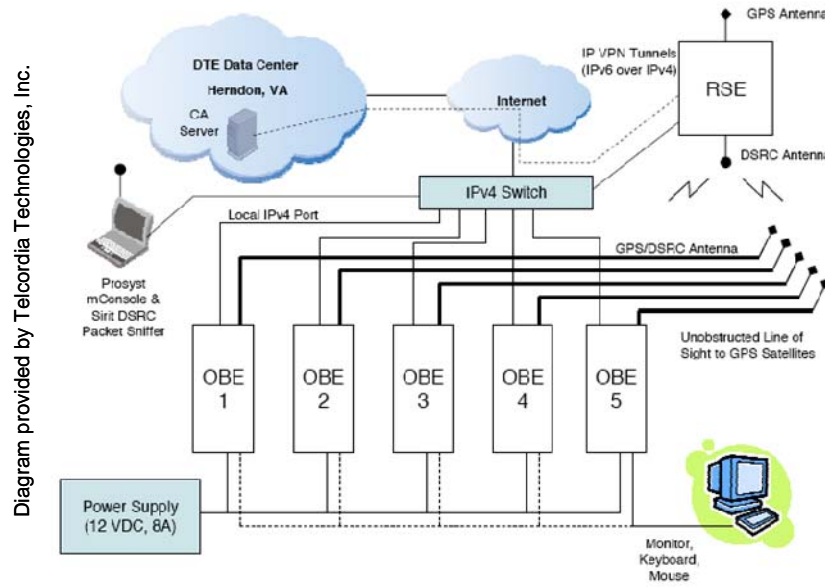
**Figure 4-29 Phase 1 Laboratory Security Test Setup**

The Phase 1 laboratory tests were carried out in a laboratory facility at Telcordia. This setup, shown in Figure 4-29, consisted of a single RSE and five OBEs. Each OBE was equipped with its own dual antenna to receive GPS signals and DSRC Radio signals. Each OBE was connected to an Internet Protocol version 4 (IPv4) switch which was used for remote account access and to configure the OSGi framework using the mConsole client from a laptop connected to the local network.

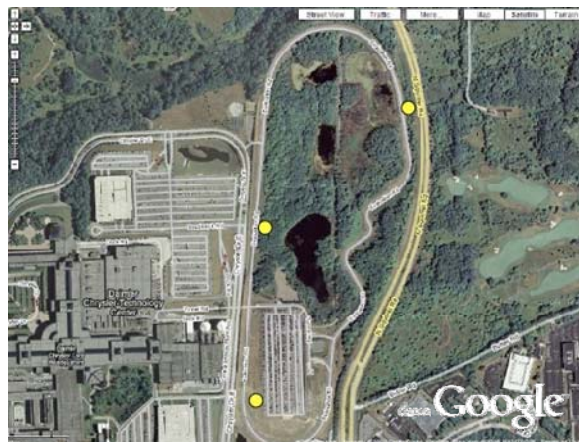
**Figure 4-30 Phase 2 Track Security Test Environment**

In Phase 2, testing was conducted on a closed test track with multiple RSEs that were linked to the VII data center infrastructure located in Herndon, VA. The tests in this phase required the full geographic footprint of the RSE and required vehicles with OBEs to be traveling through one or more RSE zones.

The testing was conducted at the CTC Track in Auburn Hills, MI. An aerial photo of the facility is provided in Figure 4-30. Three general locations for RSE positions are indicated in the photo by yellow markers.

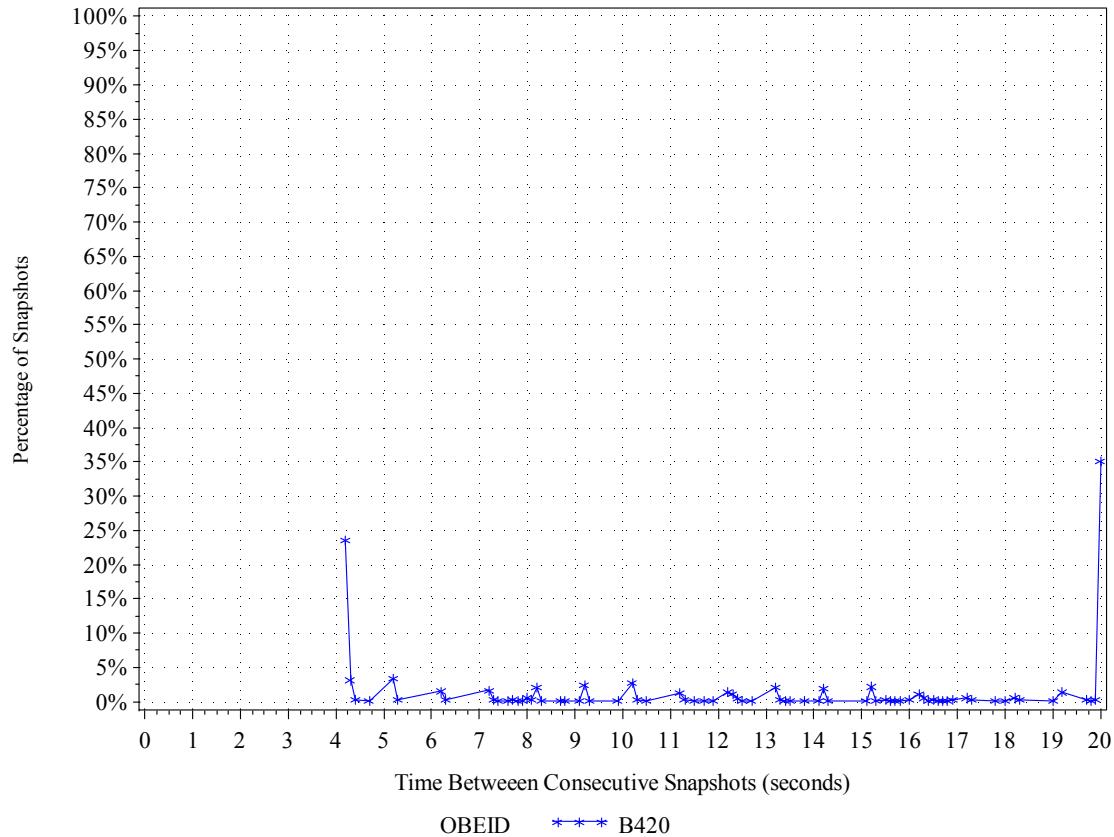
**Figure 4-33 Snapshot Generation Interval**

points taken at four second intervals. Once the vehicle passes the 20 mph speed point, the samples are spread more or less evenly at increasing intervals up to 20 seconds. Again, at the 20 second interval, the figure shows a large number of samples indicating that for the period where the vehicle was traveling faster than 60 mph, the system was collecting samples at 20 second intervals.

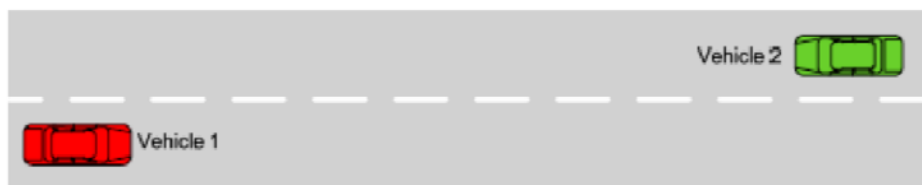
**Figure 4-34 Test HB-1 Setup**

The basic test scenario is depicted in Figure 4-34, and the test course illustrated in Figure 4-35.

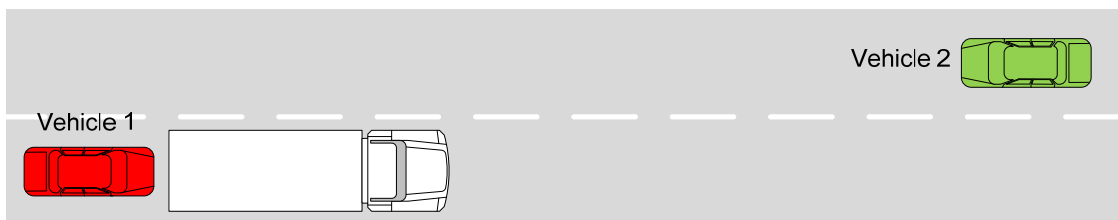
**Figure 4-36 Test HB-2 Setup**

The goal of this test was to evaluate the behavior of Heartbeat message exchange between two approaching vehicles in the presence of occluding vehicles (in this case a large truck). As illustrated in Figure 4-36, the two vehicles were driven past each other in opposite directions at 50 mph, and one vehicle was traveling behind the truck. The Heartbeat message transmission and reception at each vehicle was logged and the data was subsequently analyzed. The road segment used for this test was the same as that used in Test HB-1.

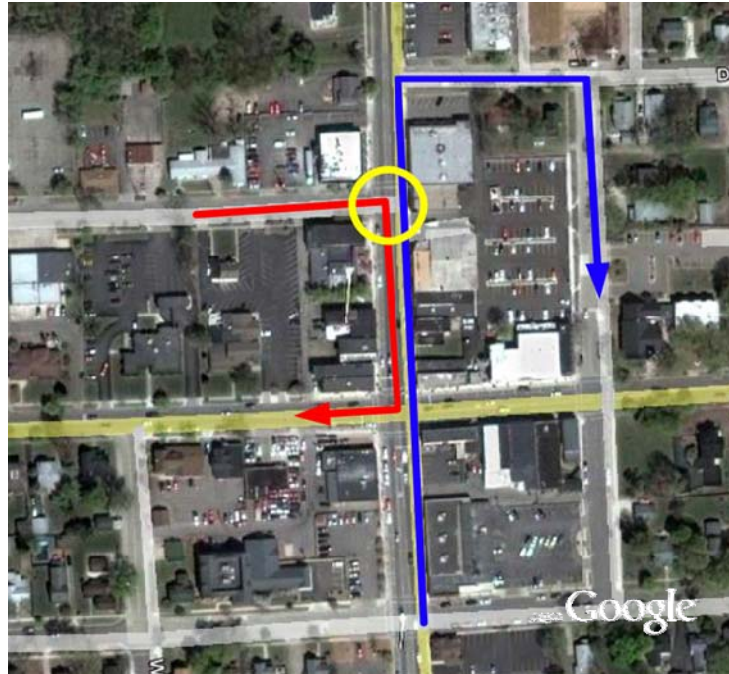
**Figure 4-37 Intersection Approach Test Scenario**

The goal of this test was to evaluate the behavior of Heartbeat message exchange between two vehicles approaching each other orthogonally (at 90°). This scenario featured an intersection in which the line of sight was blocked by a large building. As illustrated in Figure 4-37, the two vehicles were both in motion and approached the intersection from different directions as shown in the illustration. One vehicle performed a “right turn,” and the other proceeded straight through the intersection.

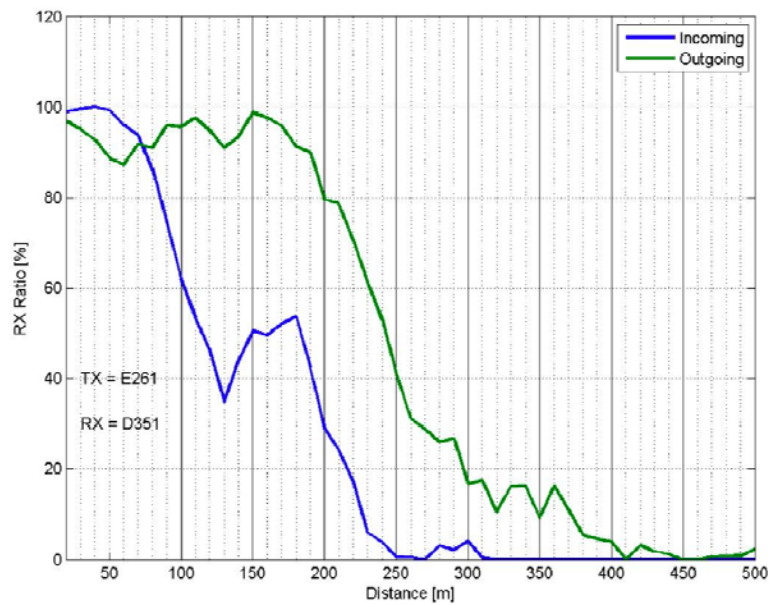
**Figure 4-41 Heartbeat Success Ratio vs. Range On Open Road**

As shown in Figure 4-41, it appears that we can achieve >99% Heartbeat message reliability within  $\pm 50$  m range, and >90% reliability within 75 m range, although clearly antenna performance and orientation play a key role in this performance measure. A substantial improvement would result if the recommendations in Section 4.3.1 were implemented. Range at first reception was better than expected ( $\approx 180$  m open road, no other vehicles).

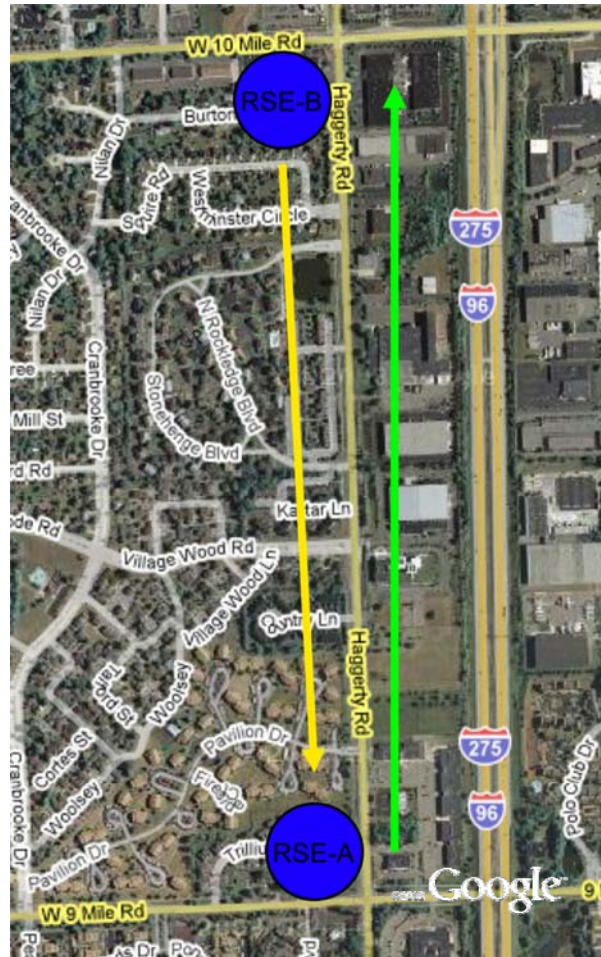
**Figure 4-50 Off-Board Navigation Test Setup**

The test setup for all three tests is illustrated in Figure 4-50. Each test was run several times, with tests originating alternately from RSE A and RSE B.

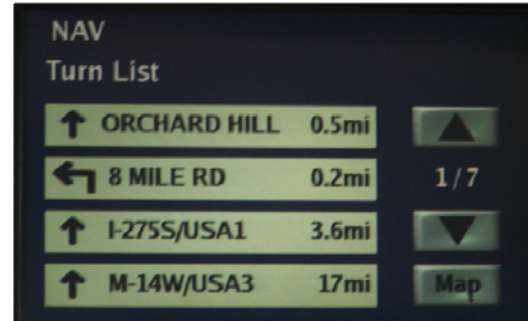
Figure 4-52 Long Route Directions

Figures 4-51 and 4-52 show a typical cross-country route delivered during the Network Service Enablers tests.

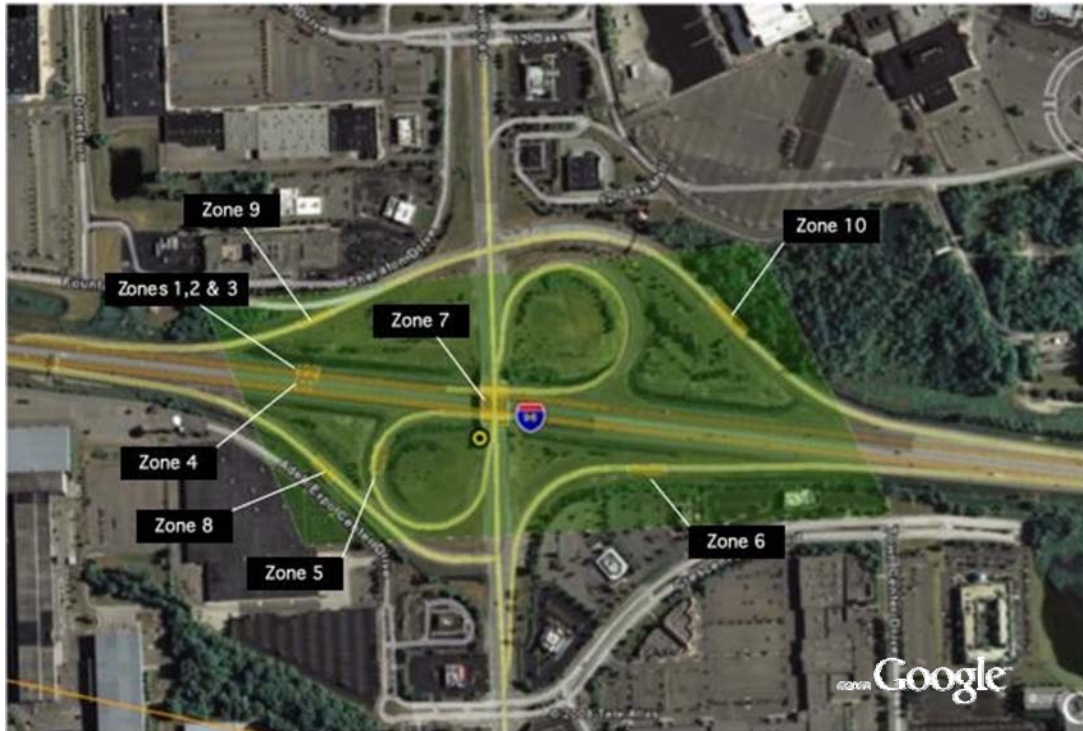
**Figure 4-53 Toll Plaza Region for Tolling Application Test**

The DTE Toll Plaza zone, shown in Figure 4-53, encompasses the interchange including all of the exit and entrance ramps (shaded green). Ten Toll Collection zones (shaded yellow and labeled in the figure) are located as specific regions of roadway within the Toll Plaza.

During the tests the vehicles, were driven through the site on a course that passed through all of the collection zones at least once. The tests consisted of multiple passes through or near the plaza zone. Some passes were specifically intended to activate payments in specific zones, while others were intended to test the ability of the system to differentiate when to pay and when not to pay. These tests included passes on nearby side roads that are close but not inside the toll plaza where no toll was to be paid, and also passes that entered, exited and then re-entered payment zones to test the ability of the system to resist accidentally paying the toll twice.

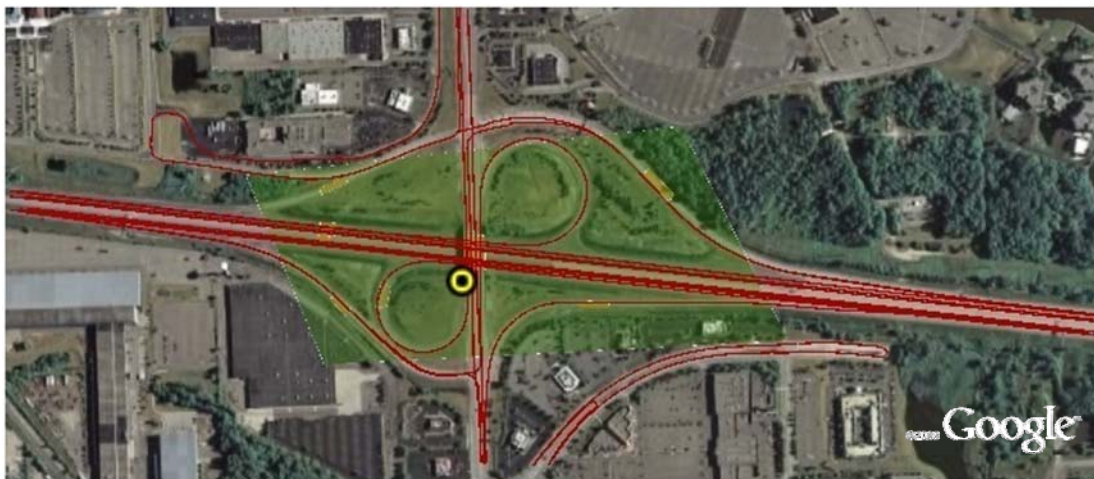
**Figure 4-54 Cumulative Vehicle Passes During Tolling Tests**

Figure 4-54 below shows (red lines) a composite of all of the passes through the DTE tolling test site accumulated during the trial. The yellow circle near the center of the interchange is the location of the RSE.

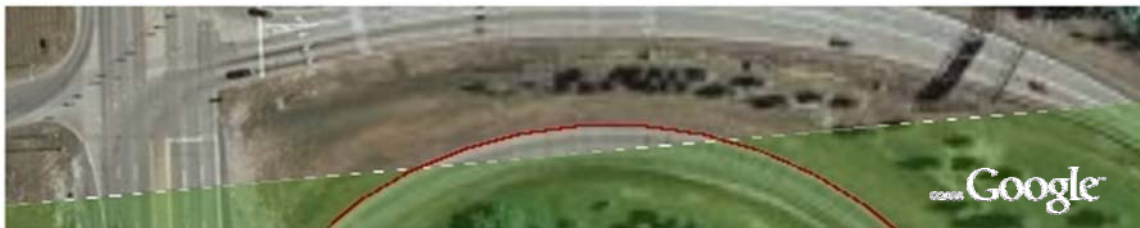
**Figure 4-56 Test Setup For Plaza Exit and Reentry Test**

The plaza geometry and vehicle path for Test E are shown in Figure 4-56 below.

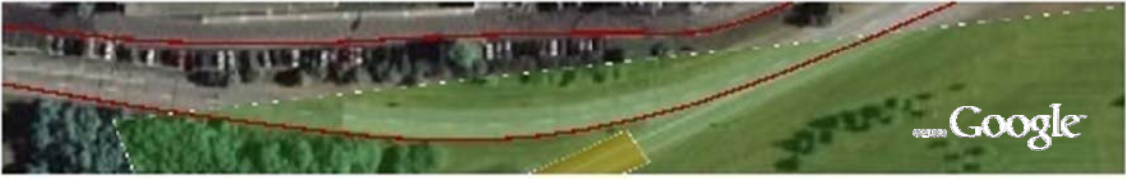
<p><b>Test H: Differentiation Of Zones with Close Passes</b></p> <ul style="list-style-type: none"> <li>• Southbound on Novi Rd to Fountain Walk Ave to Sheraton Dr.</li> <li>• Vehicle should enter and exit the plaza without paying a toll.</li> </ul>	<p>Successful:</p> <ul style="list-style-type: none"> <li>• System indicated entry of plaza</li> <li>• Vehicle passed close to Zone 9, but system did not indicate entry of zone 9.</li> <li>• System indicated plaza exit.</li> </ul>
<p>The plaza geometry and vehicle path for Test H are shown in Figure 4-57 below.</p>

<p style="text-align: center;"><b>Figure 4-57 Close Approach Test Setup</b></p>	
<p><b>Test H: Multiple Zone Encounters</b></p> <ul style="list-style-type: none"> <li>• Southbound on Novi Rd to eastbound I-96. Vehicle should enter the plaza, then enter zone 7 without paying a toll.</li> <li>• Vehicle then enters zone 5, and pays a toll.</li> <li>• Vehicle then enters zone 7 again without paying a toll, and then exits the plaza.</li> </ul>	<p>Successful:</p> <ul style="list-style-type: none"> <li>• System indicated entry of the plaza, and zone 7.</li> <li>• Vehicle did not pay a toll.</li> <li>• System indicated entry of zone 5.</li> <li>• Vehicle paid a toll.</li> <li>• System indicated reentry of zone 7.</li> <li>• Vehicle properly ignored zone 7 (toll already paid).</li> </ul>

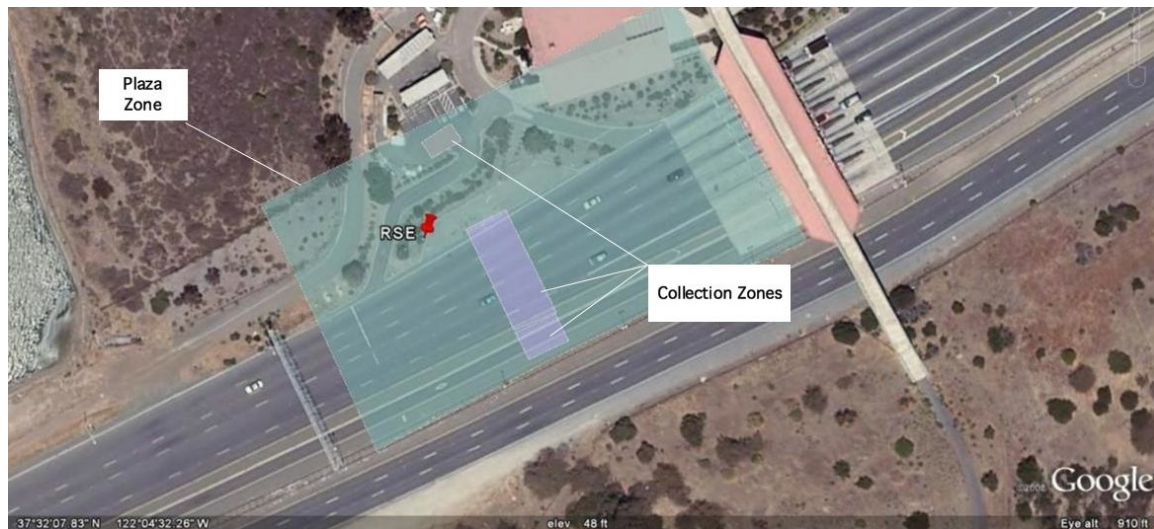
**Figure 4-58 Dumbarton Bridge Toll Plaza Setup**

Figure 4-58 shows the POC test electronic toll plaza and collection zones overlaid on the conventional toll collection facility at the Dumbarton bridge entry area on California Highway 84. This roadway is not limited access, but the pedestrian and bike traffic is isolated from the motor vehicle traffic by a concrete barrier. While speed through the toll plaza is limited to about 20 mph, speeds on the roadway either side of the plaza are typically higher.

In the figure above, the vehicles enter the electronic plaza zone as they pass through the conventional toll gates (bridge over the roadway). This facility is equipped with the FasTrak Electronic Toll Collection system, so properly equipped vehicles typically pass through the toll gates at about 20 mph. Once in the plaza zone, the vehicle sets up a session with the Toll Payment Application in the Local Transaction Processor (LTP) attached to the RSE (located in the region of the red pin in the figure), and when it enters the collection zone, the vehicle system sends a message to the LTP Application indicating that it has entered the collection zone. The LTP Application then sends a payment invoice that is to be signed by the vehicle system and returned for payment.

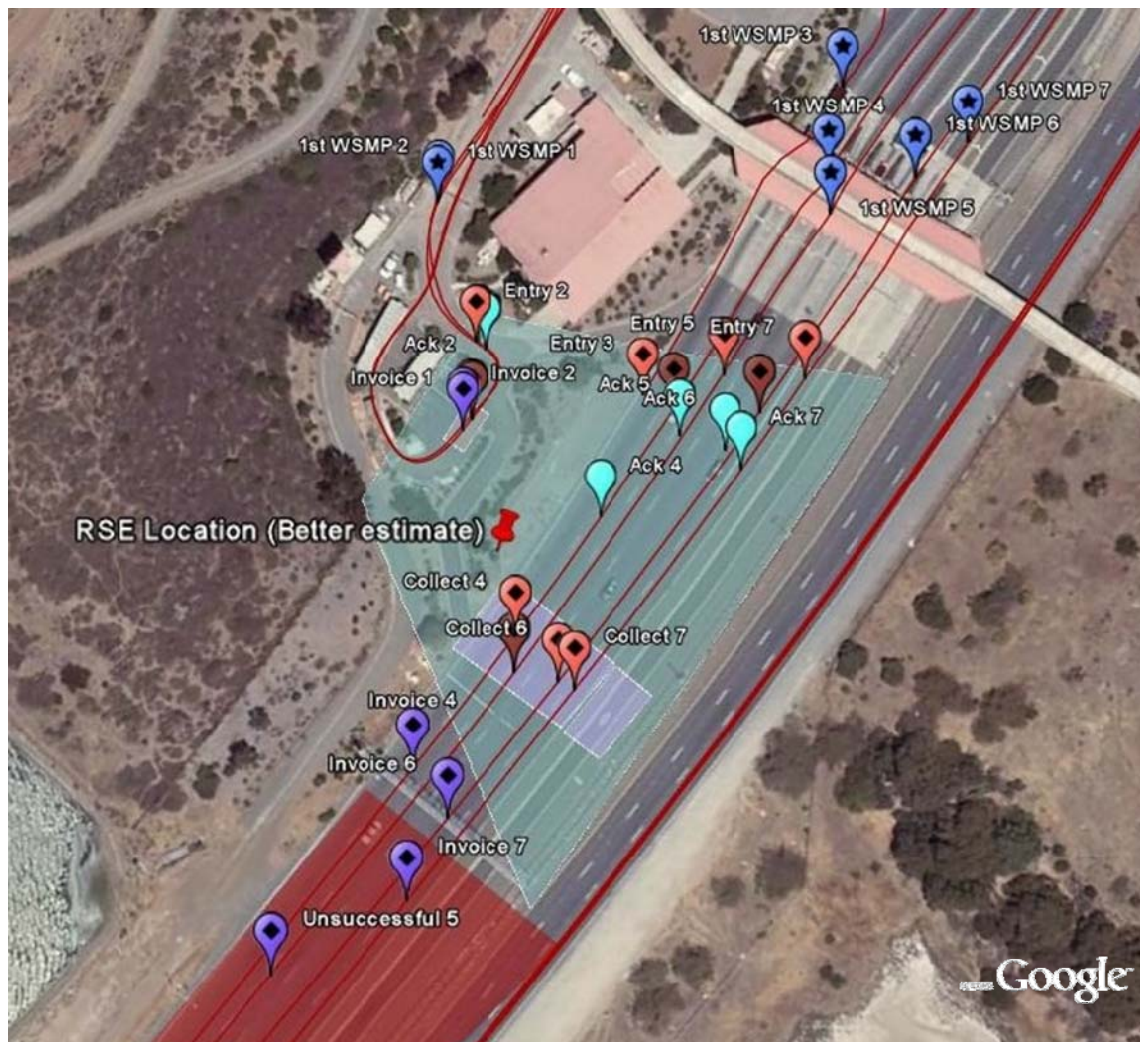
**Figure 4-59 Dumbarton Bridge Toll Test Results**

The test results are shown in Figure 4-59. This figure represents seven passes through the plaza as indicated by the red path lines. The location where the first indication of the toll plaza is received is denoted by “1<sup>st</sup> WSMP”. This represents the point where the vehicle system first becomes aware of the toll plaza. The entry to the plaza zone is denoted “Entry”. This is the location where the vehicle system identifies itself to the tolling system and informs it that it has entered the plaza zone. The toll system responds with an acknowledgement including an invoice for the toll (based on the vehicle type). When the vehicle enters the collection zone, it then responds by sending the signed invoice back to the LTP. This location is denoted “Collect” in the figure. The LTP then finalizes the transaction by sending an executed copy of the invoice for the vehicle’s records. This location is designated as “Invoice” in the figure. Each type of location identified in the figure also includes the number of the run it is associated with.

The first two runs passed through the plaza in the upper left region which is a toll plaza parking area. This allowed low speed test of the system and facilitated configuration and debugging without the need for the vehicle to drive over the entire bridge.

The third through seventh runs passed through the plaza zone on the main road at full road speed (40-60 mph).

An unexpected system behavior was observed during the Dumbarton tolling tests. As can be seen in Figure 4-59, at the location of the “Invoice 6” balloon, there is a gantry that crosses the east-bound traffic lanes. This gantry houses equipment used for enforcement of the FastTrak tolling system. The gantry is composed of a large steel tube structure supporting a variety of cameras and

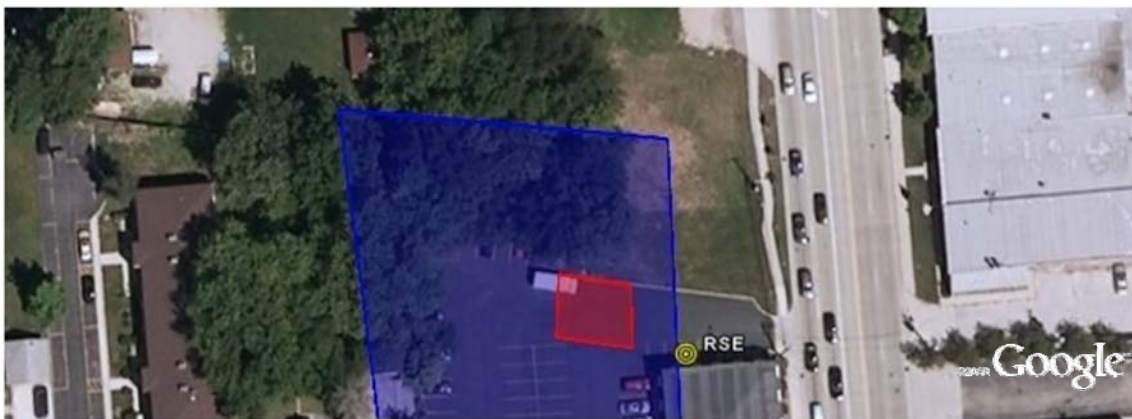
**Figure 4-60 Electronic Parking Payment Test Setup**

The test facility is shown in Figure 4-60. In the figure, the dark blue region is the Parking Plaza zone, and the red region is the Parking Payment zone. This setup is intended to simulate a confined entry region typical of most pay parking facilities. The RSE is located next to the building on the right side of the blue plaza region.

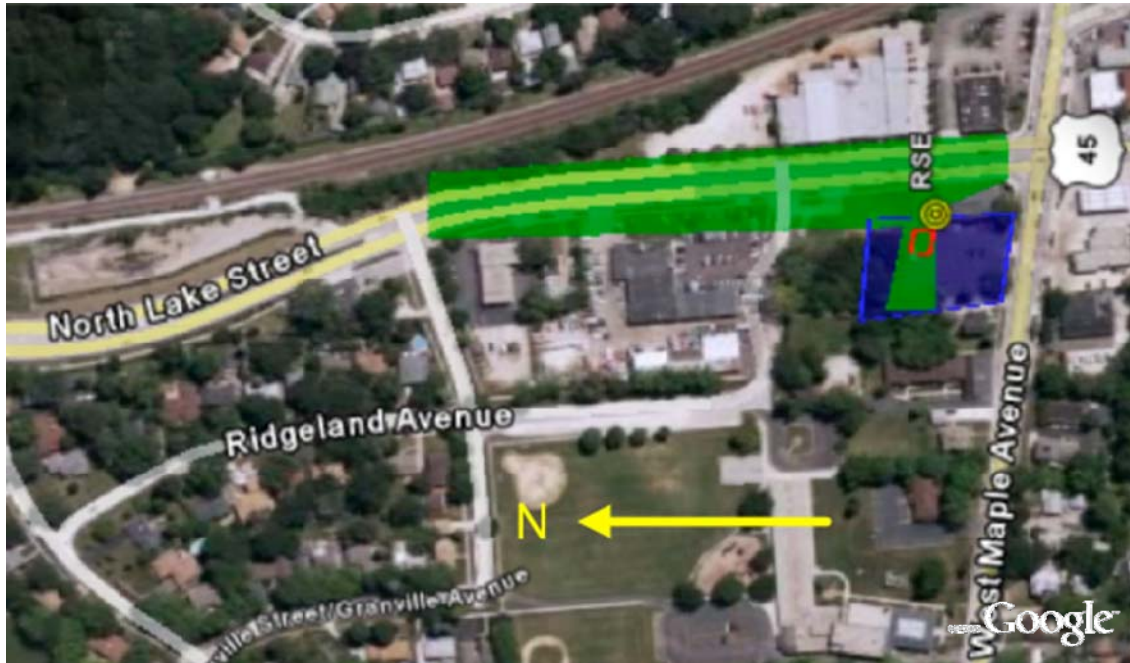
**Figure 4-61 Parking Payments RSE Coverage**

The surrounding trees and other buildings give an approximate coverage pattern shown shaded in green in Figure 4-61 below (the figure has been rotated 90° counter clockwise from Figure 4-62 for clarity). The test cycle was designed so that vehicles traveling south on Lake Street would receive the parking lot announcements well in advance of the entrance to the parking lot on the north end of the building.

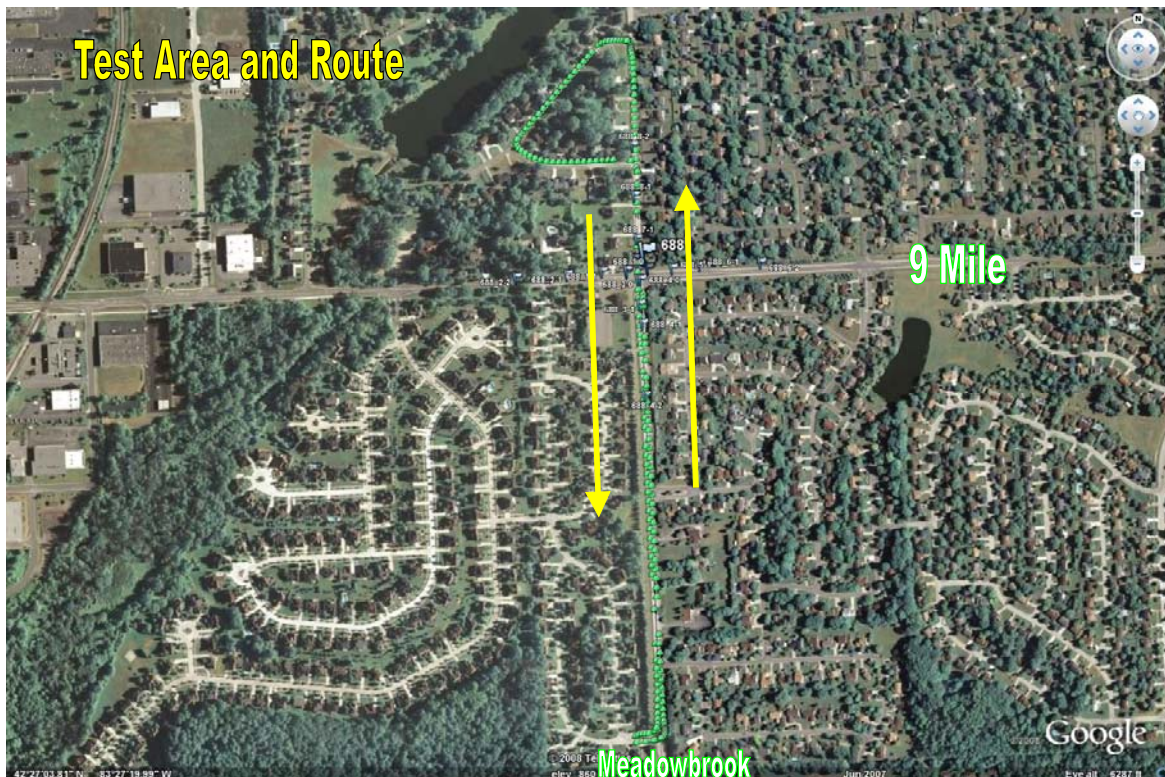
Figure 4-62 Safety Message Test Setup

The tests were conducted at the intersection of 9 Mile Road and Meadowbrook Road, the site of RSE# 688. This site is illustrated in Figure 4-62.

The intersection consists of eight approaches with four through lanes and four dedicated left turn lanes controlled by a single Siemens Eagle Mod52 traffic signal controller. There is no separate traffic signal for separately controlling the left turn lanes.

Four tests were conducted in all with each test including approach and departure of the intersection in two different directions. For each of the four tests the Heartbeat transmission rate was increased to simulate increased DSRC message traffic. The objective was to measure the impact that this increasing message density had on the successful transmission and reception of the SPAT messages. The Heartbeat rates used in the test were: zero (no interfering heartbeat messages), 10 heartbeat messages per second 20 Heartbeat messages per second then 50 Heartbeat messages per second.
