Federal Highway Administration  
**Every Day Counts**  
Innovation Initiative

Safety Edge<sub>SM</sub>  
Demonstration Project  
Menominee County,  
Wisconsin

**Field Report**  
**May 4, 2011**

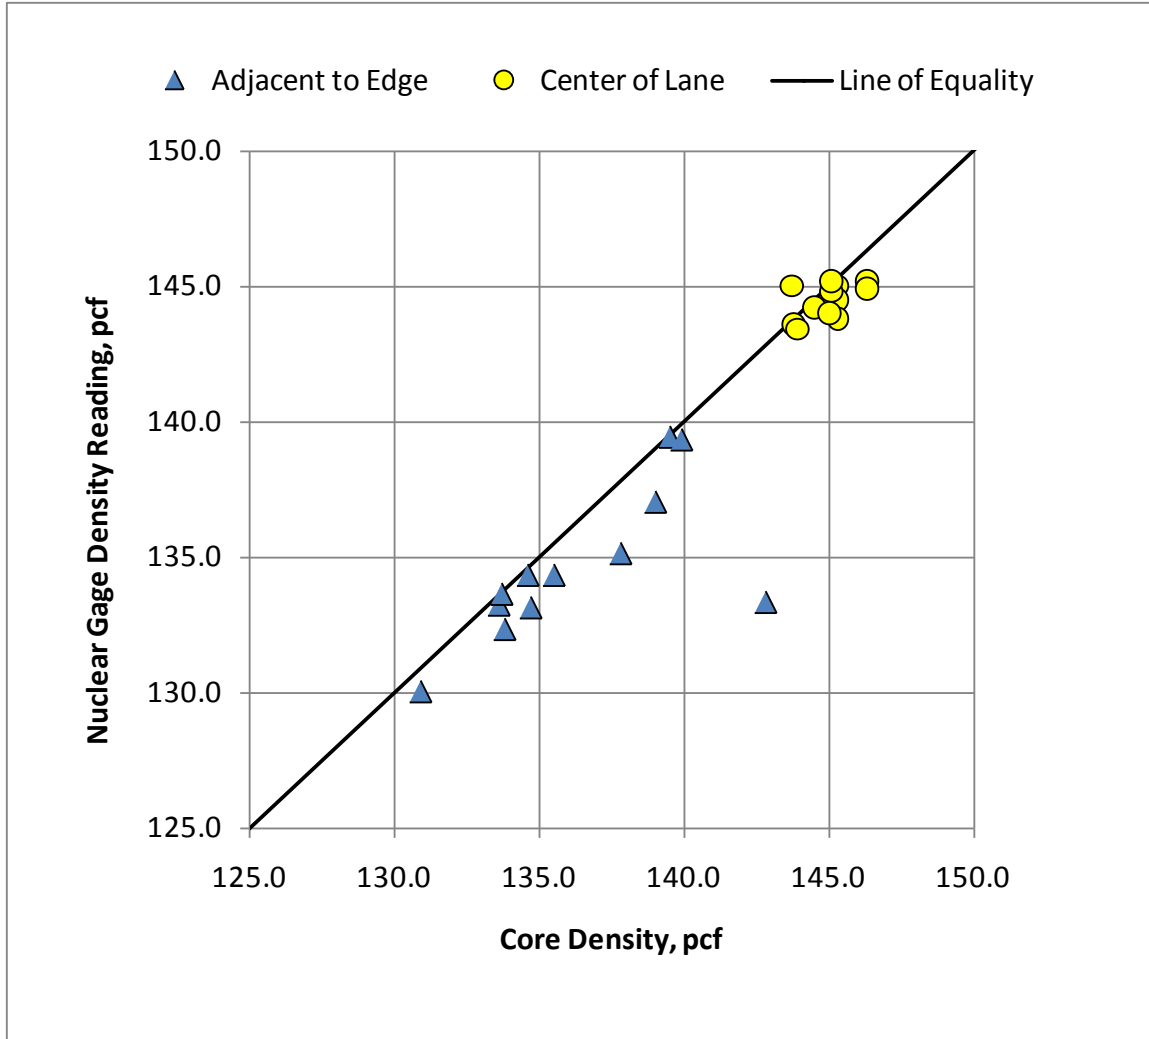
Figure 5. Comparison of the nuclear densities and core densities.

Density tests were conducted using a nuclear density gauge in backscatter mode for 60 second test durations. The tests were conducted adjacent to the edge and at the center of the lane at 50-ft intervals and at the location of each core. Figure 5 shows a comparison of the nuclear densities and densities measured on the cores. As shown, there is close correlation between the nuclear and core densities.

Adjustment factors were determined from correlating the nuclear density readings and the core laboratory density results shown in Table 3. The factors were used to adjust the nuclear density gauge readings to be consistent with the densities that were measured in the laboratory. The following summarizes the adjustment factors determined for this project.

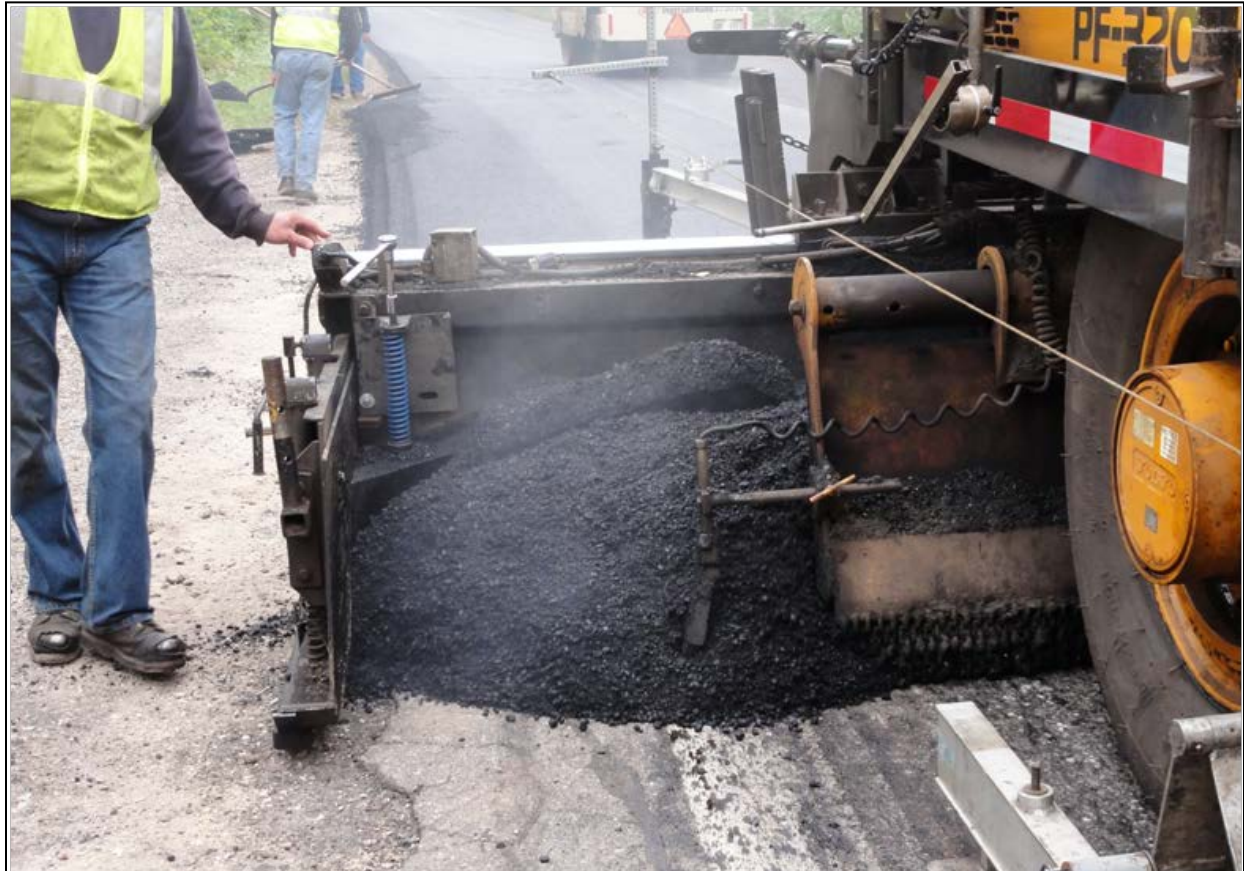
Figure 8. Paving with the Carlson prototype #2 device with the TransTech device is still attached but raised and out of the way.

with the TransTech device mounted on the screed extension next to the end gate. Next, test section #2 was paved with the Carlson prototype #2 device which was quickly installed during a short break in paving. This device and Carlson's prototype #3 was a modified end gate with the angle of the Safety Edge<sub>SM</sub> built into the end gate ski. The end gate ski was flat in the front and transitioned to 30° at the back of the ski. While paving with the Carlson prototype #2, the TransTech device remained mounted to the paver and was simply raised up and out of the way (Figure 8).

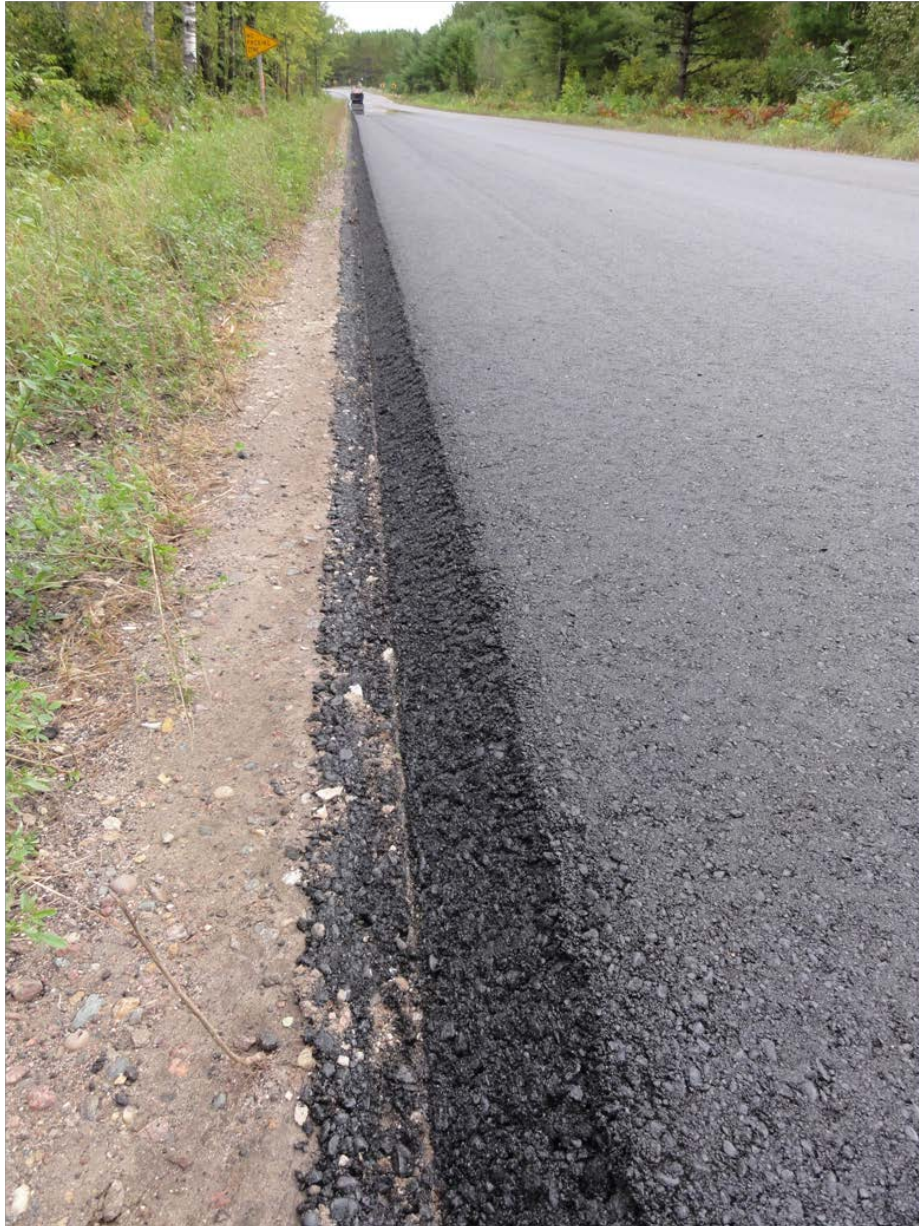
Figure 9. TransTech edge.

Visual inspection of the slope faces of the first two sections revealed a coarse appearance with more gaps between exposed aggregate in section #1 than section #2 which had a smooth or sealed appearance. The smooth slope face produced by the Carlson device is thought to be a result of extruding the HMA over the length of the end gate ski into the Safety Edge<sub>SM</sub> shape gradually from no slope near the front of the ski to 30° at the end of the ski.

Regardless of which device was used, the shape of the slope faces were consistent throughout the test sections. One distinct difference among the edges was the slope face on section #2 produced by the Carlson Prototype #2 had a 0.25-inch vertical rise or lip as the slope face meets the horizontal surface of the mat. The lip may help retain the granular shoulder material. Figure 9, 10, and 11 show the three finished edges after compaction.

- The slope of the edges produced by the three devices varied from 33° to 36°. Each device produced a uniform edge with unique characteristics. The TransTech device produced a relatively coarse slope face whereas the slope produced by the Carlson devices had a smooth/sealed appearance which may promote increased durability by reducing water infiltration at the edge. The Carlson prototype #2 device produced a 0.25-inch lip on the slope face that may help to retain the shoulder dressing material.

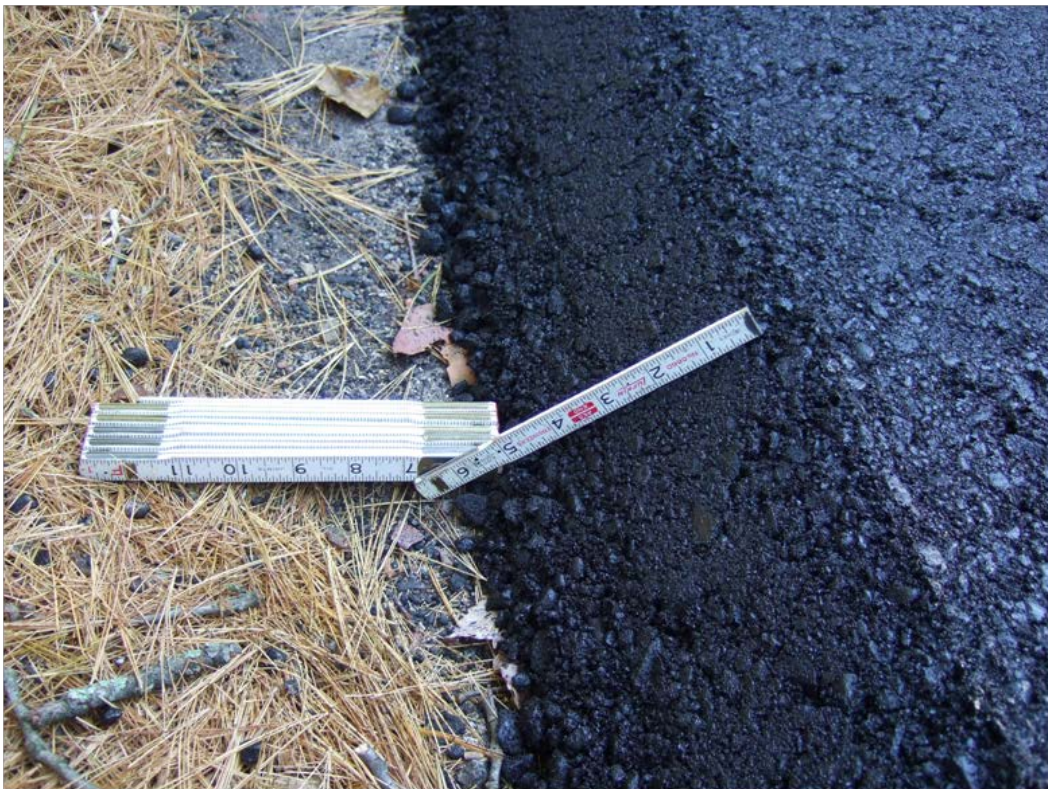
Figure 11. Carlson Prototype #3 edge.

Test section #3 was paved after the site visit and photos from WisDOT show a smooth slope face similar to section #2. An FHWA engineer on site indicated that before the Carlson Prototype #3 was sufficiently heated from the fresh HMA the slope face appeared only slightly smoother than the slope face produced by the TransTech device. It took roughly 200 ft of paving to heat up the end gate ski of the Carlson device after which the slope face became sealed and smooth. Future

design modifications to the end gate design are expected to include a heating element to preheat and maintain the temperature of the device.
