U.S. Department
of Transportation
**Federal Highway
Administration**

In Reply Refer To:
HSST/B-219

Name of system: W6 x 8.5 Steel Guiderail Post over Ground Structures
Type of system: Permanent Guiderail Component
Test Level: National Cooperative Highway Research Program (NCHRP) Report 350
Test Level 3 (TL-3)
Testing conducted by: Texas Transportation Institute (TTI)
Date of Request: December 28, 2010
Drawing Designator: SGR04-d

STEEL POST OVER
UNDERGROUND STRUCTURES

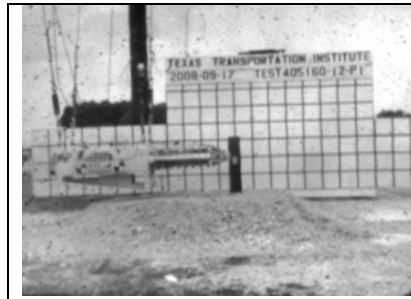
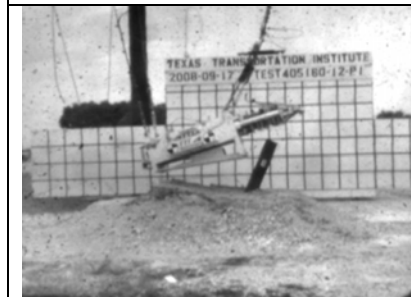
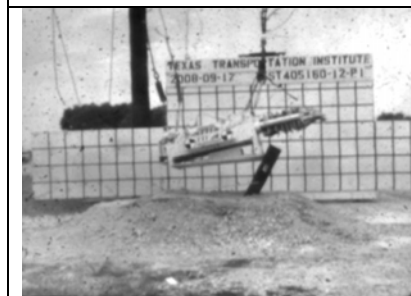
Table D1. Summary of results for pendulum test 405160-12 P1.

0.000 s

0.146 s

0.289 s

0.434 s

Test Agency..... Texas Transportation Institute
 Test No. 405160-12 P1
 Date 2008-09-17

Type..... Steel Posts over Underground Structures
 Installation Height (m)..... 28.5 inches
 Material of Key Element..... W6x8.5 steel post

Soil Type..... 60-inch Concrete footing in Standard Soil

Speed 21.6 mi/h
 Angle 90 deg

Impact Velocity
 Longitudinal direction..... 24.6 ft/s (7.5 m/s)
 Ridedown Accelerations
 Longitudinal direction..... -3.6 g's

Maximum Change in Velocity 19.2 ft/s

The pendulum bogie, traveling at an impact speed of 21.6 mph (34.7 kmh), impacted the guardrail post with the centerline of the pendulum nose aligned with the centerline of the steel post. The center height of the nose was 20.5 inches above finished grade. At 0.005 s, the steel post began to deform, and at 0.046 s, the concrete footing began to lift up in the soil. The pendulum bogie lost contact with the steel post at 0.155 s, and exit speed at loss of contact

was 8.5 mph. At 0.260 s, the concrete footing began to rotate, and at 0.352 s, the base of the pendulum contacted the post. The pendulum bogie came to rest on top the steel post at 0.994 s. Maximum dynamic deflection of the steel post during the test was 20.0 inches, and the final deformation of the steel post was approximately 12.25 inches. The footing was moved as a result of the pendulum impact on the post. The leading edge of the footing (traffic face edge) was uplifted and came to rest approximately 3.0 inches above the grade surface. After the test, no visible distress was observed in the concrete footing, post base plate, or anchor bolts. Maximum rise of the nose of the pendulum during the test was 24.1 inches, and maximum crush of the honeycomb nose of the pendulum was 10.1 inches. Longitudinal occupant impact velocity was 24.6 ft/s (7.5 m/s), longitudinal ridedown acceleration was -3.6 g's, and maximum 50-ms average was -8.7 g's. Change in velocity at loss of contact was 19.2 ft/s (5.9 m/s).

- A. The 5 ft x 5 ft footing rotated approximately 6 degrees from the pendulum impact. The dynamic rotation of the post was approximately 30 degrees. Plastic failure occurred in the W6 x 8.5 steel posts for this design tested. No distress was observed in the anchor bolts or concrete. The Occupant Risk Value Impact Velocity, longitudinal direction is 24.6 ft/s (7.5 m/s). The Ridedown Acceleration for longitudinal direction is -3.6 g, with a maximum change in velocity of 19.2 f/s.
