FACILITY LAYOUT

SHOULDER AREA REPAIR (TYPICAL)

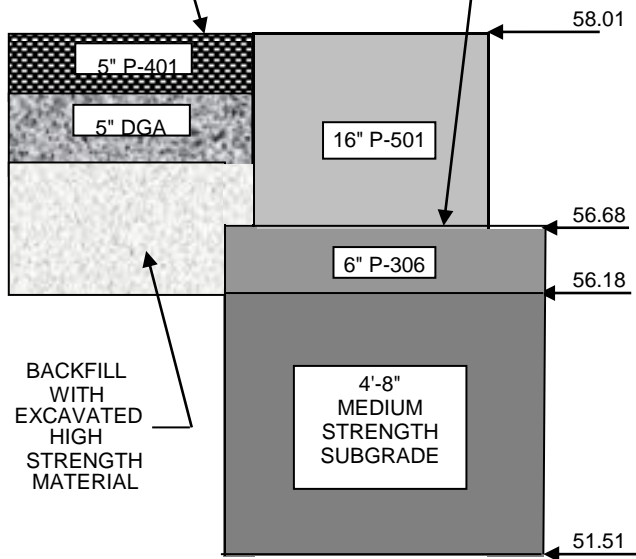
SECTION RIGID PAVEMENT

INSTALL PAPER BOND BREAK BETWEEN P-306 & P-501

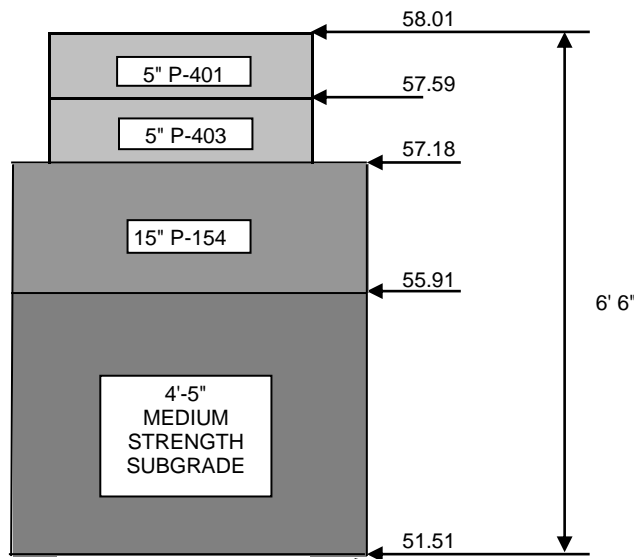
SECTION FLEXIBLE PAVEMENT

EXTEND THE SUBGRADE AND P-154 3FT BEYOND THE LIMITS OF THE P-403
