National Transportation Safety Board

Safety Recommendation

In reply refer to: R-15-14 through -17

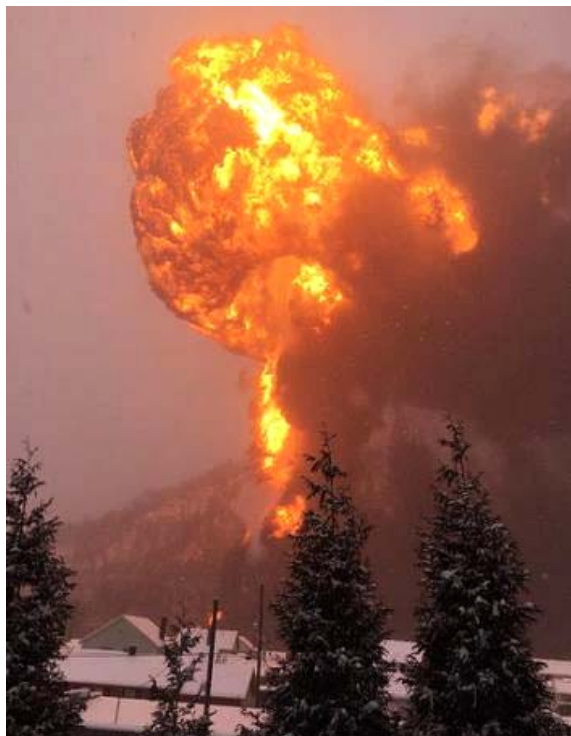
Emergency responders reported that the first thermal failure occurred about 25 minutes after the accident. By about 65 minutes after the accident, at least four thermal failures with energetic fireball eruptions had occurred (see Figure 1). The 13th and last thermal failure occurred more than 10 hours after the accident.

Figure 1. Fireball eruption from Mount Carbon, West Virginia derailment scene, February 16, 2015. (Photo courtesy WWVA News Radio, Wheeling, West Virginia.)

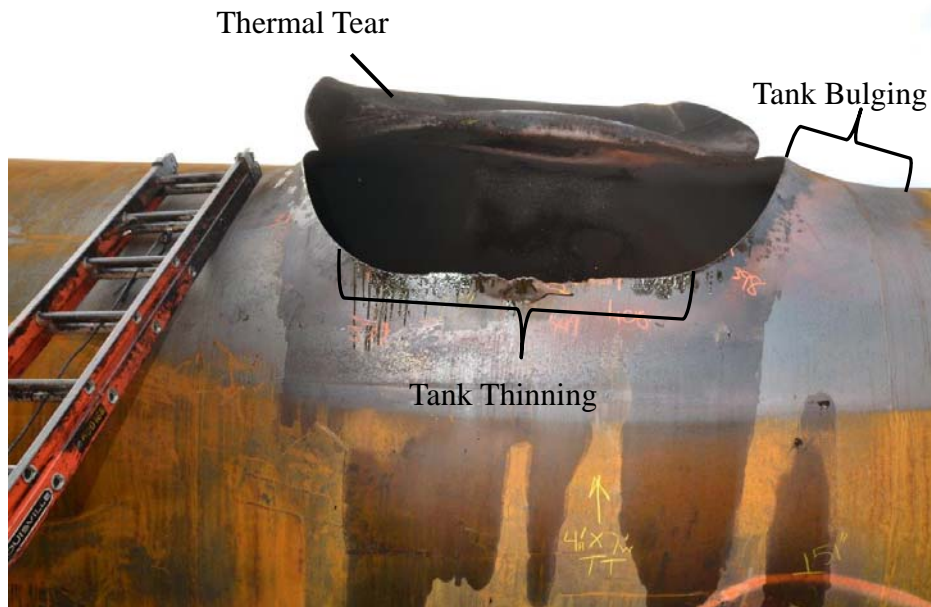
Preliminary investigation results indicate that a total of 28 CPC-1232 compliant tank cars thermally failed in these four accidents. One person was injured, and thousands of gallons of crude oil were released, causing significant property damage and environmental pollution. In these four accidents, investigators have found consistent evidence of shell bulging from overpressure, shell material thinning, and tank shell tears in the vapor space of bare steel CPC-1232 tank cars exposed to pool fire conditions (see Figure 2). The NTSB concludes that the thermal performance and pressure relief capacity of bare steel tank cars that conform to current federal and industry requirements is insufficient to prevent tank failures from pool fire thermal exposure and the resulting overpressurization.

Figure 2. CPC-1232 tank car CBTX 741946 thermal shell tear surrounded by a bulging and thinning shell.

These findings also suggest that, contrary to model predictions the tank shell thermal resistance and the capacity of pressure relief devices of bare shell CPC-1232 cars are insufficient to prevent shell rupture within a relatively short period when exposed to a large flammable liquid pool fire. Tank car breaches from thermal failures in these accidents contributed to increased severity of postaccident fires and damage and demonstrate the potential for these breaches to affect adjacent tank cars and cause the release of additional flammable hazardous material. The NTSB concludes that tank failure of unprotected flammable liquid tank cars exposed to pool fires can occur in a much shorter time than the 100-minute benchmark provided by 49 CFR 179.18(a).

Require that all new and existing tank cars used to transport all Class 3 flammable liquids be equipped with thermal protection systems that meet or exceed the thermal performance standards outlined in Title 49 *Code of Federal Regulations* 179.18(a) and are appropriately qualified for the tank car configuration and the commodity transported.

In conjunction with thermal protection systems called for in safety recommendation R-15-29, require that all new and existing tank cars used to transport all Class 3 flammable liquids be equipped with appropriately sized pressure relief devices that allow the release of pressure under fire conditions to ensure thermal performance that meets or exceeds the requirements of Title 49 *Code of Federal Regulations* 179.18(a), and that minimizes the likelihood of energetic thermal ruptures.
