LTPP Newsletter

Spring 2013
Volume 9, Issue 2

New LTPP Profilers Hit the Road Smoothly

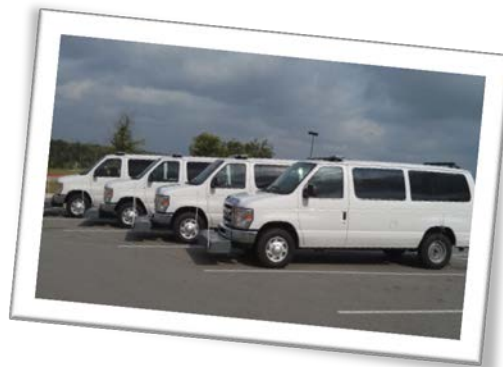
The new LTPP profilers

The new profilers not only collect longitudinal profile data, but have also added new capabilities. Pavement macrotexture measurements are a new data collection element, and all of the data, including ambient and surface temperature, is now referenced with Global Positioning System (GPS) coordinates. The cockpit of the vehicle has been designed to minimize driver distractions and provide ease of access to all controls and testing switches. As compared to the old LTPP profilers that used 2002-era computer technology, the new system's hardware requirements are minimized resulting in a very low computer rack footprint. System software has been designed through a collaborative manufacturer/LTPP program process to be user-friendly and intuitive.

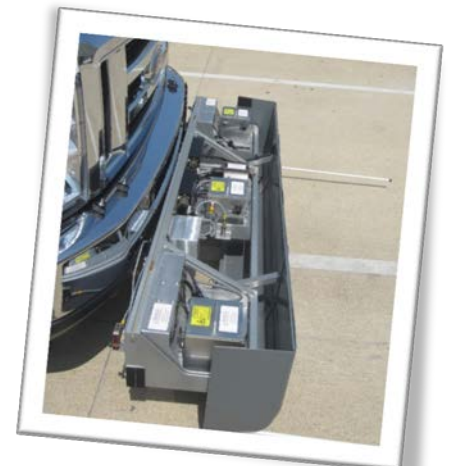
Sensor Chassis

Static Sensor Test: Researchers evaluated the precision and bias of the profile and texture height sensors in the static mode.

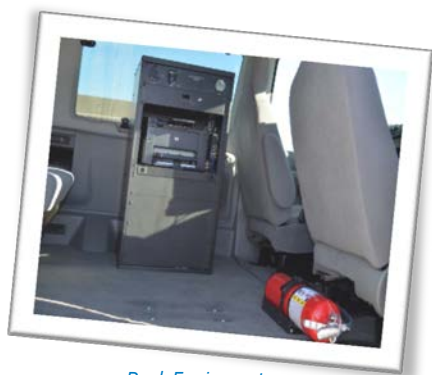
Rack Equipment

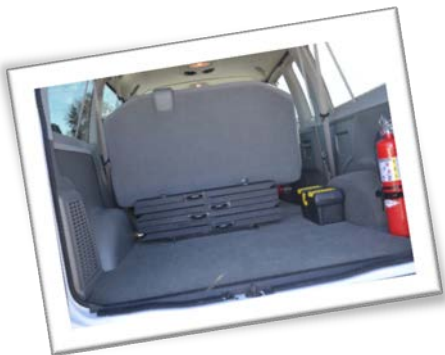
Calibration Ramps

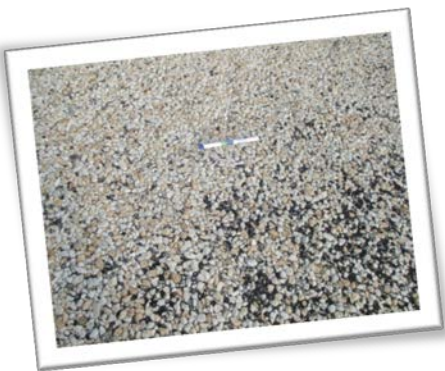
Chip Seal Surface

In order to conduct the acceptance testing, several reference test sections were established near College Station, Texas. These sections consisted of two asphalt concrete, two Portland cement concrete (PCC), and one chip seal surface. The sections were selected to obtain a range of roughness and MPD values.
