Evaluation of Shared Lane Markings

PUBLICATION NO. FHWA-HRT-10-041

DECEMBER 2010

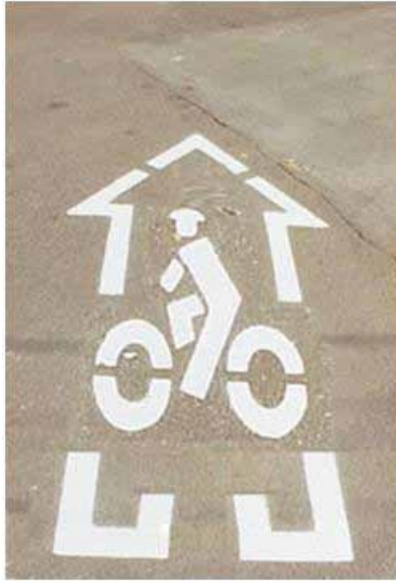
Figure 2. Photo. Bike-in-house marking.

The original bike-in-house design that has been used or slightly modified in other locations for some time is shown in figure 2. This design was used in Gainesville, FL, in a wide curb lane situation and was previously evaluated by the Highway Safety Research Center (HSRC). It was found that the markings increased the safety margin for bicyclists riding near the curb. Additionally, sidewalk riding decreased.⁽⁴⁾

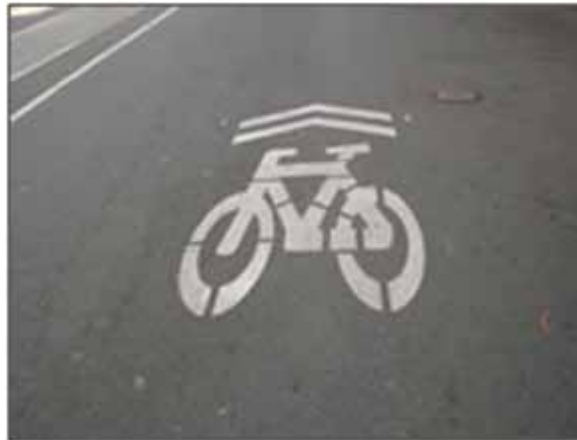
Figure 3. Photo. Bike-and-chevron marking.

The bike-in-house marking was modified to a bike-and-chevron marking, and the two designs were evaluated in San Francisco, CA. Superior results were associated with the bike-and-chevron marking shown in figure 3.⁽³⁾ Based on feedback from bicyclists and motorists, the pitch on the chevrons was subsequently increased to resemble more of a directional guide. Given the results of the evaluation, the bike-and-chevron marking was added to the existing *2003 California Manual on Traffic Control Devices* through a policy directive in September 2005.⁽⁵⁾ Additional evaluation detail is provided in chapter 2 of this report.

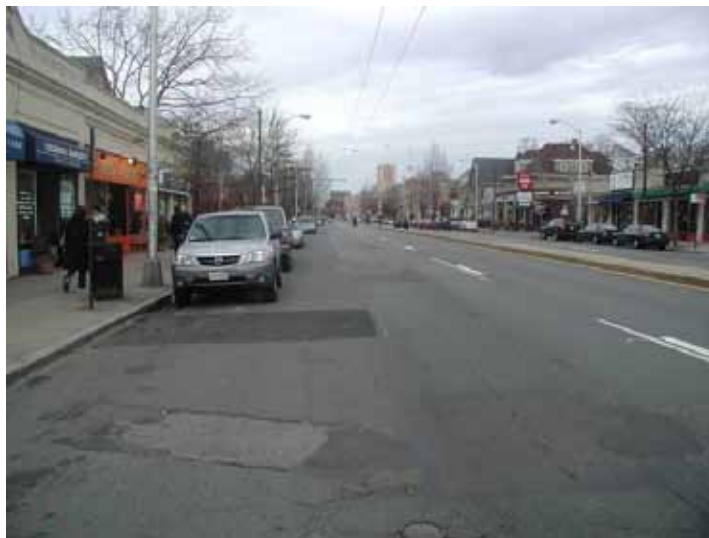
Figure 5. Photo. Massachusetts Avenue in the before condition.

The experiment was conducted on Massachusetts Avenue, a four-lane divided street with approximately 29,000 vehicles per day, parallel parking on both sides of the street, and a speed limit of 30 mi/h. The street is a busy transit corridor, and parked motor vehicle turnover is frequent. The number of peak hour bicyclists ranges from approximately 150 bicyclists in the morning peak to 200 bicyclists in the evening peak. The sharrows were placed 10 ft from the curb with approximately 200 ft of spacing on both sides of the street over approximately 2,500 ft before and after the immediate vicinity of where data were being collected (near Lancaster and Garfield streets). Information on the sharrows and the study was discussed at the city's bicycle advisory committee, the Cambridge Bicycle Committee, and posted on the city Web site, but no other direct outreach was made to road users. Figure 5 shows a view of Massachusetts Avenue in the before condition, and figure 6 shows the typical cross section sketch of Massachusetts Avenue, representing the before and after conditions. The cross section for Massachusetts Avenue in the study area is variable and is a few inches wider in the outbound direction (away from Boston) near Garfield Street. Other than the addition of the sharrows, no changes were made to the street.

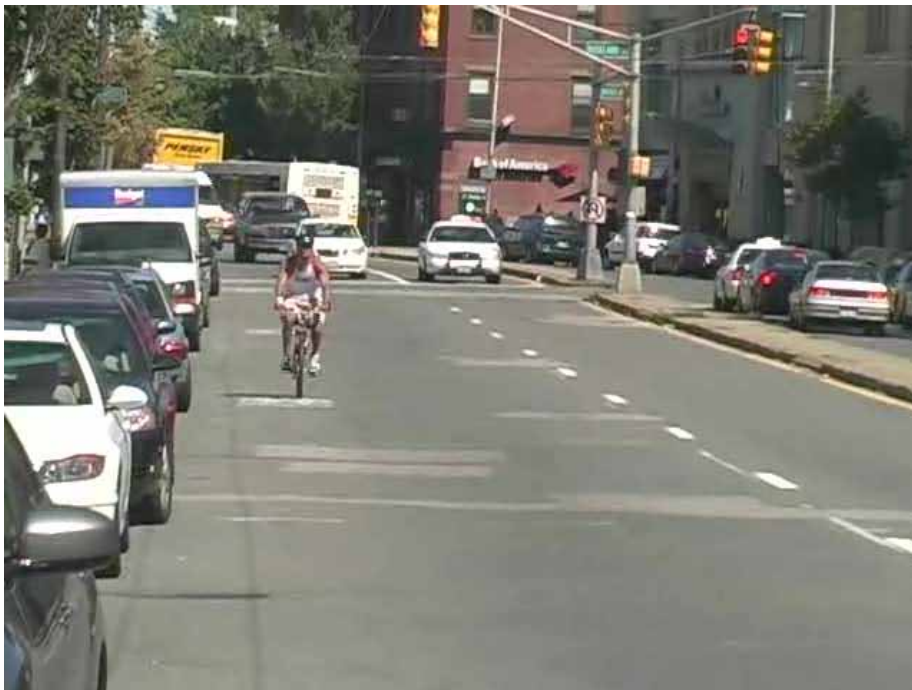
Figure 7. Photo. Bicyclist riding over the sharrows.

In the after period, 94 percent of bicyclists rode over the sharrows (see figure 7), 4 percent did not, and the position could not be determined for 1 percent of bicyclists.

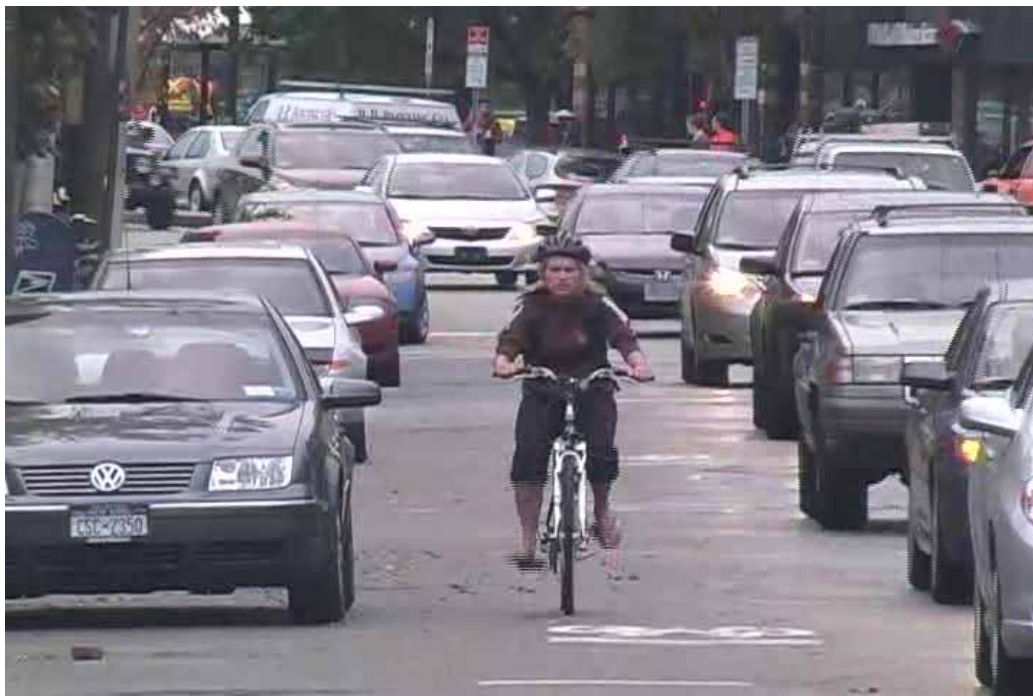
Figure 10. Photo. Operating space for a bicyclist in the after period.

A number of variables related to the interaction of bicycles and motor vehicles also showed positive effects. The overall results reflect more segregated flow with less lateral movement of bicycles and motor vehicles (see figure 10). The figure shows motor vehicles tracking behind each other while giving operating space to a bicyclist in the after period. It might be inferred that motorists in the after condition were traveling in a lane location to give bicyclists sufficient room and did not need to change lanes in order to pass safely.

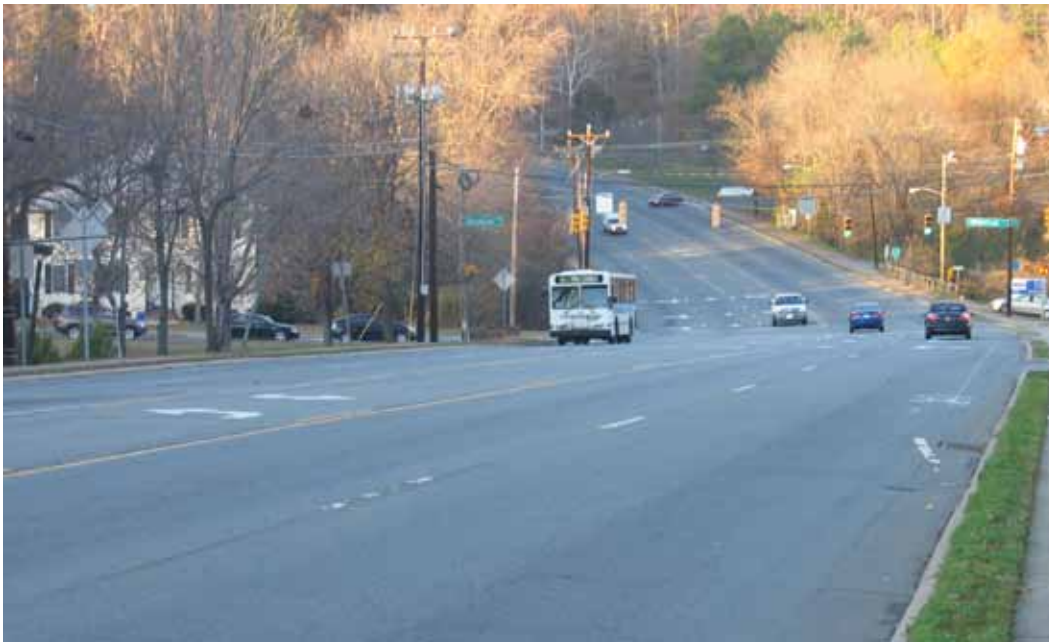
Figure 11. Photo. Outbound view of MLK Boulevard.

In Chapel Hill, NC, sharrows were placed on Martin Luther King Jr. (MLK) Boulevard, which is a four-lane undivided route with a center, two-way left-turn lane. The route has no parking, 27,000 vehicles per day, and a speed limit of 35 mi/h. The street serves as a major corridor to the University of North Carolina (UNC) and has approximately 40–70 bicyclists per day. In previous counts, about one-third of the bicyclists were riding on the adjacent sidewalk. There is a 3 to 4 percent grade at the location where data were collected, allowing an examination of whether the effects of sharrows differ for downgrade and upgrade (see figure 11).

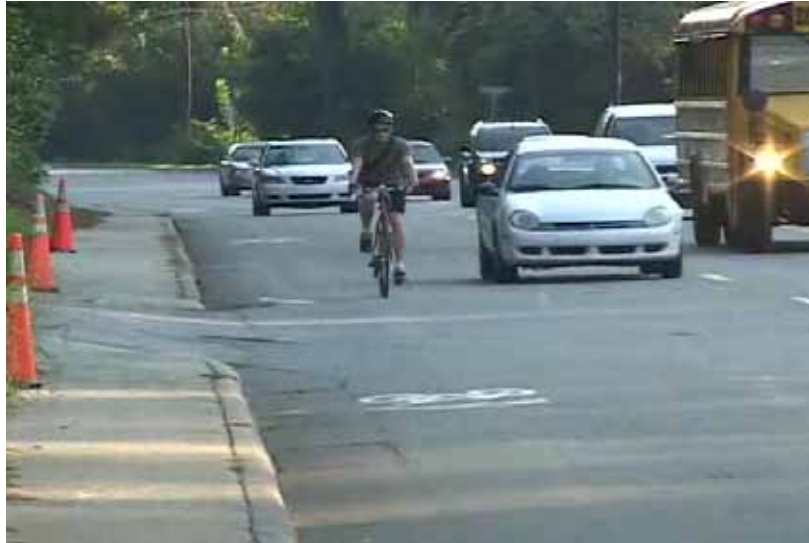
Figure 13. Photo. Motor vehicle passing a bicycle after sharrow placement with traffic in the adjacent lane.

Figure 13 shows a motor vehicle passing a bicycle when there is traffic in the adjacent lane after the sharrow was introduced.

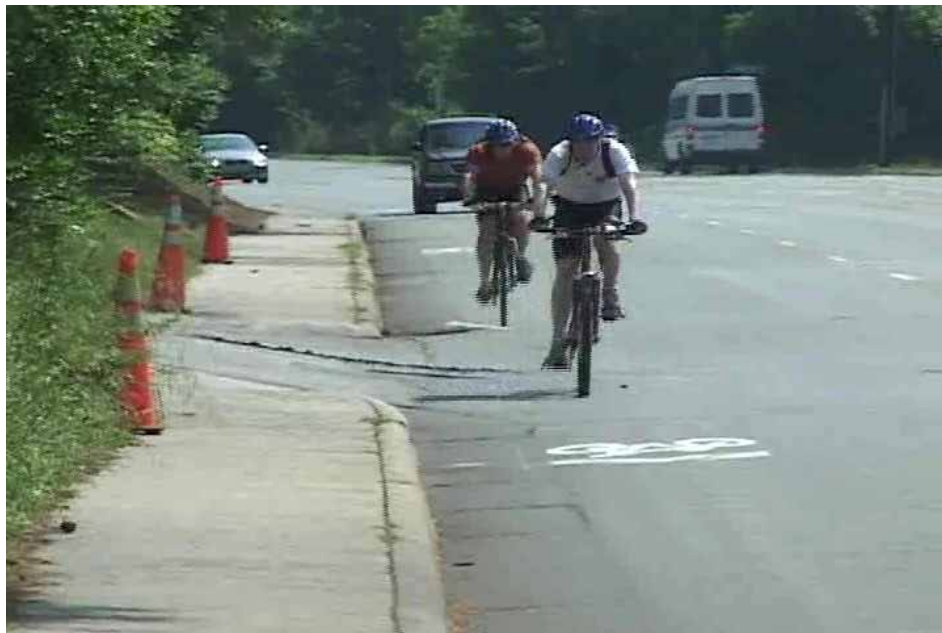
Figure 14. Photo. Bicyclists riding over the sharrow in the outbound (downhill) direction.

In the after period, 91 percent of the bicyclists rode over the sharrow, and 9 percent did not (see figure 14). The percentage of bicyclists who rode over the sharrow was 88 percent in the uphill direction and 97 percent in the downhill direction. In the uphill direction, the grade was such that the speed of the bicycle was relatively slow, and many bicyclists rode relatively close to the curb (see figure 15).

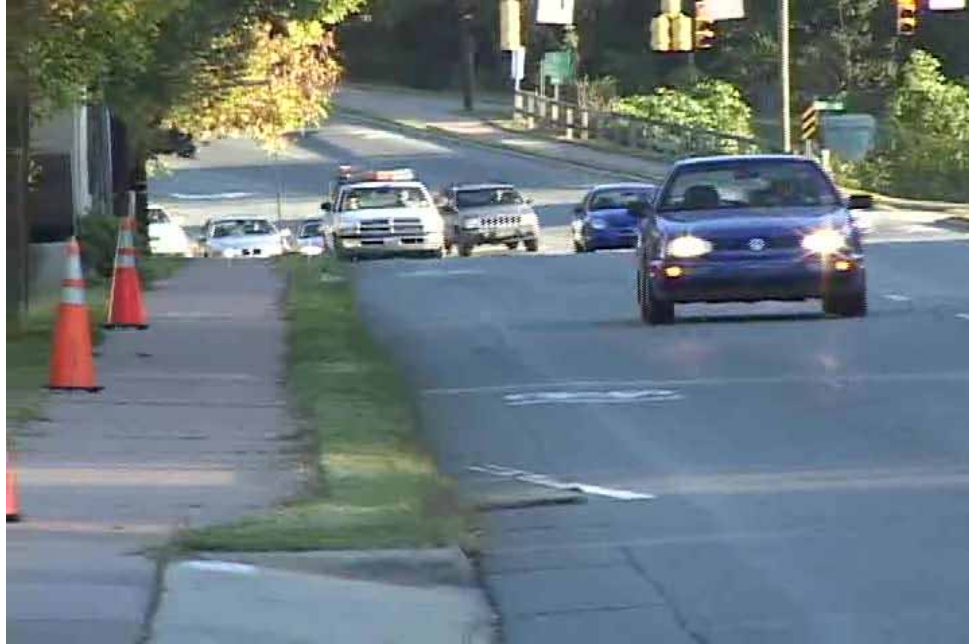
Figure 16. Photo. Motor vehicle position in the uphill direction after the sharrow.

Table 24 shows the results from the analysis of the distance of a motor vehicle in the travel lane and the curb. This distance increased about 7 inches when both directions were combined ($p < 0.001$). The more prominent increase was 8.3 inches in the uphill direction ($p < 0.001$). There was an increase of approximately 5 inches in the downhill direction ($p = 0.017$). The percentages within 50 and 60 inches were also significantly lower in the after period. The effect was most pronounced in the uphill direction. Figure 16 shows a typical view for the uphill direction.

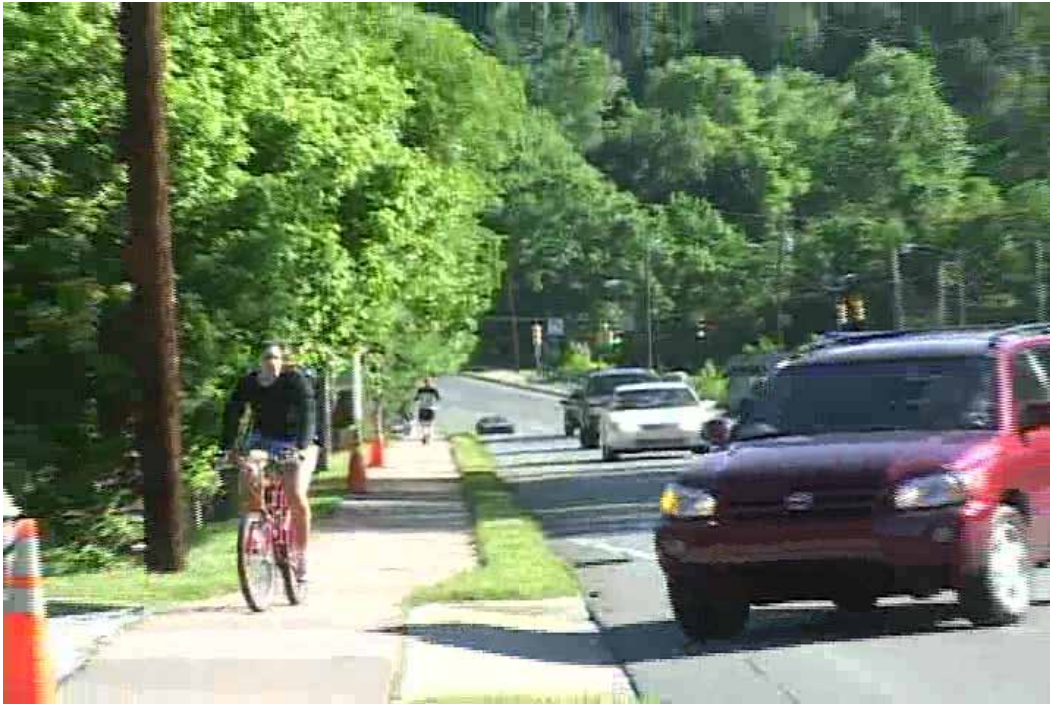
Figure 17. Photo. Bicyclist interaction with motor vehicle at driveway.

A possible effect of the sharrow is to shift bicyclists' riding on the sidewalk to riding on the roadway. In this corridor, sidewalk riding is particularly dangerous due to the large number of driveways (see figure 17).

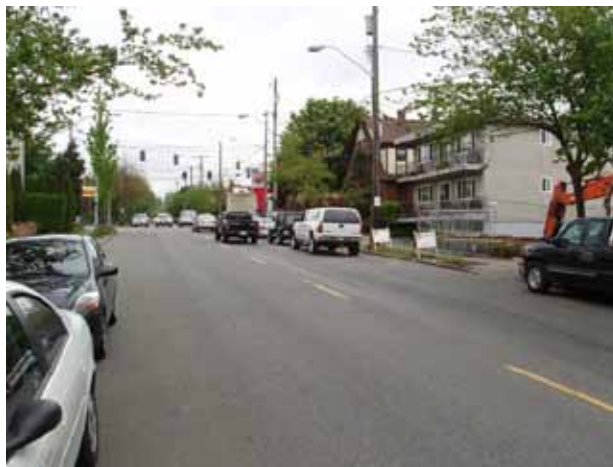
Figure 18. Photo. Fremont Street in the before condition.

Seattle, WA, is in the process of placing sharrows as approved in the bicycle plan adopted in fall 2007. Based on this plan, the city is expected to have up to 100 mi of streets with sharrows in a variety of situations. Some streets have the sharrows on both sides of the street, including sharrows to prevent dooring from parked vehicles. The city was interested in experimenting with placing sharrows in the center of the lane on a downhill portion (3.6 percent grade) of Fremont Street, a popular street for bicycle commuters. Fremont Street is a two-lane street with parking on both sides, a speed limit of 30 mi/h, and approximately 10,000 vehicles per day (see figure 18). The distance from the curb to the centerline was 20 ft on both sides. Sharrows had previously been installed at the traditional 11-ft spacing from the curb on a four-lane section of the street with parking on both sides for approximately 2,000 ft prior to this downhill section.

The remainder of the street change was to shift the center line of the street and to place a 5-ft bicycle lane on the uphill portion of the street (right side of figure 18). Parking would remain on both sides of the street. Since bicycles travel close to the same speed as motor vehicles on the downgrade (left side of figure 18), the hypothesis was that placing the sharrow in the center of the lane would potentially encourage bicyclists to take the lane, removing them from the door zone.

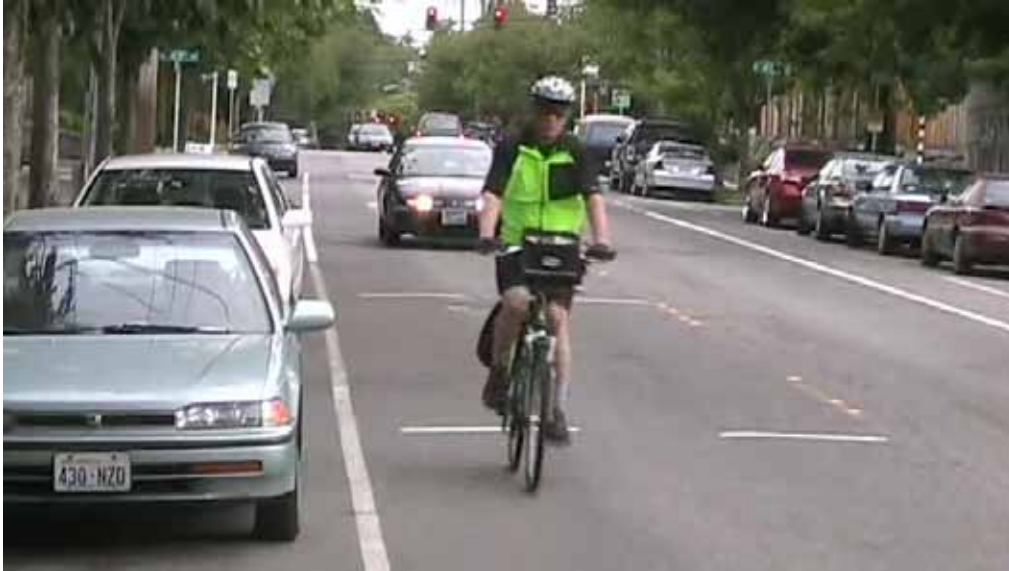
Figure 20. Photo. Typical position of bicyclist after sharrows installation.

In after period 2, 15 percent of bicyclists rode over the sharrows, while 85 percent did not. Figure 20 shows the typical position of a bicyclist riding downhill. The travel lanes were narrowed to 10.5 ft wide in after period 2. The horizontal lines on the street are grids used as calibrators for the determination of spacing data. There was no evidence that the grids had any effect on bicycle position.
