1. Report No. FHWA-HIF-08-009		2. Government Accession No.		3. Recipient's Catalog No.	
4. Title and Subtitle Construction of a Precast Prestressed Concrete Pavement Demonstration Project on Interstate 57 near Sikeston, Missouri				5. Report Date March 2008

6. Performing Organization Code	
7. Author(s) David K. Merritt, Richard B. Rogers, Robert Otto Rasmussen				8. Performing Organization Report No.	
9. Performing Organization Name and Address The Transtec Group, Inc. 6111 Balcones Dr. Austin, Texas 78731				10. Work Unit No. (TRAIS)

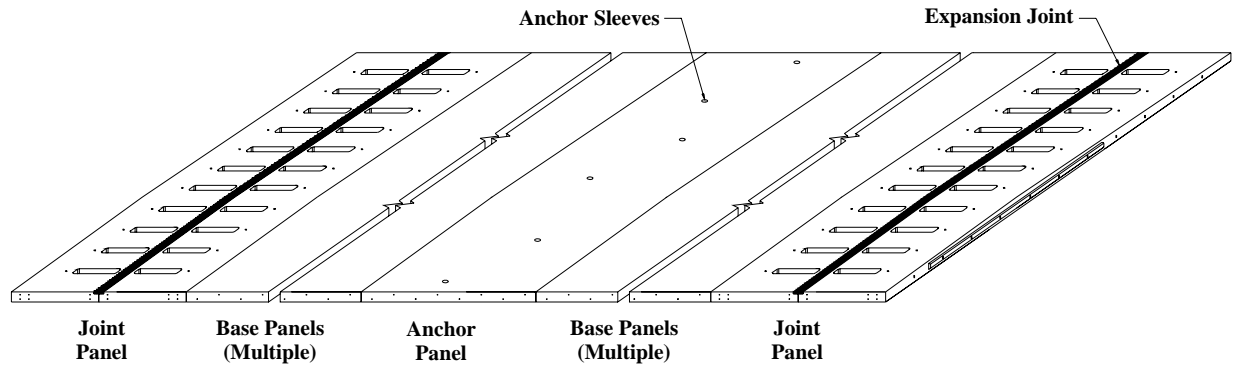
Figure 1. Illustration. Typical PPCP panel layout.

After each section of panels is installed (from joint panel to joint panel), the post-tensioning strands are fed into the post-tensioning ducts from the pockets in the joint panels (described below). The strands are pushed or pulled through all of the panels to the post-tensioning anchors in the joint panels at the other end of the section. Post-tensioning is then completed from the pockets in the joint panels. Each post-tensioned slab acts independently of the adjacent slab in terms of expansion and contraction movements. Expansion joints are cast into the joint panels (described below) to permit adjacent slabs to move independently, with dowels across the expansion joints for load transfer. The length of each post-tensioned slab can be adjusted by increasing or decreasing the number of base panels between the joint panels.

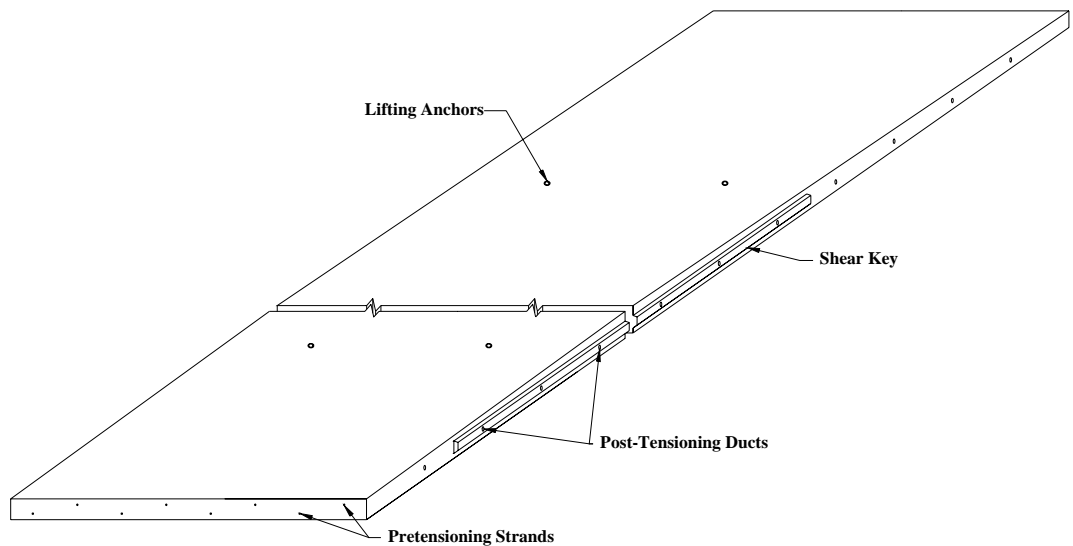
Figure 2. Illustration. Typical Base Panel.

The base panels, shown in Figure 2, make up the majority of each post-tensioned slab. Figure 2 shows the typical components of the base panels, including the transverse pretensioning strands, longitudinal post-tensioning ducts, and keyways along the edges of the panels. Approximately every 5th base panel contains grout inlets/vents for the longitudinal post-tensioning tendons. For the Missouri demonstration project, a pavement crown was cast into the precast panels, resulting in panels with variable thickness, as will be described in Chapter 3. Because of the variable panel thickness, the keyway along the edge of the panel was only provided in the traffic lanes and discontinued in the shoulders.

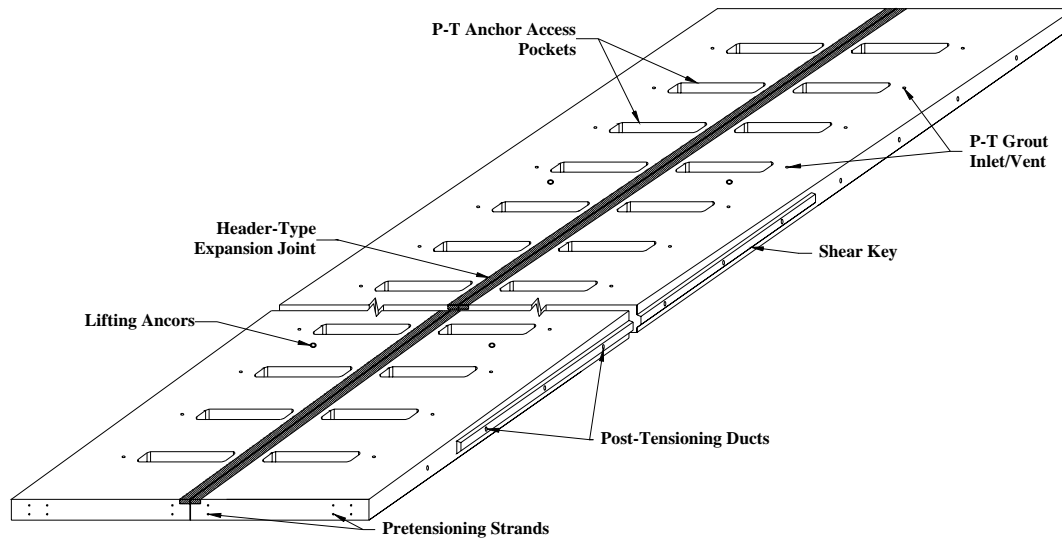
Figure 3. Illustration. Typical Joint Panel.

The joint panels, shown in Figure 3, contain both the expansion joint and the post-tensioning anchorage. The expansion joint is designed to accommodate the significant amount of horizontal slab movement during daily and seasonal temperature cycles, while providing load transfer across the joint. The pockets cast into the joint panels provide access to the post-tensioning anchors for stressing the tendons with a monostrand stressing ram. The stressing pockets are also used for temporary post-tensioning during installation of the panels (described in Chapter 6). Grout ports are located just in front of each of the post-tensioning anchors for grouting the longitudinal tendons.

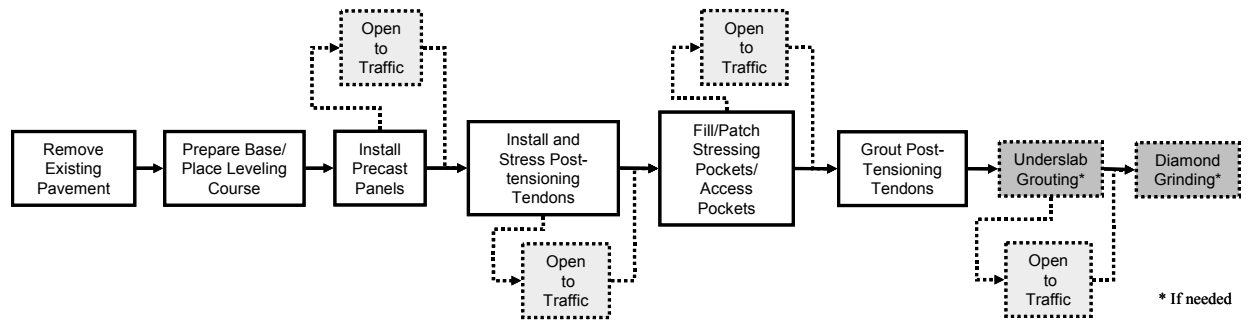
Figure 5. Illustration. Flowchart for the overall construction process.

Figure 5 shows a general flowchart for the construction process for PPCP. Although every project will have different design features and different constraints on construction, it should be noted that, when properly planned, many of the steps of the construction process can be completed independently, allowing the pavement to be opened to traffic in between steps. Each project must be carefully planned from the beginning to help ensure minimal impact on the motoring public during construction, as this is the primary benefit of precast concrete pavement construction.

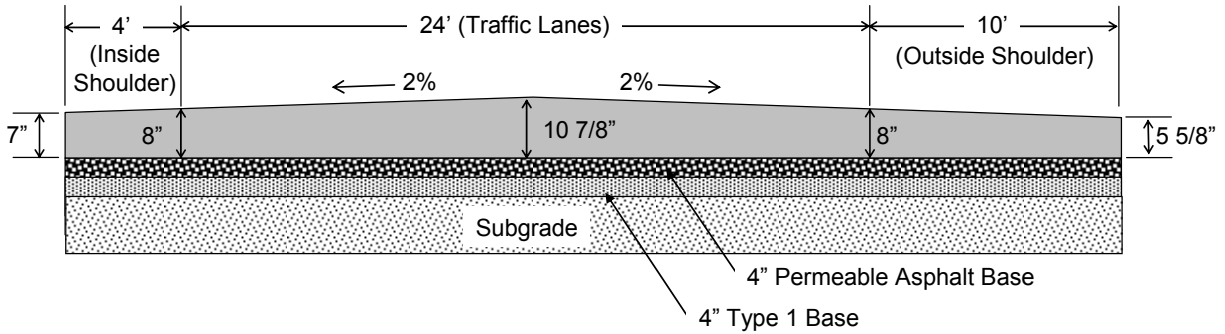
Figure 7. Illustration. Cross section of the precast panels, incorporating the change in cross-slope into the surface of the panel. (Note: 1 inch = 25.4 mm)

(8 inches) for the traffic lanes. In order to achieve the two percent crown in the pavement surface, the thickness was varied from 276 mm (10 7/8 inches) at the peak of the crown down to 178 mm (7 inches) at the edge of the inside shoulder and 143 mm (5 5/8 inches) at the edge of the outside shoulder, as shown in Figure 7.

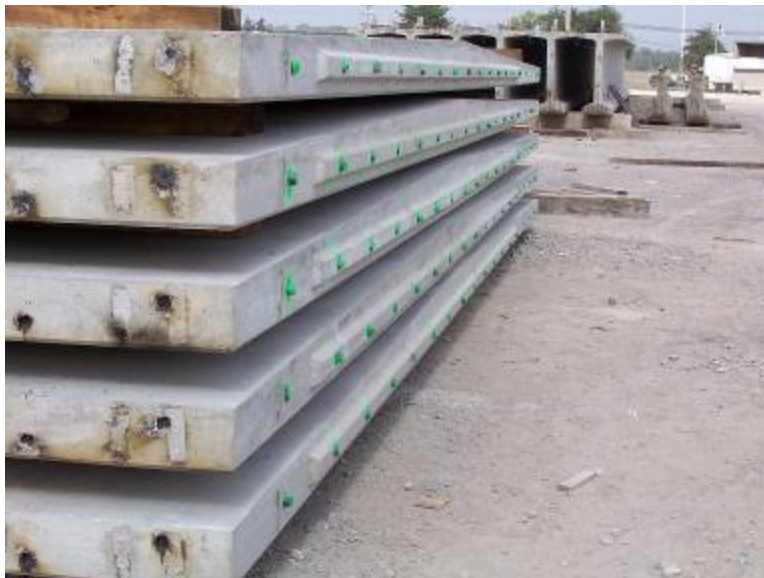
Figure 8. Photo. Precast panels at the fabrication plant after removal from the forms showing the variable thickness cross-section.

Figure 8 shows a profile view of the precast panels at the fabrication plant, showing the variable thickness panel. Because of the variable thickness of the panels and the need for the keyways to be parallel to the flat bottom of the panels, it was not possible to extend the keyways across the full width of the panels. As a minimum requirement, the keyways were maintained across both traffic lanes and extended one foot into each shoulder to ensure load transfer from the keyways within the traffic lanes.

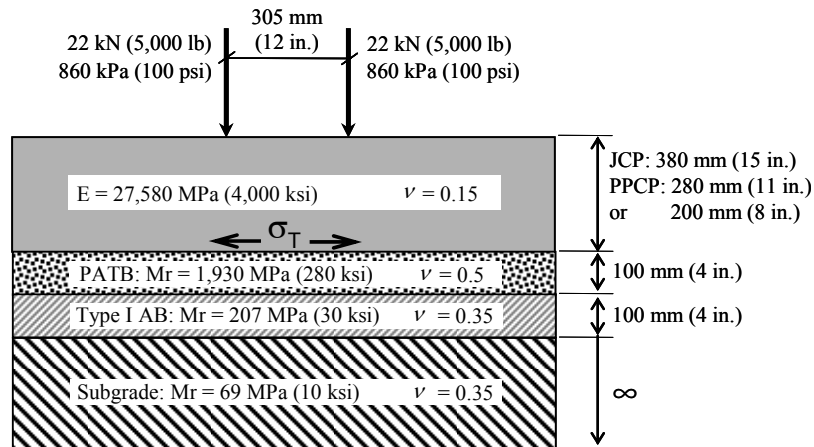
Figure 9. Illustration. Layered pavement structure used for elastic layered analysis of slab stresses under traffic loading.

Figure 9 shows the pavement structures and loading condition used for the layered elastic analysis. A 380 mm (15 inch) slab thickness was analyzed representing the conventional pavement, and 200 mm (8 inch) and 280 mm (11 inch) slab thicknesses were analyzed for the precast pavement. The 200 mm (8 inch) and 280 mm (11 inch) slab thicknesses represent the precast panel thickness at the edges of the traffic lanes and at the pavement crown, respectively, as determined by the pavement cross section shown in Figure 7. Because the shoulders were integral with the mainlanes for the precast pavement panels and tied shoulders would be provided for conventional pavement, only interior slab loading was considered in the analysis. The wheel loads represent the loading from dual wheels on a 89 kN (20,000 lb) single axle.

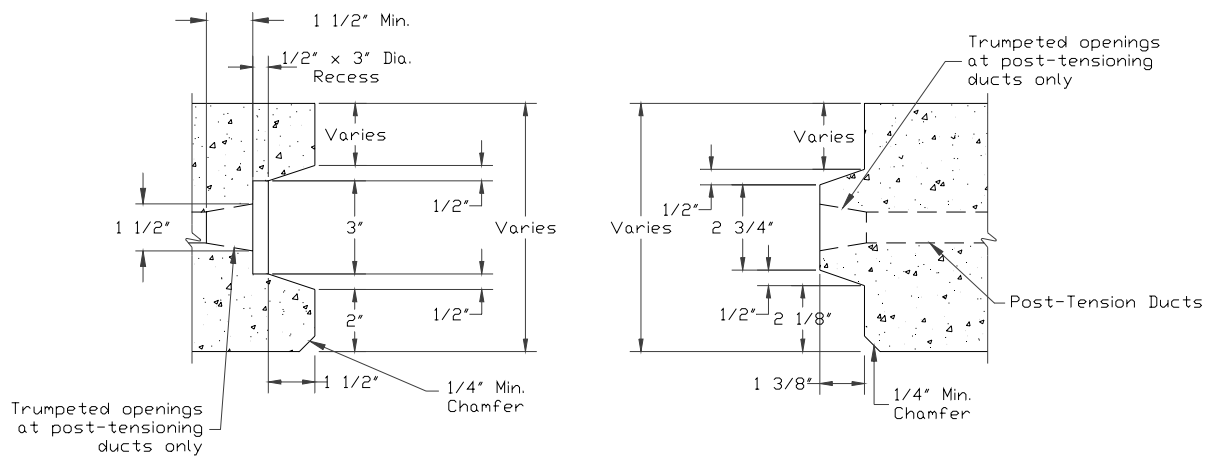
Figure 10. Illustration. Keyway dimensions for I-57 precast panels. (Note: 1 inch = 25.4 mm)

A flared or trumpeted opening was provided at the end of each post-tensioning duct to accommodate slight misalignment of the ducts on site. For the recessed keyway, a recess around each post-tensioning duct was provided to receive compressible foam gaskets. The compressible foam gaskets were installed prior to setting each panel in place and helped to minimize grout leakage from the post-tensioning ducts during the tendon grouting operation.

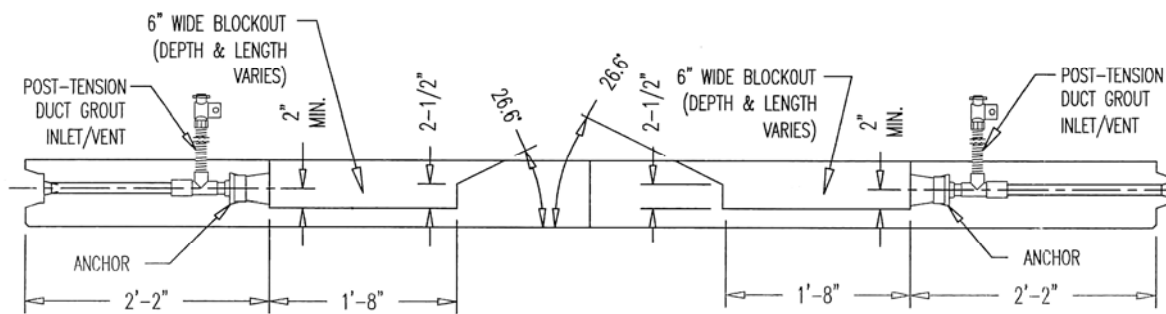
Figure 13. Illustration. Typical post-tensioning pocket cast into the joint panels (*Note: 1 inch = 25.4 mm*).

To accommodate end stressing, anchor access pockets were specified such that they were large enough to accommodate the stressing ram and would permit the post-tensioning strands to be fed into the ducts from the pockets. Figure 13 shows the stressing pockets that were developed by the post-tensioning supplier (Dywidag Systems International) to meet these requirements. The intent was to minimize the size of the stressing pockets as much as possible. As such, a pocket which could accommodate a “banana-nose” post-tensioning ram was used. The pockets featured a sloped face in the back of the pocket to accommodate the ram. Because of the variable thickness of the precast panels, the dimensions for each pocket were different and required pocket formers to be fabricated for each individual pocket.

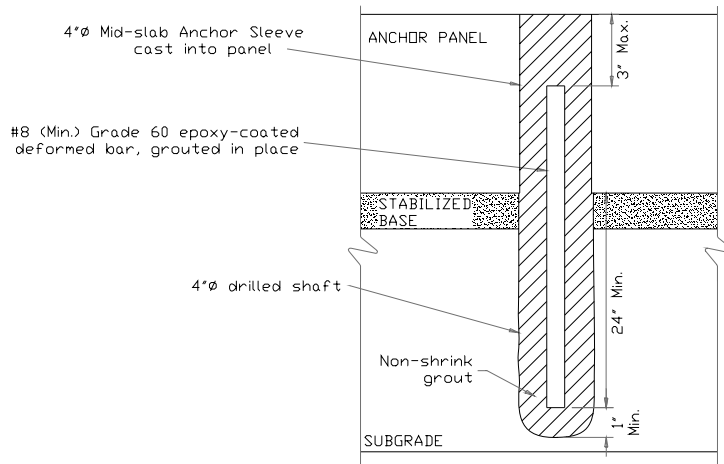
Figure 15. Illustration. Mid-slab anchor detail (Note: 1 inch = 25.4 mm).

As discussed in Chapter 2, it was necessary to anchor the center of each post-tensioned section of precast panels to the underlying base so that they will expand and contract outward from the center, ensuring uniform expansion joint widths and preventing the pavement sections from “creeping” in the direction of traffic under traffic loading. For this purpose, Anchor Panels were located at the center of each post-tensioned section of pavement. A series of 100 mm (4 inch) diameter sleeves were cast into these panels to receive dowel pins which were drilled and grouted into the underlying base/subgrade after installation of the panels, as shown in Figure 15. While this did create another type of precast panel, the anchor sleeves could have simply been drilled into standard base panels on-site if necessary.

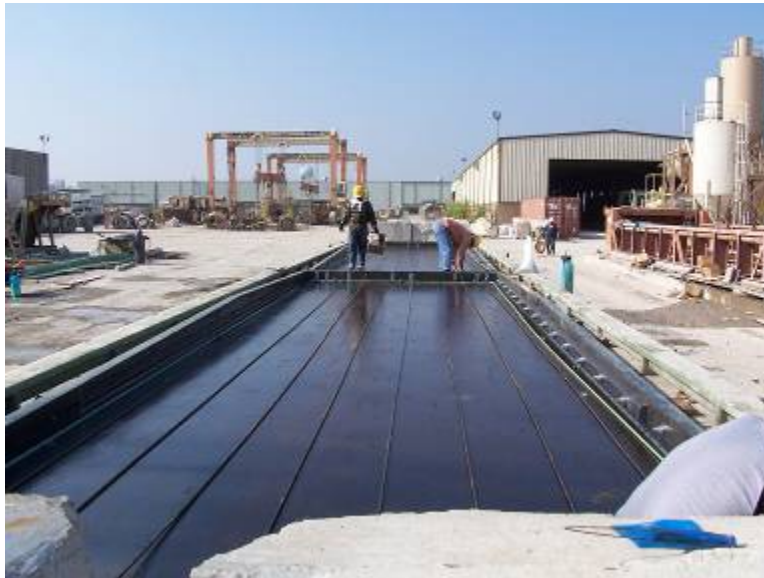
Figure 16. Photo. Precast panel forms during installation of the pretensioning strands.

The panels were fabricated on a 4.3 m (14 ft) wide flat steel casting table which was long enough to produce up to two panels end to end. Steel sideforms and bulkheads were custom made for the panels. The pretensioning strands extended through both panels, anchored at bulkheads at either end of the self-stressing casting bed. Bulkheads between the precast panels, bolted down to the casting bed, were used to hold the pretensioning strands at the proper elevation at the ends of the precast panels. Steel chairs were used to harp the strands within the precast panels to match the strand profile provided in the panel detail drawings. Figure 16 shows the forms as the pretensioning strands are threaded through the forms.

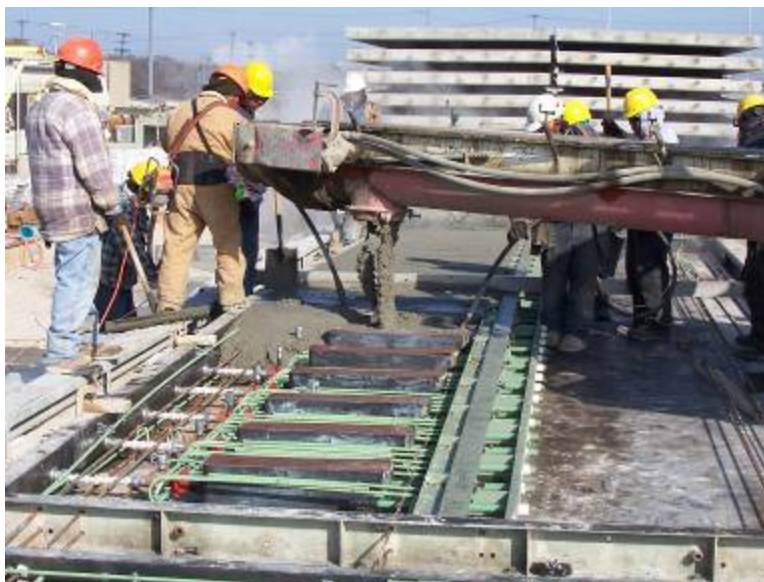
Figure 18. Photo. Fabrication of the first half of a joint panel.

the expansion joint. The first half of the joint panel was cast and steam cured, but the pretensioning strands were not released until after the second half had been subsequently cast and cured. The second half of the panel was set up and cast either the afternoon of the same day (if the first half was cast in the morning) or the following day. Figure 17 shows the fabrication of a base panel and Figure 18 shows fabrication of a joint panel during concrete placement for the first half of the panel.

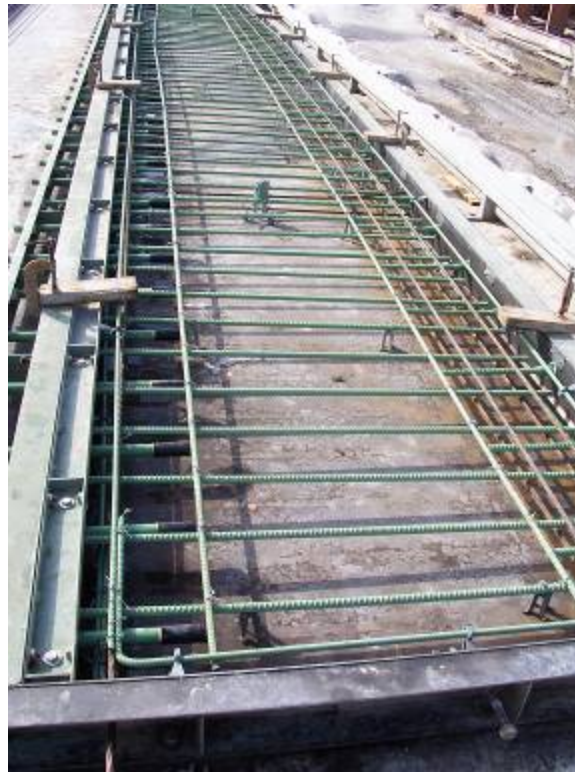
Figure 19. Photo. Reinforcement for the non-post-tensioned half of a joint panel prior to casting.

Minimal mild-steel (non-prestressed) reinforcement was provided in the base panels. As the panel detail drawings in the Appendix show, only perimeter steel at the top and bottom of the panel was provided for the base panels. Joint panels also had perimeter steel, but were heavily reinforced with stirrups around the stressing pockets and post-tensioning anchors as discussed previously. Epoxy-coated grade 60 No. 4 deformed bars were specified for all non-prestressed reinforcement. For the joint panels abutting the existing cast-in-place pavement, the half of the panel not post-tensioned was reinforced with mild steel in the longitudinal direction. No. 6 epoxy-coated reinforcing bars spaced at 200 mm (8 inches) on center provided approximately 0.65 percent steel for this portion of the precast panel. Figure 19 shows the reinforcement for the non-post-tensioned half of a joint panel prior to concrete placement.

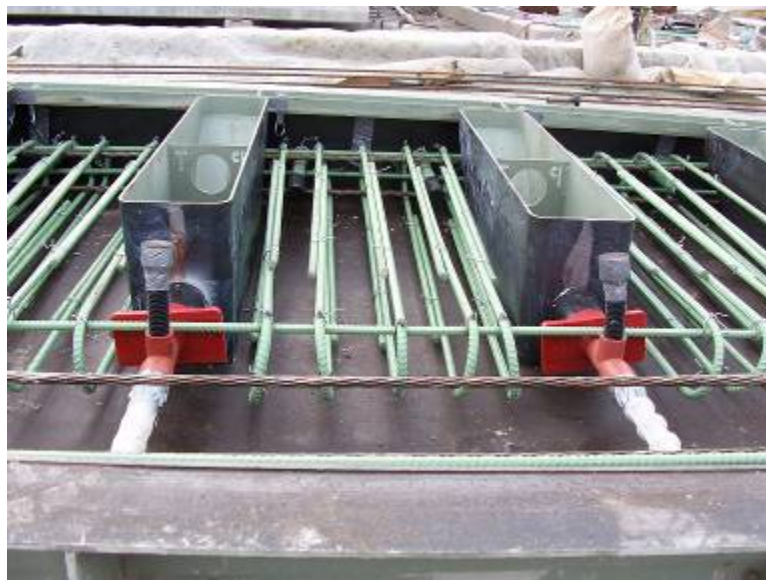
Figure 20. Photo. Post-tensioning duct, anchor, and blockout former in a joint panel.

Encapsulated monostrand anchors were used for the post-tensioning anchors. The anchors were cast into the joint panels and bolted to the post-tensioning blockout formers. Grout ports were located just in front of the anchors and in every 5th base panel along the length of each post-tensioned section of pavement. Trumpeted openings and recesses for the foam gaskets were formed at the ends of the post-tensioning ducts in each panel using machined steel recess formers. Figure 20 shows the post-tensioning duct, anchor, and blockout former used in the joint panels.

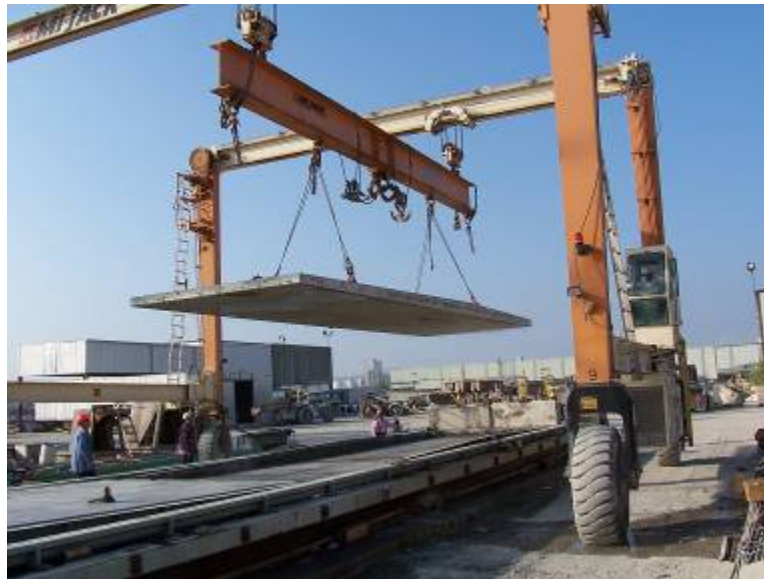
Figure 26. Photo. Removal of a panel from the forms after curing.

The precast panels were removed from the forms and transported to the storage area using a straddle-lift crane, as shown in Figure 26. As per PCI Design Handbook recommendations, a lifting angle (angle between the top surface of the panel and the lifting line) of at least 60 degrees was required in order to minimize bending stresses in the panels when lifted.<sup>(17)</sup> Because a spreader beam was used for lifting the panels at the fabrication plant, this was not a concern. For the joint panels, steel strongbacks (angle steel) were bolted across the expansion joints, using the lifting anchors as bolt-down points, to ensure that expansion joints remained closed during handling and that the dowels were not subjected to bending.

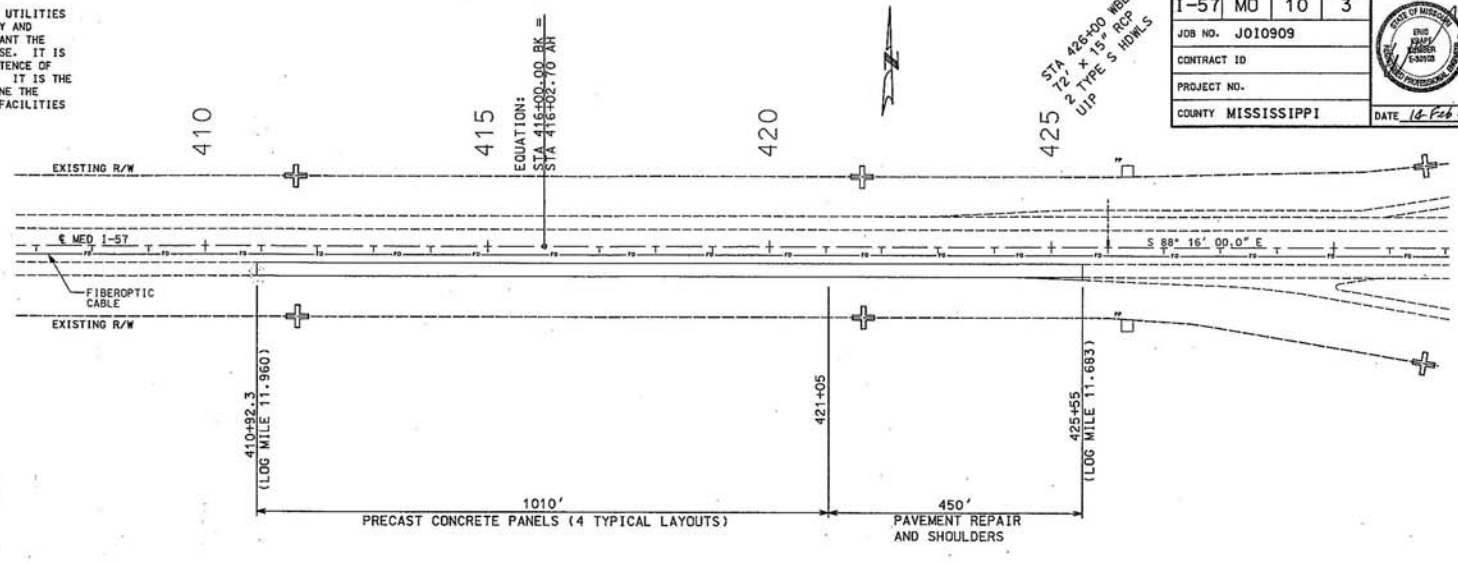
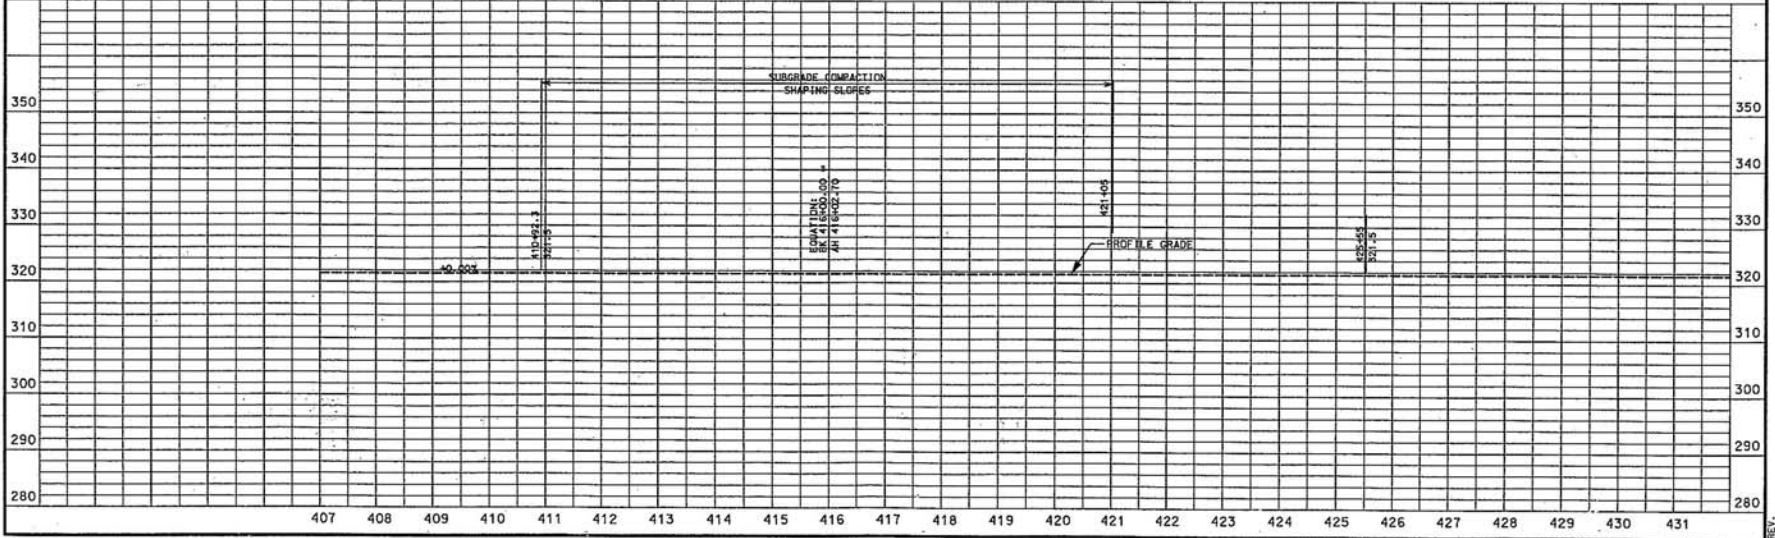
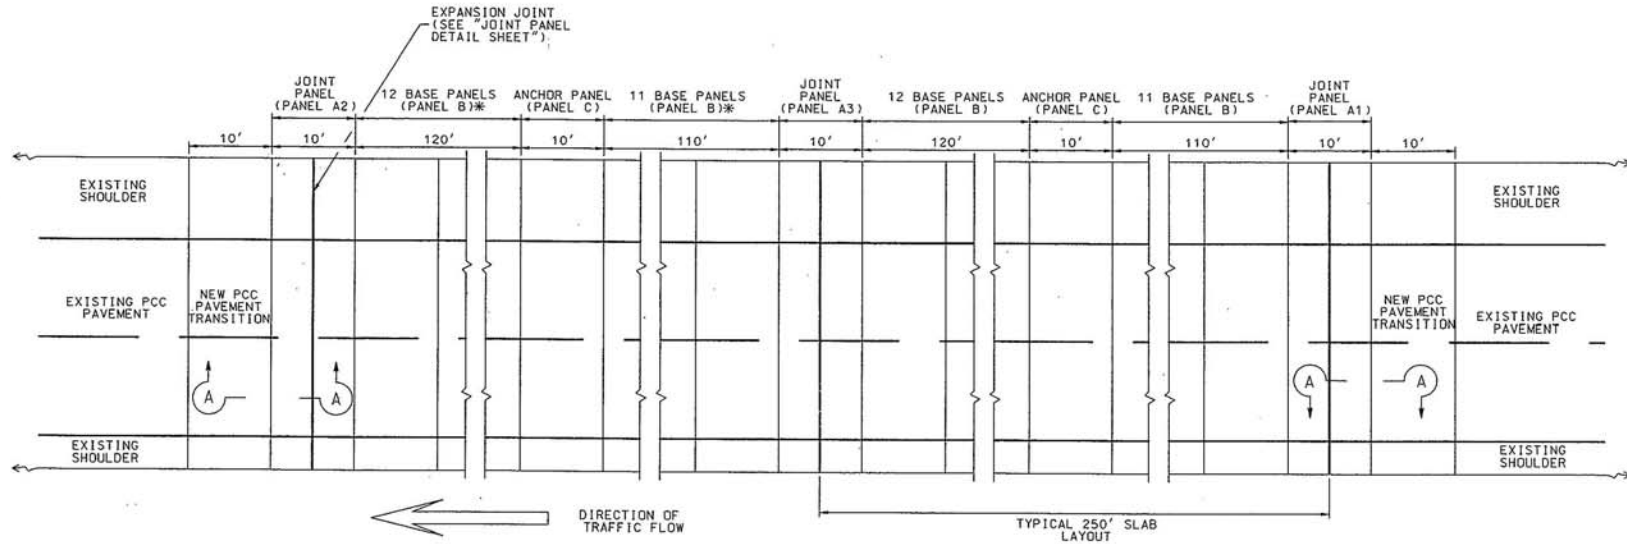
# PRECAST PAVEMENT PANEL LAYOUT AND TIE-IN DETAILS

\* NUMBER OF BASE PANELS MAY BE REDUCED TO STAY WITHIN PROJECT LIMITS. BASE PANELS SHOULD BE EVENLY DISTRIBUTED ON EITHER SIDE OF THE ANCHOR PANEL (TYPE C). TOTAL SLAB LENGTH (BETWEEN EXPANSION JOINTS) SHOULD NOT BE LESS THAN 100 FT.
