## Maintenance of Highway Edgedrains

Robert H. Baumgardner

**February 2002**

The purpose of this paper is to identify maintenance problems with edgedrains and document FHWA attempts at stressing the importance of maintenance to SHA's. A description of the various maintenance problems encountered by SHA's follows.

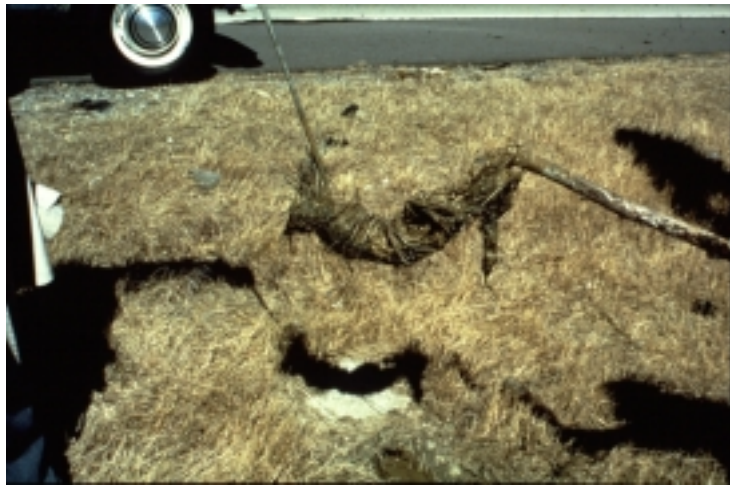
**Photo No. 1 Vegetative Material Removed from an Edgedrain System**

An example of vegetative material removed from an edgedrain is shown in Photo No. 1, while an edgedrain pipe blocked by a rodent's nest is shown in Photo No. 2.

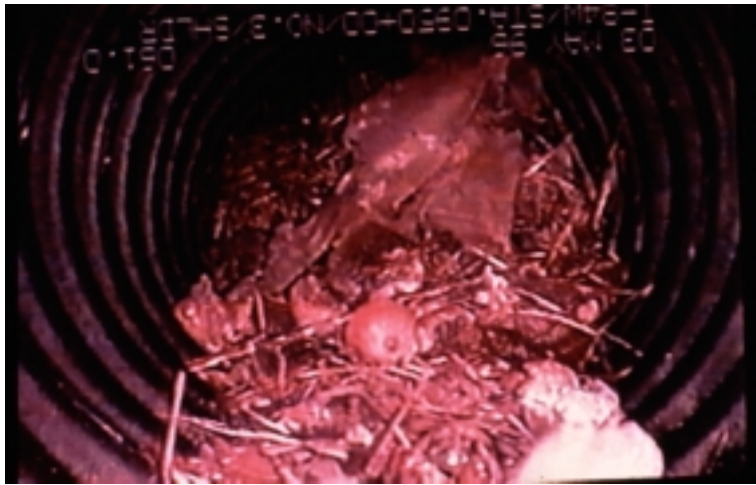
**Photo No. 2 Rodent's Nest**

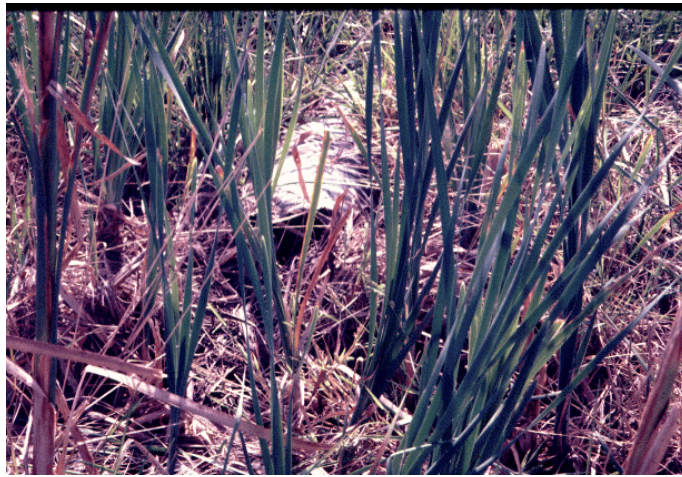
**Photo No. 5 Hidden Outlet Pipe**

Often outlets cannot be found because they are hidden by vegetative growth. Photo No. 5 shows a typical hidden and crushed outlet. Note that there is no headwall.

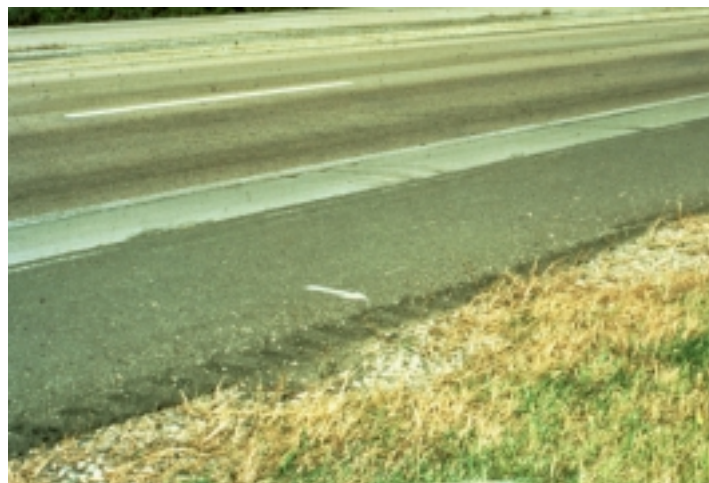
**Photo No. 6 Painted Arrow as a Reference Marker**

It is obvious that if maintenance personnel can not find the outlets, no maintenance can be performed. SHA's that use concrete headwalls, reference markers, signs on fences, reflector disks in the shoulder, or painted arrows on the shoulders have better success in providing maintenance. It is also important that maintenance activities not block or damage the pipe outlet. A simple arrow painted on the edge of the shoulder, as shown in Photo No. 6, is a good reference marker for maintenance personnel.

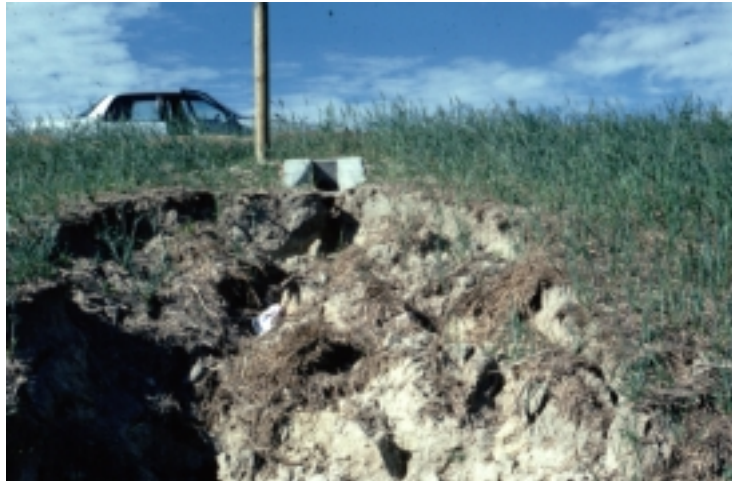
**Photo No. 7 Excessive Erosion at the Outlet Pipe**

One of the purposes of a headwall is to eliminate erosion at the pipe outlet. Unfortunately, excessive erosion at an edgedrain outlet is shown below in Photo No. 7.

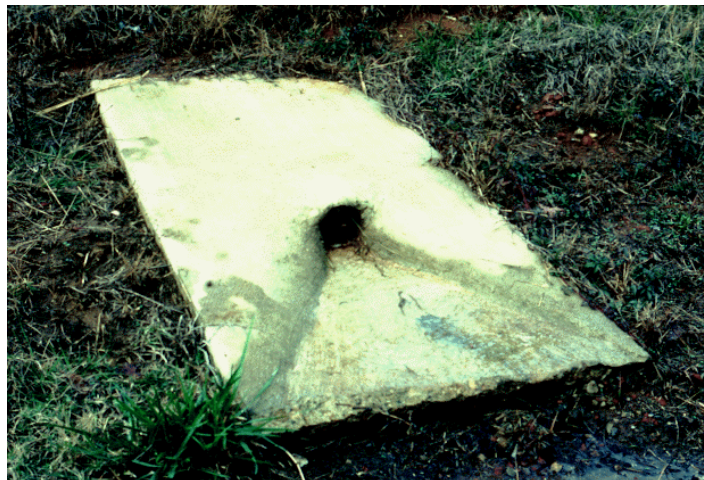
**Photo No. 8 Large Outlet Pipe Headwall**

Larger headwalls, as shown in Figure No.8 have the following advantages:

- \$ Easier for maintenance personnel to locate
- \$ Roadside vegetation located farther away from the outlet pipe.
- \$ Reduce erosion
- \$ Prevents crushing of the outlet pipe.

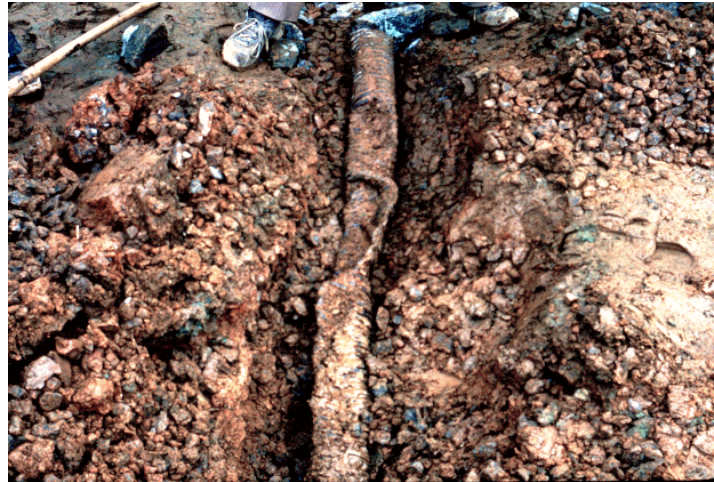
**Photo No. 9 Crushed Edgedrain Pipe**

Photo No. 9 shows a section of edgedrain that has collapsed. This problem was identified by video inspection.

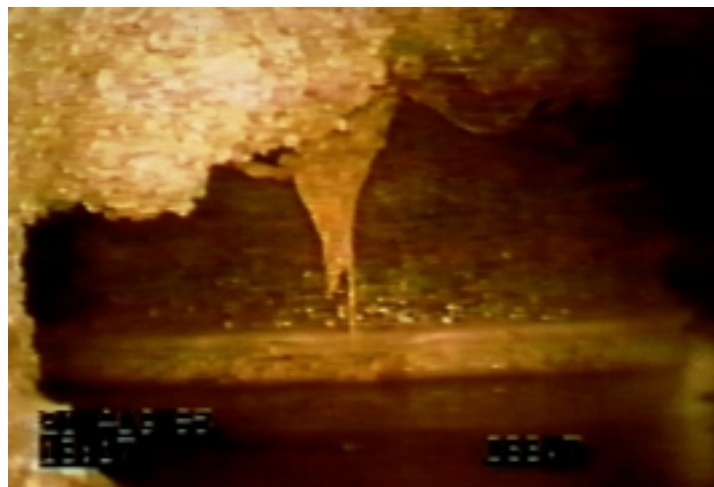
**Photo No. 10 Ninety Degree Tee**

In Photo No. 10, the video inspection camera is approaching the main line longitudinal edgedrain. It will be difficult for the camera to make this turn from the outlet pipe to the edgedrain. It will also be difficult for any cleaning equipment to make the turn. This is why FHWA recommends large radius pipe or a combination of bends to make the turn.

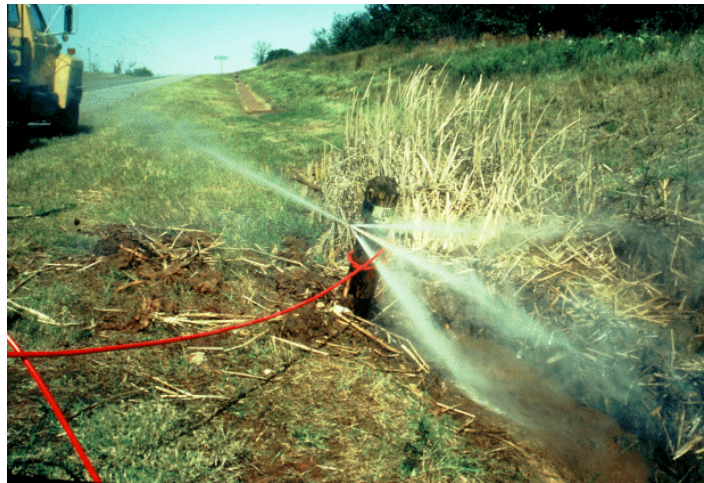
**Photo No. 11 Pipe Flushing Unit**

A pipe flushing unit is shown in Photo No. 11. The water jets point towards the rear of the unit so that the jetting action helps to propel the unit through the pipe.
