Preliminary Evaluation of LTPP Continuously Reinforced Concrete (CRC) Pavement Test Sections

PUBLICATION NO. FHWA/RD-99-086

6. Performing Organization Code	
7. Author(s) Shiraz D. Tayabji, Olga Selezneva, and Y. Jane Jiang		8. Performing Organization Report No.	
9. Performing Organization Name and Address ERES Consultants, Inc. 9030 Red Branch Road, Suite 210 Columbia, Maryland 21045		10. Work Unit No. (TRAIS) C6B

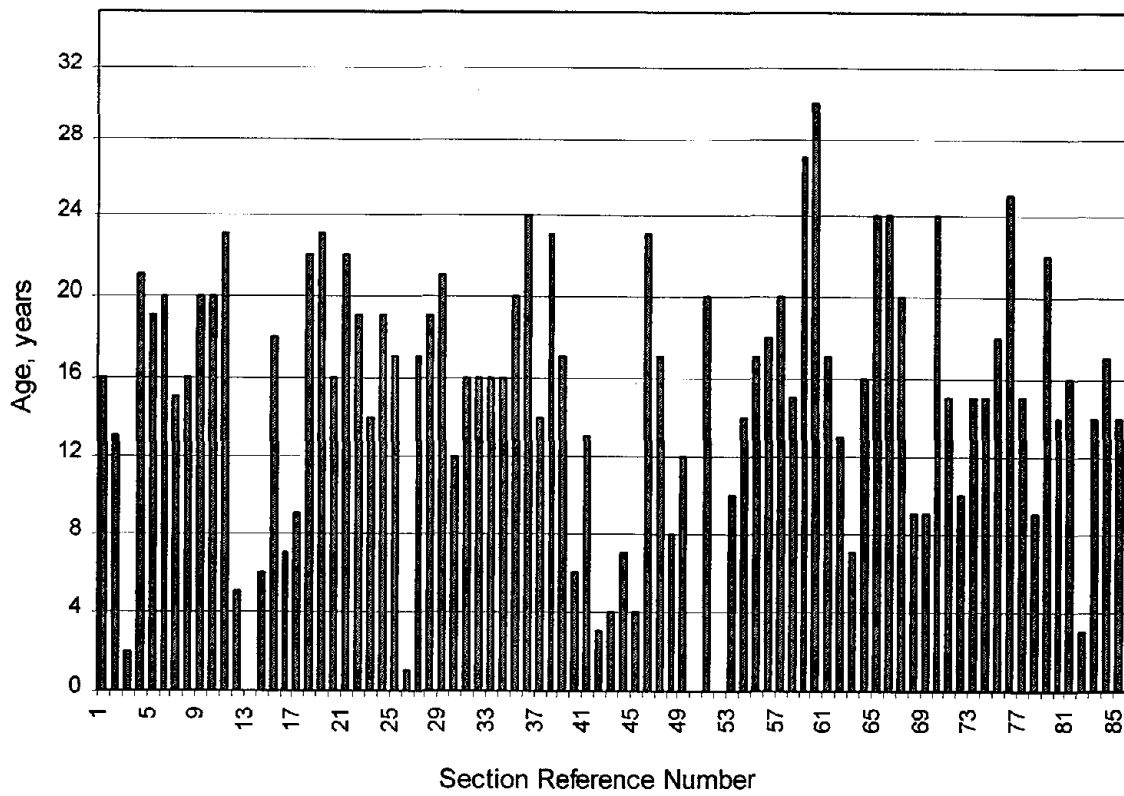
Figure 1. Age as of latest distress survey.

The age for the GPS-5 sections was determined as the difference between the date of the last crack survey and the traffic opening date. Based on this calculation, the age of the test sections ranged from 1 to 30 years. The age summary is given in figure 1. Also, another age calculation was made as of December 31, 1997, as presented in figure 2. As of December 31, 1997, there were 59 sections that were 15 years of age or older and 42 of these sections were 20 years of age or older. With respect to the age at the time of the last distress survey, there were 23 sections that were 20 years of age or older.

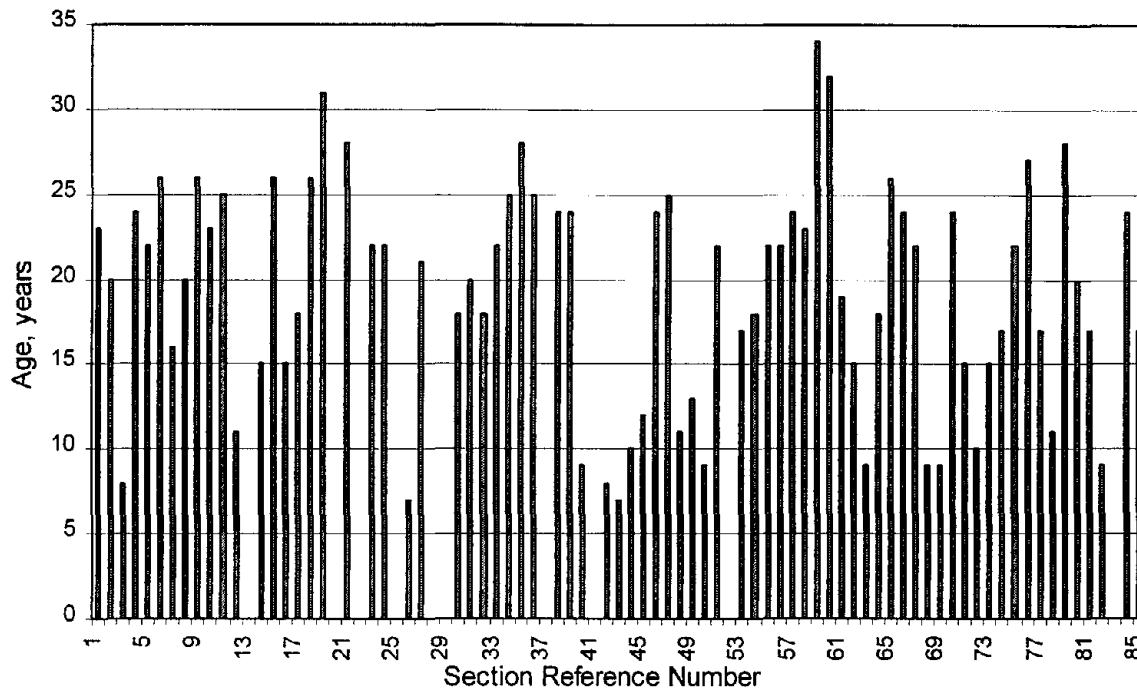
Figure 2. Age as of December 31, 1997.

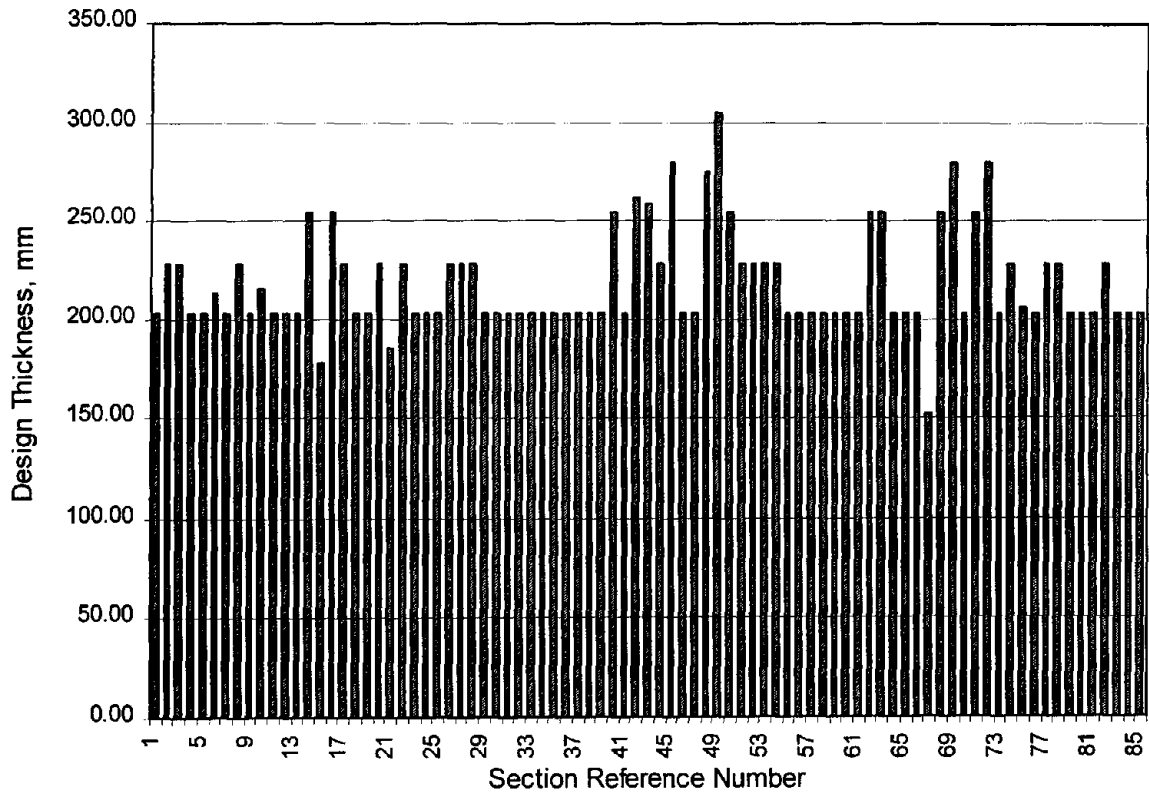
Figure 3. Design slab thickness.

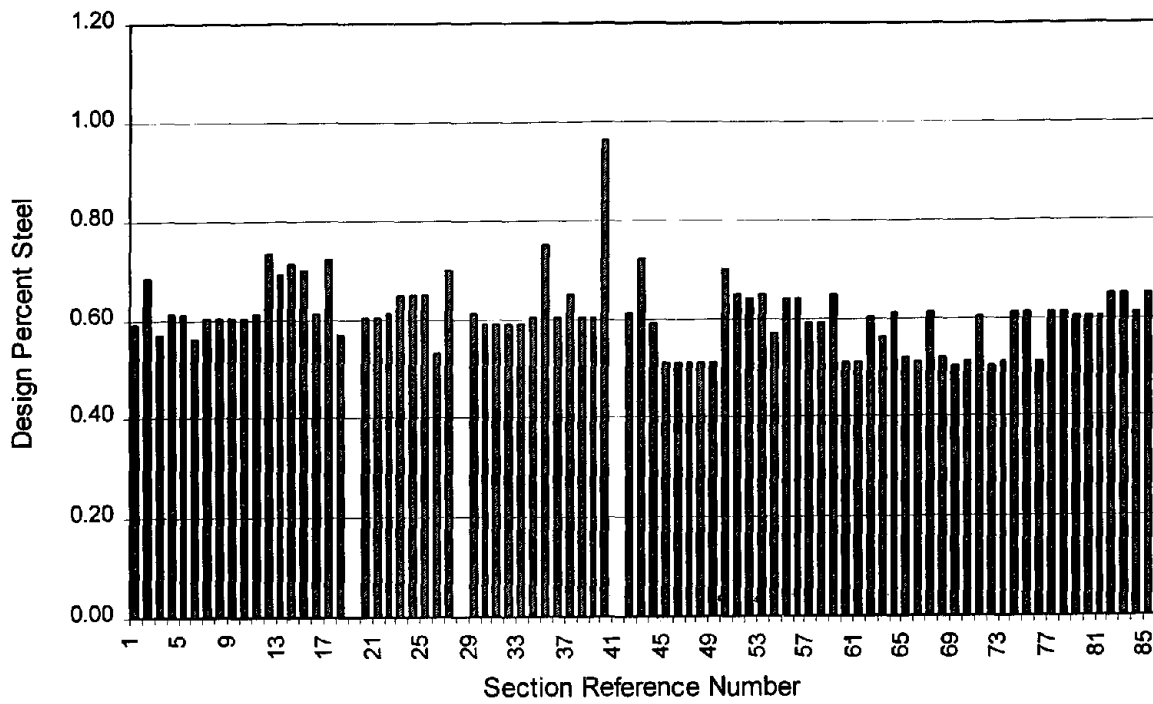
Figure 4. Design percent longitudinal steel.

2. Most sections have 0.62 percent or less longitudinal steel. Only 10 sections had steel equal to or greater than 0.7 percent. Fifteen sections had steel equal to or less than 0.5 percent.
3. Depth of longitudinal reinforcement was generally greater than 75 mm.
4. Spacing of longitudinal bars was generally more than 150 mm.
5. Where transverse bars were used, bar spacing was generally greater than 600 mm.

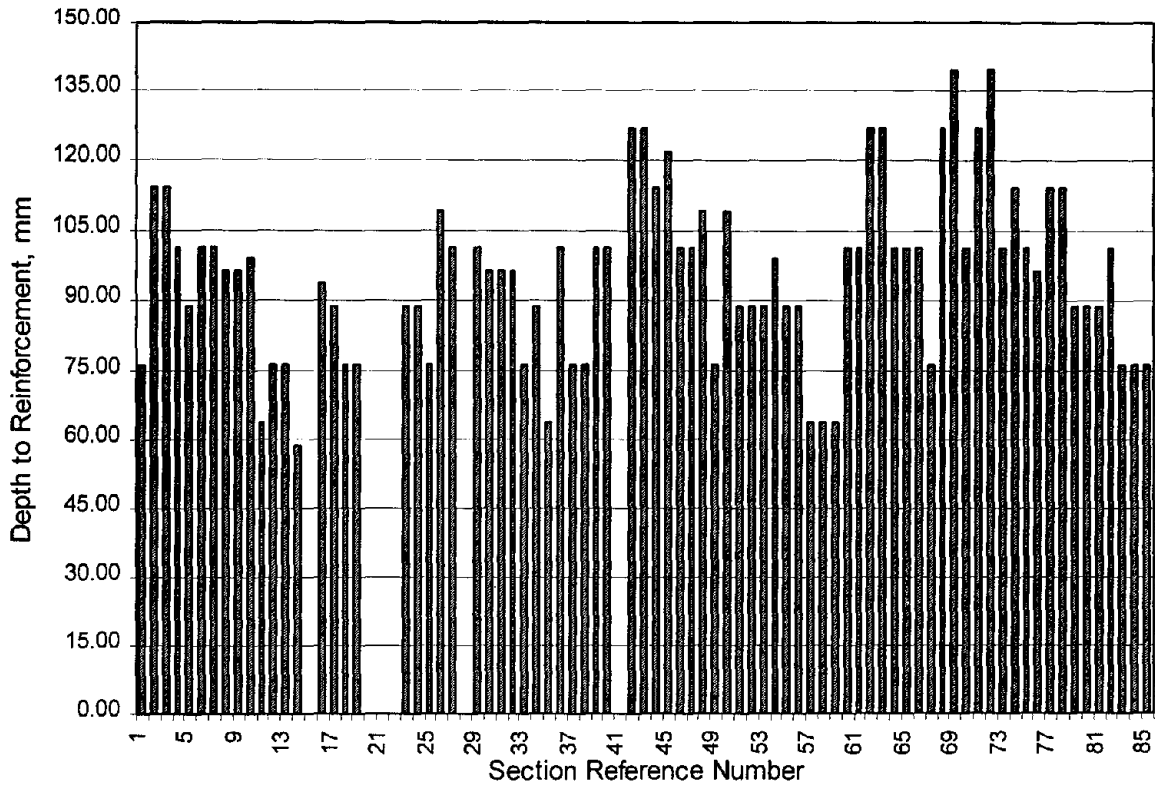
Figure 5. Depth to longitudinal reinforcement.

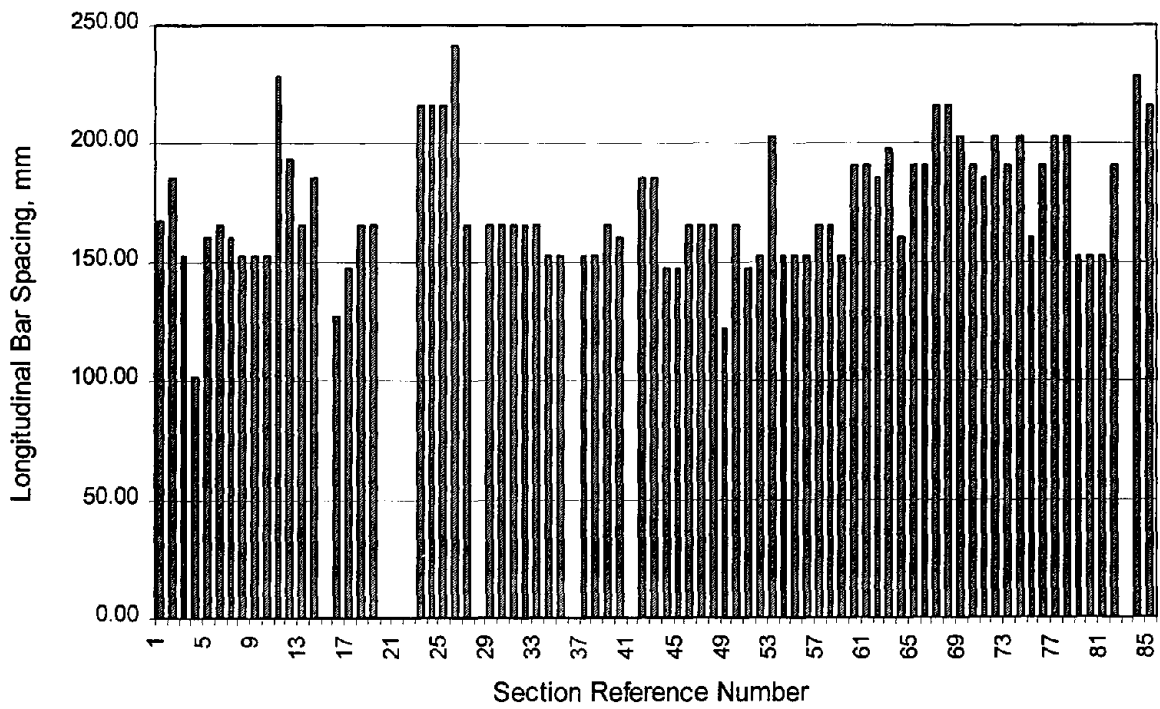
Figure 6. Longitudinal bar spacing.

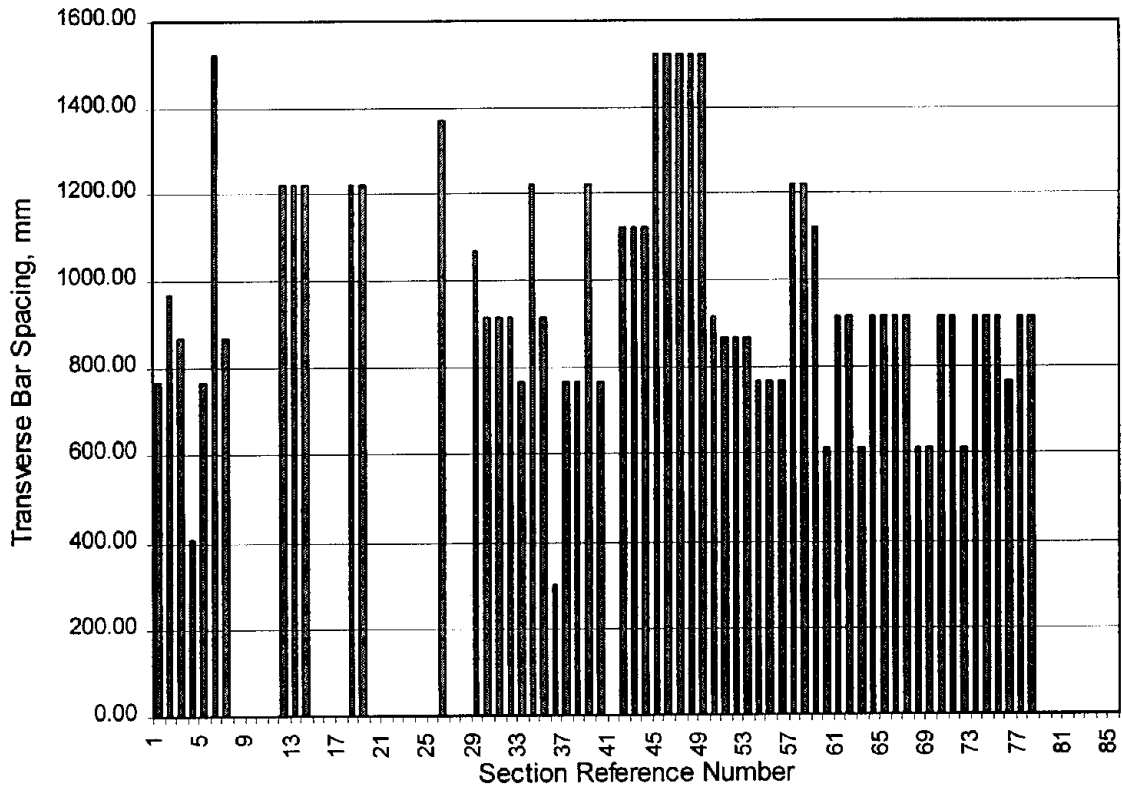
Figure 7. Transverse bar spacing.

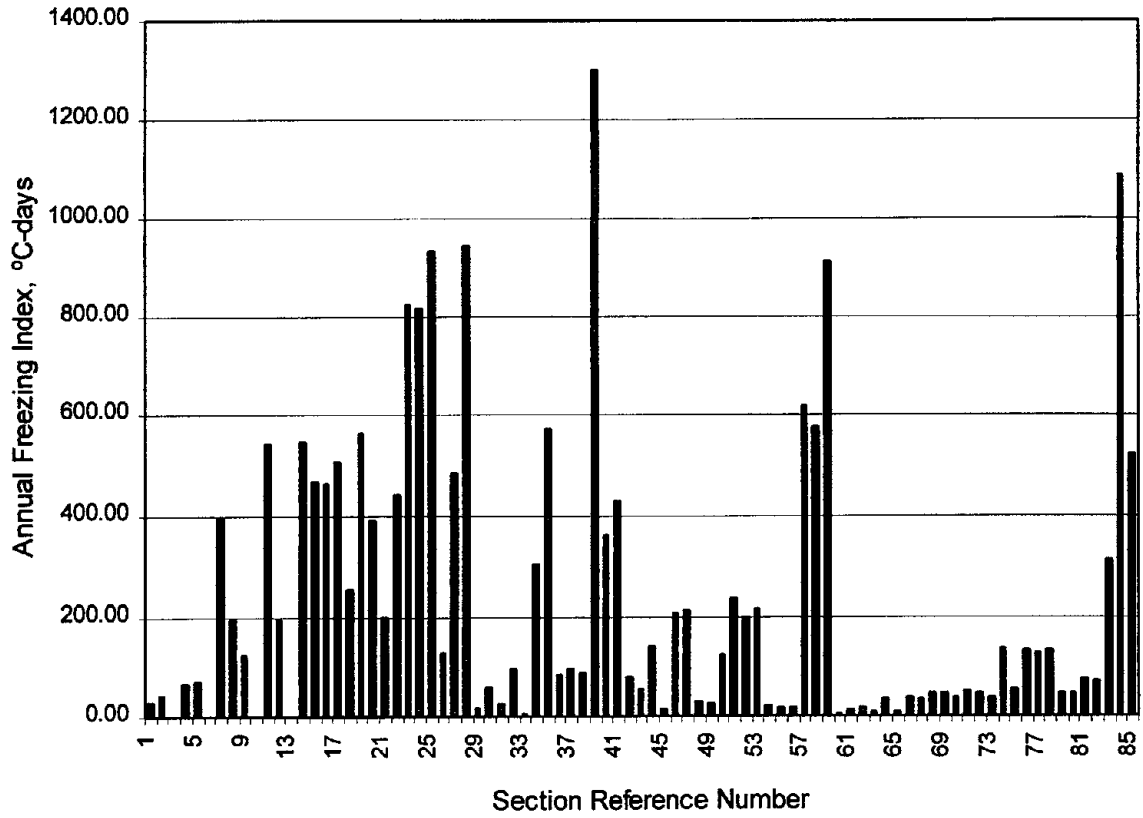
Figure 8. Annual freezing index summary.

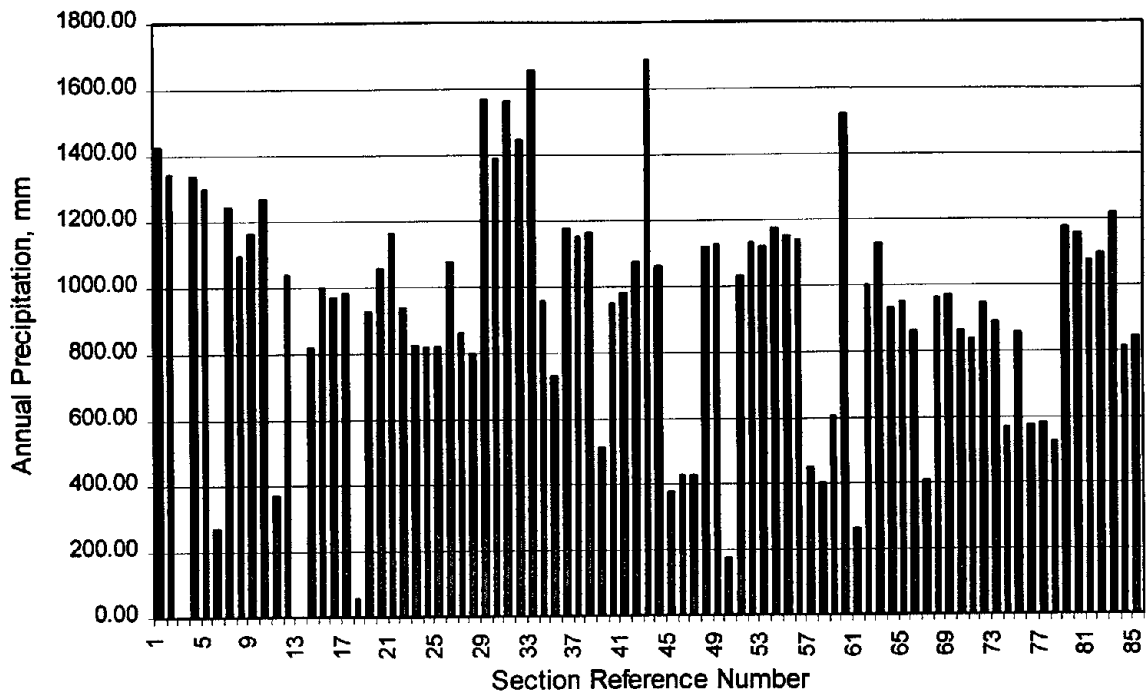
Figure 9. Annual precipitation summary.

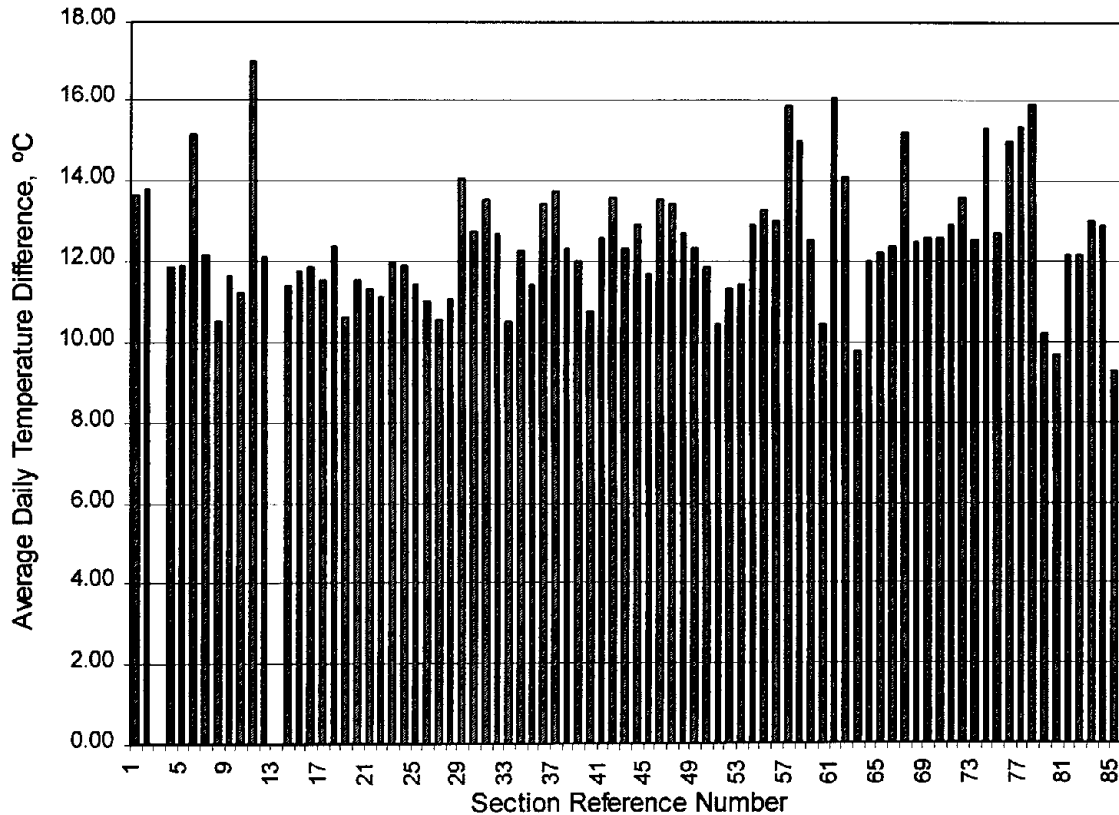
Figure 10. Average daily temperature range.

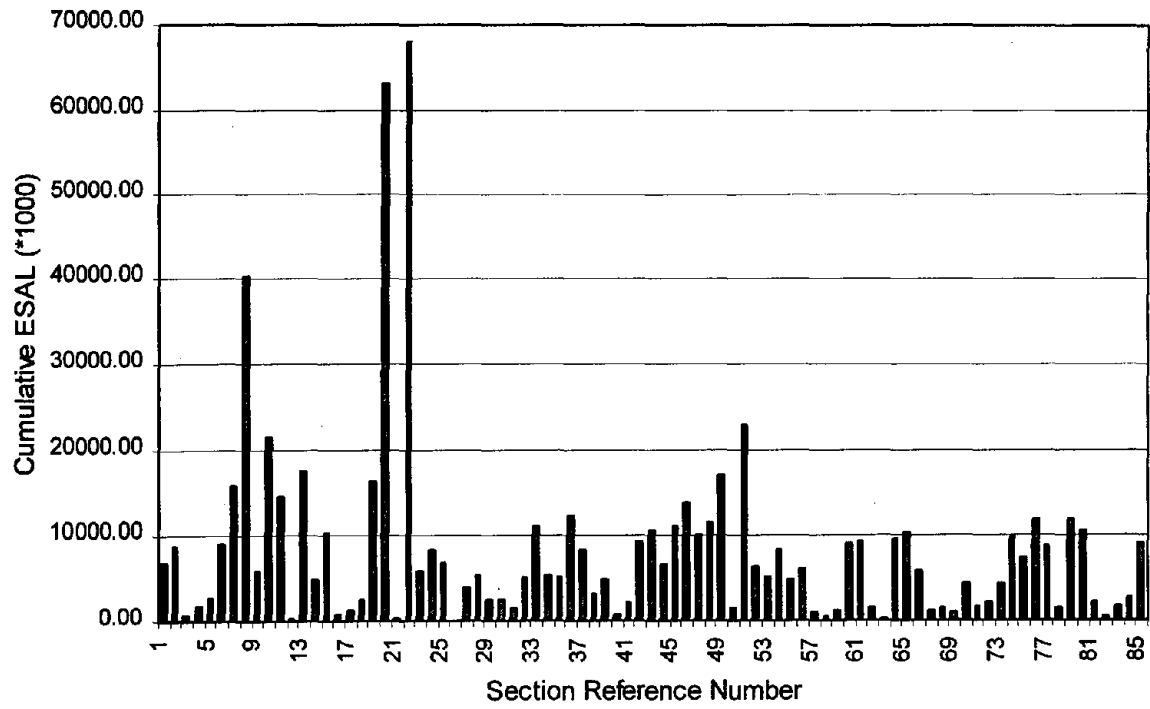
Figure 11. Cumulative ESAL summary.

Section 24-5807 had no traffic data and was therefore not considered in subsequent analyses. A summary of the ESAL data is given in figure 11.

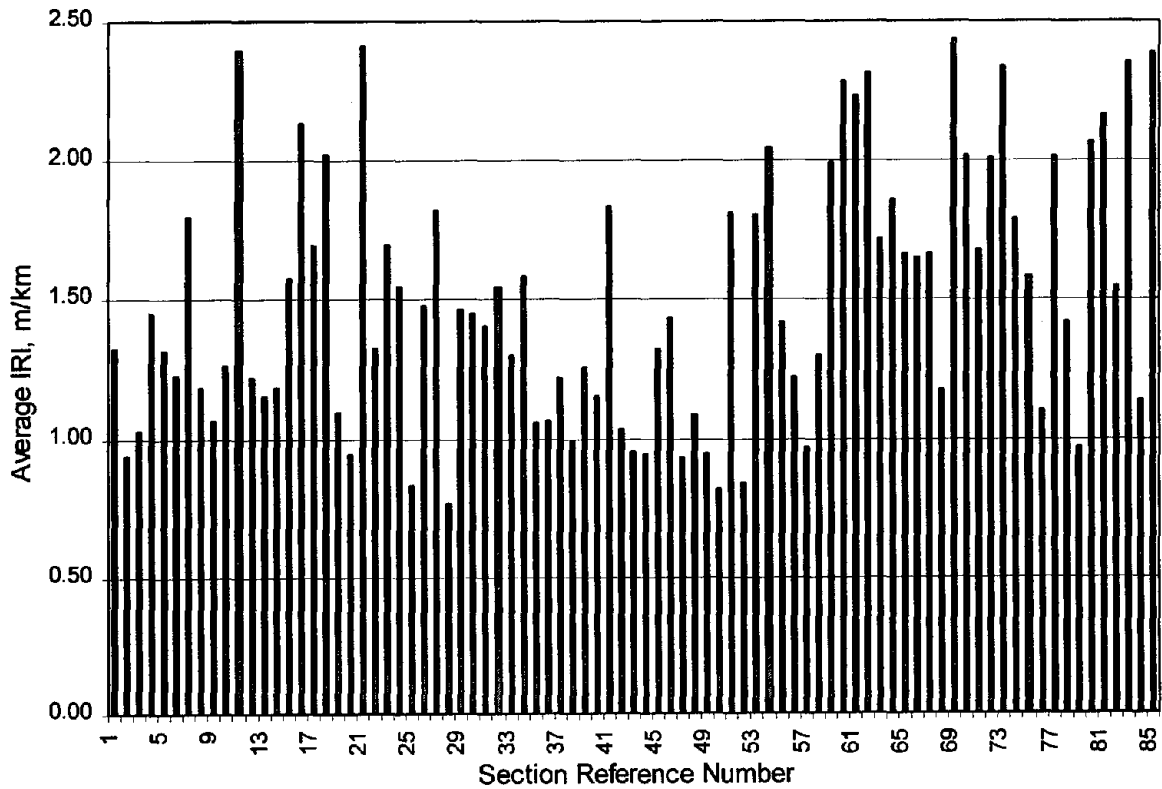
Figure 12. Average IRI summary.

International Roughness Index (IRI) is one of the indices used in the LTPP program for characterization of pavement section roughness. IRI values determined at different test times over the years are available in the database. Values at times that correspond to the latest distress survey dates were used for characterization of profile condition of pavement sections. A summary of IRI data is given in table 5 and figure 12. The IRI values for GPS-5 sections ranged from about 0.7 to 2.4 m/km, with a large number of sections exhibiting IRI values less than 1.8 m/km. Considering the service lives of the CRC sections in the GPS-5 experiment, the CRC pavements are exhibiting good ride characteristics.

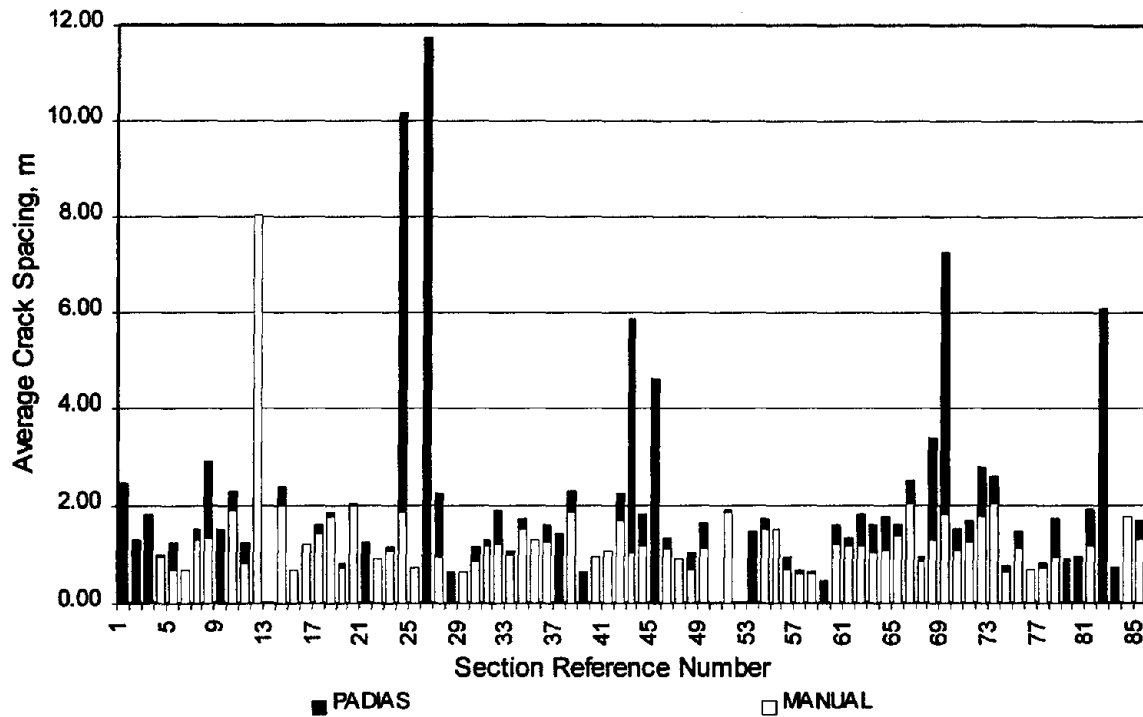
Figure 13. Average crack spacing.

Average transverse crack spacing was calculated by dividing the length of the section by the total number of cracks. The total number of localized failures was found as a summation of the total number of rigid and flexible patches and punchouts. Table 5 gives a summary of GPS-5 distress survey data. Generally, PADIAS surveys predicted larger crack spacings compared to the manual survey, as shown in figure 13. The crack spacing shown in figure 13 is based on the most recent surveys listed in table 5. Overall, the average crack spacing for the GPS-5 test sections was found to be about 1.2 m (4 ft) based on manual surveys. It appears that the photographic procedure fails to adequately identify all low-severity transverse cracking.

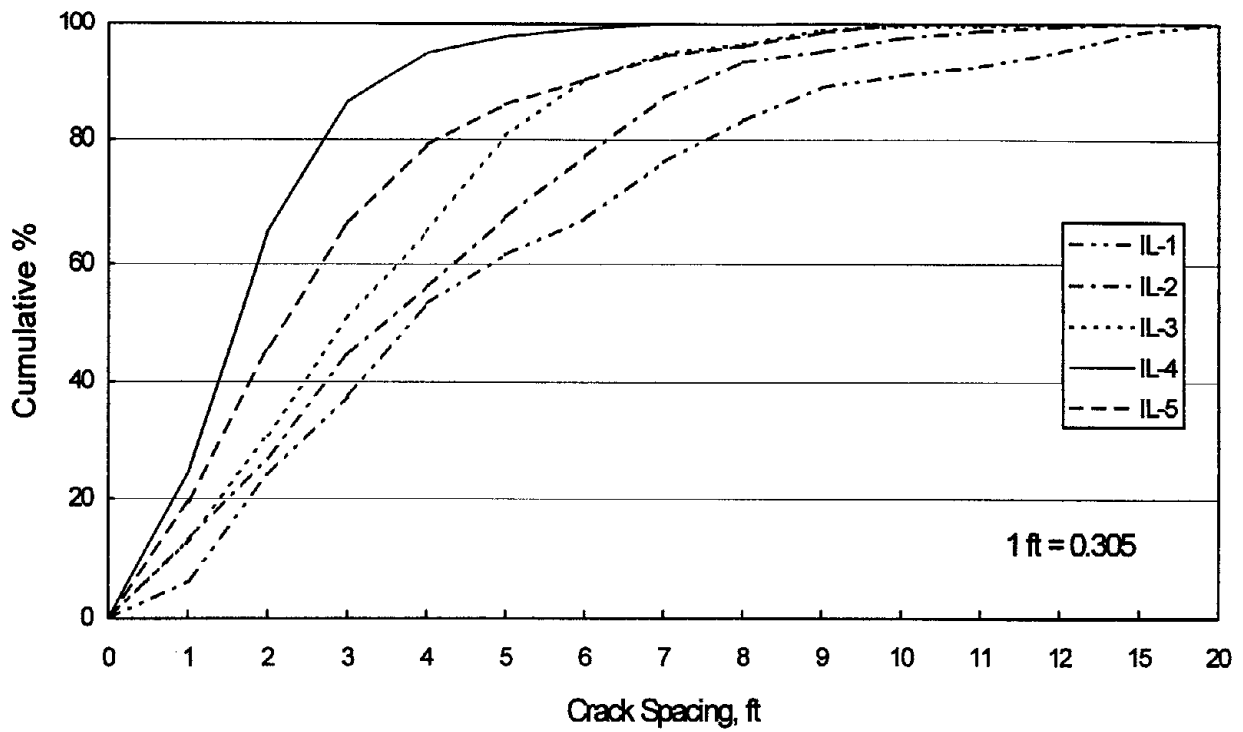
Figure 14. Typical crack spacing distribution plot for a CRC pavement³.

Another data type that is currently not available is the data on individual crack spacing. Without this data, analysis of the characteristics of the crack spacing pattern is not possible. Previous studies have shown that frequency distribution curves for crack spacing and plots of “average spacing of the closest five cracks” (ASCFC) can be useful in understanding the behavior of CRC pavements and in determining potential areas of future localized failures. The ASCFC plots can identify poor crack spacing patterns within a section of CRC pavements. Cluster cracking areas and areas with large crack spacings can be easily identified. Wide crack spacing can result in premature crack spalling and “companion” punchouts at the location of wide cracks. Typical frequency distribution curves and the plots of ASCFC are shown in figures 14 and 15. It is believed that in the future, the interpretation of distress data will also include data on individual crack spacing along the 152.4-m length of each GPS-5 test section. Future analysis of the CRC pavements will also benefit if actual distress survey maps are made available to the analysts. Then it would be possible to relate the locations of the failures to crack spacing characteristics at these locations.

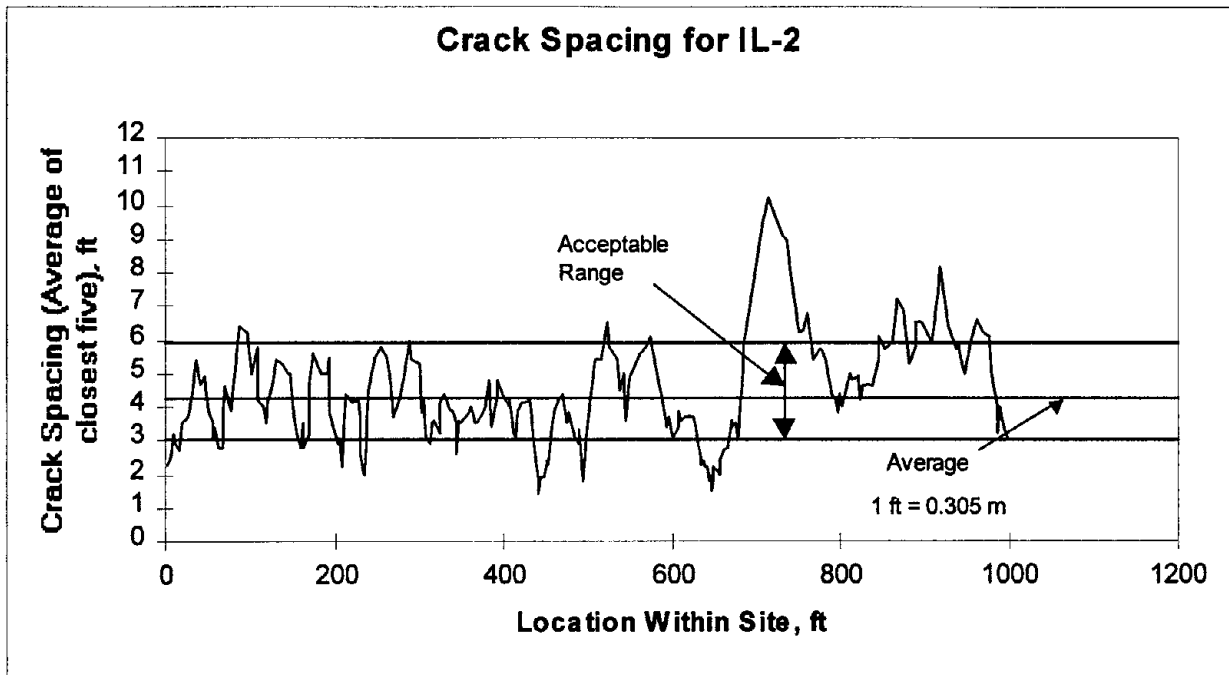
Figure 15. Typical plot of ASCFC for a CRC pavement³.

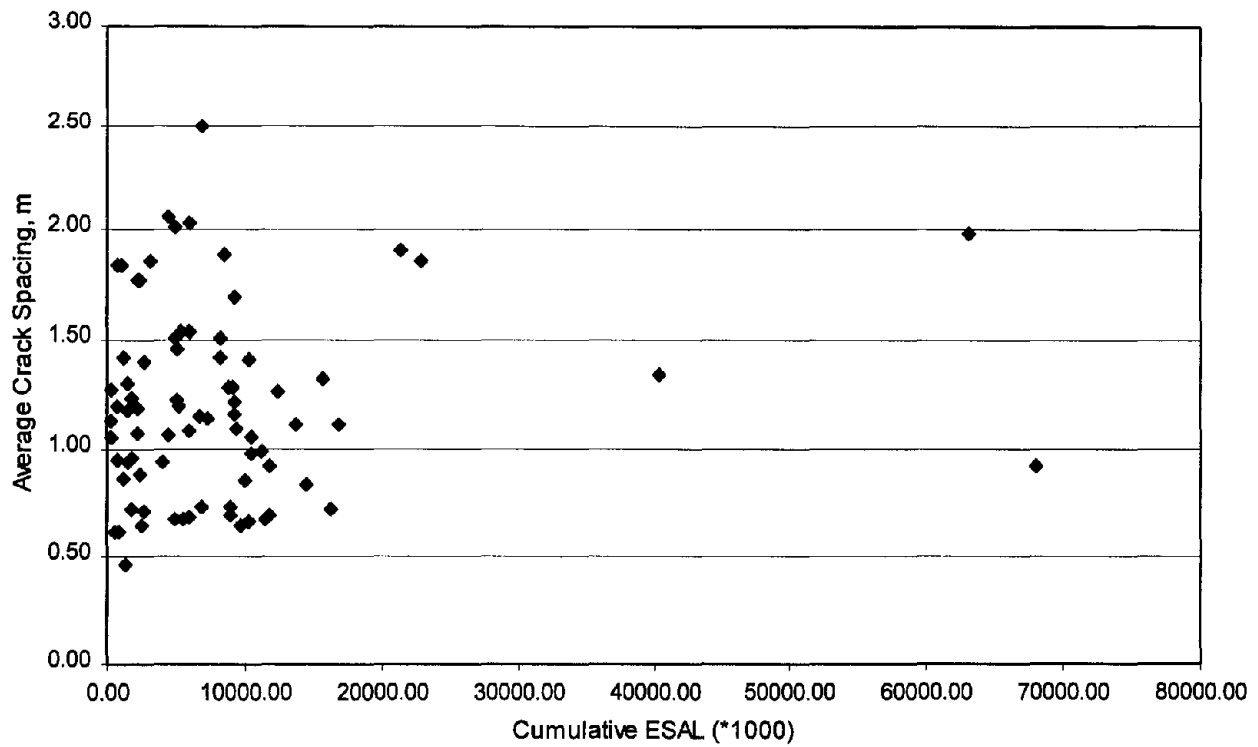
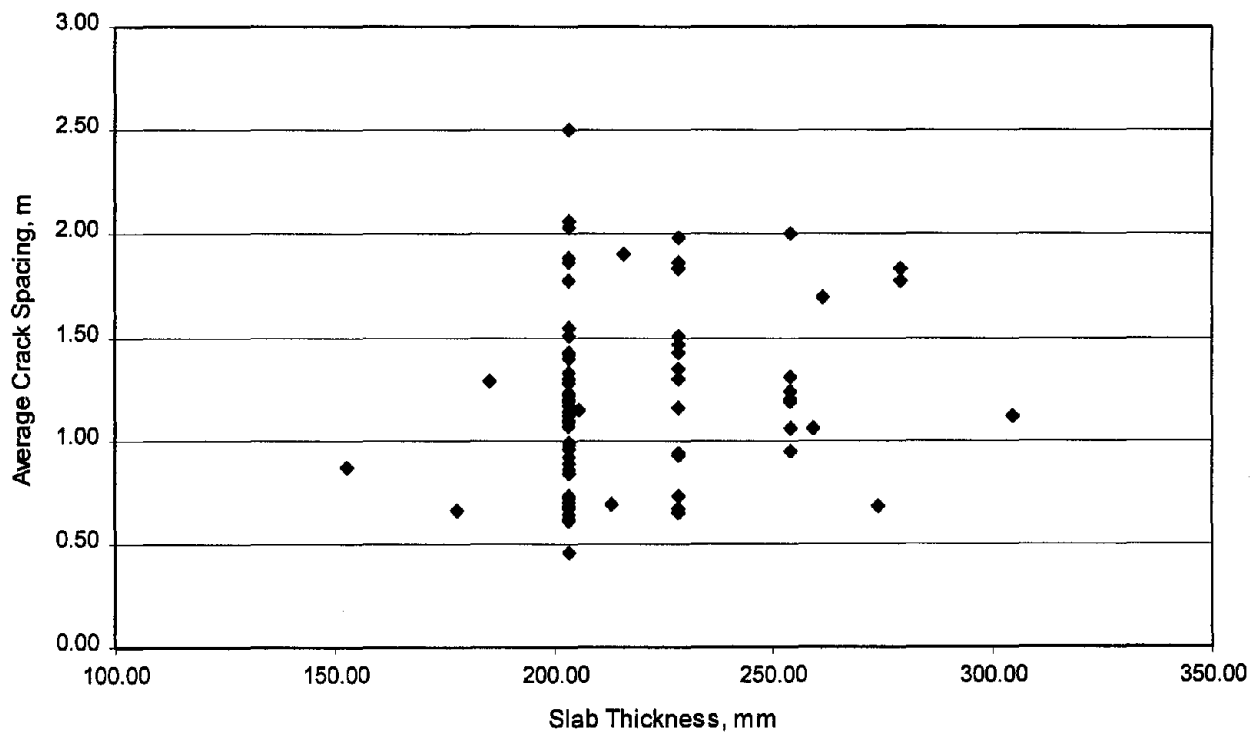
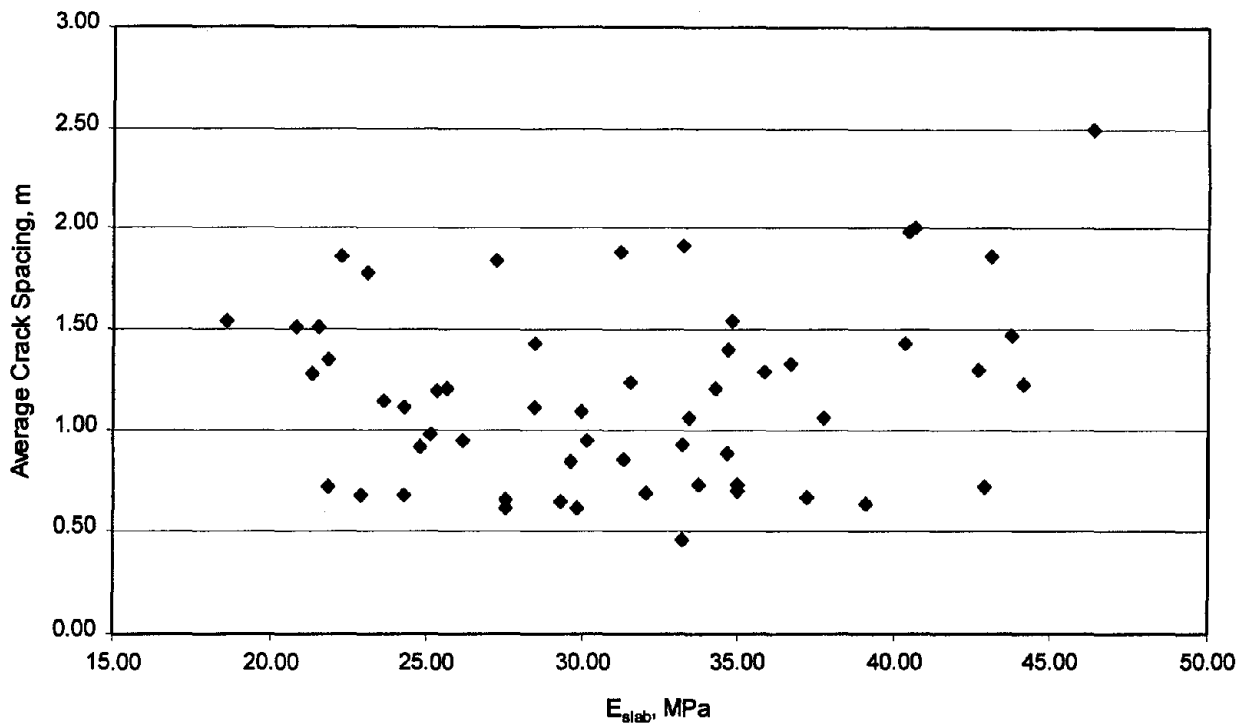
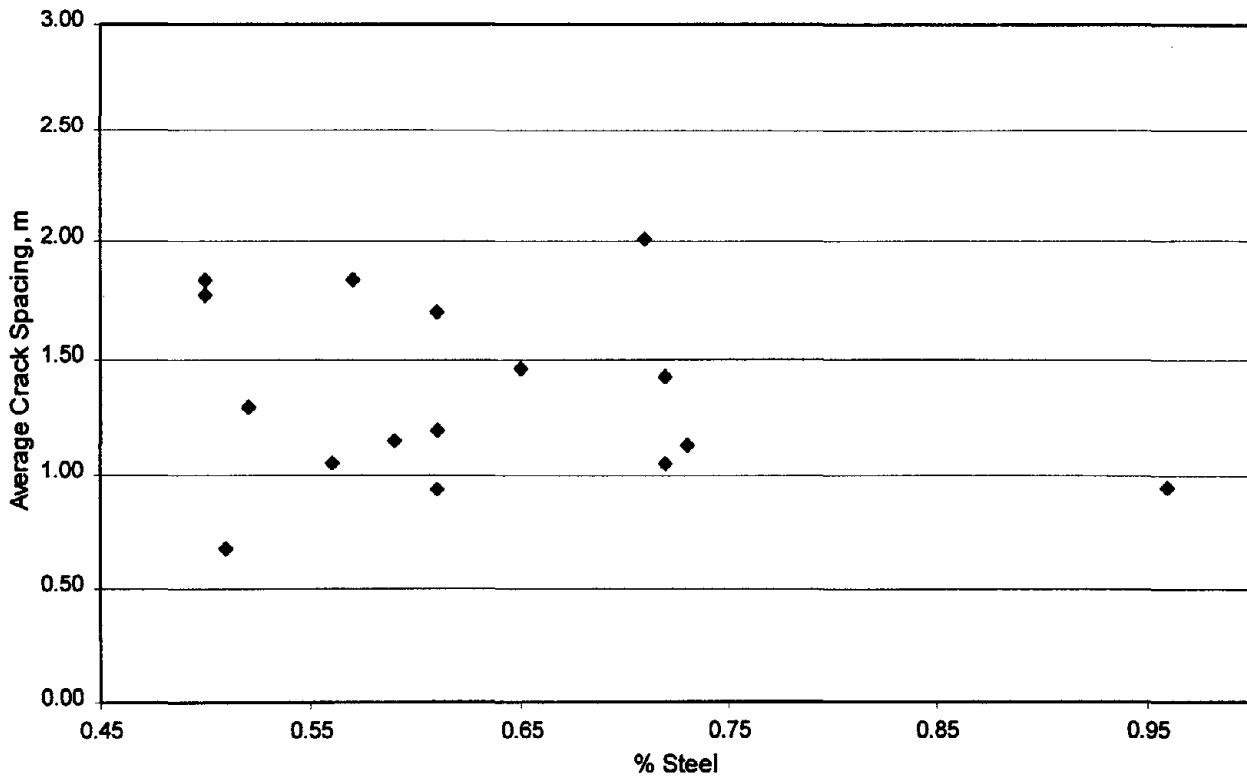
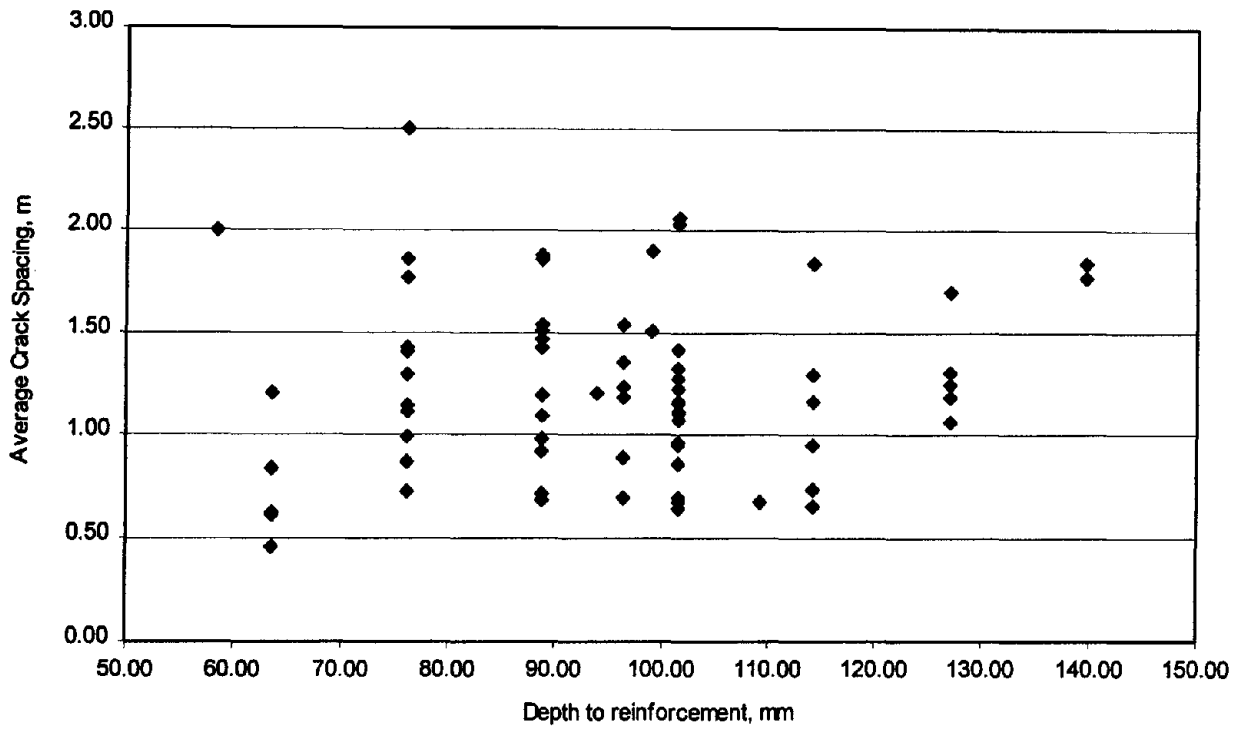
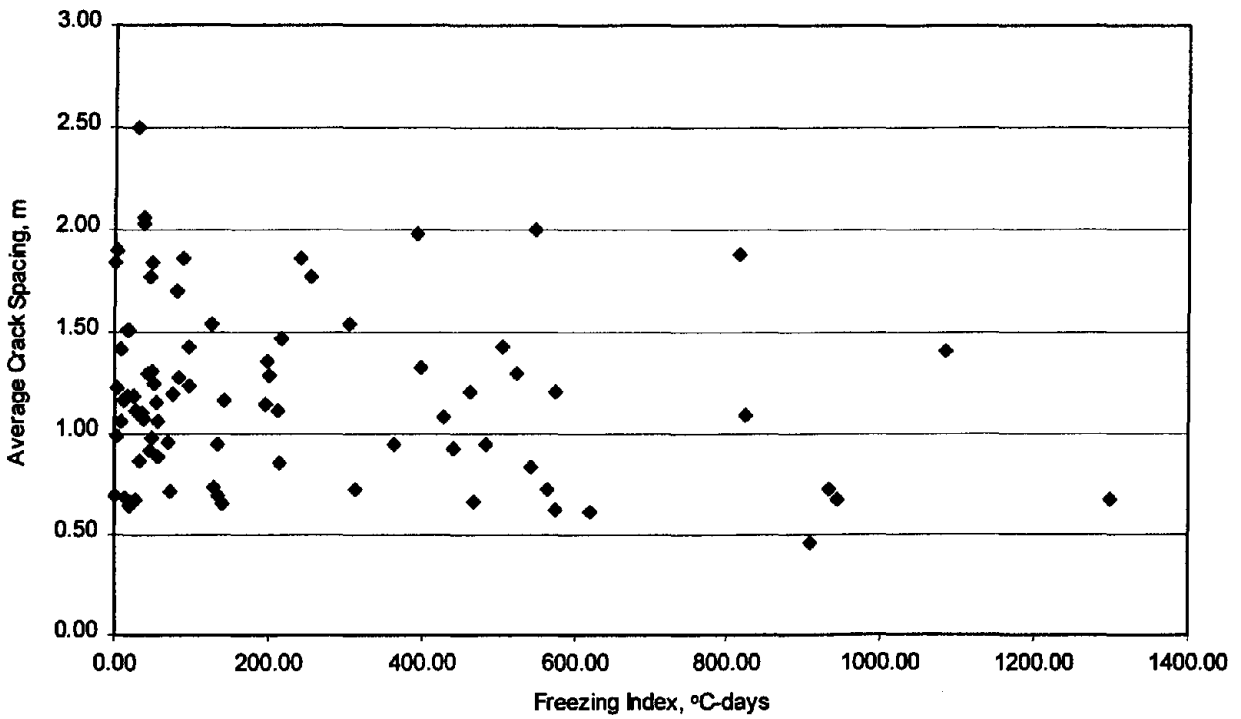
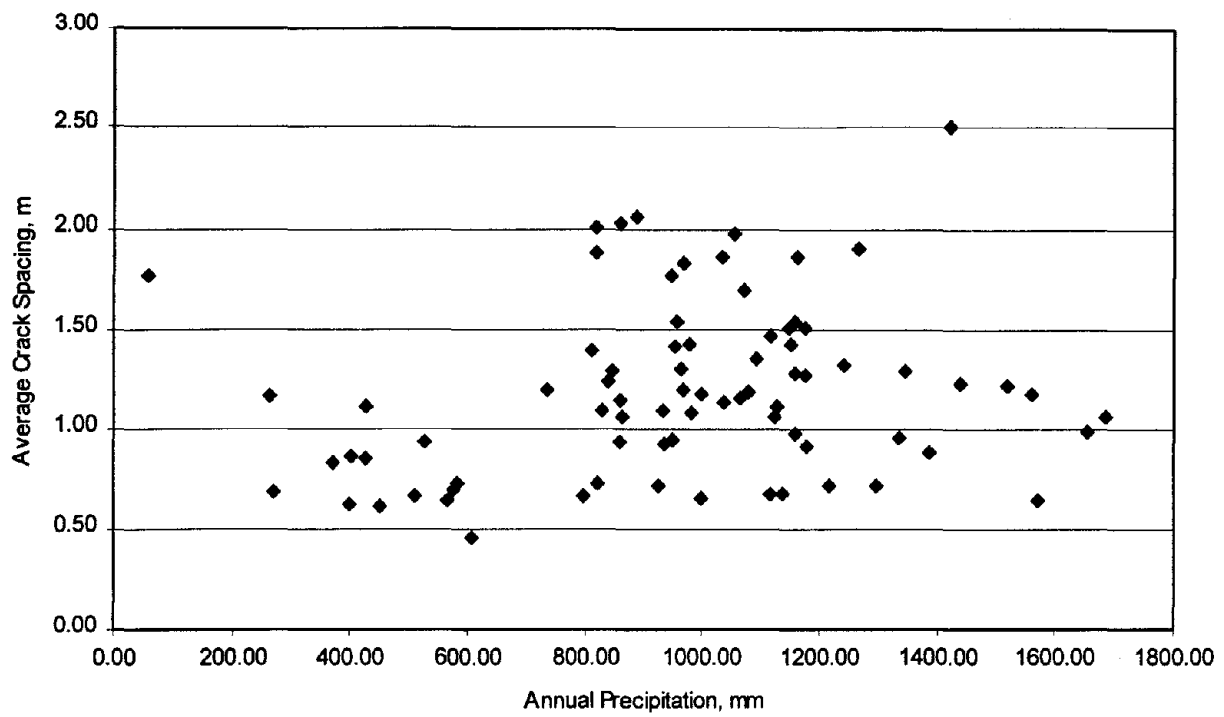
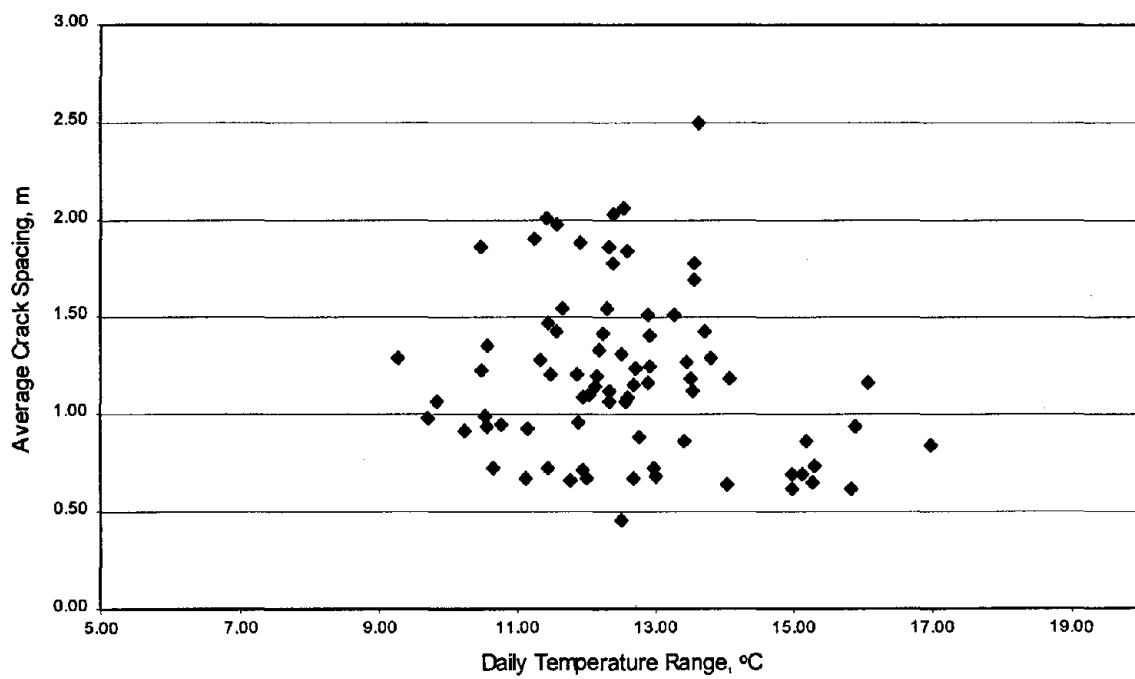
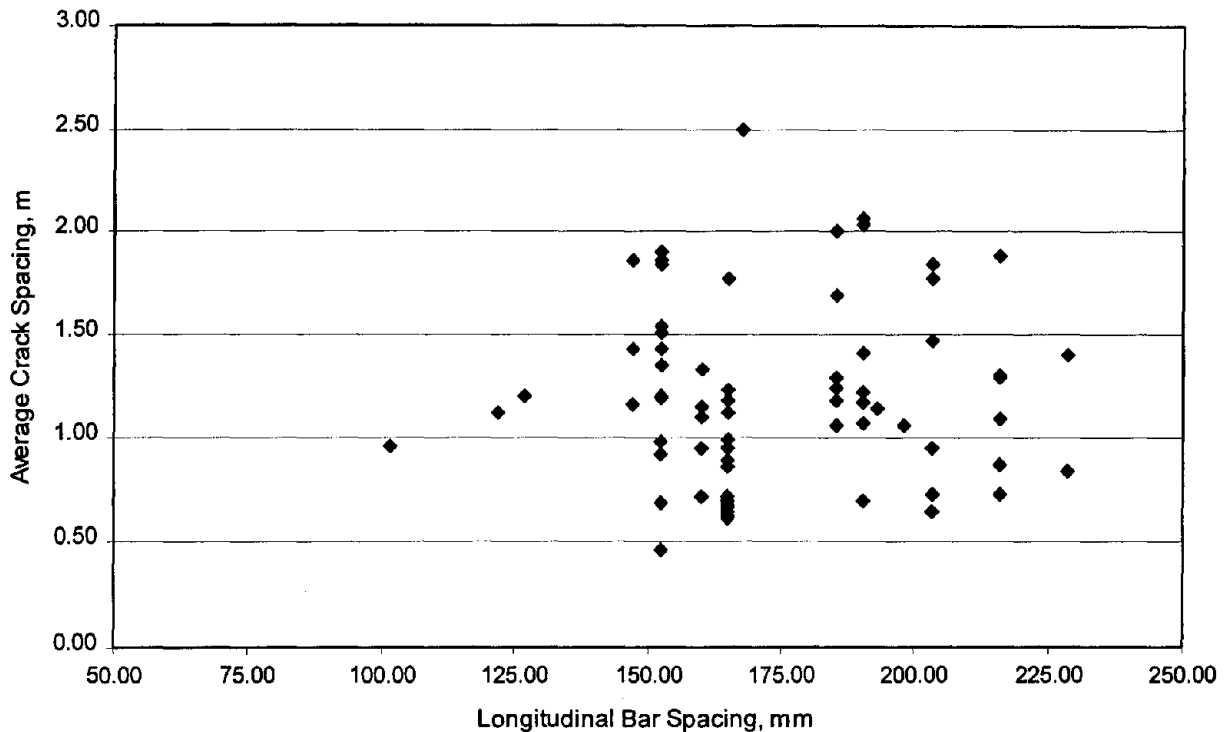
Figure 16. Crack spacing versus age.

Figure 17. Crack spacing versus cumulative ESALs.

Figure 18. Crack spacing versus slab thickness.

Figure 19. Crack spacing versus concrete modulus of elasticity, E_{slab} .

Figure 20. Crack spacing versus percent longitudinal steel.

Figure 21. Crack spacing versus percent longitudinal steel (age < 10 years).

Figure 22. Crack spacing versus percent longitudinal steel (age > 10 years).

Figure 23. Crack spacing versus depth to longitudinal reinforcement.

Figure 24. Crack spacing versus annual air freezing index.

Figure 25. Crack spacing versus annual precipitation.

Figure 26. Crack spacing versus average daily temperature range.

Figure 27. Crack spacing versus longitudinal bar spacing.

- Figure 16 – Crack spacing versus age.
- Figure 17 – Crack spacing versus cumulative ESALs.
- Figure 18 – Crack spacing versus slab thickness.
- Figure 19 – Crack spacing versus concrete modulus of elasticity.
- Figure 20 – Crack spacing versus percent longitudinal steel.
- Figure 21 – Crack spacing versus percent longitudinal steel (age < 10 years).
- Figure 22 – Crack spacing versus percent longitudinal steel (age > 10 years).
- Figure 23 – Crack spacing versus depth to longitudinal reinforcement.
- Figure 24 – Crack spacing versus annual air freezing index.
- Figure 25 – Crack spacing versus annual precipitation.
- Figure 26 – Crack spacing versus average daily temperature range.
- Figure 27 – Crack spacing versus longitudinal bar spacing.

It is seen from a review of figures 16 through 27 that no clear trends are evident on the basis of bi-variate analysis of the data. The long-term crack spacing pattern, as represented by average crack spacing, is dependent on the interactions of possibly all of the independent variables considered together with the ambient conditions during the first few days of construction. As such, an understanding of the effect of the variables noted would have to consider the interactions and the confounding effects of each of the variables. One method to account for these effects is to use multiple regression analysis. A limited effort was made to determine if robust explanatory models could be developed for crack spacing using linear regression analysis. However, the results were not promising (low coefficient of correlations) and no further effort was devoted to this activity. Use of empirical analysis was not part of the scope of the study and the results are therefore not reported here.
