Preliminary Evaluation of LTPP Continuously Reinforced Concrete (CRC) Pavement Test Sections

PUBLICATION NO. FHWA/RD-99-086

6. Performing Organization Code	
7. Author(s) Shiraz D. Tayabji, Olga Selezneva, and Y. Jane Jiang		8. Performing Organization Report No.	
9. Performing Organization Name and Address ERES Consultants, Inc. 9030 Red Branch Road, Suite 210 Columbia, Maryland 21045		10. Work Unit No. (TRAIS) C6B

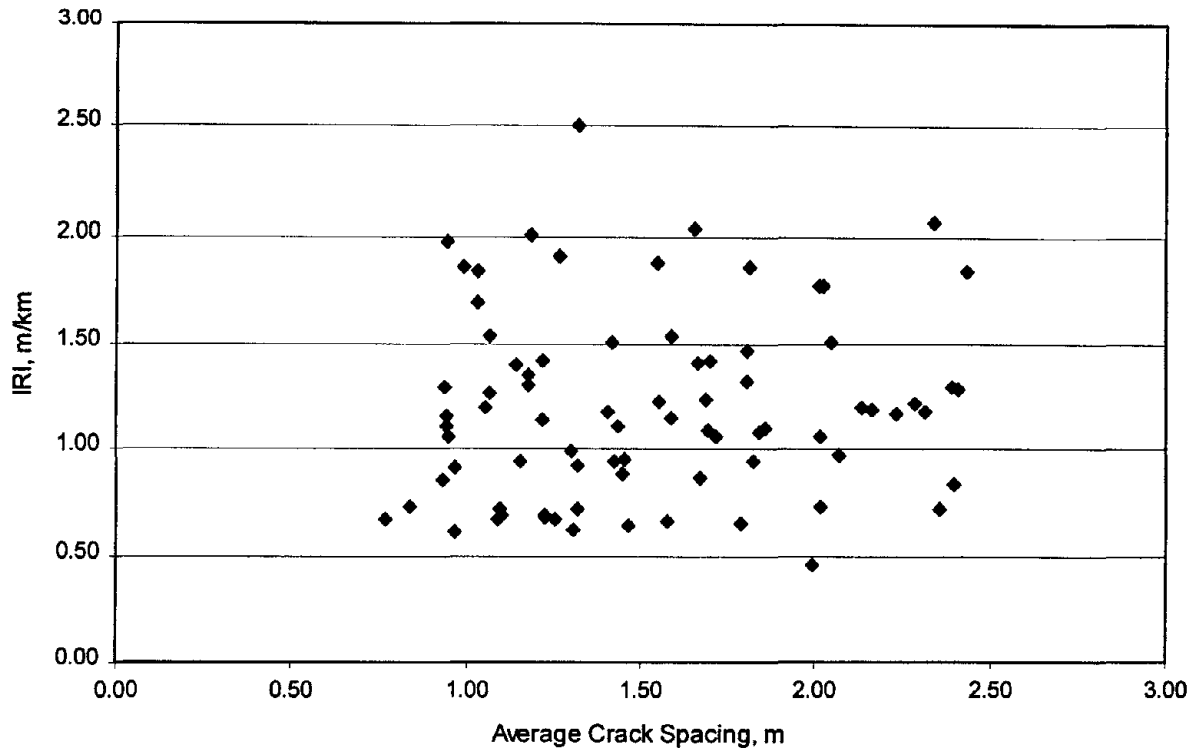
Figure 28. Effect of crack spacing on IRI.

The effect of transverse cracking on ride is shown in figure 28. No clear trends are apparent. This is possibly due to not considering the influence of initial roughness. It should be noted that previous studies have indicated that initially smooth (as-constructed) CRC pavements generally remain smooth, and rough (as-constructed) CRC pavements tend to become rougher with time.

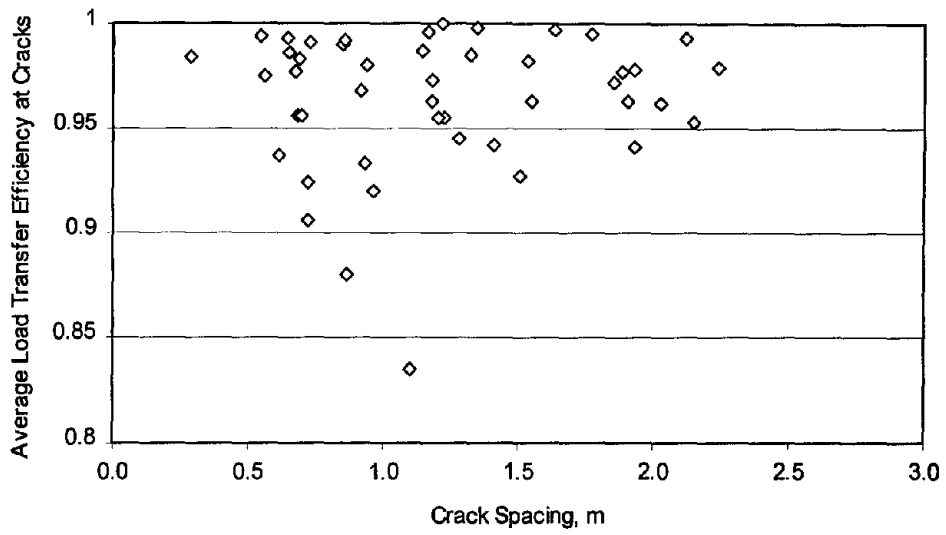
Figure 29. Average load transfer efficiency at cracks versus crack spacing.

To determine the relationship between crack spacing and deflections as measured by the falling-weight deflectometer (FWD), average crack spacing was plotted versus load transfer efficiency and the ratio of the edge deflection and the corresponding interior deflection for sections having FWD data in the database, as shown in figures 29 and 30, respectively. No clear trends in the data can be observed. It is seen that most of the sections exhibited load transfer efficiency at cracks of 90 percent or more. The ratios of the edge deflection and the corresponding interior deflection ranged from 1 to about 2. The variability within the range is possibly due to the time of testing (curling effects), slab warping effects, and the type of shoulder.

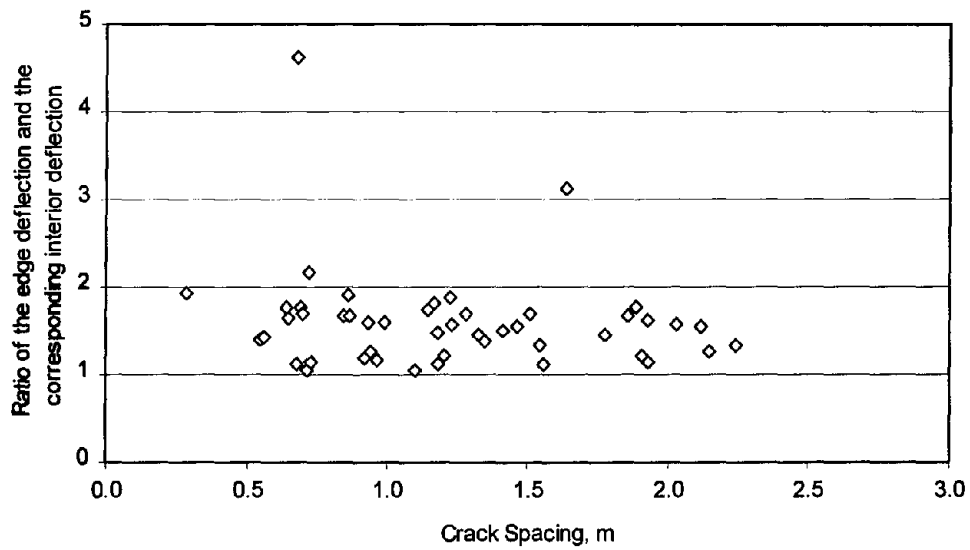
Figure 30. Ratio of maximum edge and interior deflections versus crack spacing.

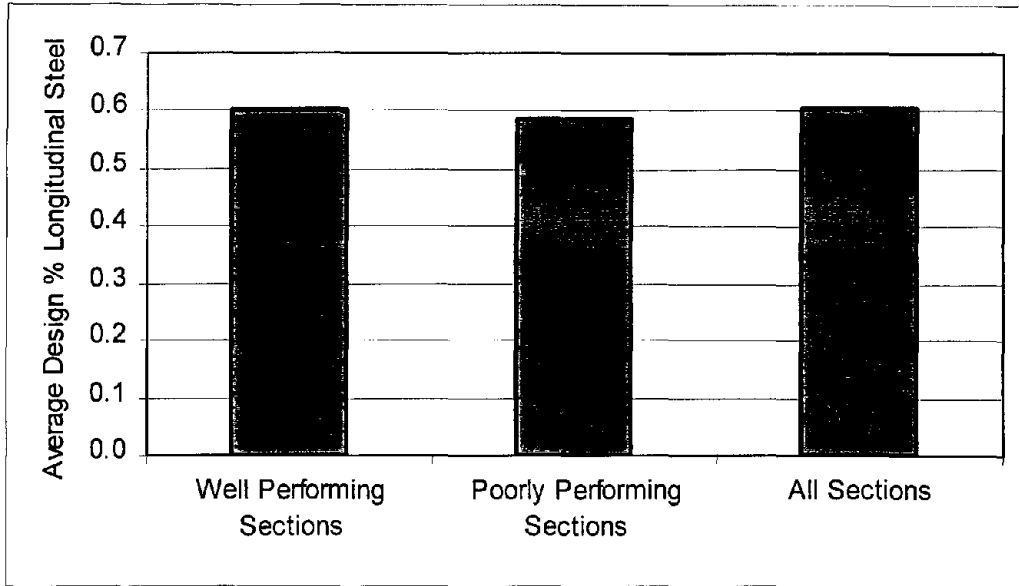
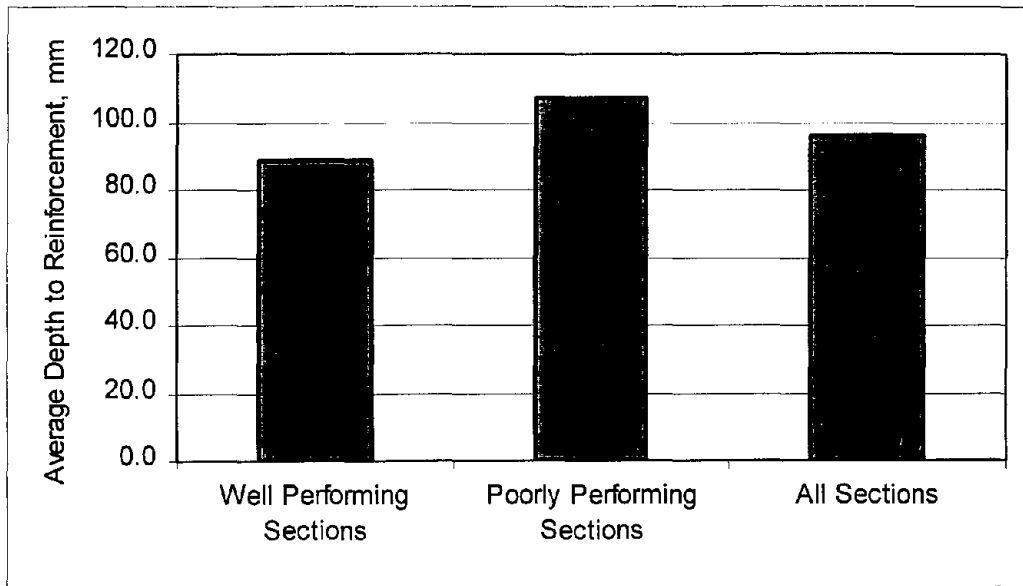
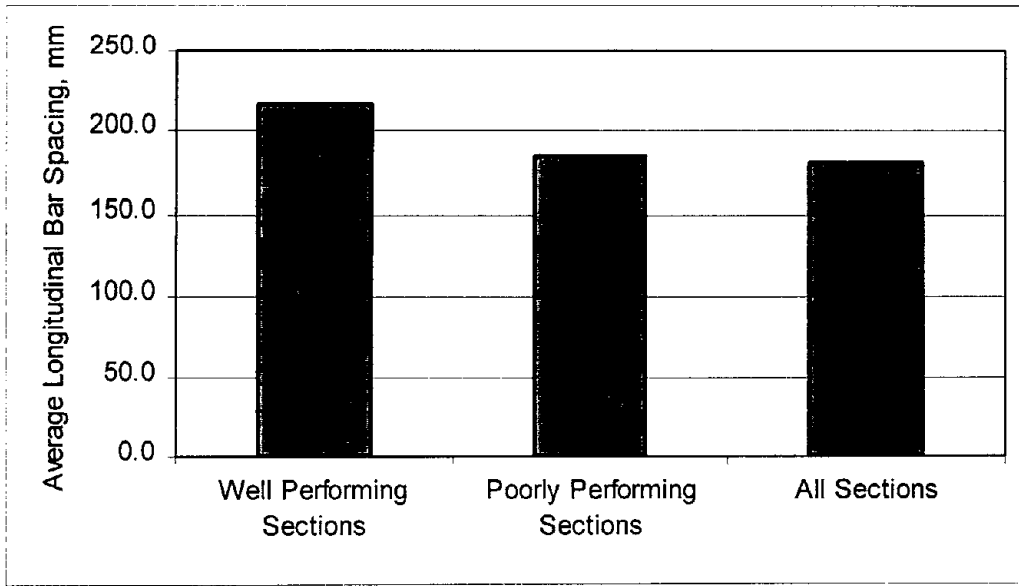
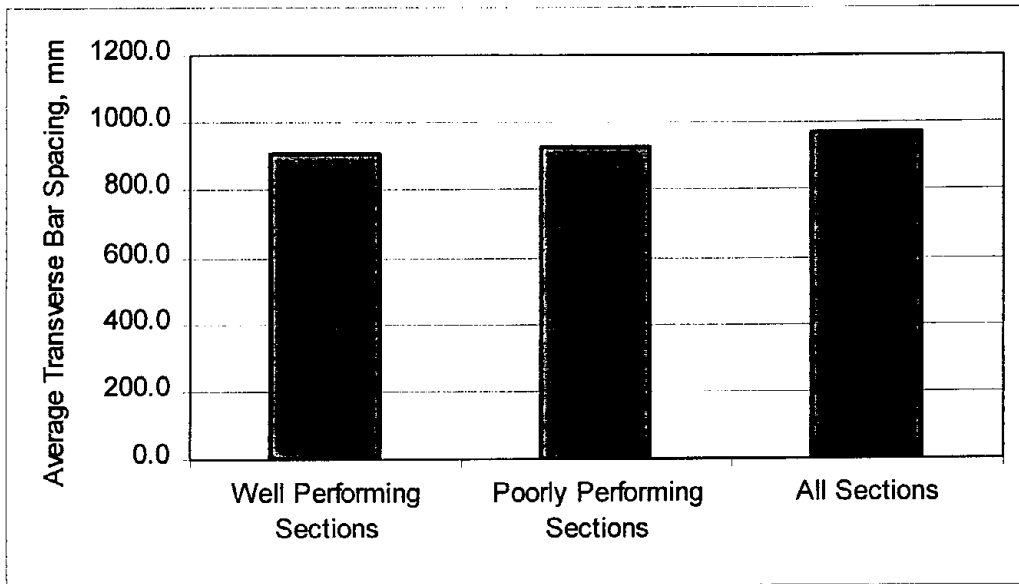
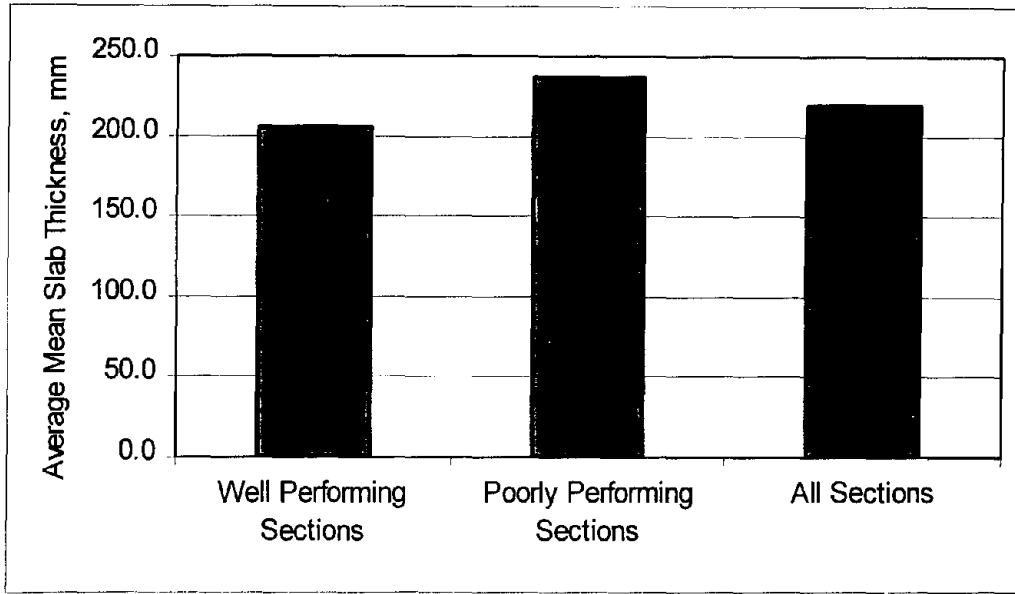
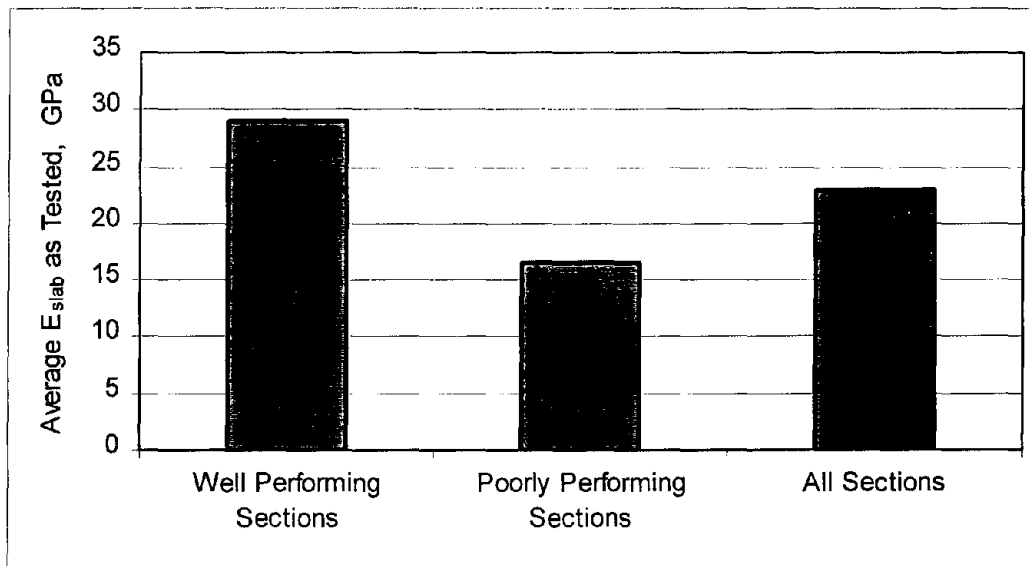
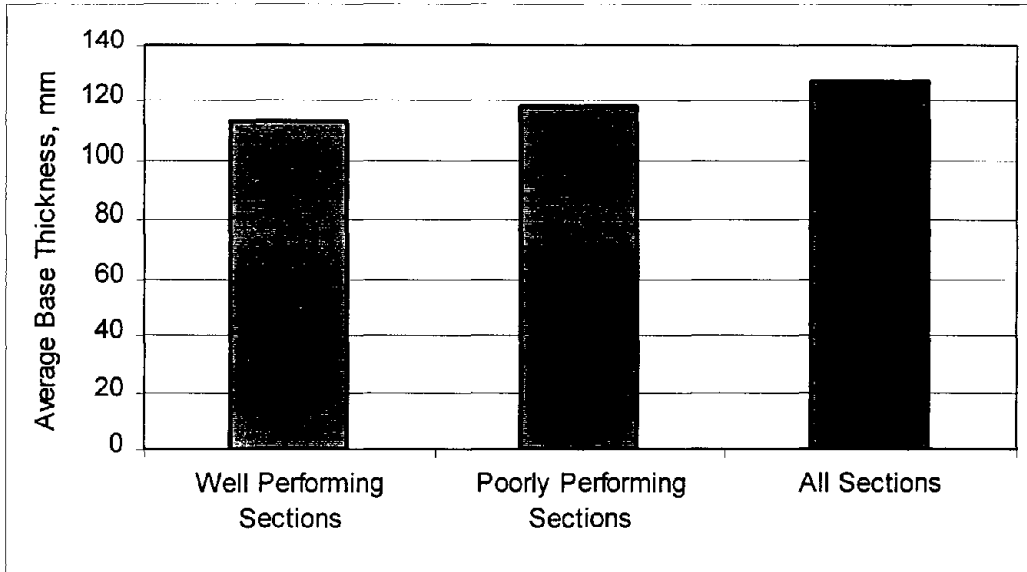
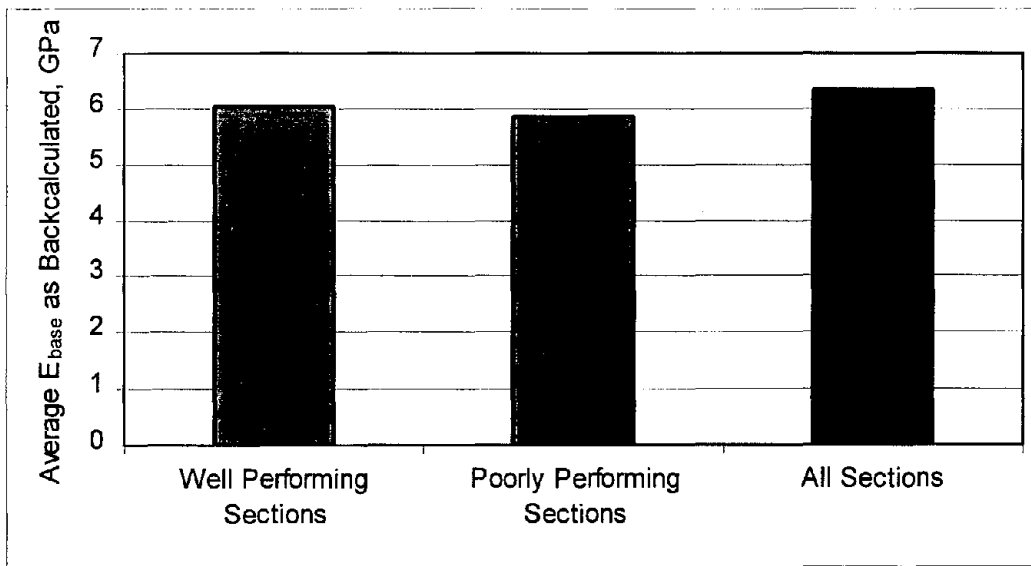
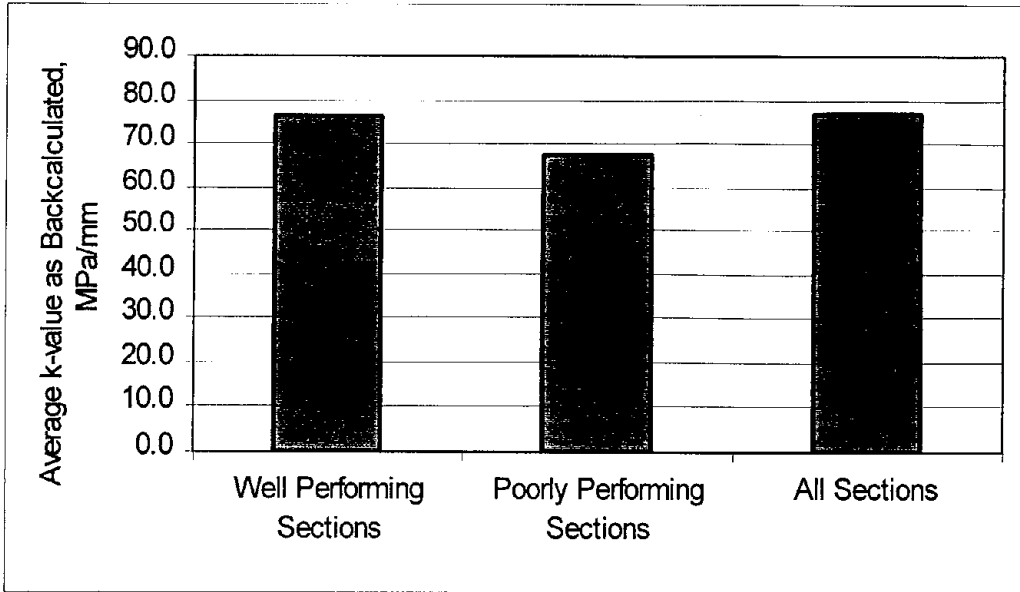
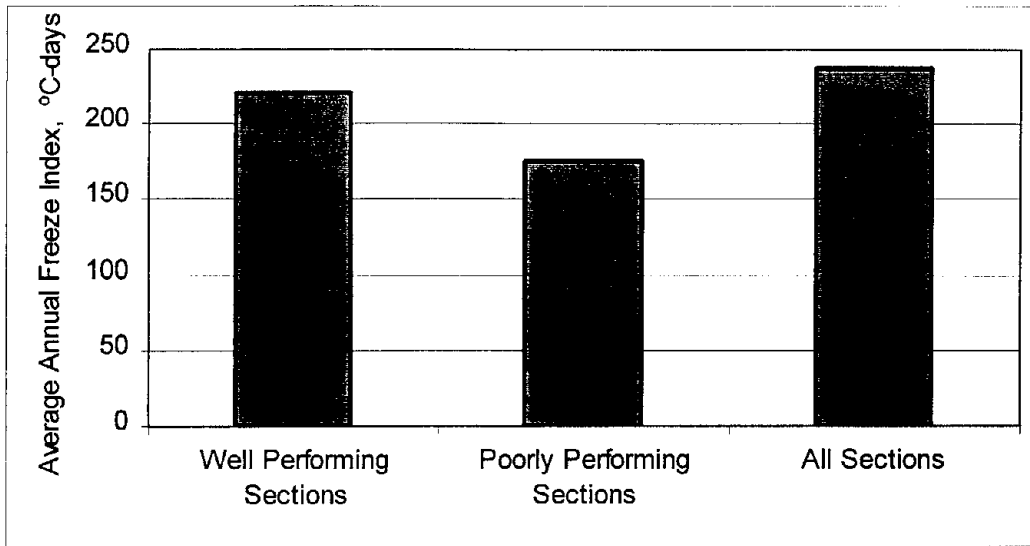
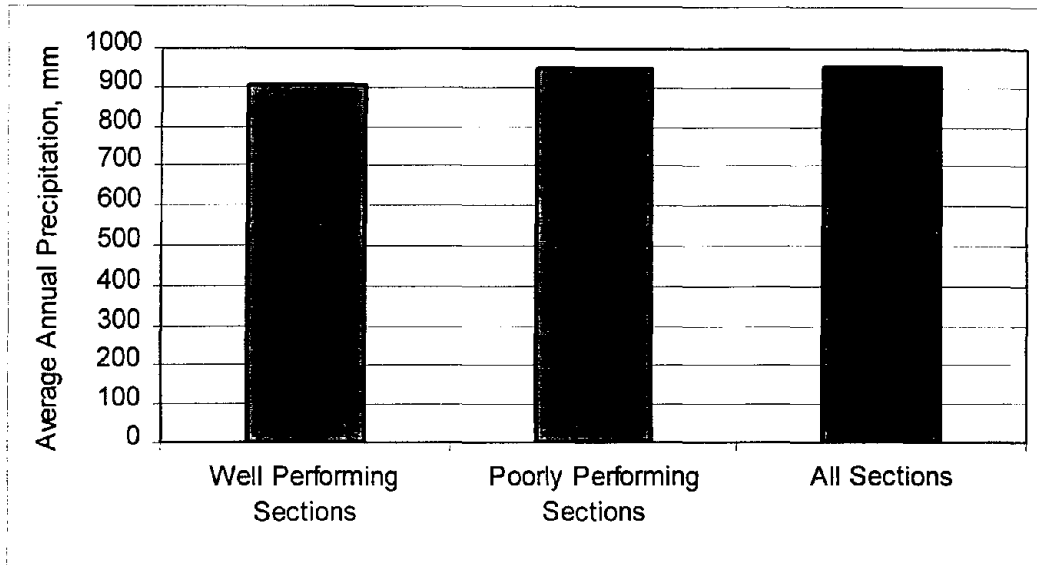
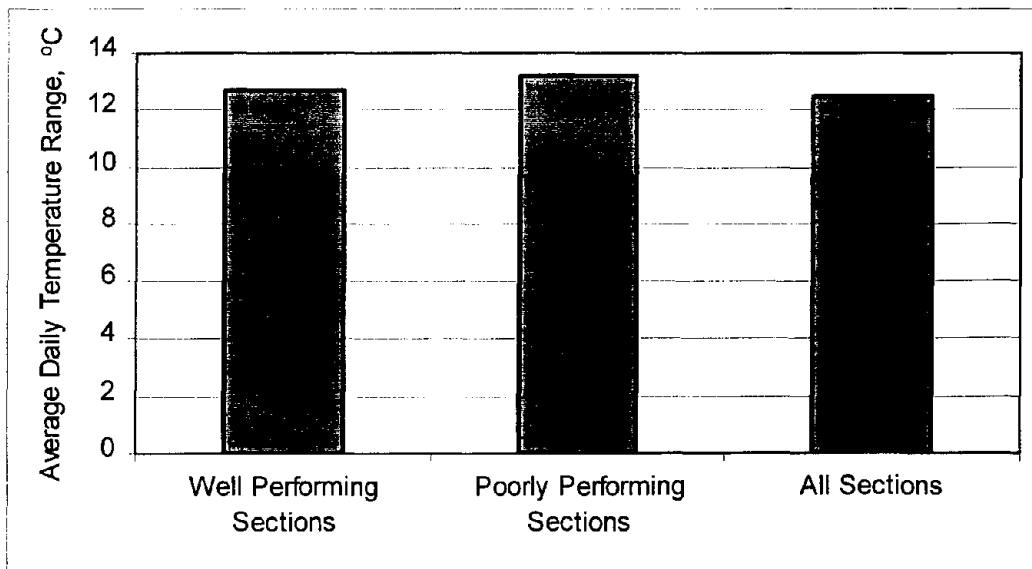
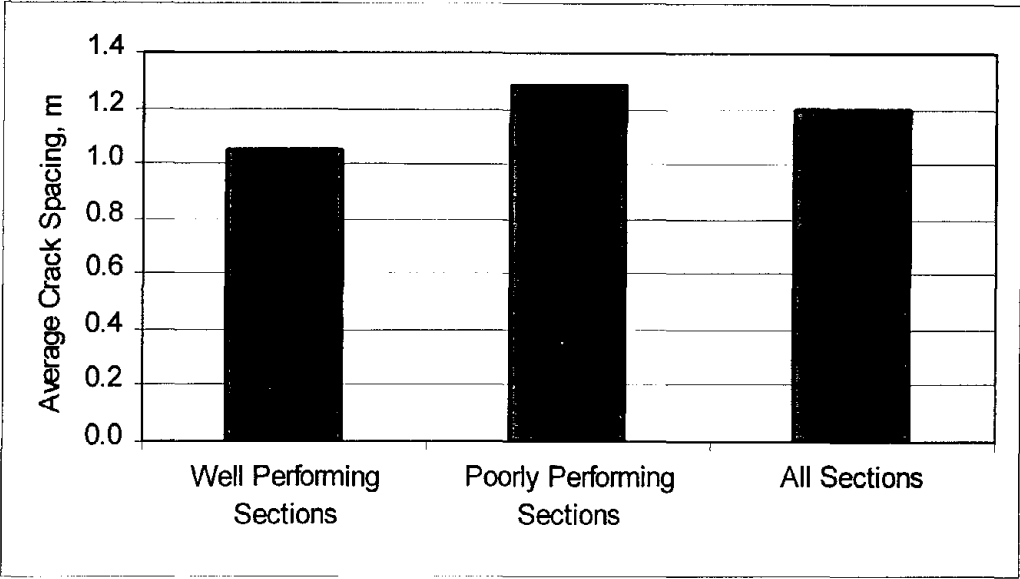
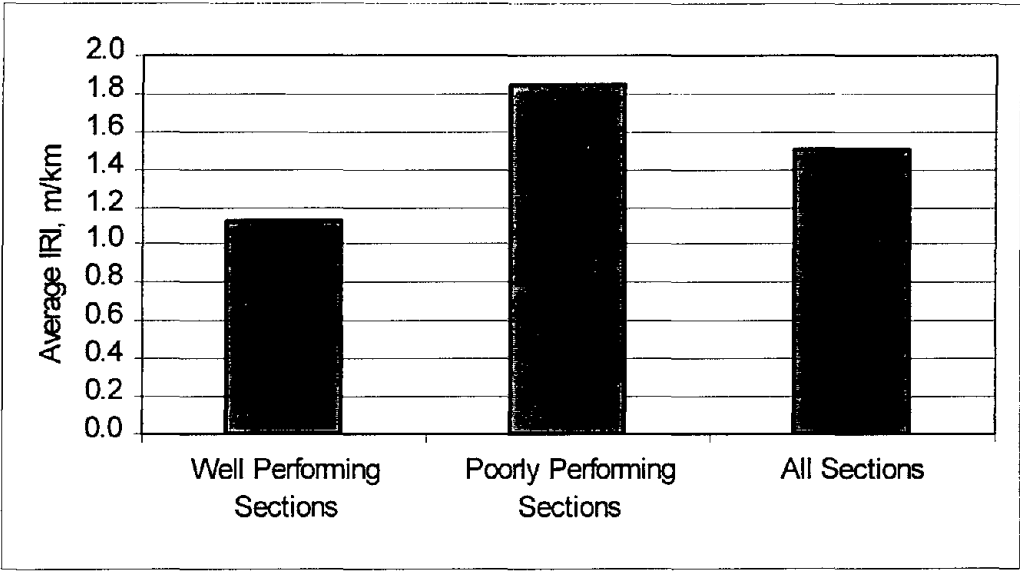
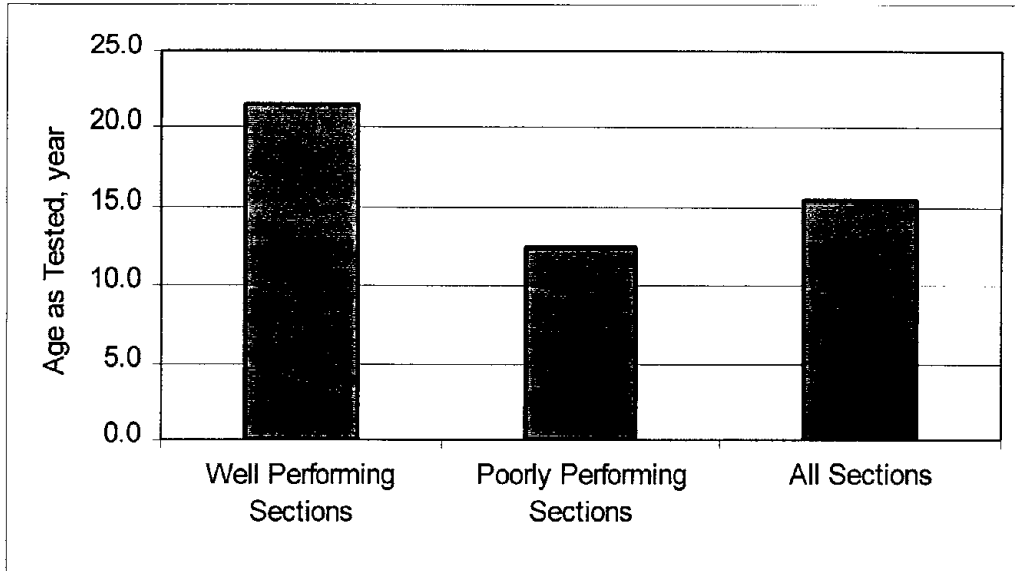
Figure 31. Comparison of design percent longitudinal steel.

Figure 32. Comparison of depth to reinforcement.

Figure 33. Comparison of longitudinal bar spacing.

Figure 34. Comparison of transverse bar spacing.

Figure 35. Comparison of slab thickness.

Figure 36. Comparison of concrete modulus of elasticity, E_{slab} , as tested.

Figure 37. Comparison of base thickness.

Figure 38. Comparison of base modulus of elasticity, E_{base} , as backcalculated.

Figure 39. Comparison of subgrade k-value as backcalculated.

Figure 40. Comparison of annual air freeze index.

Figure 41. Comparison of annual precipitation.

Figure 42. Comparison of daily temperature range.

Figure 43. Comparison of crack spacing.

Figure 44. Comparison of IRI values.

Figure 45. Comparison of age.

This indicates that for the GPS-5 sample analyzed, the sections with relatively thinner concrete slabs and stiffer concrete may result in better performance. The observation related to slab thickness appears to contradict expectations. This may possibly be due to the confounding effects of traffic loading.

- Larger crack spacing.
- Greater depth to reinforcement.
- High value of mean slab thickness.
- Low values of elastic moduli for slab and base layer.
- Low k-value for subgrade.

- Smaller crack spacing.
- Lower IRI (selection criteria).
- Shallow depth to reinforcement.
- Thinner and stronger slab.
- Stiffer base and subgrade layers.

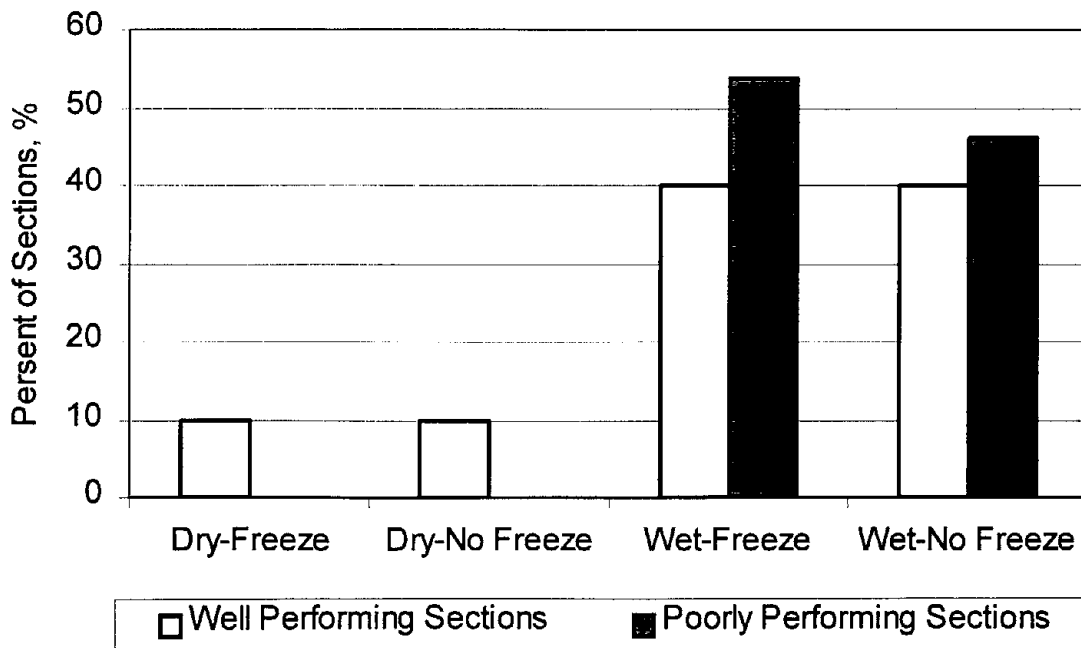
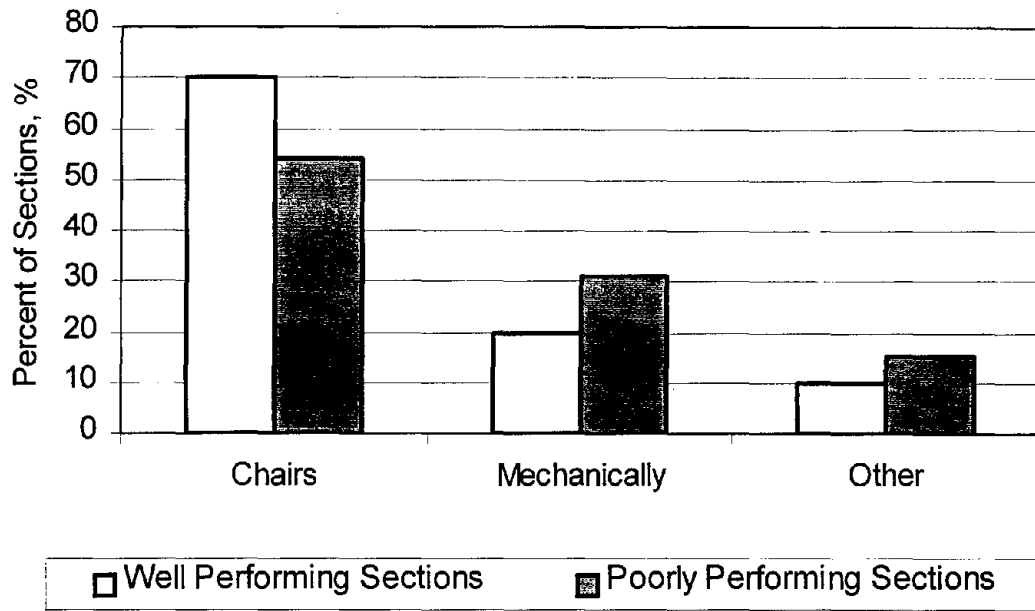
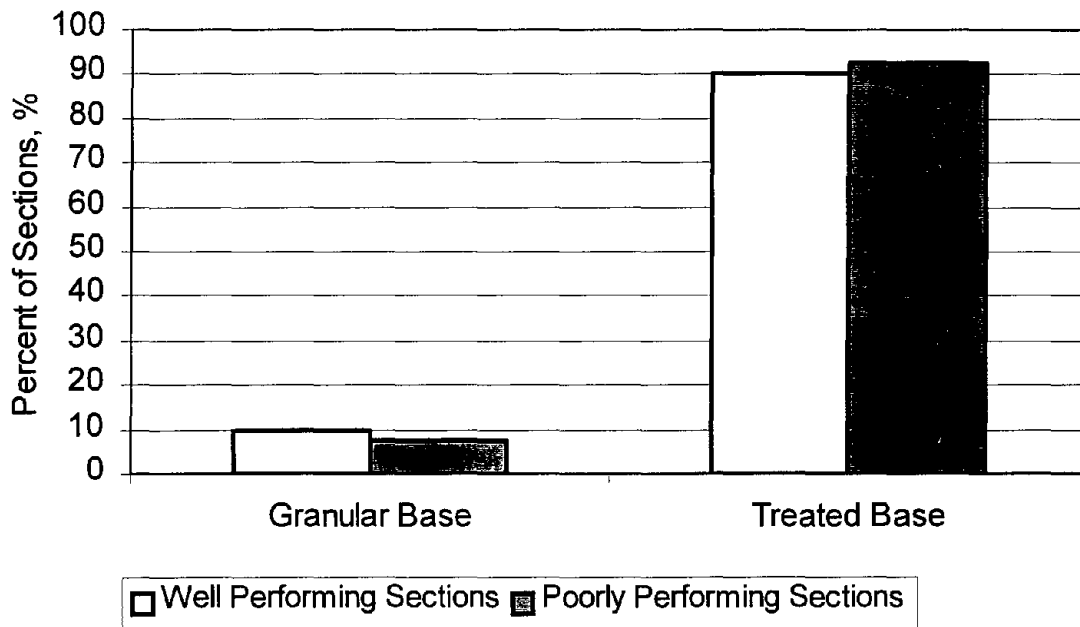
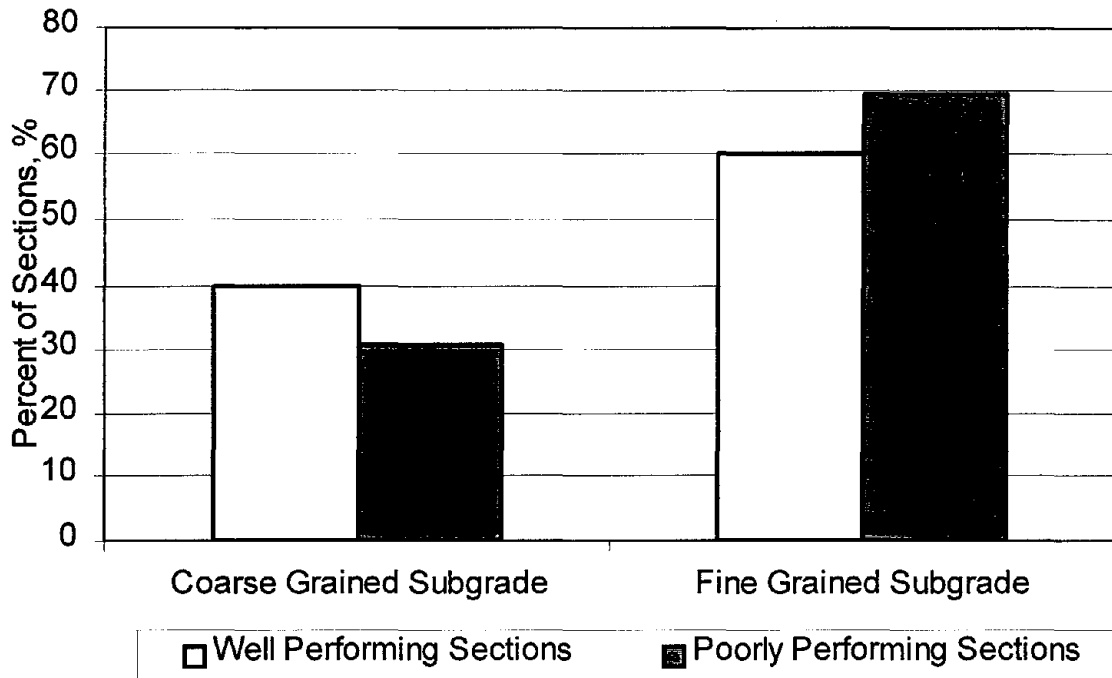
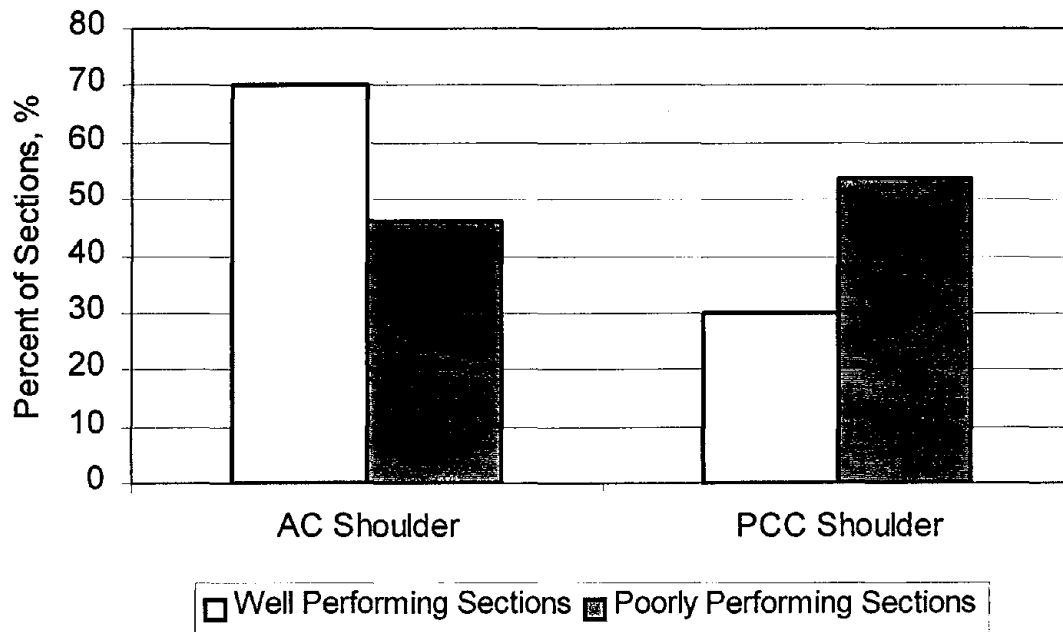
Figure 46. Effect of climatic region.

Figure 47. Effect of reinforcement placement type.

Figure 48. Effect of base type.

Figure 49. Effect of subgrade type.

Figure 50. Effect of shoulder type.
