Reducing the Risks of Nonstructural Earthquake Damage – A Practical Guide

FEMA E-74 / December 2012

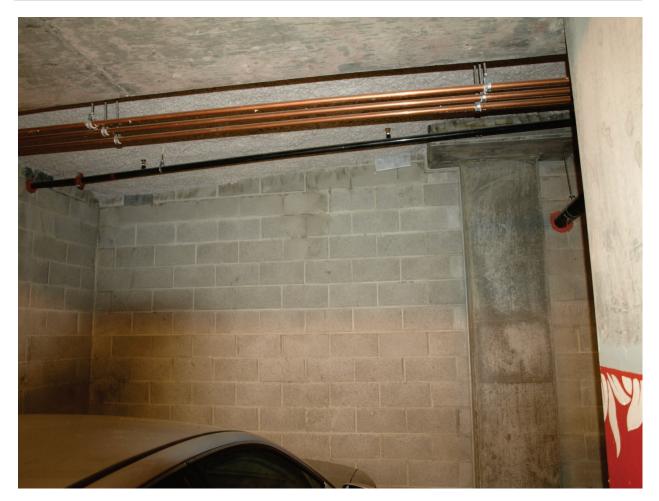
Figure 6.3.2.1-8 Full-height concrete masonry unit walls detailed with steel clip angles (3 angles visible in photo). Configuration shown includes perpendicular walls, sloping ramp above, and column with column capital. Although wall detailed with sealant joints along edges of column and column capital, it is not clear that the concrete frame can move independently of these CMU walls (Photo courtesy of Cynthia Perry, BFP Engineers).

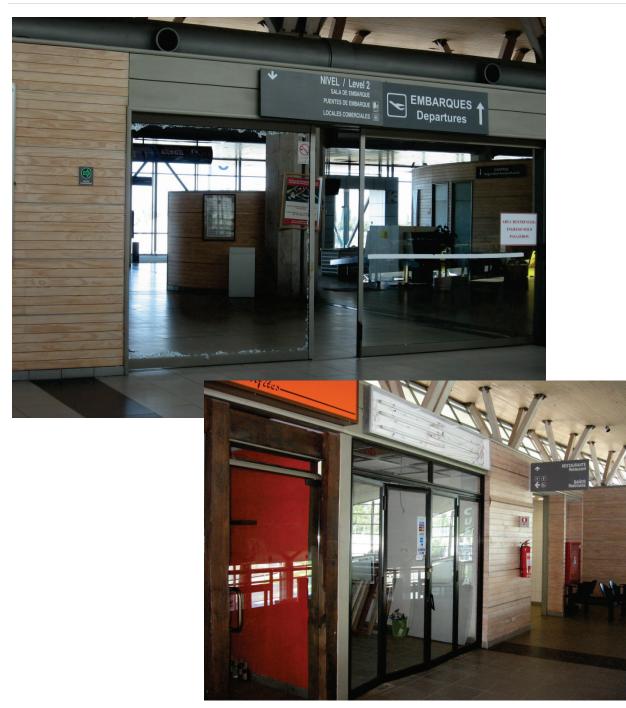
Figure 6.3.2.3-2 Damage to glazed doors at the Concepción airport in the 2010 Chile Earthquake. In the top photo the glazing in the sliding glass door shattered; in the lower photo the glass is intact but the door frames are misaligned (Photos courtesy of Rodrigo Retamales, Rubén Boroschek & Associates). Available at: http://www.fema.gov/earthquake-publications/fema-e-74-reducing-risks-nonstructural-earthquake-damage Last Modified: December 2012

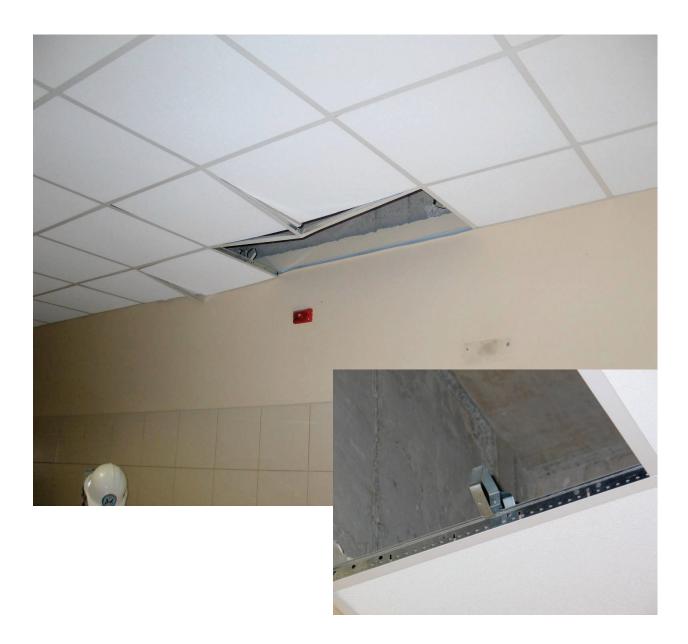
Figure 6.3.4.1-4 Fallen ceiling tiles at Talca Hospital in the 2010 Chile Earthquake, in spite of the use of clips as shown in detail at right. Most ceilings observed in Chile did not have seismic detailing (Photos courtesy of Bill Holmes, Rutherford & Chekene).

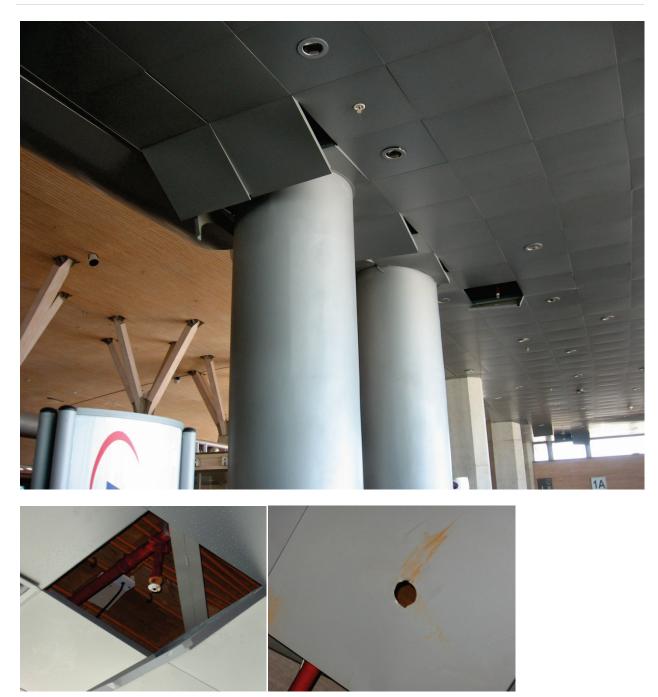
Figure 6.3.4.1-5 Damage to suspended metal panel ceiling system and fire sprinklers at Concepción airport, primarily at far end and around column obstructions in the 2010 Chile Earthquake (Photos courtesy of Rodrigo Retamales, Rubén Boroschek & Associates). The metal panel was strong enough to fail the sprinkler head shown at lower left.

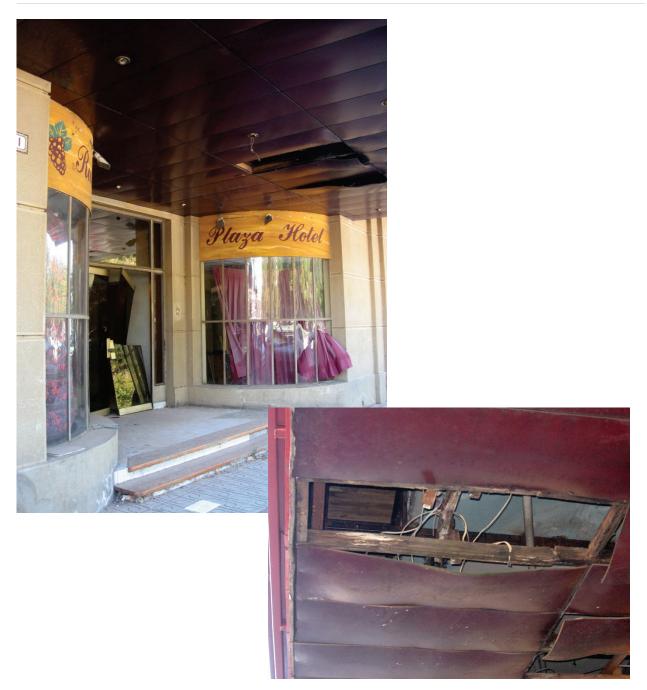
Figure 6.3.4.2-3 Damage to soffit paneling and wood framing at hotel in the 2010 Chile Earthquake; panels and wood framing show signs of prior water damage and deterioration. Note also damage to storefront glazing and glass doors (Photos courtesy of Rodrigo Retamales, Rubén Boroschek & Associates). Available at: http://www.fema.gov/earthquake-publications/fema-e-74-reducing-risks-nonstructural-earthquake-damage Last Modified: December 2012

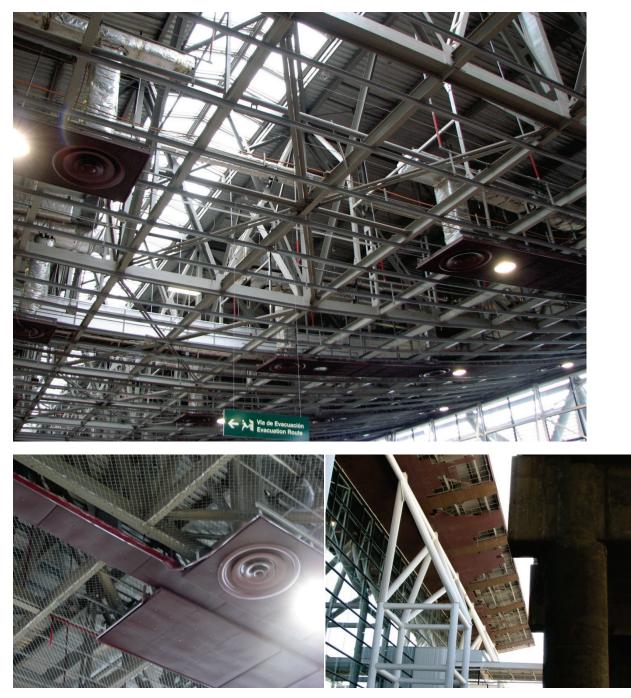
Figure 6.3.4.2-5 Extensive failure of ceiling in the main terminal of the Santiago airport in the 2010 Chile Earthquake. Metal panels with lights and diffusers hung from furring on short metal tabs; these remained in place but detail at lower left shows they also sustained some damage. Furring channels still in place throughout ceiling but majority of lightweight ceiling panels and much of the cross furring came down as shown at lower right photo of exterior soffit with same system (Photos courtesy of Antonio Iruretagoyena, Rubén Boroschek & Associates).

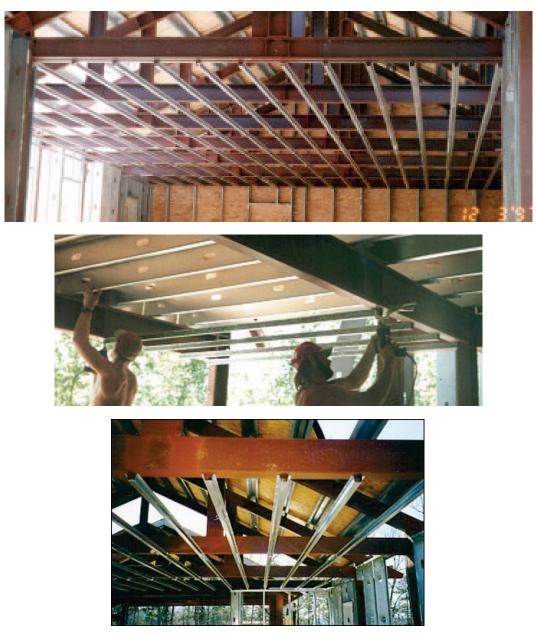
Figure 6.3.4.2-6 Mitigation examples with 1-1/2" hat channels at 16" on centers screwed in place with #12 self drilling screws and furring strips ready to receive gypsum board (Photo courtesy of Excalibur Steel). No special seismic details are required for this type of ceiling where the gypsum board is well secured directly to furring strips.

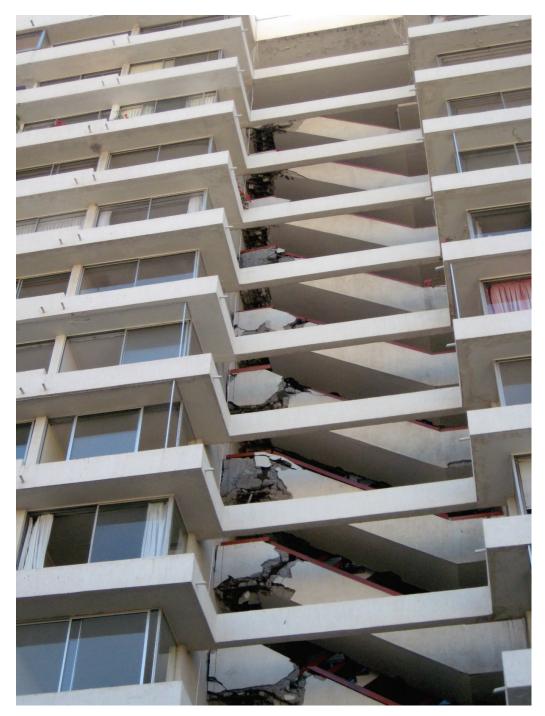
Figure 6.3.8.1-3 Stairs damaged up the full height of this apartment building in Viña del Mar in the 2010 magnitude-8.8 Chile Earthquake (Photo courtesy of Santiago Pujol, Purdue University). The stairs were rigidly attached at adjacent floors and behaved like diagonal braces although they were neither designed nor detailed to function as structural braces.

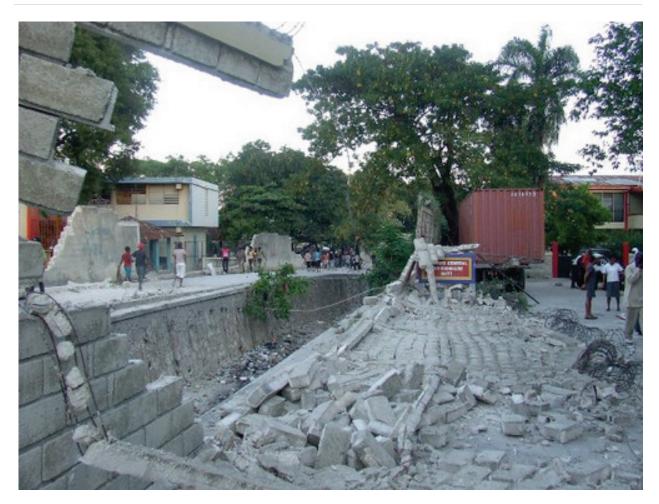
Figure 6.3.9.1-2 Freestanding masonry fences with inadequate reinforcement collapsed covering both sides of this street in Port-au-Prince in the 2010 magnitude-7 Haiti Earthquake (Photo courtesy of Yves Montoban). Many miles of such fencing collapsed in the 2010 Haiti Earthquake.

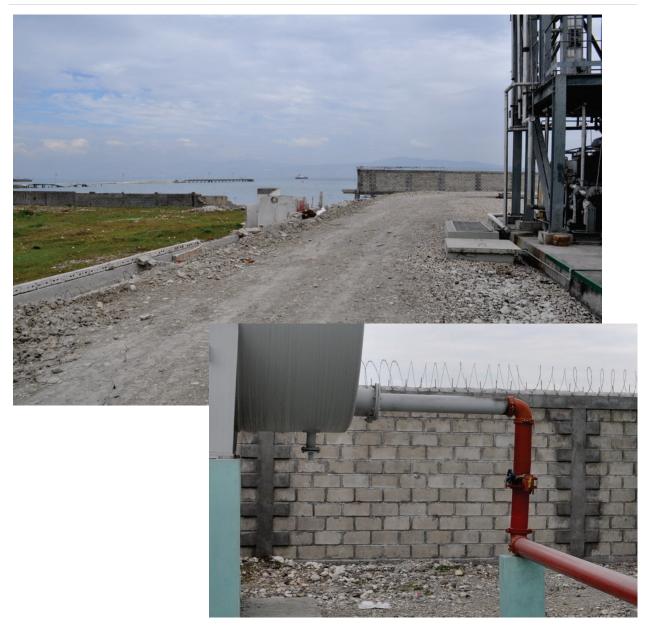
Figure 6.3.9.1-4 Photo at top shows complete collapse of poorly detailed confined masonry fence in foreground; partial collapse of poorly detailed confined masonry fence in distance at left; no damage to well detailed confined masonry fence in distance at right in the 2010 Haiti Earthquake. Close-up view of well-detailed confined masonry fence in bottom photo with concrete columns and bond beam at top (Photos courtesy of Eduardo Fierro, BFP Engineers). Fences in foreground and at right formed the security perimeter at an electric power plant in Port-au-Prince.

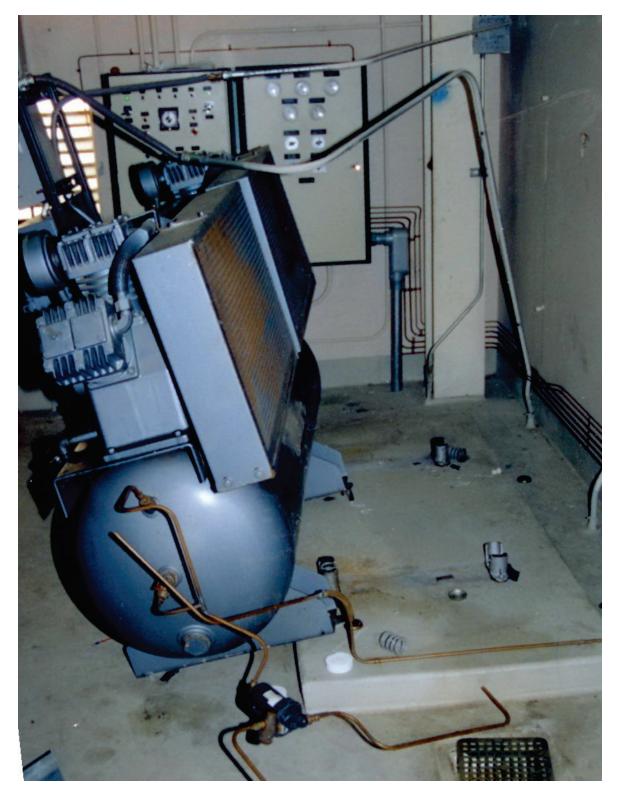
Figure 6.4.1.3-1Failure of compressor mounted on vibration isolators in the 1994 Northridge
Earthquake (Photo courtesy of Wiss, Jenney, Elstner Associates).

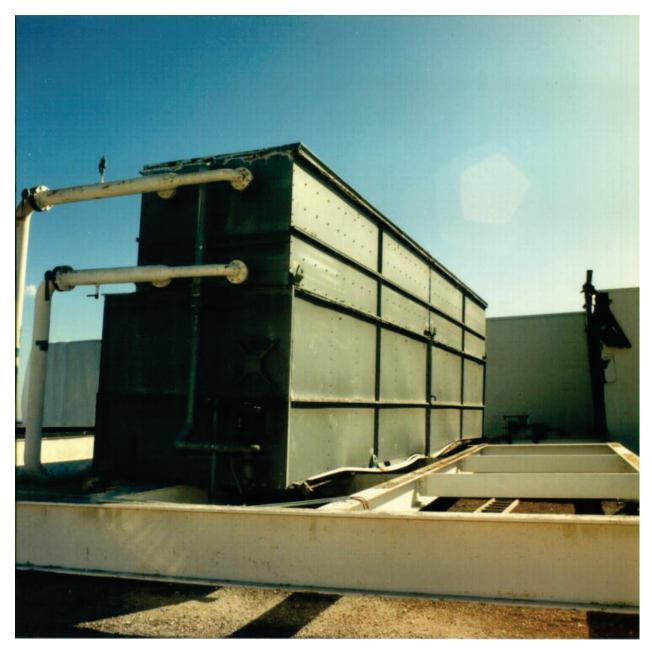
Figure 6.4.1.3-4 Rooftop equipment on isolators collapsed onto skid (Photo courtesy of Mason Industries).

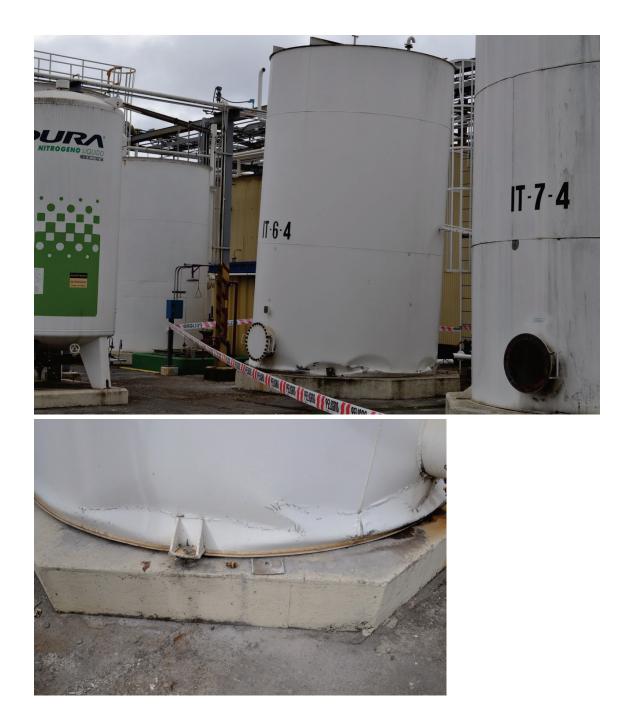
Figure 6.4.2.2-4 Anchored tank damaged at base when anchorage failed; tank slid and ruptured attached piping in 2010 magnitude-8.8 Chile Earthquake (Photo courtesy of Eduardo Fierro, BFP Engineers).

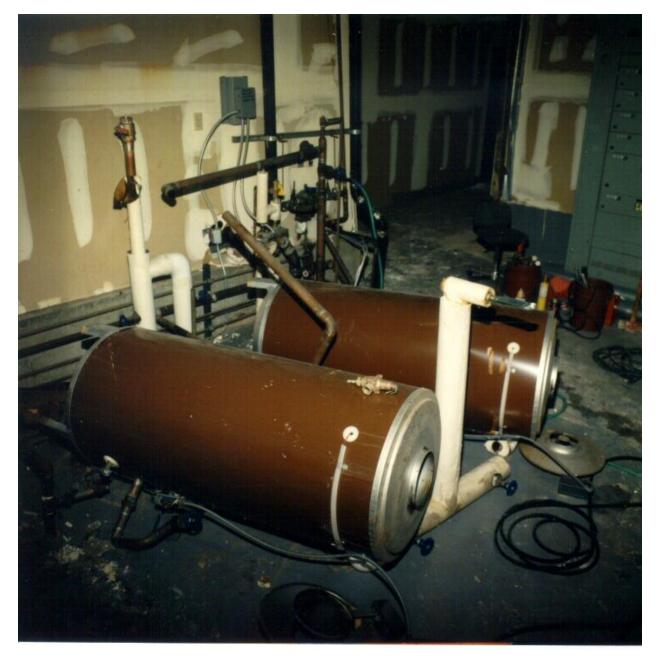
Figure 6.4.2.4-1 Unanchored water heaters overturned (Photo courtesy of Mason Industries).

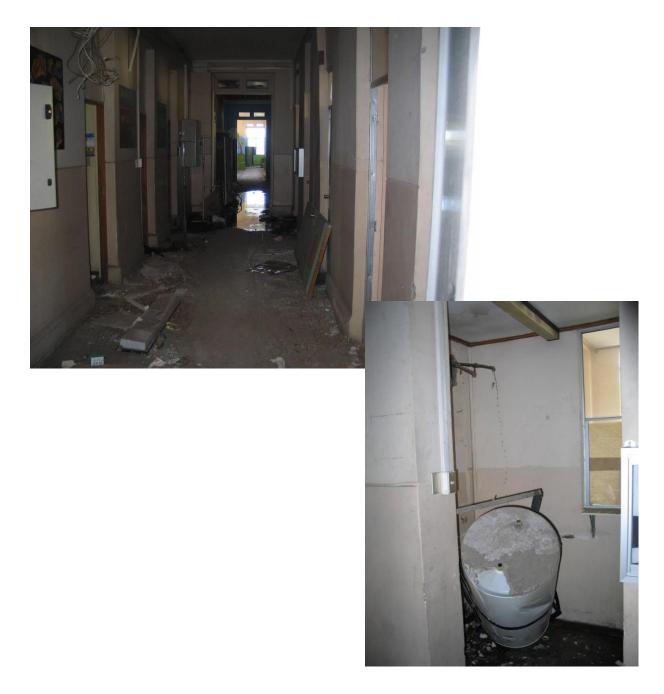
Figure 6.4.2.4-2 Water damage at the Talca Hospital in the 2010 magnitude-8.8 Chile Earthquake; water leaking from tank at right. This building was closed due to nonstructural damage, dominated by water damage (Photos courtesy of Bill Holmes, Rutherford & Chekene).

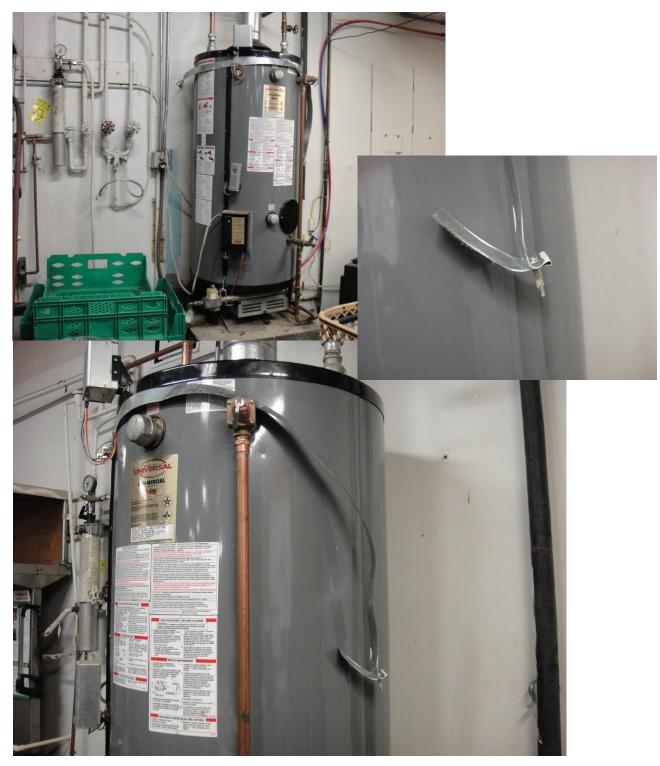
Figure 6.4.2.4-3 Damaged water heater in the 2010 magnitude-6.5 Eureka Earthquake. The water heater strap pulled out from the supporting concrete wall as a result of inadequate anchorage. The tank moved sufficiently to break interconnected water lines which were rigidly connected to the tank.

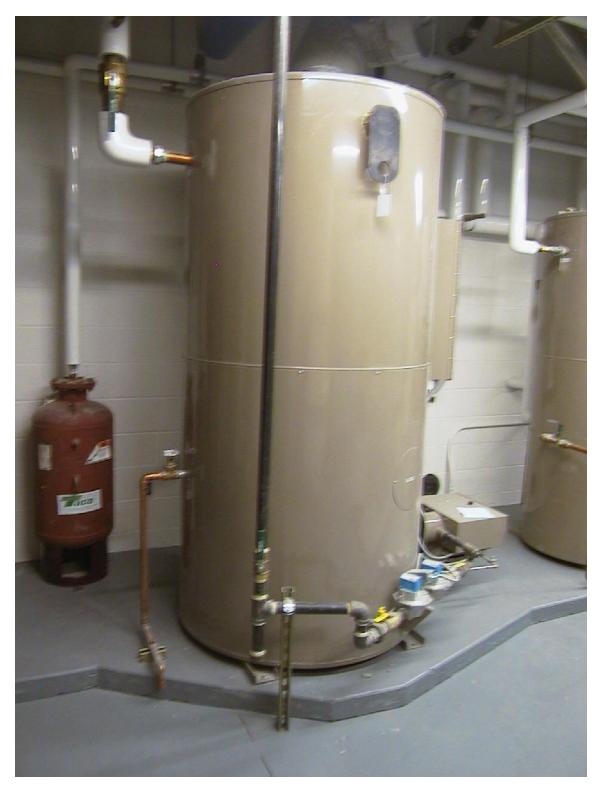
Figure 6.4.2.4-5 Base-mounted water heater located in a school; equipment supplied with metal base for mounting (Photo courtesy of EQE for the Salt Lake City School District).

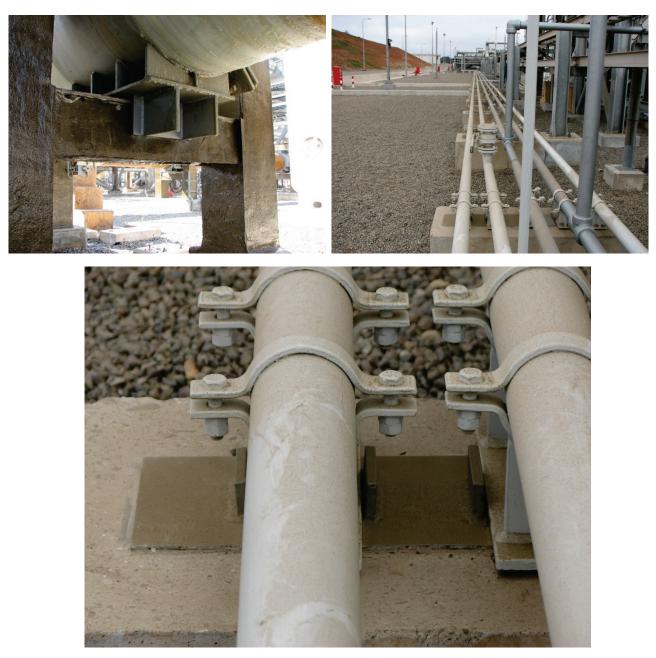
Figure 6.4.3.5-5 Floor-mounted supports for industrial piping in Chile; piping undamaged in the 2010 Chile Earthquake. The Chilean Industrial Code (Norma Chilena 2369) requires that shear forces be resisted by shear keys as shown; lower photo is detail of piping at upper right (Photos courtesy of Antonio Iruretagoyena, Rubén Boroschek & Associates).

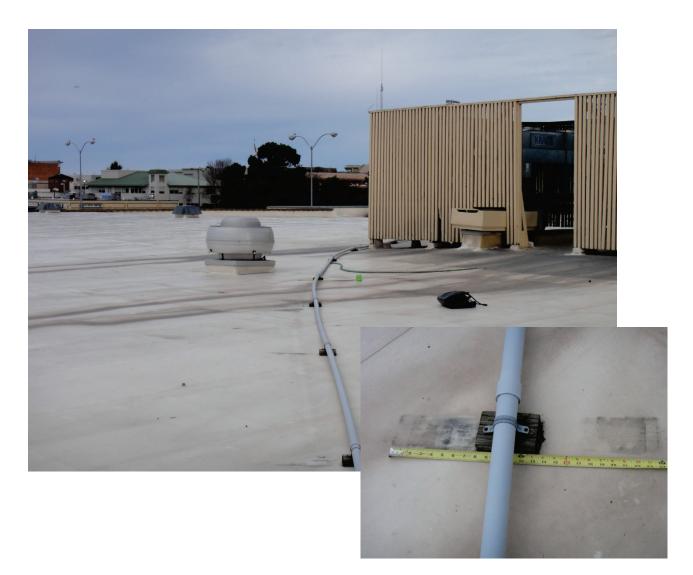
Figure 6.4.3.6-2 Unrestrained wood sleepers on roof-mounted piping slid a foot in either direction in 2010 magnitude-6.5 Eureka Earthquake (Photos courtesy of Maryann Phipps, Estructure).

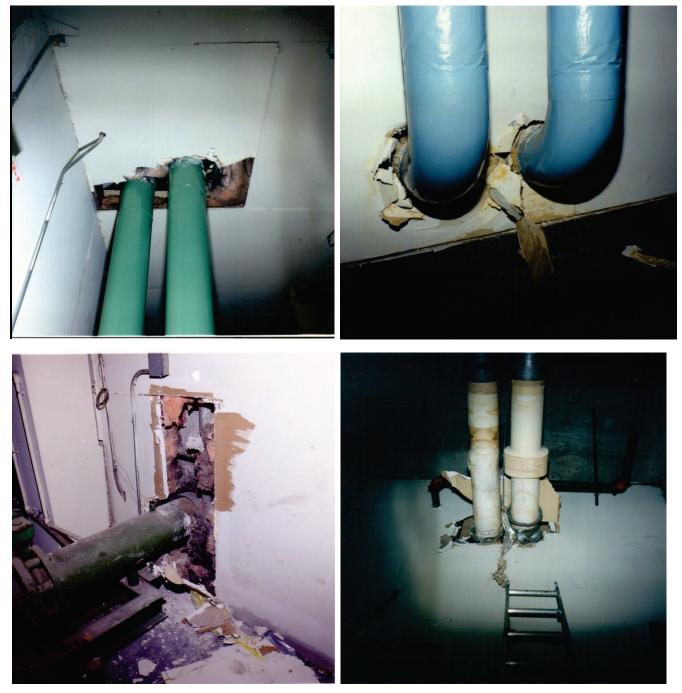
Figure 6.4.3.8-1 Damage to ceilings, gypsum board partitions, fire-proofing, and insulation in the 1994 magnitude-6.7 Northridge Earthquake (Photo courtesy of Mason Industries). Note that the blue piping has joints located in the wall space which leaked, resulting in additional damage.

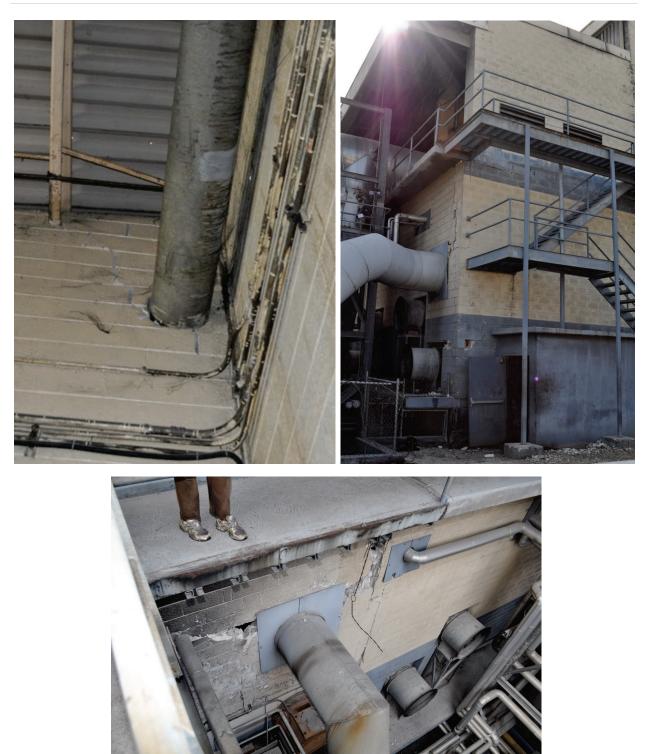
Figure 6.4.3.8-3 Wall penetrations for piping and ducts contributed to damage to unreinforced masonry walls at an industrial facility in the 2010 magnitude-7 Haiti Earthquake (Photos courtesy of Eduardo Fierro, BFP Engineers). The piping and ducts were not damaged but the walls cracked and will need to be repaired.

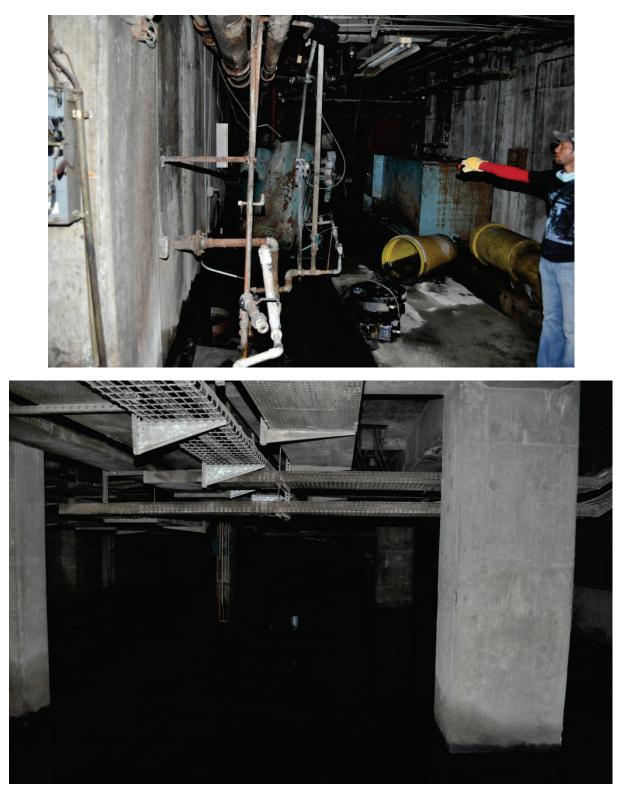
Figure 6.4.5.1-2 Basement level at power plant in Port-au-Prince flooded with oil and water in the 2010 magnitude-7 Haiti Earthquake creating hazardous conditions for inspection and clean-up (Photos courtesy of Eduardo Fierro, BFP Engineers).

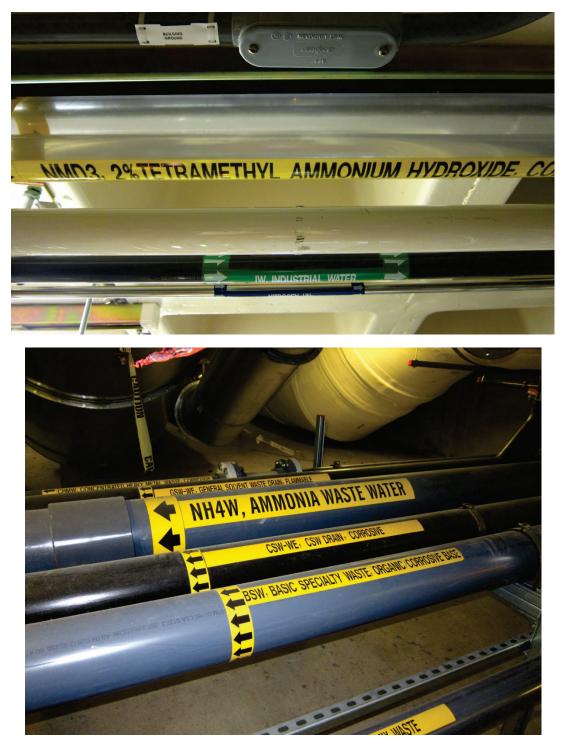
Figure 6.4.5.1-5 Two examples of double walled piping used for secondary containment of hazardous fluids. Preassembled double walled pipe with centering devices or spacers separating the inner and outer pipe is available commercially, but as shown here, the outer pipe was installed and leak tested prior to pulling the inner pipe through. Note the yellow color coded labels indicate reactive materials; flow direction also marked prominently (Photos courtesy of Jeffrey Soulages, Intel Corporation).

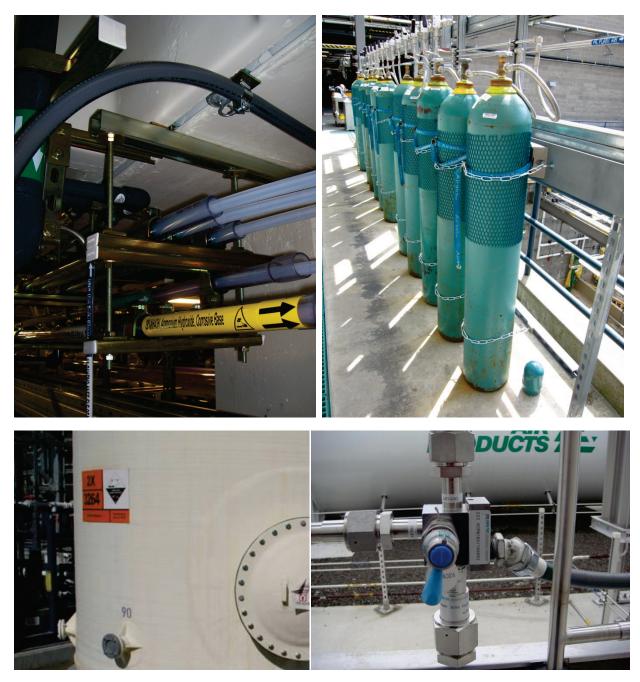
Figure 6.4.5.1-6 Clockwise from top: a) Sleeved pipe connections where seismic anchorage consists of cushioned pipe clamp attached around outer sleeve and inner pipe not restrained longitudinally. b) Airgas canisters chained and strapped to supports, fitted with flexible hose, stainless steel piping (note blue label), and a row of valves. c) Label on tank shows example of European ADR danger labeling scheme. d) Excess flow valve for large gas tank (Photos courtesy of Jeffrey Soulages, Intel Corporation).

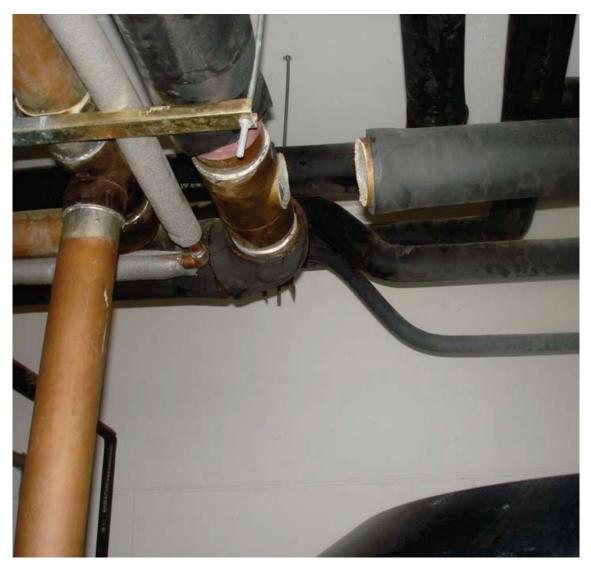
Figure 6.4.5.2-2 Broken copper piping for hot water supply in residential building in the 2010 Chile Earthquake. Trapeze shown not laterally braced but hangers appear to be less than 12" in length and may not have required lateral restraints per ASCE 7-10 (Photo courtesy of Gokhan Pekcan).

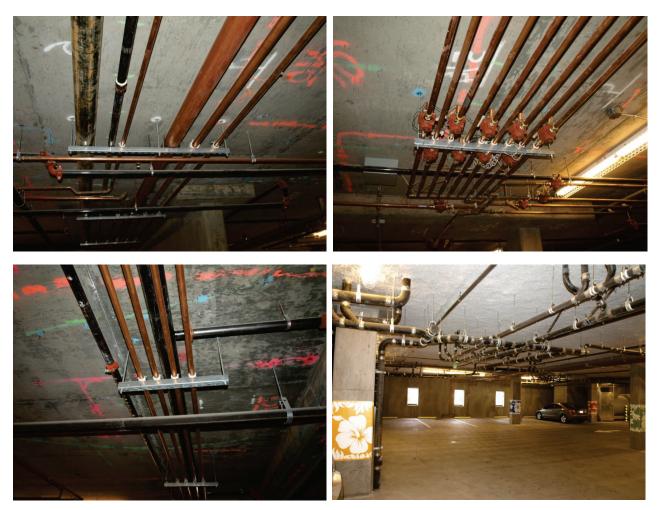
Figure 6.4.5.2-6 Piping installation in garage of mixed commercial/residential building San Francisco Bay Area completed in 2010. Note piping and trapeze supports do not have lateral restraints as all hangers were kept under 12" in length; only the sprinkler lines were laterally restrained. (Photo courtesy of Cynthia Perry, BFP Engineers).

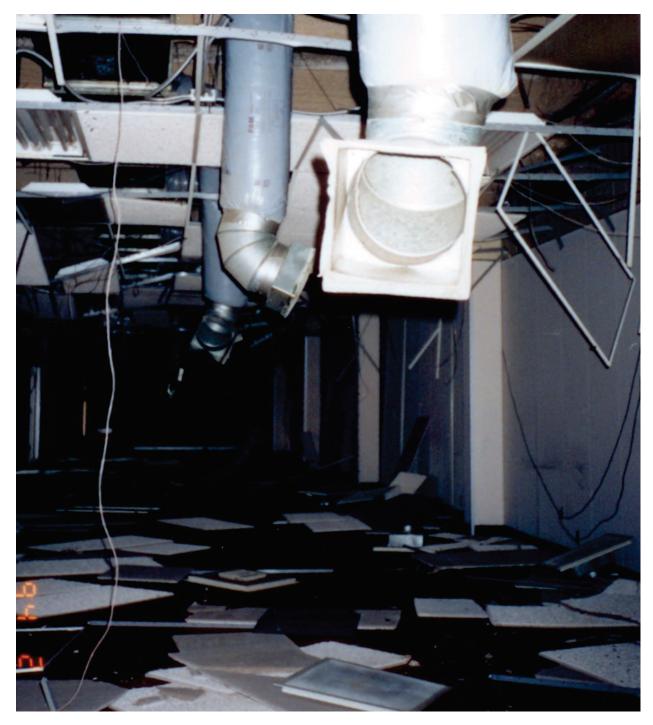
Figure 6.4.6.2-1 Air diffusers fell to the floor; ducts hanging through ceiling grid as a result of the 1994 Northridge Earthquake (FEMA 74, 1994).

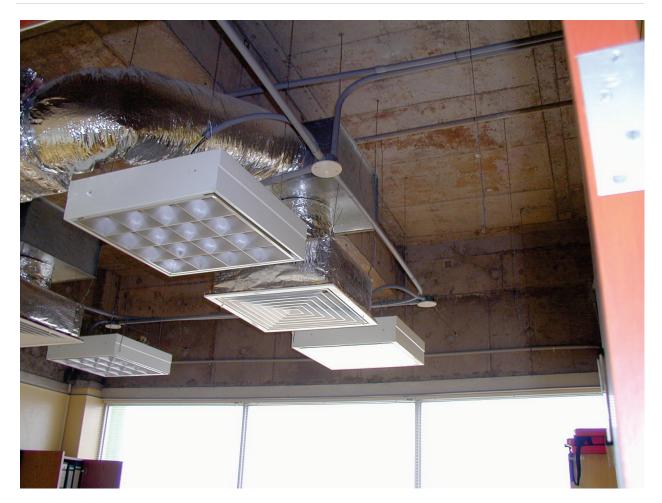
Figure 6.4.6.2-2 HVAC diffuser attached to the structure with four vertical hangers; ceiling system was damaged beyond repair in the 2001 Peru Earthquake but none of the diffusers or lights fell. Ceiling was demolished prior to photo (Photo courtesy of Eduardo Fierro, BFP Engineers).

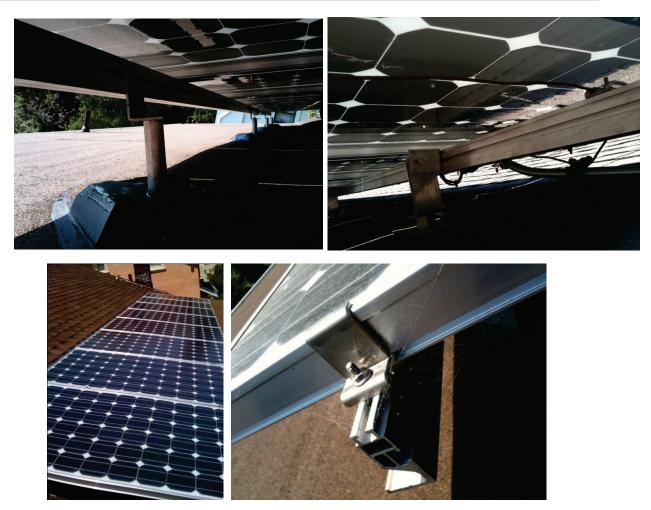
Figure 6.4.7.5-3 Residential photovoltaic system in Berkeley, California mounted over the transition between two different roof slopes (Photos courtesy of Heber Santos). Short standoff used on tar and gravel flat portion (upper left); aluminum flashing and mounting bracket used on sloped portion with composition tile roofing (upper right). The profile of one type of proprietary mounting track is seen at lower left.

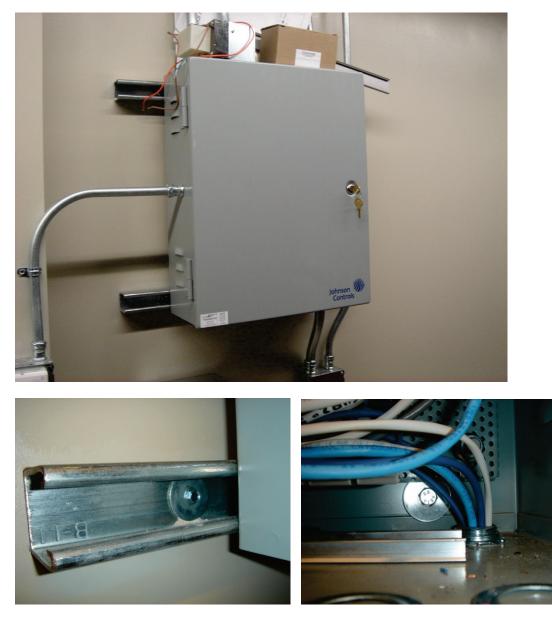
Figure 6.4.8.2-2 Wall anchorage for electrical panel; standard strut anchored to wall studs and panel anchored to strut (Photo courtesy of Maryann Phipps, Estructure).

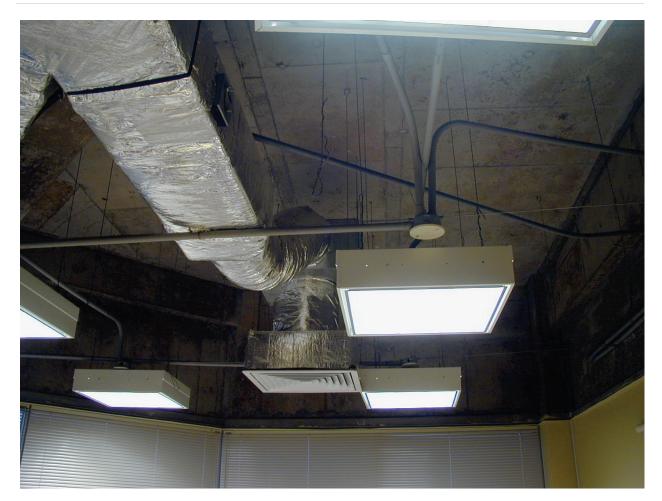
Figure 6.4.9.1-2 Overhead lights with four vertical hangers to the structure. Unbraced acoustic ceiling system was damaged beyond repair in the 2001 magnitude-8.4 Peru Earthquake but none of the diffusers or lights fell because they had independent supports. Ceiling was demolished prior to photo (Photo courtesy of Eduardo Fierro, BFP Engineers).

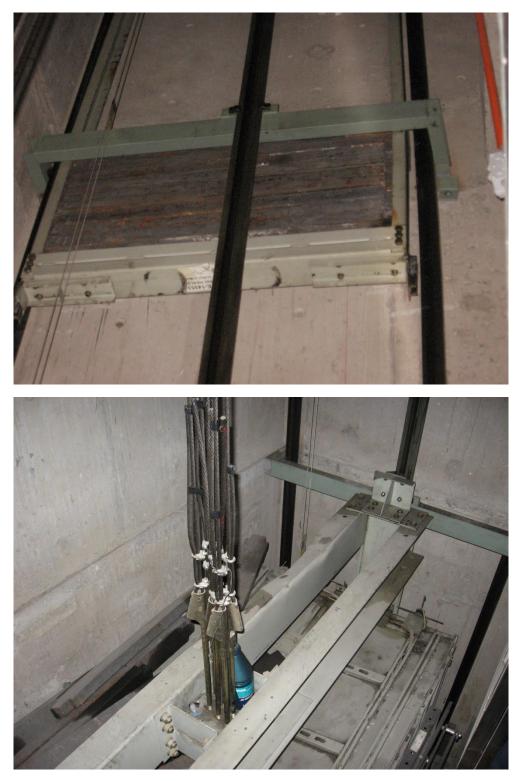
Figure 6.4.10.2-11 Unrestrained movement of the counterweights damaged the counterweight assembly and bent the counterweight guide rails; over half the subweights dropped onto the top of the cab and damaged the cab framing in the 2010
