COLORADO DEMONSTRATION PROJECT:  
**Pecos Street over I-70 Bridge Replacement  
Using SPMT Technology**

**Final Report  
October 2014**

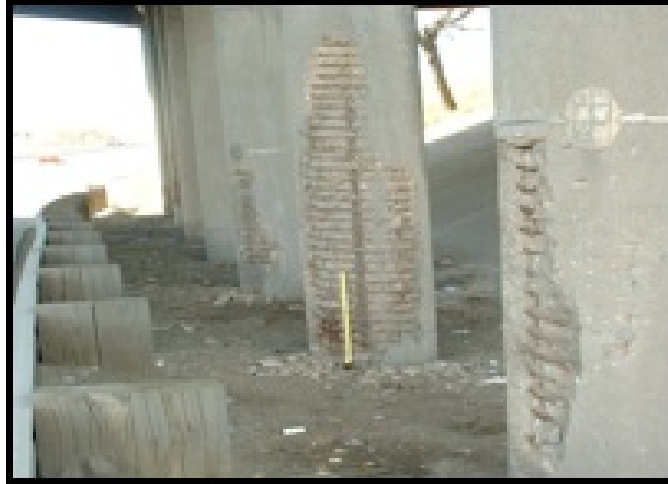
Figure 4. Photo. Spalling of columns (courtesy: Colorado DOT).

The concrete slab and girder bridge, built in 1965, was structurally deficient, with a sufficiency rating of 43.9. (See figure 3). The substructure was rated as “poor” due to deterioration, cracking, and spalling of the columns and abutments. (See figure 4).

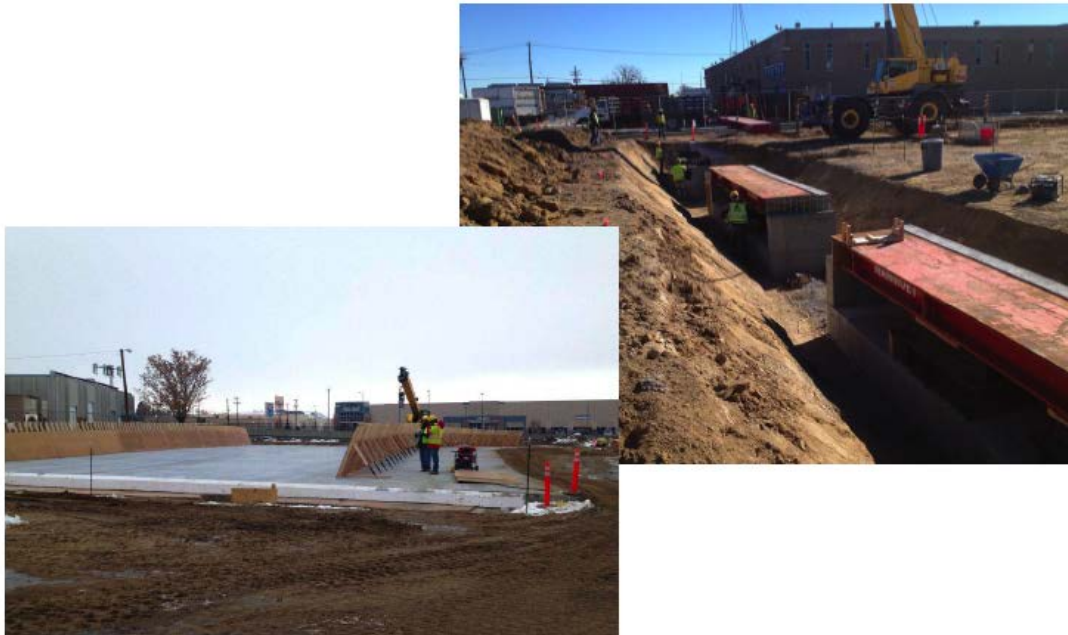
Figure 11. Photos. “Trench and “rat slab” construction in bridge staging area (courtesy: Colorado DOT).

Concurrent with the substructure construction, the bridge staging area construction got started in the southeast corner of the interchange with the casting of the “rat slab” or base slab and trenches

for the lifting jacks (figure 11). A close-up view of the slab, which served as the level ground for the SPMT to lift the superstructure at the diaphragms, is shown in figure 12.

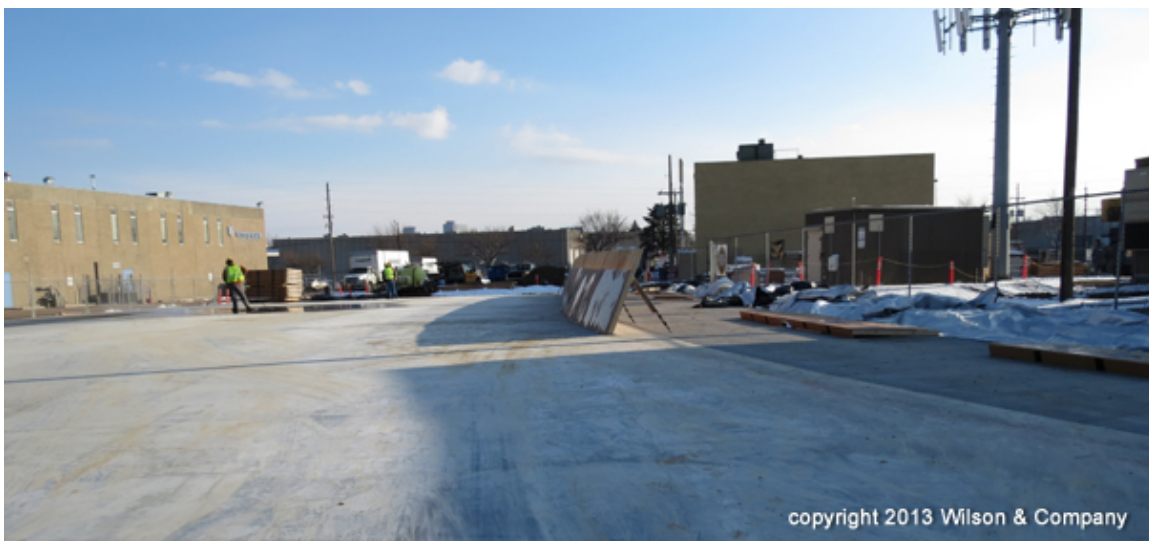
Figure 12. Photo. Close-up of completed “rat slab” or base slab construction (courtesy: Colorado DOT).

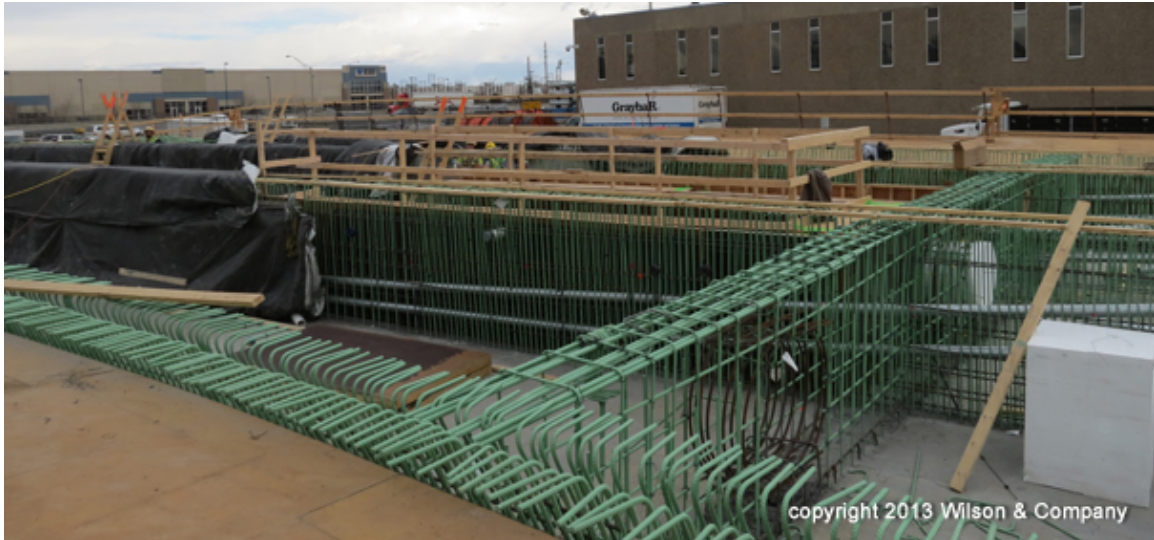
Figure 13. Photo. Epoxy-coated reinforcement for diaphragm (courtesy: Colorado DOT).

The reinforcement for one of the two diaphragms at 15 feet from each end of the superstructure is shown in figure 13, and the overview of the bridge staging area showing reinforcement work in progress is shown in figure 14.

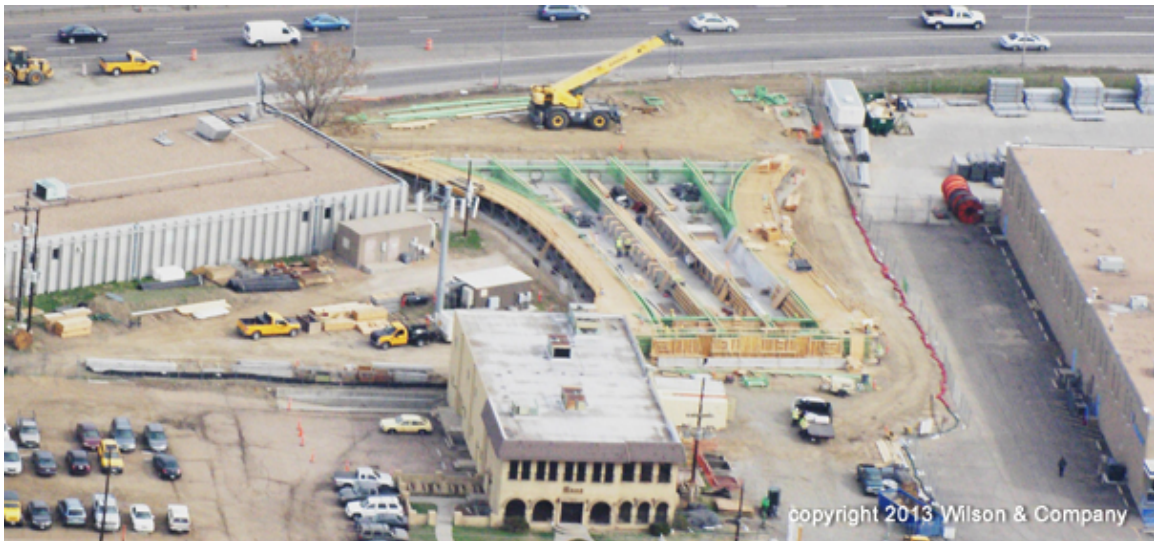
Figure 14. Photo. Overhead view of bridge staging area (courtesy: Colorado DOT).

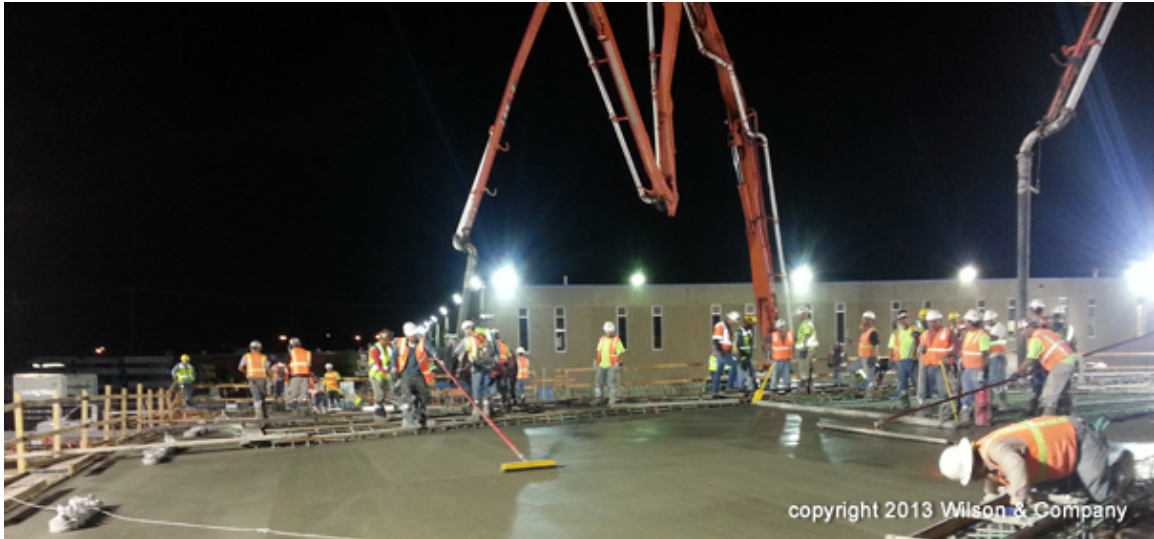
Figure 15. Photo. Deck finishing operation (courtesy: Colorado DOT).

The concrete finishing of deck for the superstructure poured in late May is shown in figure 15. Casting the deck at ground level avoided the challenges of concrete placement encountered in elevated decks.

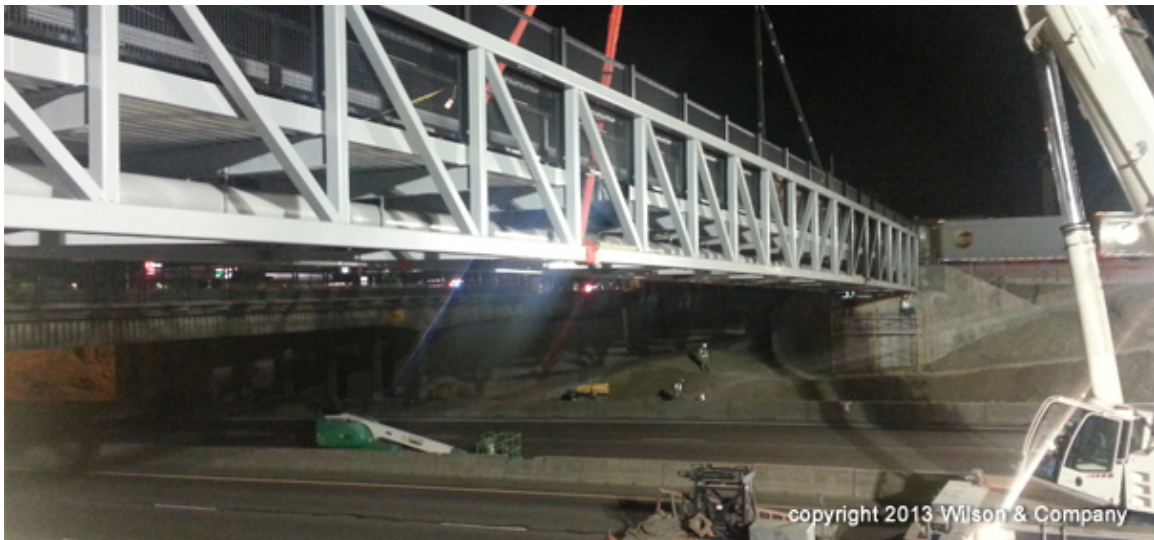
Figure 16. Photo. Placement of pedestrian bridge (courtesy: Colorado DOT).

Figure 16 shows the pedestrian bridge being positioned in place just to the west of the Pecos Street Bridge.

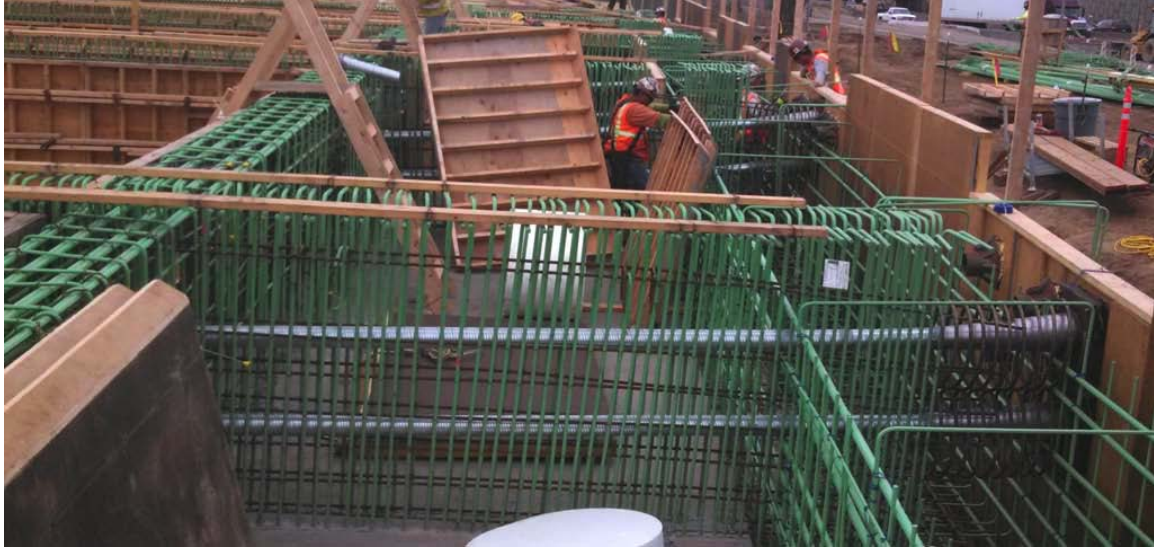
Figure 17. Photo. Longitudinal internal tendons (courtesy: Colorado DOT).

The superstructure is longitudinally post-tensioned internally in the webs and externally in the boxes. The four types of post-tensioning in the superstructure are shown in figures 17 through 20.

The transversely post-tensioned deck has a thickness of 9 to 15 inches. The bottom slab has a thickness of 6 to 8.5 inches.

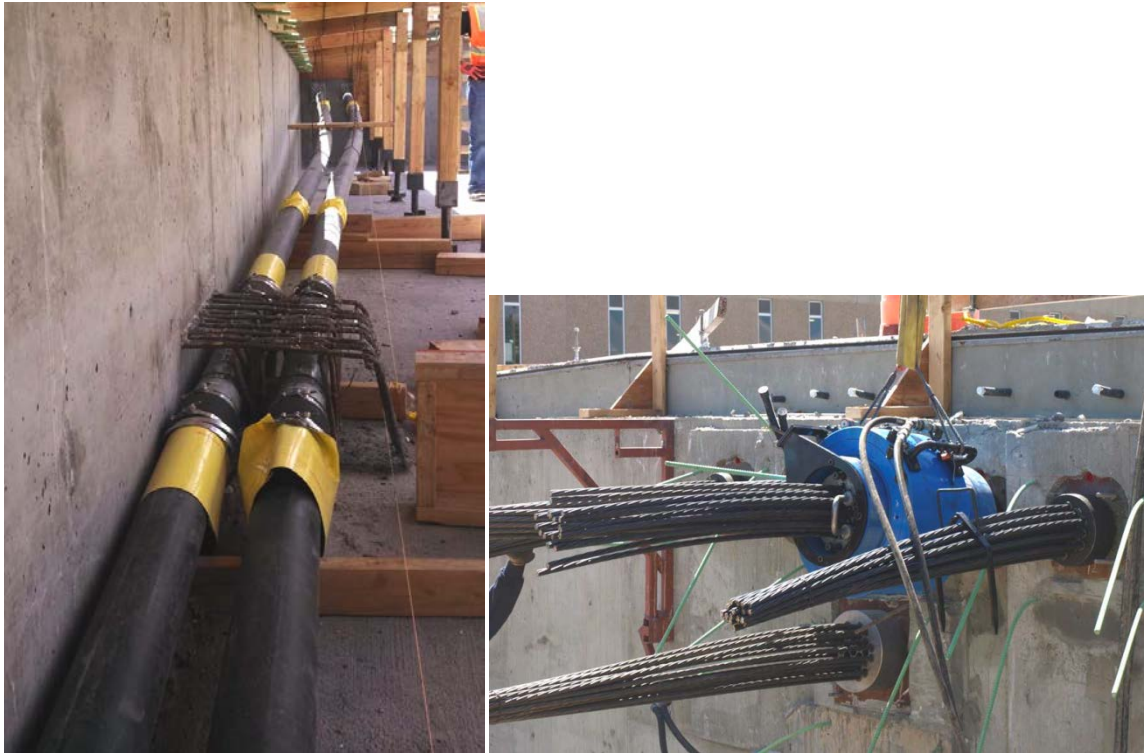
Figure 18. Photos. Longitudinal external tendons (courtesy: Colorado DOT).

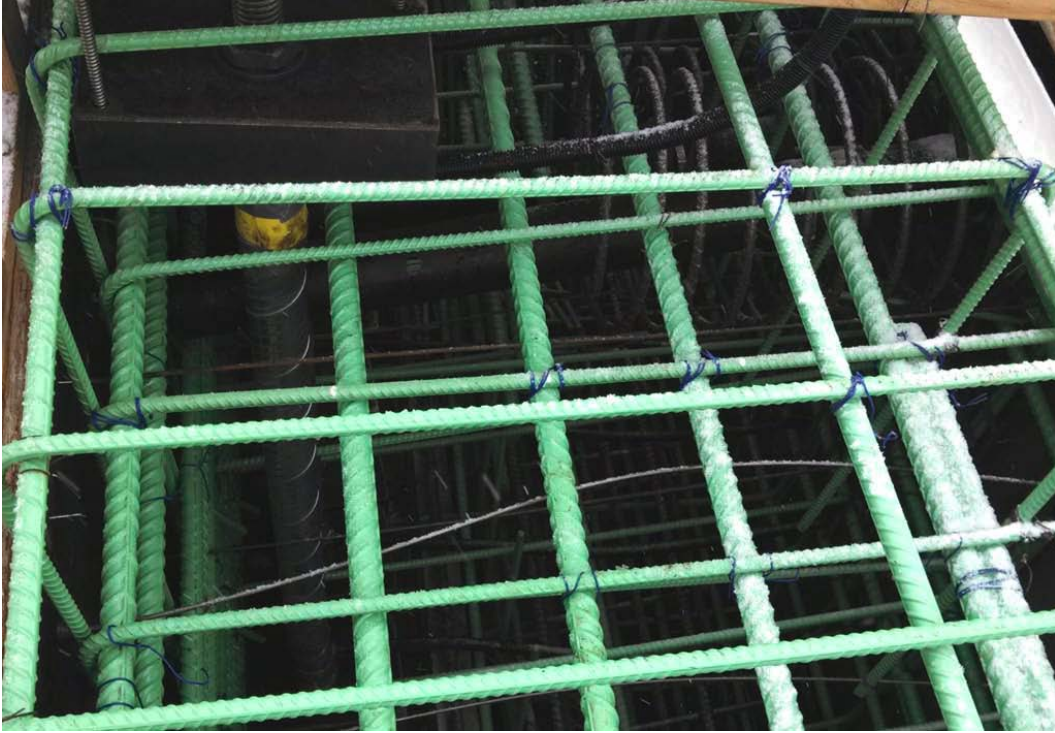
Figure 19. Photo. Vertical tendons in end diaphragms (courtesy: Colorado DOT).

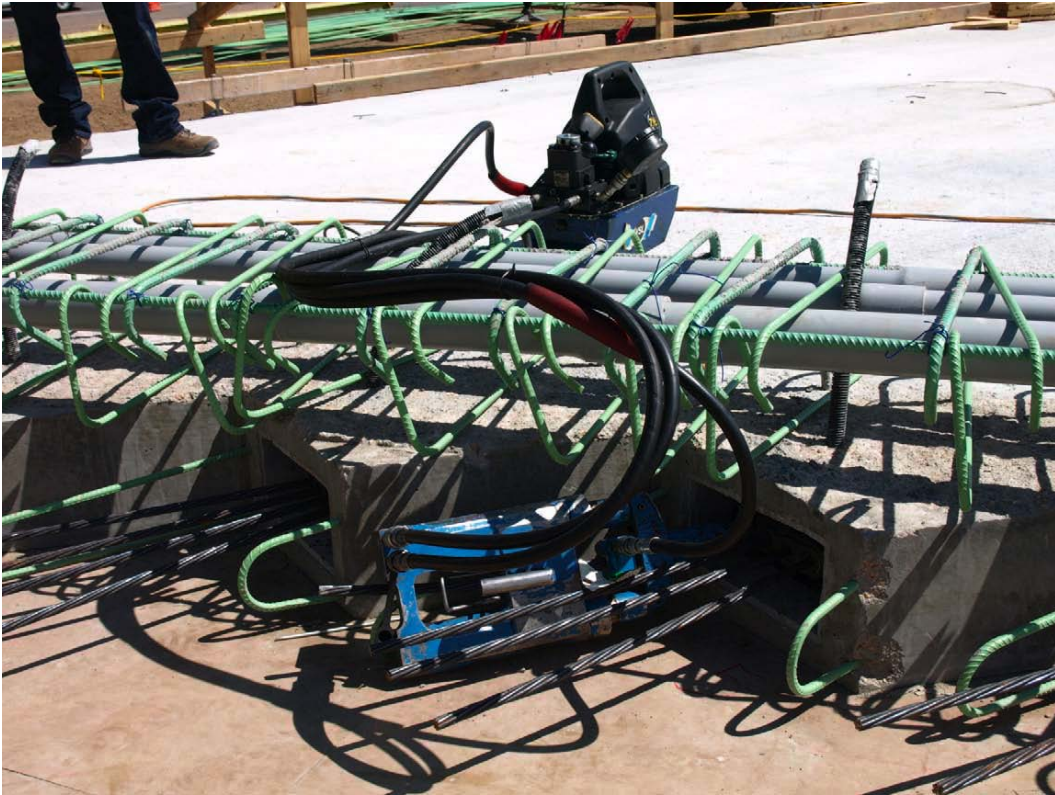
Figure 20. Photo. Transverse deck tendons (courtesy: Colorado DOT).

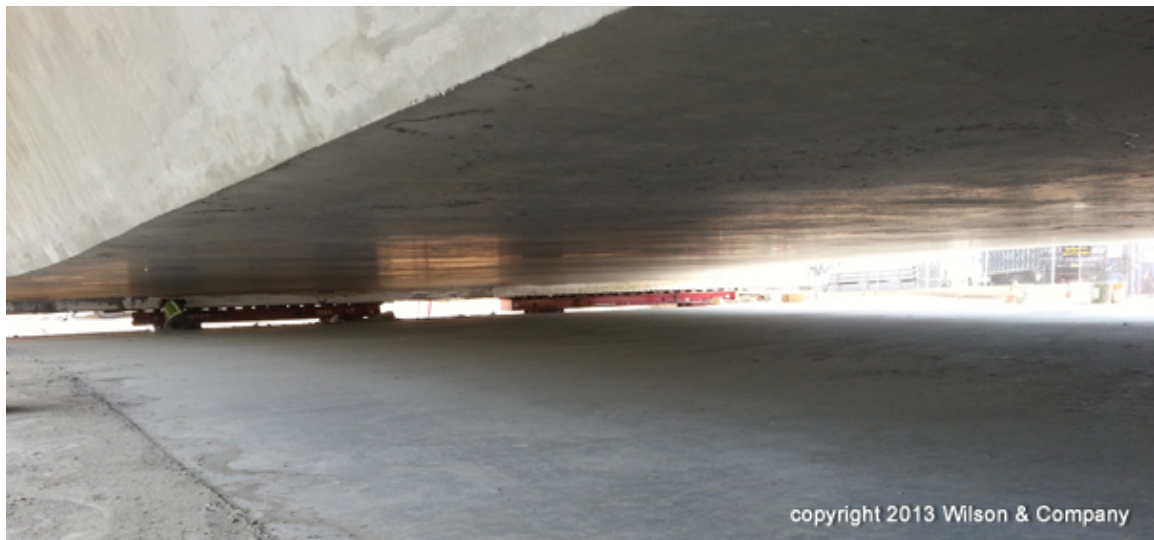
Figure 21. Photo. Completed superstructure on temporary supports (courtesy: Colorado DOT).

The completed superstructure shown in figure 21 also needed to be monitored for deflections and twist during lifting, transfer of support to lifting diaphragms, transport from the bridge staging area to the bridge abutments, and transfer to its final position. Both twist and deflection were monitored at points shown in figure 6 to ensure that they did not exceed the maximum specified (0.75 inches for twist and 0.25 inches for deflection). A total of 96 SPMT axles, each axle capable of carrying approximately 30 tons, were deployed to lift the superstructure, estimated to weigh 2,400 tons.

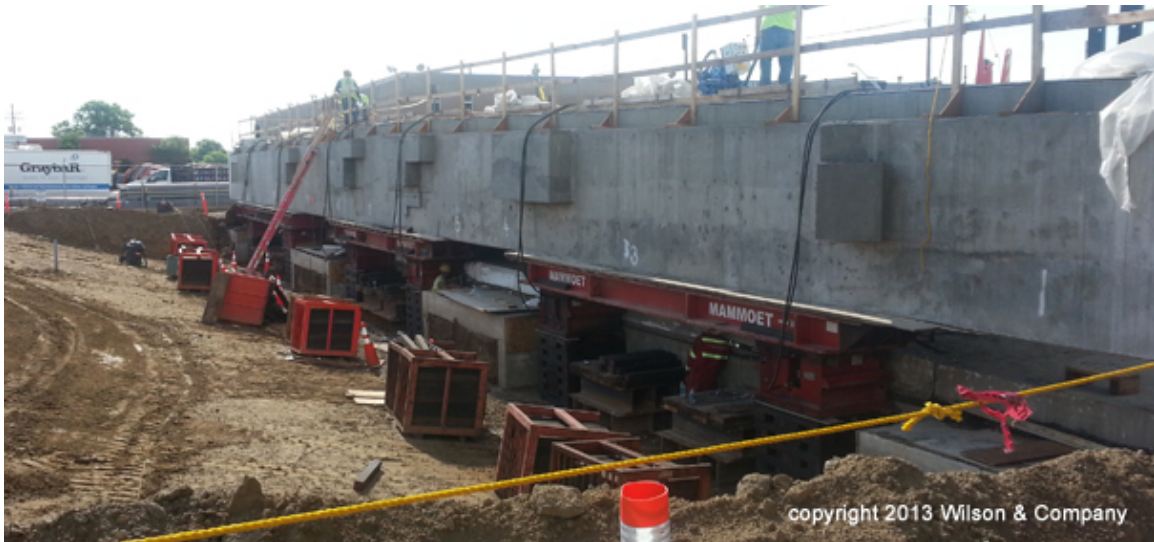
Figure 22. Photo. End diaphragms on temporary support (courtesy: Colorado DOT).

Figure 22 shows the temporary support in its lowered position, and figure 23 shows the support in raised position to accommodate rolling in of the SPMTs under the lifting diaphragms. Figure 24 shows the operator guiding a SPMT under one of the two lifting diaphragms, and figure 25 shows the frames connecting the SPMT units. Figure 26 shows workers connecting one of the two frames to a unit under one of the two lifting diaphragms.

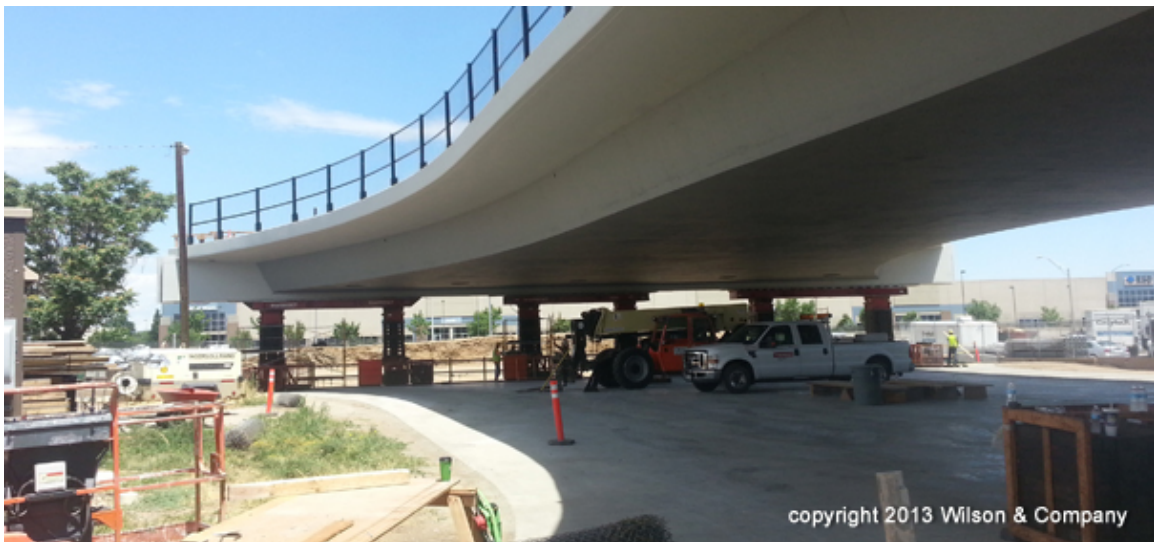
Figure 23. Photo. Superstructure lifted at end diaphragm supports (courtesy: Colorado DOT).

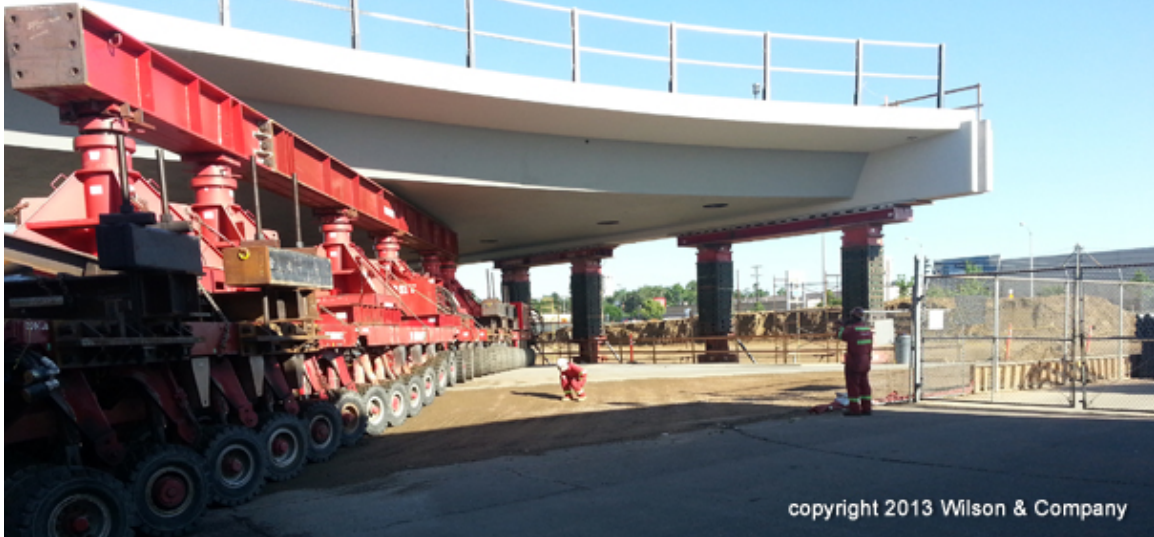
Figure 24. Photo. Operator rolling SPMT into position under the lifting diaphragms (courtesy: Colorado DOT).

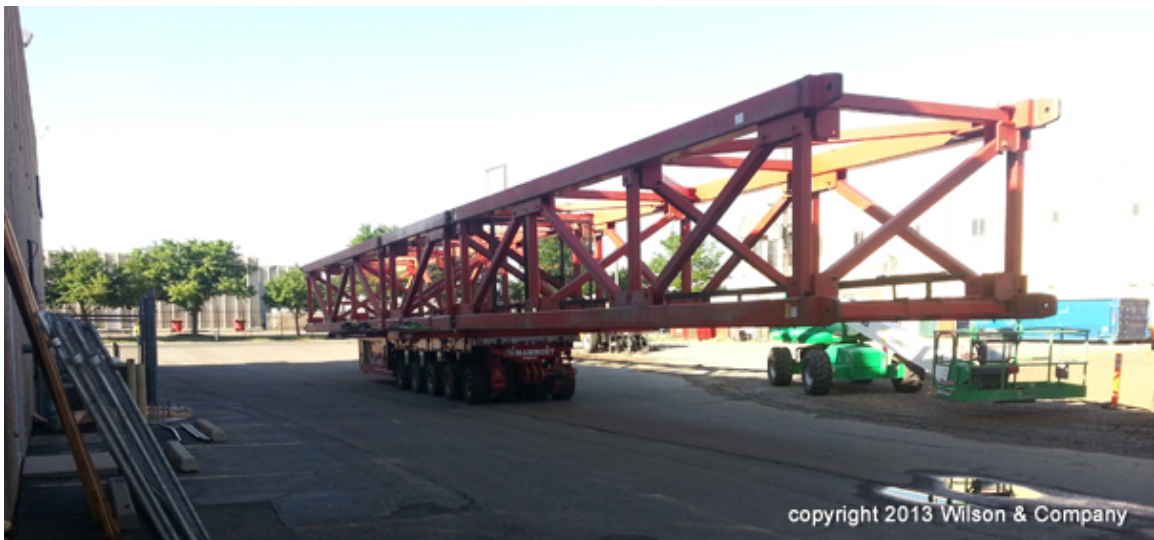
Figure 25. Photo. Frame used to connect equipment under lifting diaphragms (courtesy: Colorado DOT).

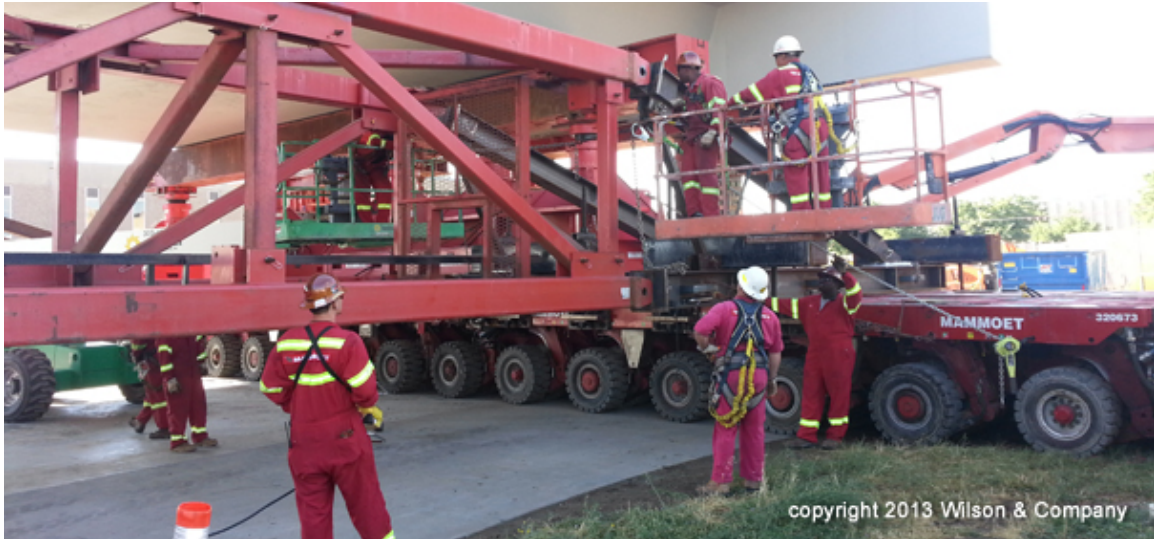
Figure 26. Photo. Workers connecting frame (courtesy: Colorado DOT).

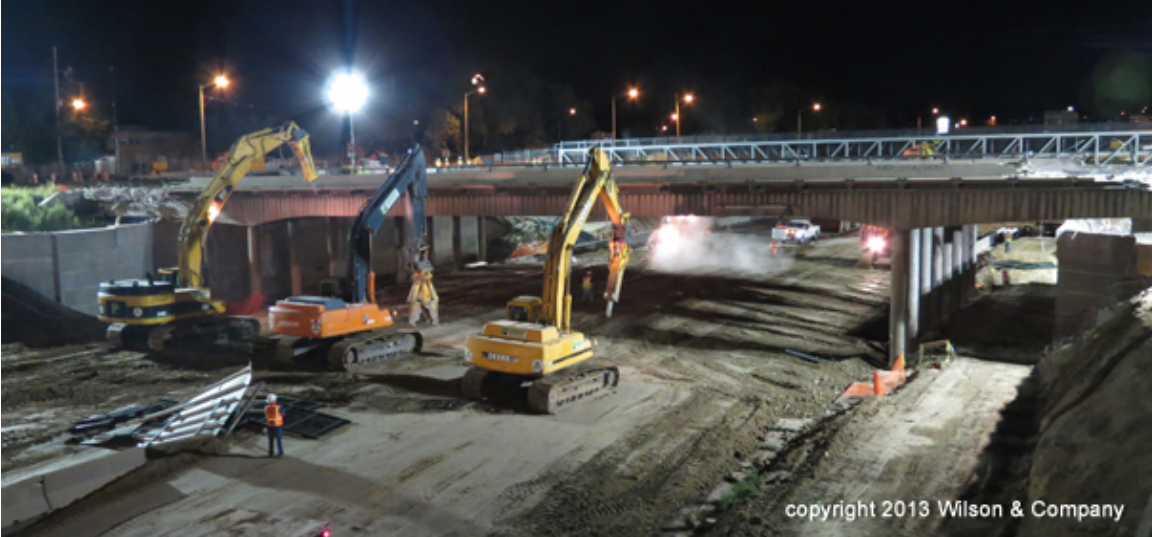
Figure 28. Photo. Demolition of old structure underway (courtesy: Colorado DOT).

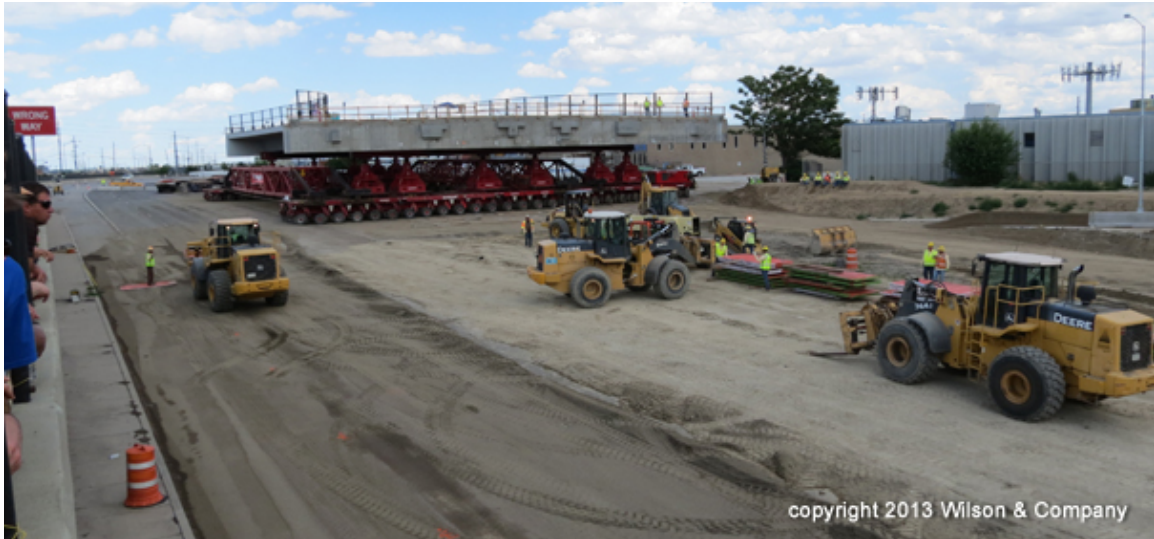
Figure 30. Photo. Superstructure on SPMT preparing to get on to I-70 (courtesy: Colorado DOT).

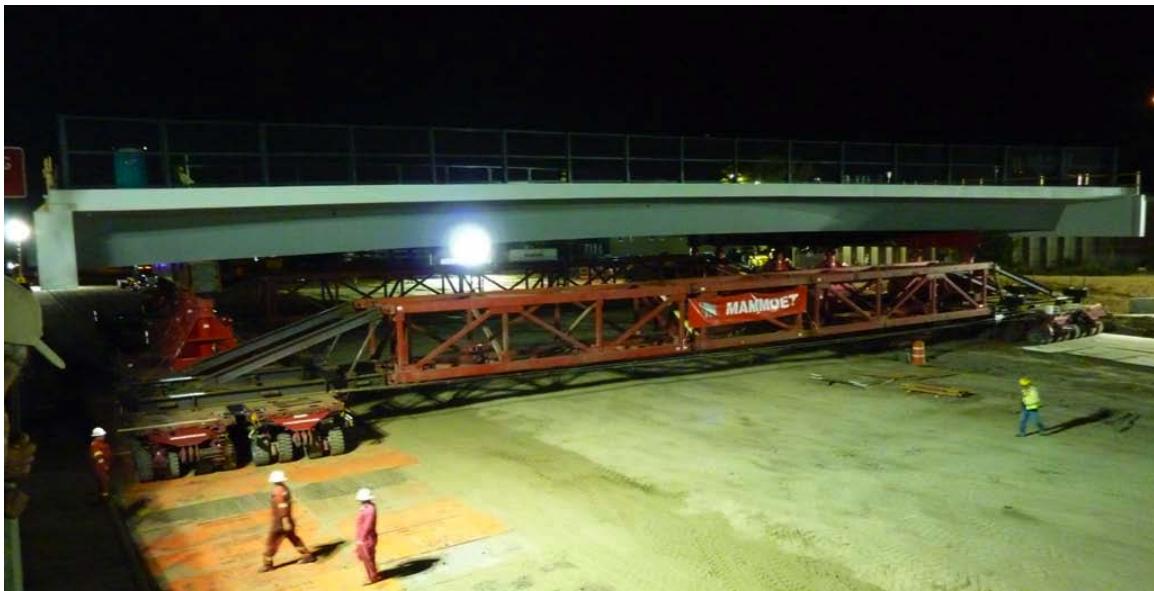
Figure 31. Photo. SPMT traveling over steel plates westward on I-70 (courtesy: Colorado DOT).

I-70 traveling at approximately 100 to 120 feet per hour. Figure 31 shows the SPMT moving westward over steel plates along the travel path, and figure 32 shows the structure being aligned and positioned over the abutments.

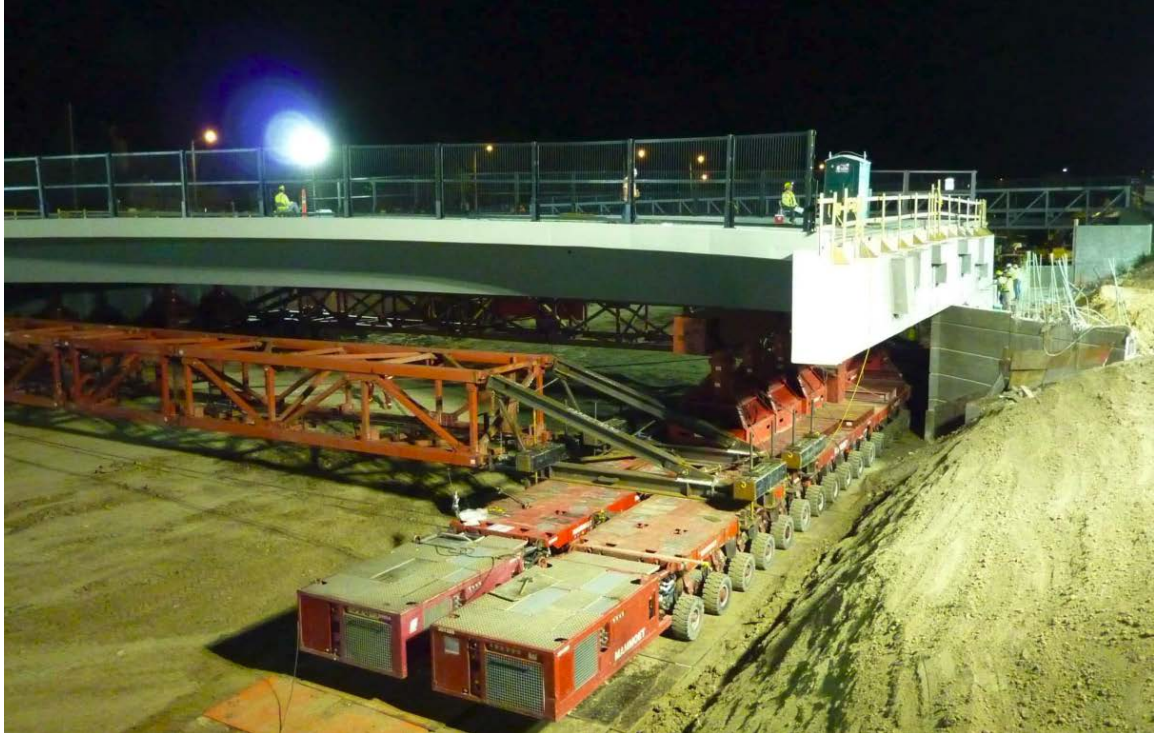
Figure 32. Photo. Superstructure being placed over abutments (courtesy: Colorado DOT).

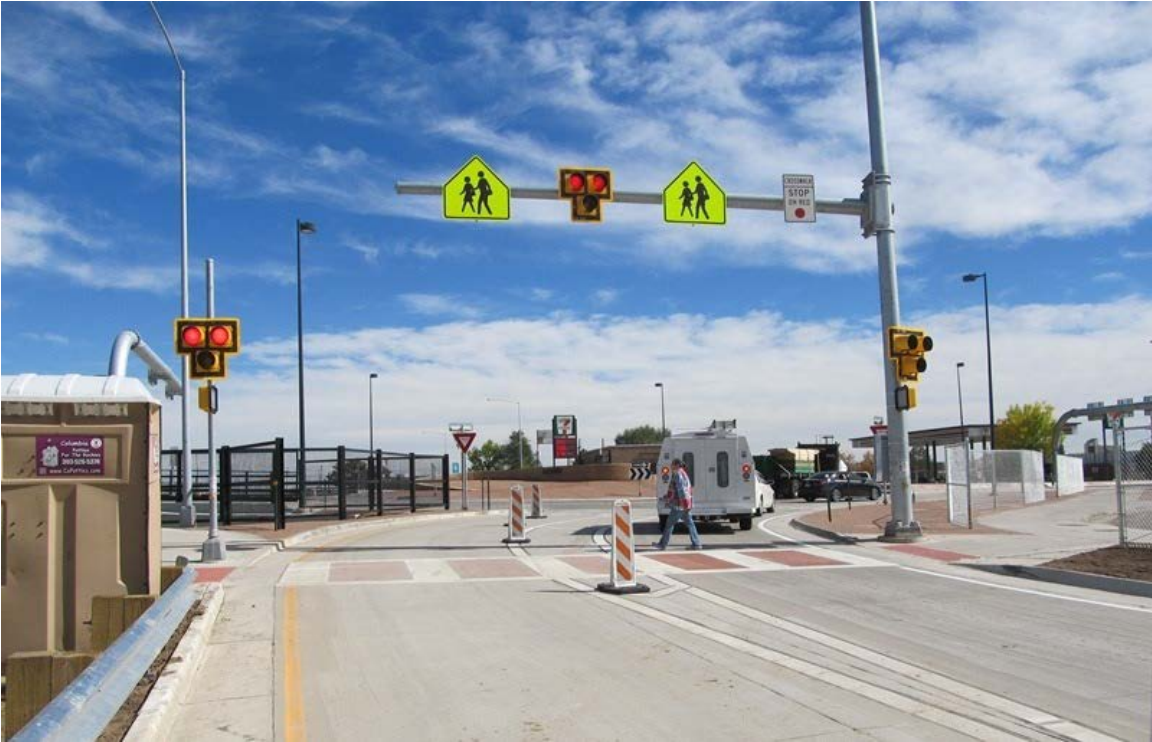
Figure 33. Photo. Pedestrian crossing with HAWK signal (courtesy: Colorado DOT).

walk” mode until the signal is activated by another pedestrian. Figure 33 shows the pedestrian signal, and figure 34 shows the pedestrian bridge crossing over I-70.
