# Reducing the Risks of Nonstructural Earthquake Damage

## **A Practical Guide**

**FEMA 74/September 1994  
Supersedes 1985 Edition**

**WISS, JANNEY, ELSTNER ASSOCIATES, INC.**

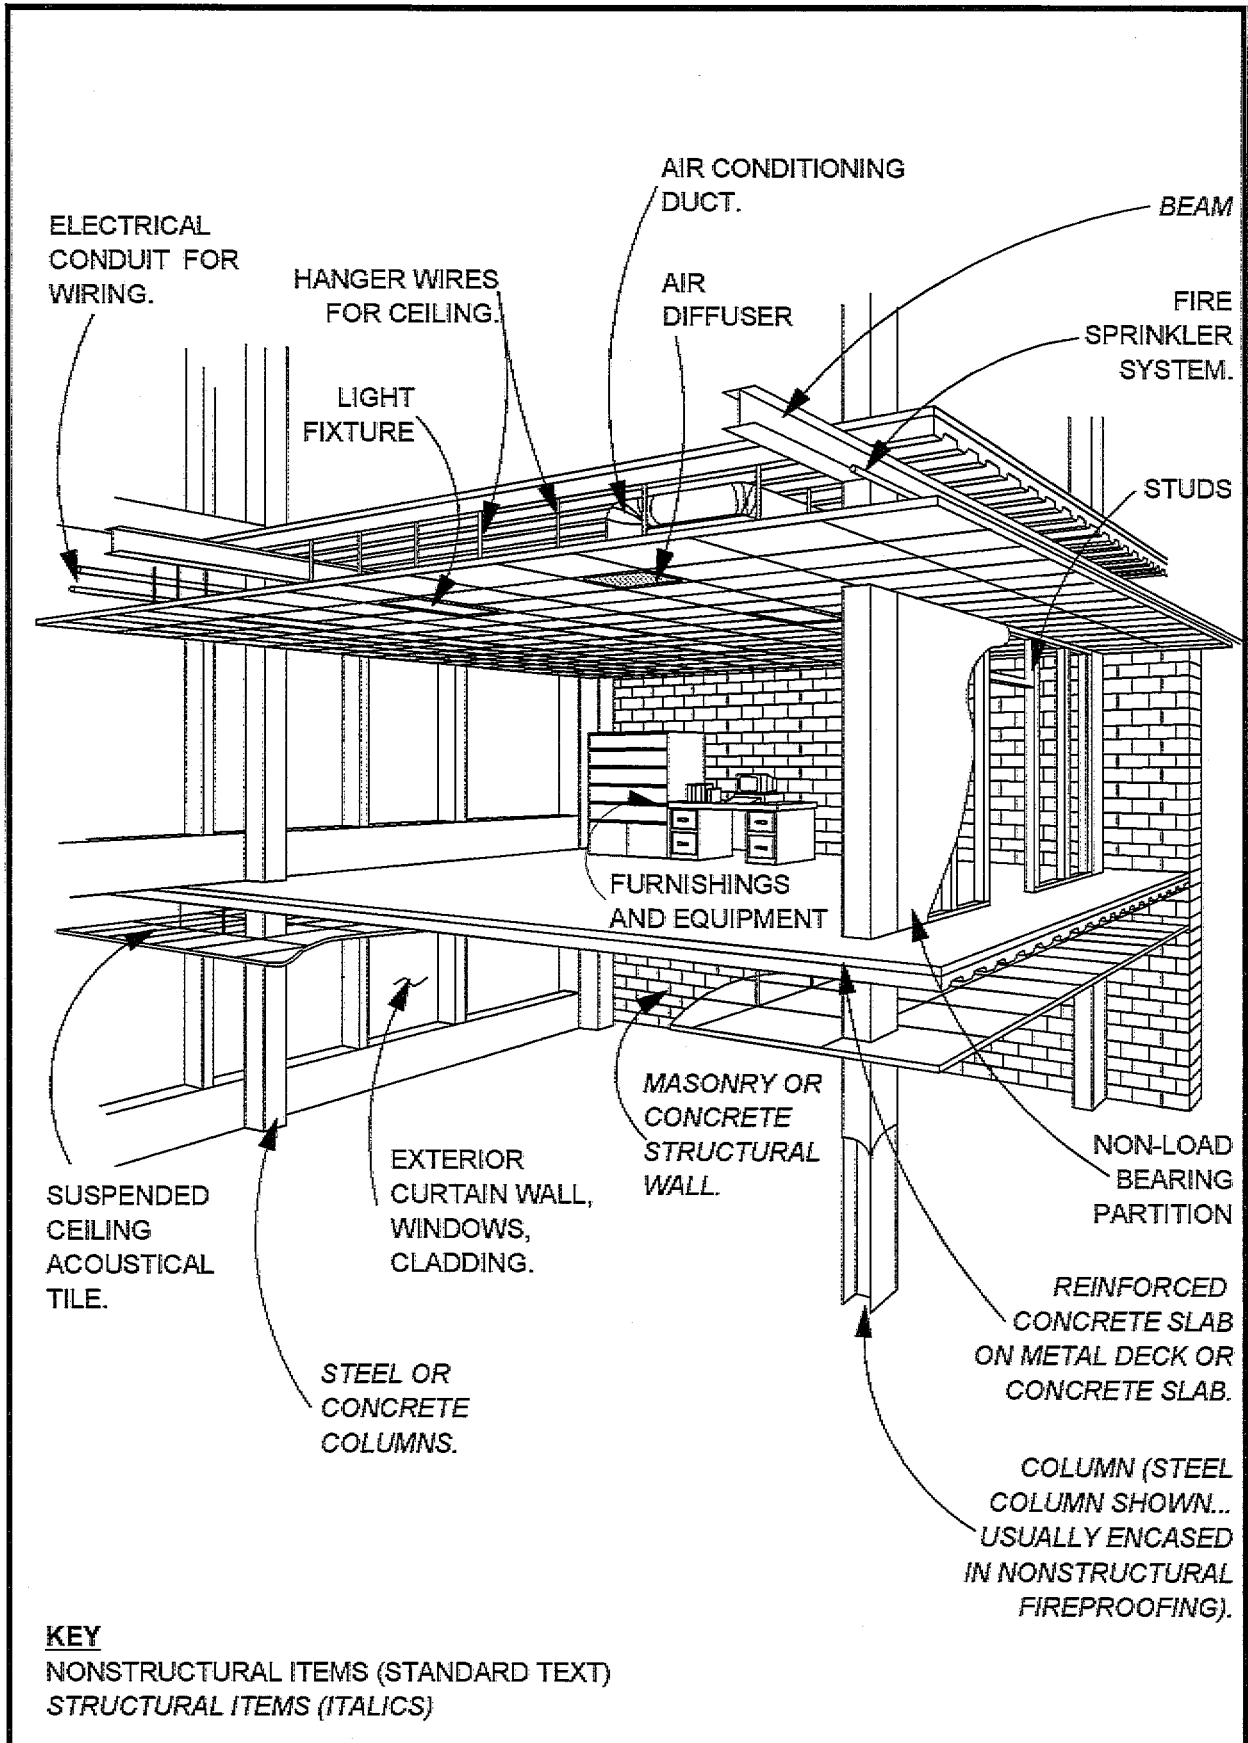
**Figure 1 - Nonstructural and Structural Components of a Typical Building**

**Structural** The structural portions of a building are those that resist gravity, earthquake, wind, and other types of loads. These are called structural components and include columns (posts, pillars); beams (girders, joists); braces; floor or roof sheathing, slabs, or decking; load-bearing walls (i.e., walls designed to support the building weight and/or provide lateral resistance); and foundations (mat, spread footings, piles). For buildings planned by design professionals, the structure is typically designed and analyzed in detail by a structural engineer.

**Nonstructural** The nonstructural portions of a building include every part of the building and all its contents with the exception of the structure--in other words, everything except the columns, floors, beams, etc. Common nonstructural components include ceilings; windows; office equipment; computers; inventory stored on shelves; file cabinets; heating, ventilating, and air conditioning (HVAC) equipment; electrical equipment; furnishings; lights; etc. Typically, nonstructural items are not analyzed by engineers and may be specified by architects, mechanical engineers

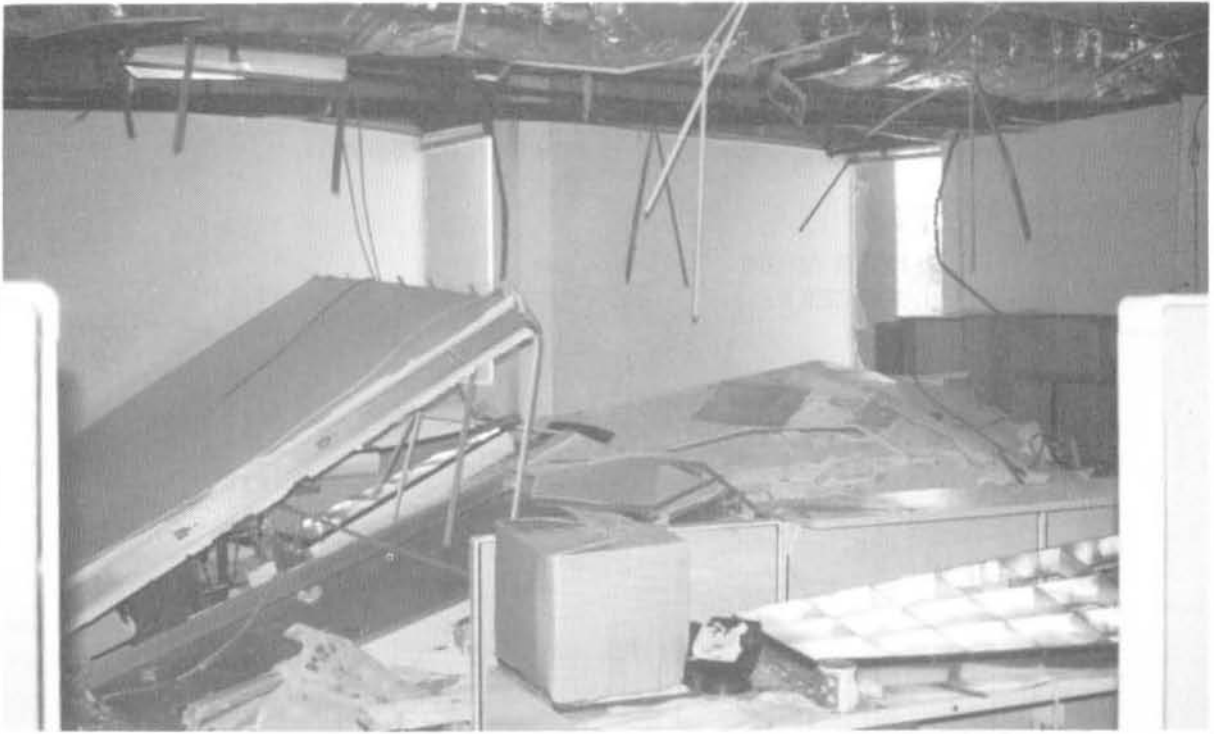
**Figure 2 - Examples of Hazardous Nonstructural Damage**

Failure of office partitions, ceilings, and light fixtures  
Earthquake Damage: 1994, Northridge, California  
Photo Credit: Wiss, Janney, Elstner Associates, Inc.

has occurred during past earthquakes include broken glass, overturned tall and heavy cabinets or shelves, falling ceilings or overhead light fixtures, ruptured gas lines or other piping containing hazardous materials, damaged friable asbestos materials, falling pieces of decorative brickwork or precast concrete panels, and collapsed masonry walls or fences. (Figures 2 and 3).

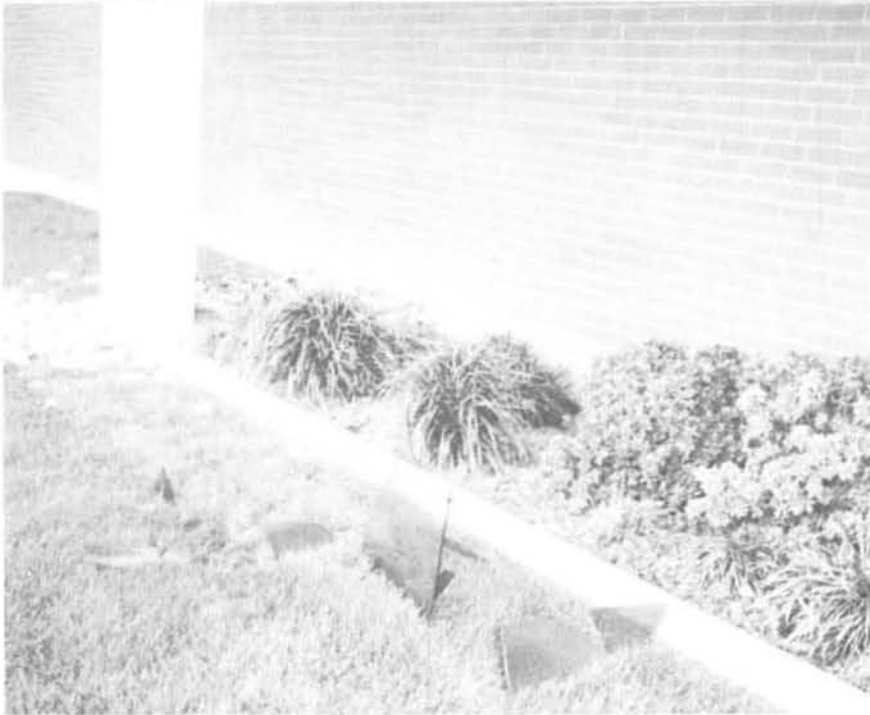
Shard of broken nontempered glass that fell several stories from a multistory building  
Earthquake Damage: 1994, Northridge, California  
Photo Credit: Wiss, Janney, Elstner Associates, Inc.

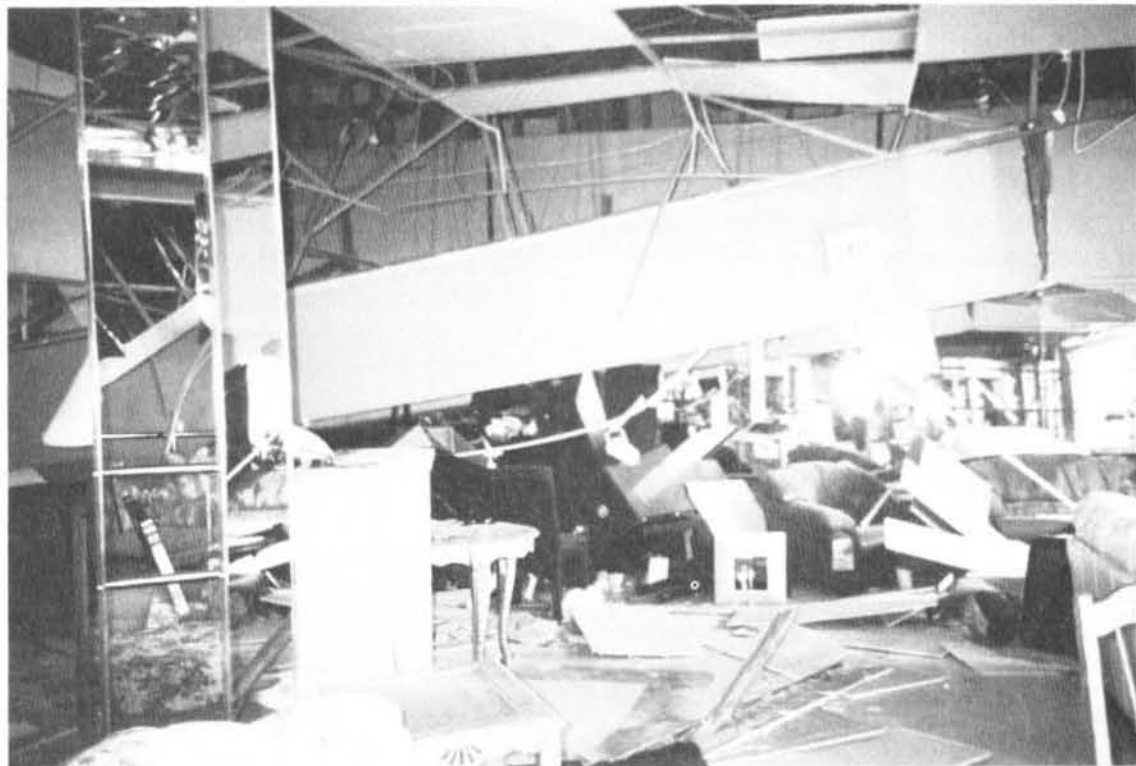
**Figure 3 - Examples of Hazardous Nonstructural Damage**

Failure of suspended ceiling and light fixtures in furniture store  
Earthquake Damage: 1994, Northridge, California  
Photo Credit: William McKeivitt

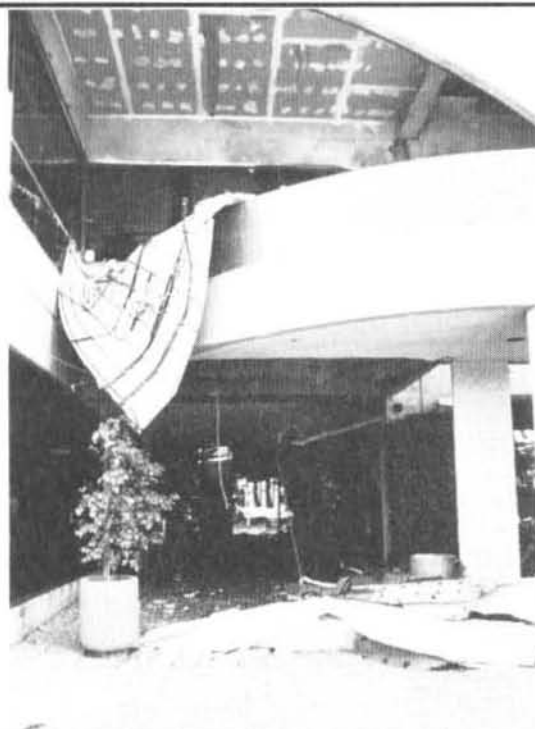
Failure of heavy stucco soffit at building entrance  
Earthquake Damage: 1994, Northridge, California  
Photo Credit: Robert Reitherman

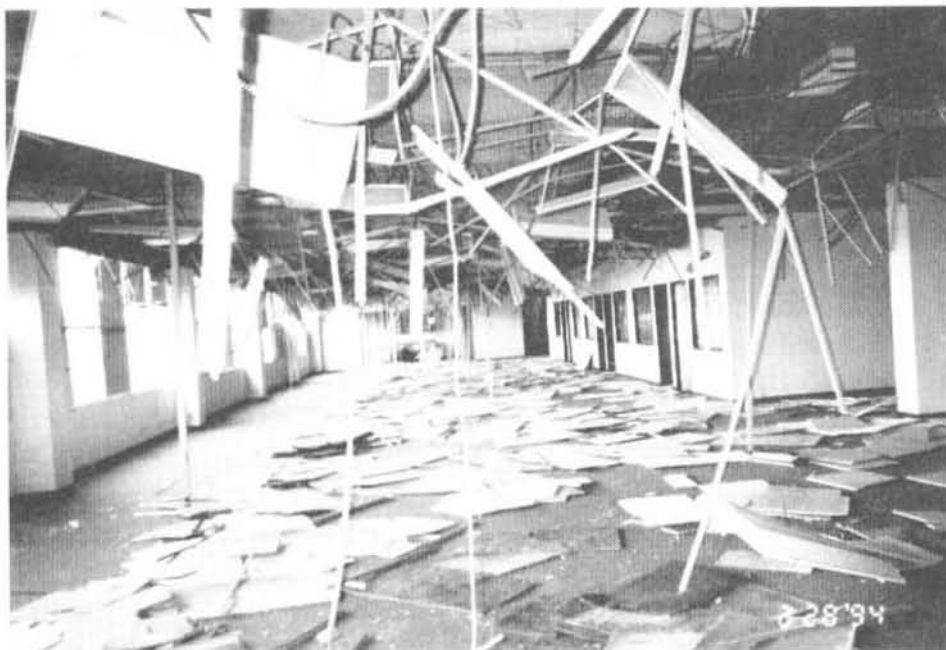
**Figure 4 - Examples of Property Loss Due to Nonstructural Damage**

Complete loss of suspended ceiling and light fixtures  
Earthquake Damage: 1994, Northridge, California  
Photo Credit: Wiss, Janney, Elstner Associates, Inc.

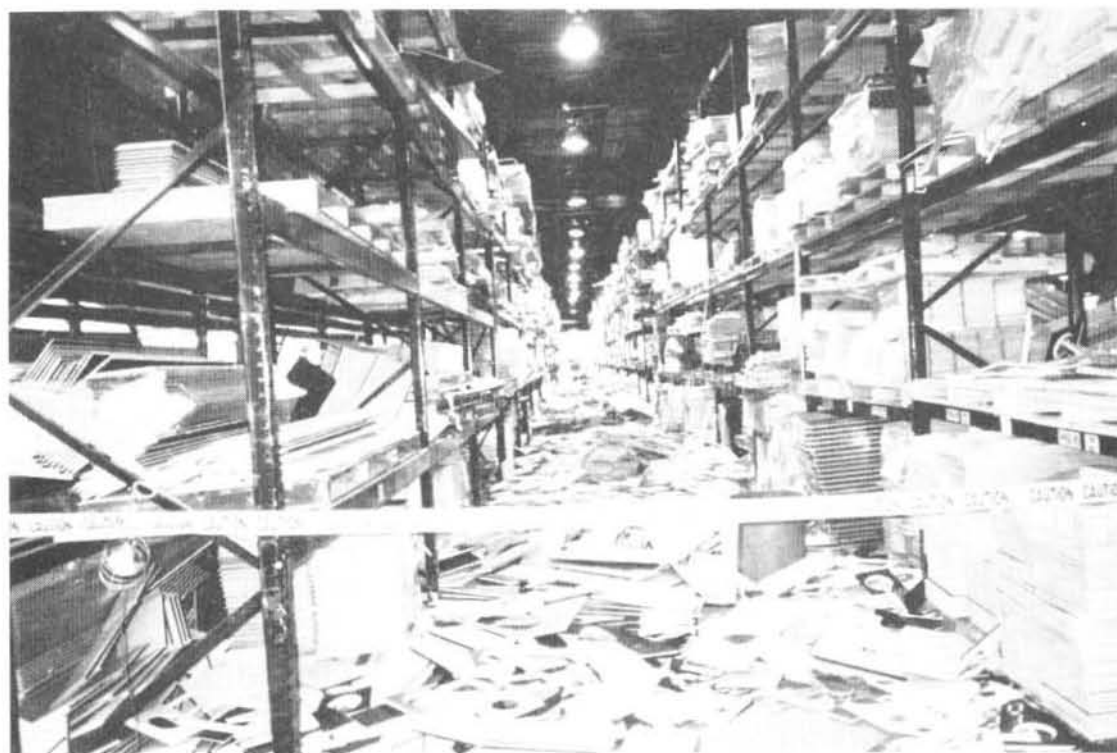
Damage to inventory on industrial storage racks  
Earthquake Damage: 1994, Northridge, California  
Photo Credit: Wiss, Janney, Elstner Associates, Inc.

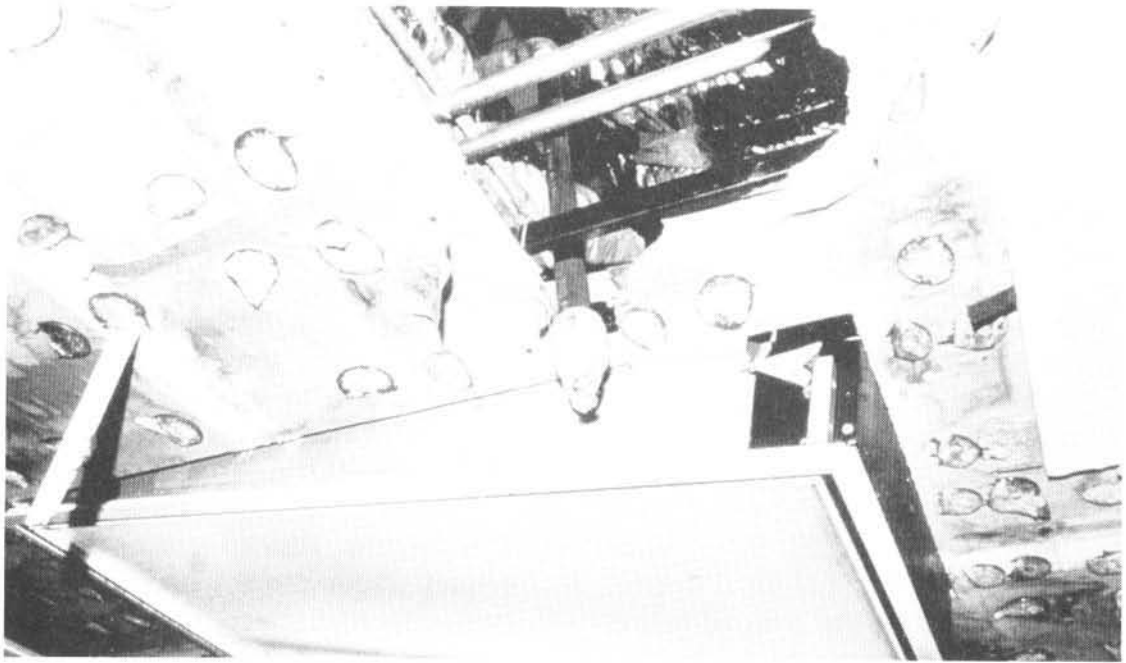
**Figure 5 - Examples of Loss of Function Due to Nonstructural Damage**

Broken sprinkler pipe at Olive View Hospital in Sylmar—pipe ruptured at the elbow joint due to differential motion within the ceiling plenum. Water leakage from broken fire sprinklers and water lines forced the hospital to close for several days.  
Earthquake Damage: 1994, Northridge, California  
Photo Credit: Robert Reitherman

in some cases water was flowing for many hours. At one facility, water up to 2 feet deep was reported at some locations in the building as a result of damage to the domestic water supply tank on the roof. At another, the emergency generator was disabled when its cooling water line broke where it crossed a separation joint. Other damage at these facilities included broken glass, dangling light fixtures, elevator counterweight damage, and lack of emergency power due to failures in the distribution or control systems. Two of these facilities, Los Angeles County Olive View Medical Center and Holy Cross Medical Center, both in Sylmar, California, had suffered severe structural damage or collapse during the 1971 San Fernando earthquake and had been demolished and entirely rebuilt [3]. (See Figure 5).

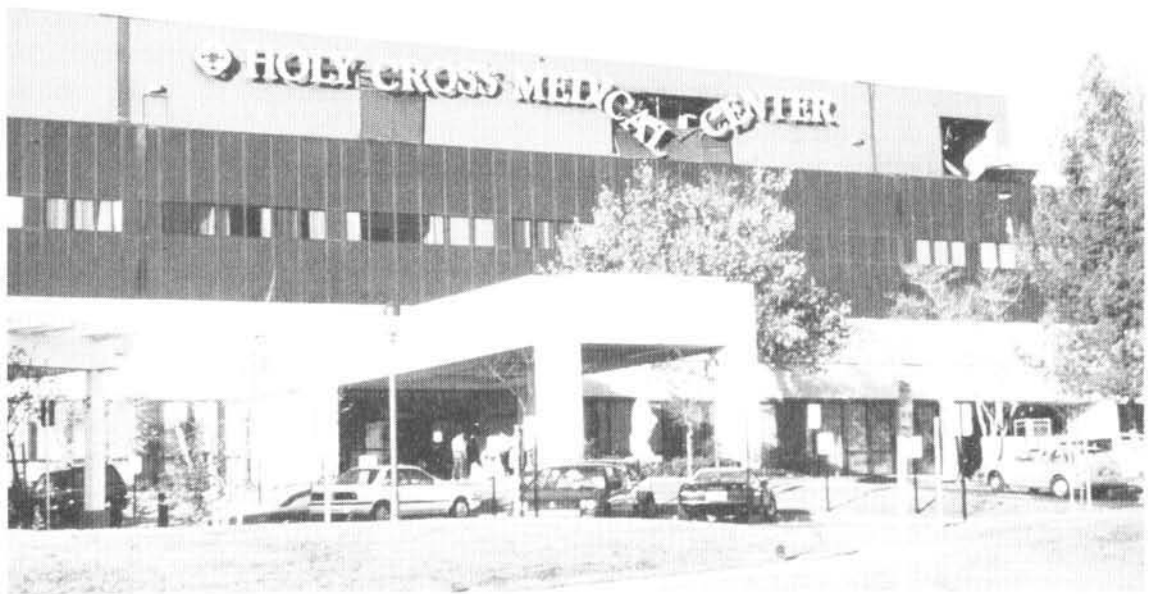
HVAC damage at Holy Cross Medical Center in Sylmar—damage to signage and louvers caused when suspended fans in the mechanical penthouse swung and impacted the louver panels. HVAC service outage caused the temporary evacuation of all patients.  
Earthquake Damage: 1994, Northridge, California  
Photo Credit: Robert Reitherman

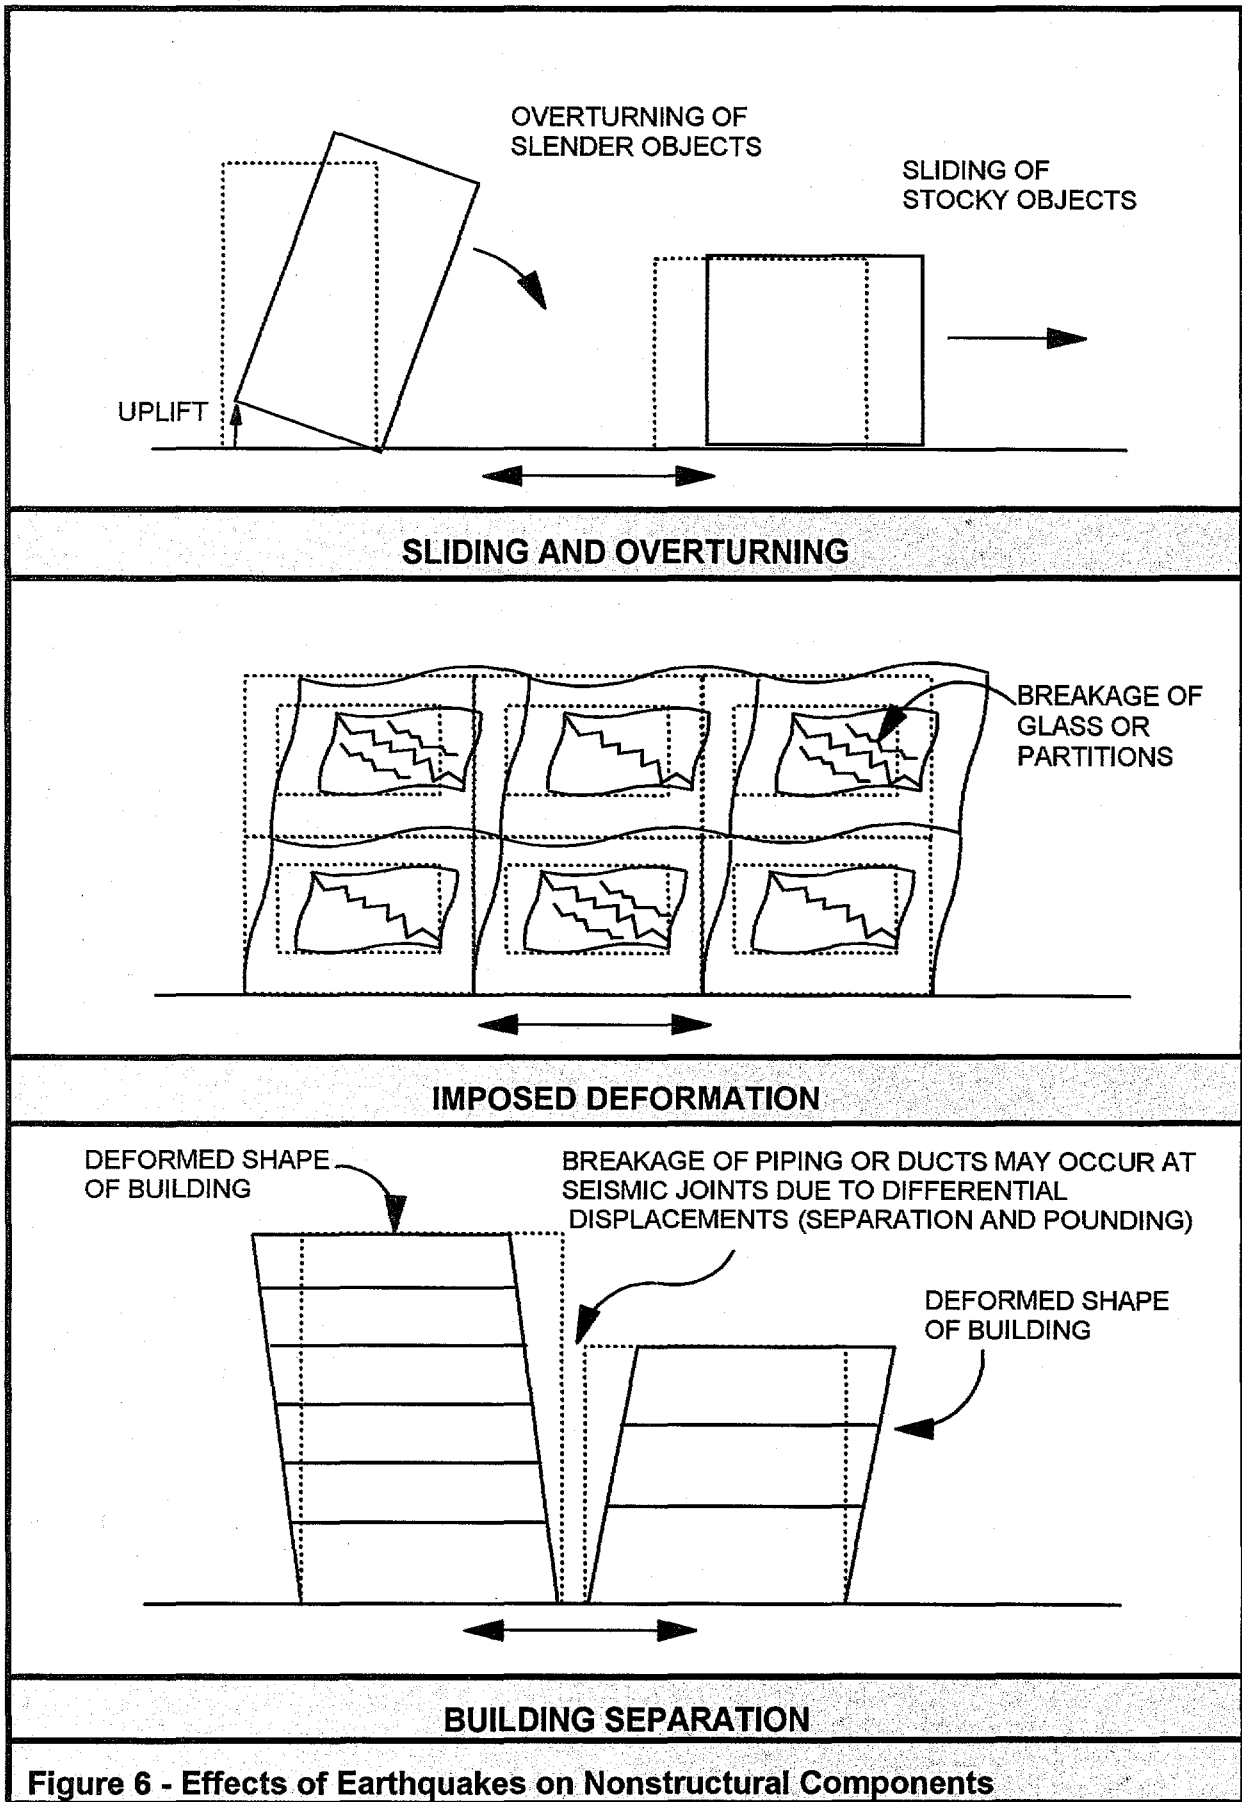
**Figure 6 - Effects of Earthquakes on Nonstructural Components**

File cabinets, emergency power-generating equipment, freestanding bookshelves, office equipment, and items stored on shelves or racks can all be damaged because of inertial forces. When unrestrained items are shaken by an earthquake, inertial forces may cause them to slide, swing, strike other objects, or overturn. Items may slide off shelves and fall to the floor. One common misconception is that large, heavy objects are stable and not as vulnerable to earthquake damage as lighter objects, perhaps because we may have difficulty moving them. In fact, many types of objects may be vulnerable to earthquake damage caused by inertial forces: since inertial forces during an earthquake are proportional to the mass or weight of an object, a heavily loaded file cabinet requires much stronger restraints to keep it from sliding or overturning than a light one with the same dimensions.

***Building Separations*** Another source of nonstructural damage involves pounding or movement across separation joints between

adjacent structures. A separation joint, is the distance between two different building structures, often two wings of the same facility, that allows the structures to move independently of one another. A seismic gap is a separation joint provided to accommodate relative lateral movement during an earthquake. In order to provide functional continuity between separate wings, building utilities must often extend across these building separations, and architectural finishes must be detailed to terminate on either side. For base-isolated buildings that are mounted on seismic shock absorbers, a seismic isolation gap occurs at the ground level, between the foundation and the base of the superstructure. The separation joint may be only an inch or two in older construction or as much as a foot in some newer buildings, depending on the expected horizontal movement, or seismic drift. Flashing, piping, fire sprinkler lines, HVAC ducts, partitions, and flooring all have to be detailed to accommodate the seismic movement expected at these locations when the two structures move closer together or further apart. Damage to items crossing seismic gaps is a common type of earthquake damage. If the size of the gap is insufficient, pounding between adjacent structures may result in damage to structural components but often causes damage to nonstructural components, such as parapets, veneer, or cornices on the facades of older buildings.

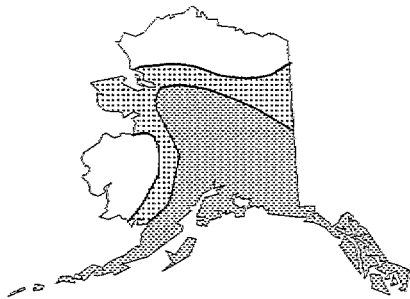
For the purposes of this guide, seismic hazard has been characterized in terms of three levels of shaking intensity: namely light, moderate, and severe. The seismic hazard maps presented in Figure 7 show the geographic areas in the United States where light, moderate and severe shaking are likely to occur in future earthquakes.

Note: There is approximately a 10% chance in 50 years that any given site will experience the shaking intensity shown. Map adapted from the following sources: 1991 NEHRP Recommended Provisions (primary source) and 1994 Uniform Building Code (basis for western states).
