Earthquake Resistant Construction of Electric Transmission and Telecommunication Facilities Serving the Federal Government Report

NISTIR 89 - 4213

**EARTHQUAKE RESISTANT CONSTRUCTION OF ELECTRICAL TRANSMISSION AND
TELECOMMUNICATION FACILITIES SERVING THE FEDERAL GOVERNMENT**

Felix Y. Yokel

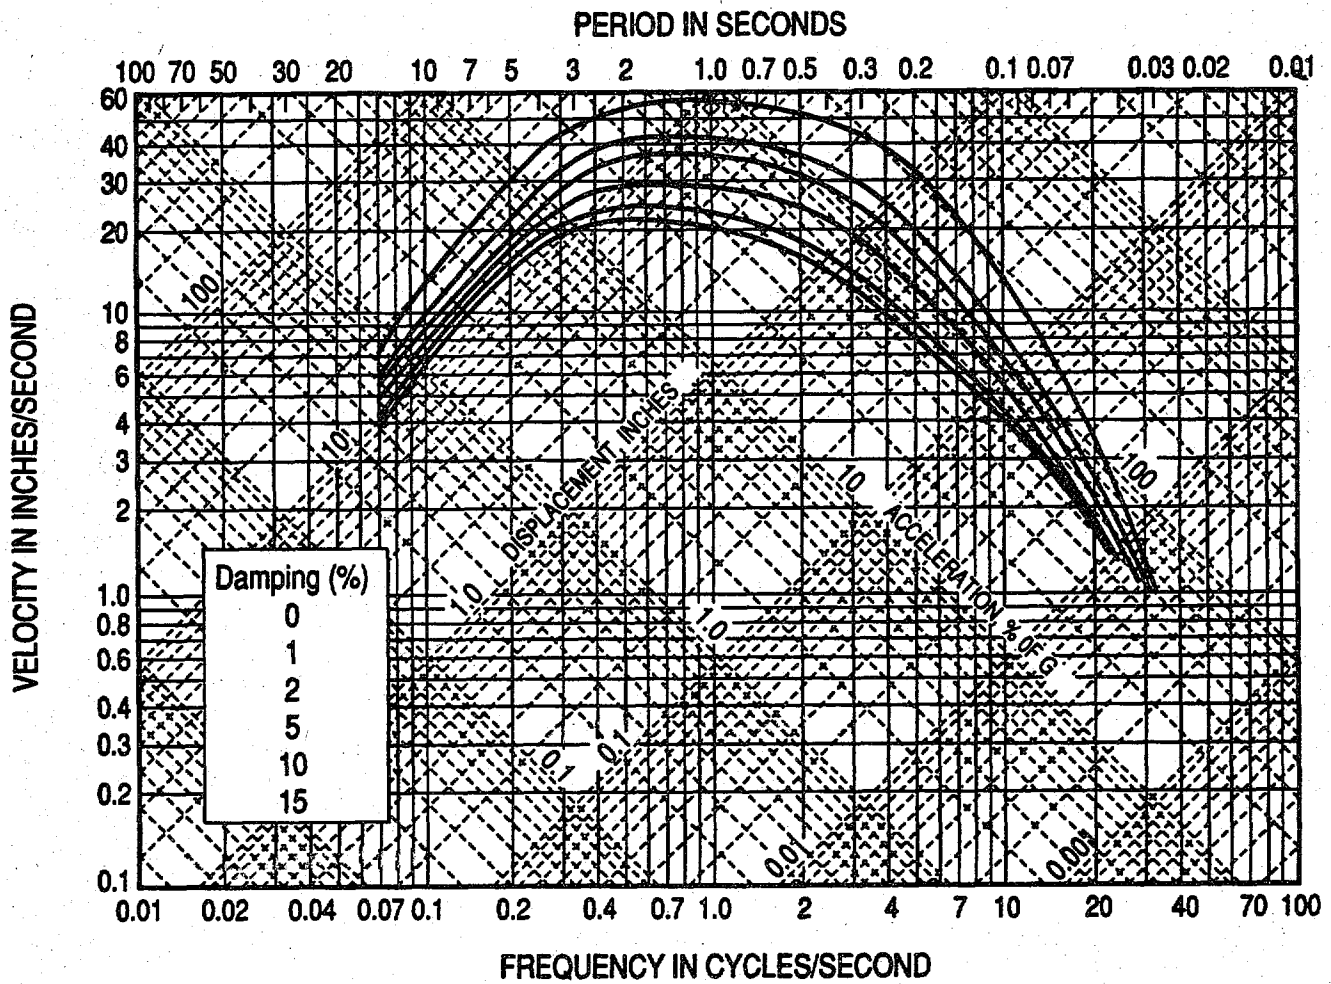
Figure 1: Seismic Design Response Spectra for Electrical Substation Equipment (from City of Los Angeles, 1988).

Seismic design of electrical equipment in substations is covered by the American National Standards Institute (ANSI) and the Institute of Electrical and Electronics Engineers, Inc.(IEEE), ANSI/IEEE Standard 693-1984, which in turn references ANSI/IEEE Standard 344-1987, "IEEE Recommended Practice for Seismic Qualification of Class 1E Equipment for Nuclear Power Generating Stations". The standard identifies Class A equipment or systems, whose failure would prevent the proper functioning of the substation, and equipment of lesser importance. Equipment can be qualified by testing, analysis, or on the basis of prior experience. The standard contains performance criteria for all substation components. However, its most important features are criteria for the qualification of equipment. These criteria, together with a specified maximum design ground acceleration, specify the seismic resistance of equipment to be furnished by suppliers. West Coast power companies consider the present ANSI/IEEE Standard 693 inadequate and substitute their own specifications for the performance of individual components. Figure 1 shows design spectra specified by the City of Los Angeles for various damping ratios for a maximum ground acceleration is 0.5 G. The accelerations in the spectra are scaled up or down in accordance with the stipulated maximum ground acceleration.

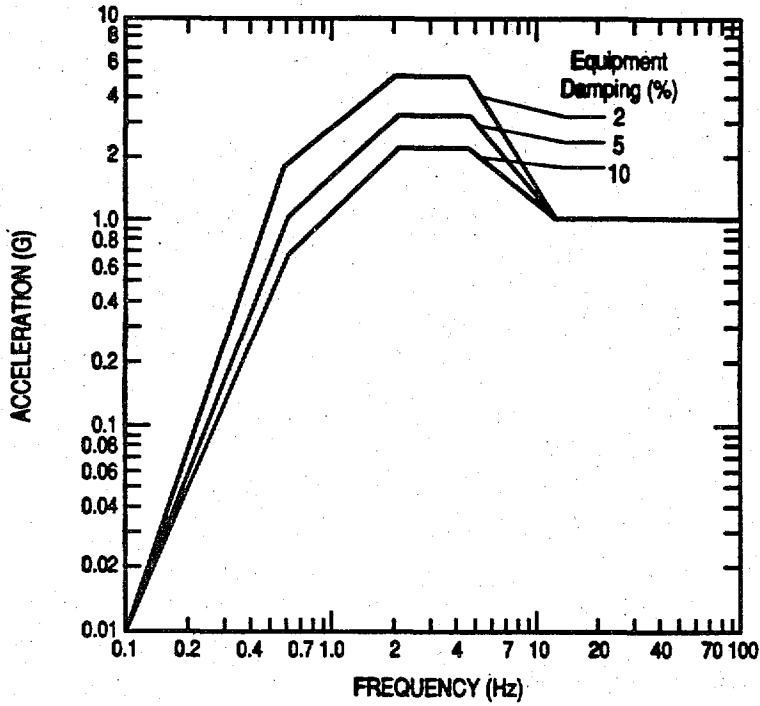
Installation Location	Zone			
	4	3	2	1
Upper Floors	1.0	0.6	0.4	0.3
Midlevel Floors	0.9	0.5	0.3	0.2
Ground-Level and Basement Floors	0.8	0.4	0.2	0.1

Figure 2: Seismic Design Response Spectra Recommended for Telecommunication Equipment (reproduced from Bellcore, 1988)
