# Reconstructing Non-Residential Buildings After a Tornado

**TORNADO RECOVERY ADVISORY**

RA8, August 2011

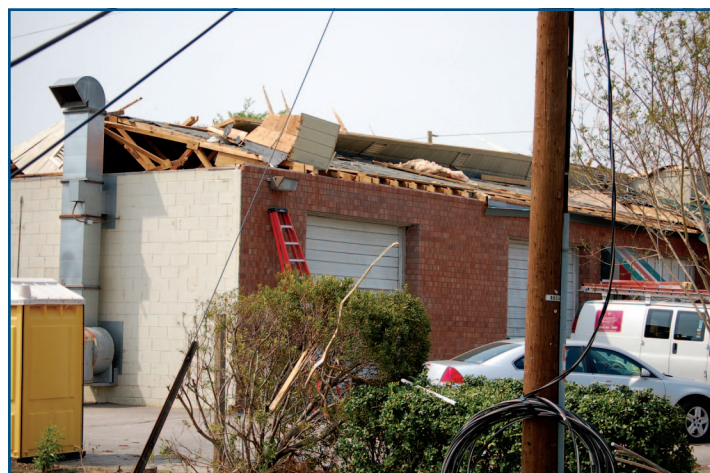
**Figure 1: A business damaged by roof damage and water intrusion from a weak tornado**

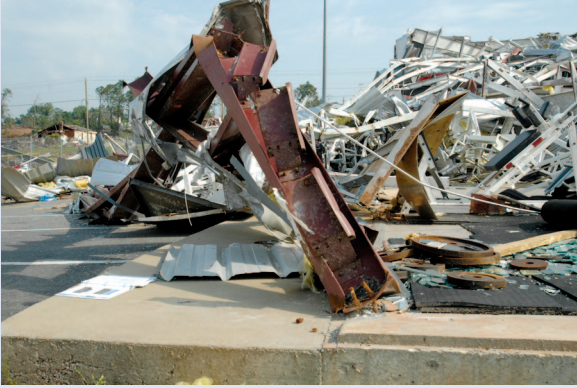
Building Component	Typical Failure	Recommended Practice
Superstructure		
Pre-Engineered Buildings	<p>Failure of endwall trusses and endwall truss bracing.</p>

<p>Size the endwall trusses to resist wall loads and verify that anchor bolts are sized to resist lateral loading. (Source: FEMA 489)</p>
Masonry Buildings	<p>Collapse of unreinforced masonry walls.</p>

**Pre-Engineered Buildings:** Pre-engineered buildings can sustain significant loss of exterior sheeting, and in some cases, failure of the frame. Exterior sheeting should be sufficiently supported to resist deflection from high winds; additional girts and purlins may be required. Increasing the thickness of the exterior sheeting can reduce the potential for sheeting pulling off connectors. Endwall trusses of pre-engineered buildings should be designed to resist wall loads, and anchor bolts should be sized to resist uplift from high wind loads.

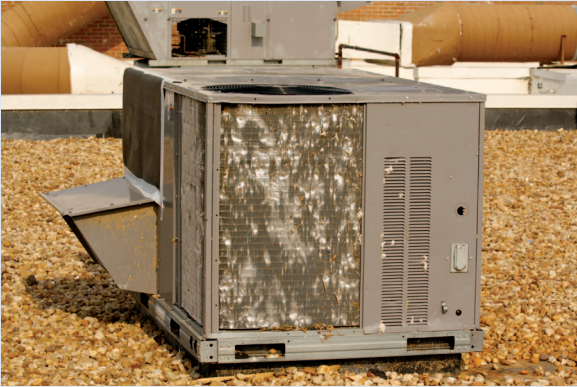
<p>Fully grout walls and increase reinforcement to resist lateral loads and uplift loads on the roof system. (Source: FEMA P-424)</p>
Roof Coverings and Roof Systems		
Ballasted Roofs	<p>Ballasted roof systems can become wind-borne debris and damage surrounding objects.</p>

<p>Select an alternative ballasting system or fully adhere ballast to the roof system. (Source: FEMA P-424)</p>

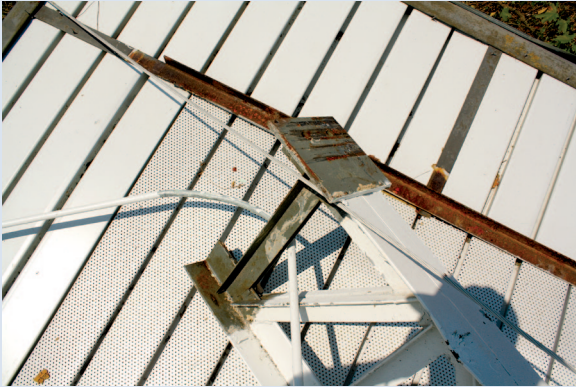
Building Component	Typical Failure	Recommended Practice
<p>Roof Truss Connections</p>	<p>Loss of roof trusses from uplift loads. Trusses typically fail at the connection with the wall system, either through poor grouting of anchor bolts or insufficient embedment.</p>

<p>Improve connection of roof trusses to prevent failure from uplift loads. Verify that the load path is continued through the wall system into the foundation. (Source: FEMA P-424)</p>
<p>Double Tee Connections</p>	<p>Double tees shift due to uplift loads and failures at angle iron welds or insufficient anchor bolts, allowing the double tee to slip off the corbel.</p>

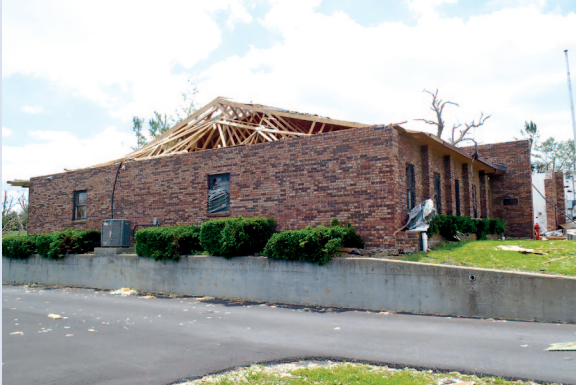
<p>Ensure that anchor bolts provide sufficient strength to prevent uplift. (Source: FEMA P-424)</p>
<p>Gable End Walls</p>	<p>Insufficient attachment of gable end walls results in building pressurization, loss of the roof system, and possibly large sections of the building.</p>

<p>Improve the gable end wall bracing details with additional connections and strengthen the load path. (Source: FEMA P-804)</p>

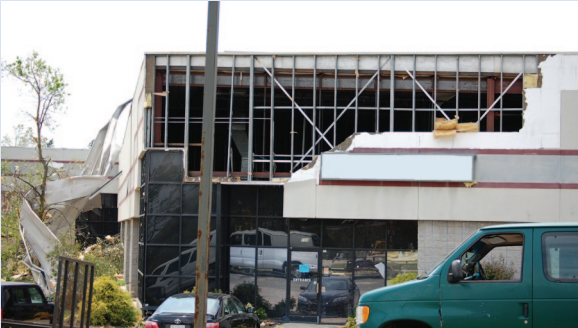
Building Component	Typical Failure	Recommended Practice
Building Envelope		
Metal Sheeting	<p>Loss of wall coverings due to insufficient girts.</p>  	<p>Increase framing between trusses to reduce loads on metal sheeting. Increase metal sheeting thickness to resist the potential for pulling off connectors. (Source: FEMA 489)</p>
Brick Veneer	<p>Wall failures resulting from insufficient brick ties.</p>  	<p>Increase number of brick ties, properly attach ties to the wall system, and sufficiently embed ties into the brick veneer. (FEMA P-499, Fact Sheet 5.1)</p>
Exterior Insulation and Finishing System (EIFS)	<p>Loss of large sections of EIFS due to impact of wind-borne debris.</p>

<p>Reduce vulnerability of EIFS by using it in locations that are high enough to prevent damage from wind-borne debris. (Source: FEMA 424)</p>
Rooftop Equipment	<p>Damage to rooftop equipment, typically by wind-borne debris or as a result of insufficient anchorage.</p>

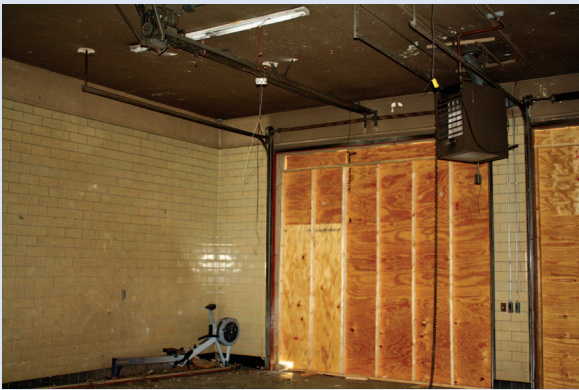
Building Component	Typical Failure	Recommended Practice
Roll-up Door Systems	Buckling of roll-up door systems, typically due to either positive or negative pressures. Door tracks and rollers can fail in high winds.

Specify a door system for a higher wind speed than the minimum required by code. (Source: FEMA 489)
