PNNL-22495

# NDE to Manage Atmospheric SCC in Canisters for Dry Storage of Spent Fuel: An Assessment

September 2013

Prepared for the  
U.S. Nuclear Regulatory Commission  
under a Related Services Agreement  
with the U.S. Department of Energy  
under Contract DE-AC05-76RL01830

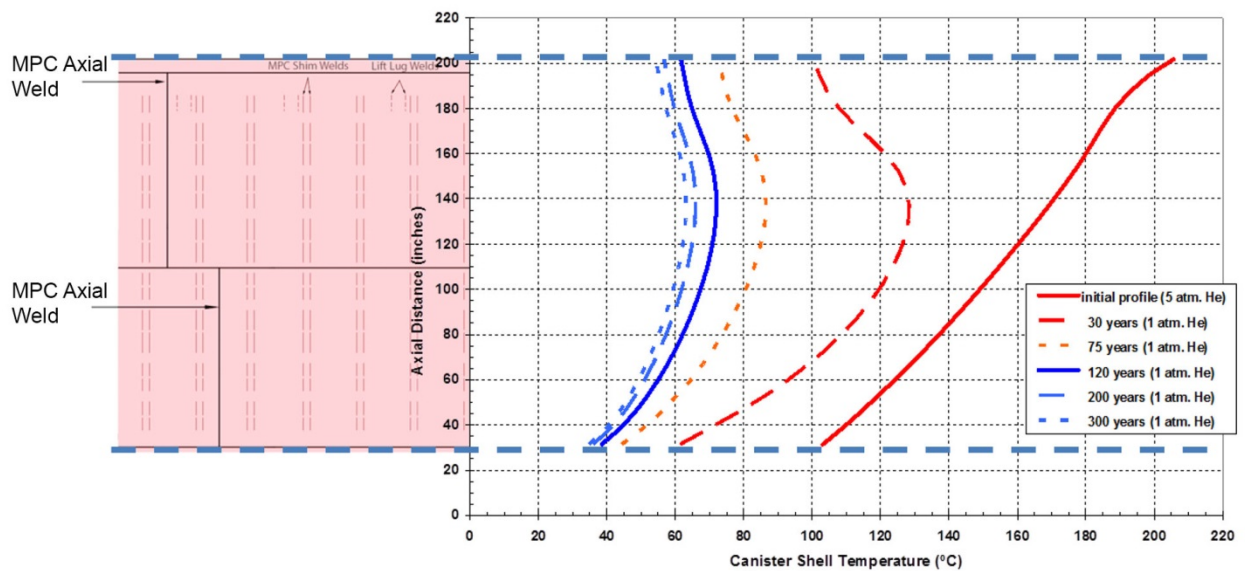
**Figure S.8.** Axial Temperature Distribution at the Canister Shell Surface for Projected Decay Heat Decrease over Time in Vertical Storage

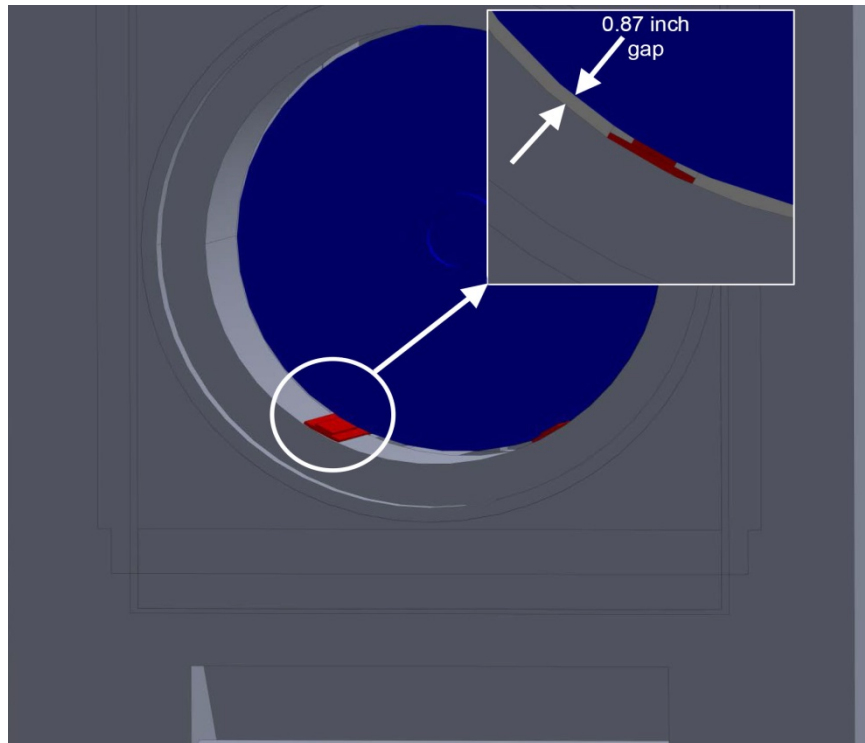
**Figure 4.17.** Illustration of Front View of HSM Module and Depiction of Clearance between HSM Entry Sleeve and Canister

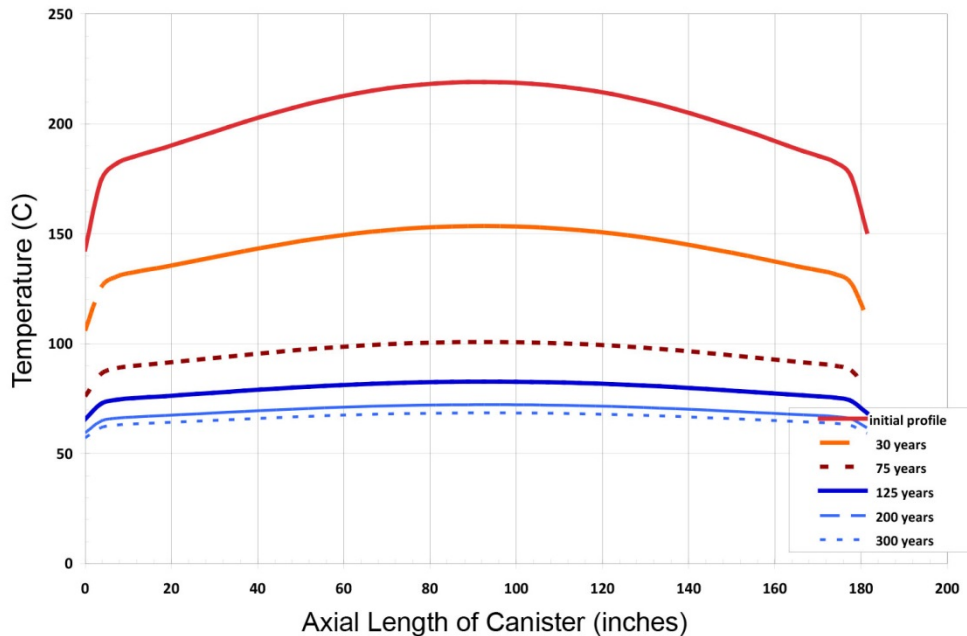
**Figure 5.1.** Axial Temperature Distribution at the Canister Shell Surface at the Peak Temperature Location for Projected Decay Heat Decrease over Time in Horizontal Storage

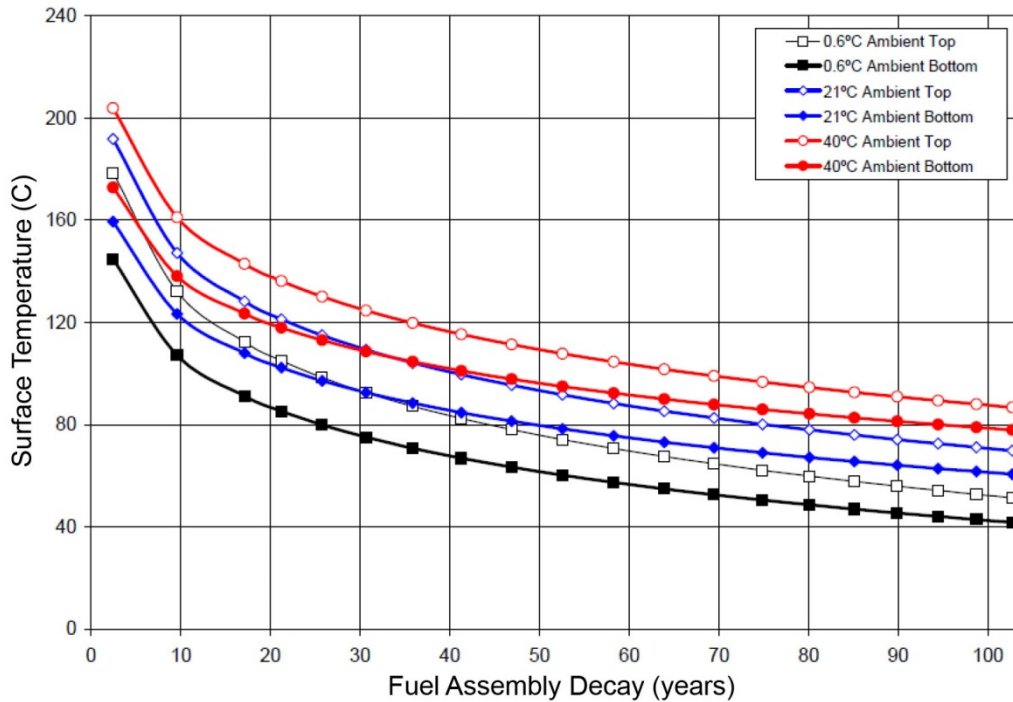
**Figure 5.6.** Calculated Temperature Estimations for Canisters with an Initial Heat Loading of 24 kW Under Different Ambient Conditions (Gordon et al. 2006). Copyright 2006, Electric Power Research Institute; used with permission.

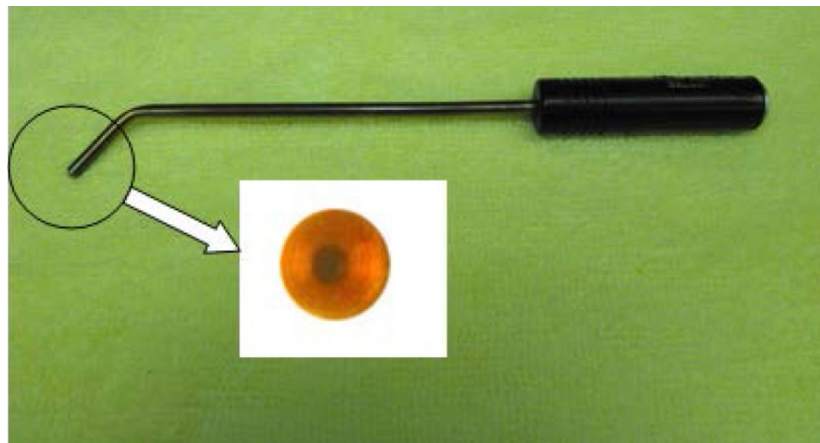
**Figure 5.9.** Photograph of an Eddy Current Surface Probe and View Showing the Coil Winding

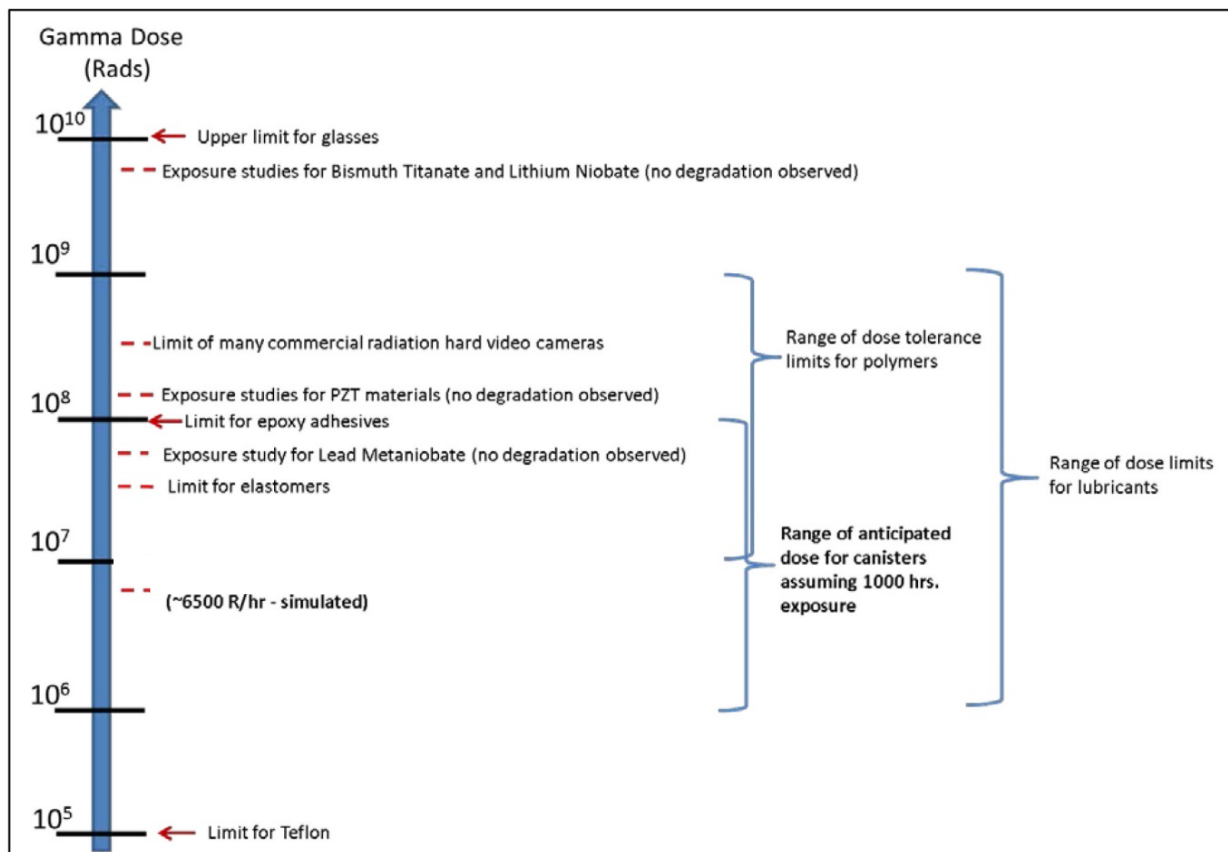
**Figure 5.13.** Illustration of the Relative Tolerance of Many NDE Sensor Component Materials to Gamma Radiation Compared to Anticipated Gamma Radiation Dose Values Near the Canister Surface
