Hydraulic Laboratory Report HL-2011-05

Physical Hydraulic Model Study of the Lower Yellowstone Diversion Dam Rock Ramp

Phase II
Lower Yellowstone Project
Montana Area Office

U.S. Department of the Interior
Bureau of Reclamation
Technical Service Center
Hydraulic Investigations and Laboratory Services Group
Denver, Colorado

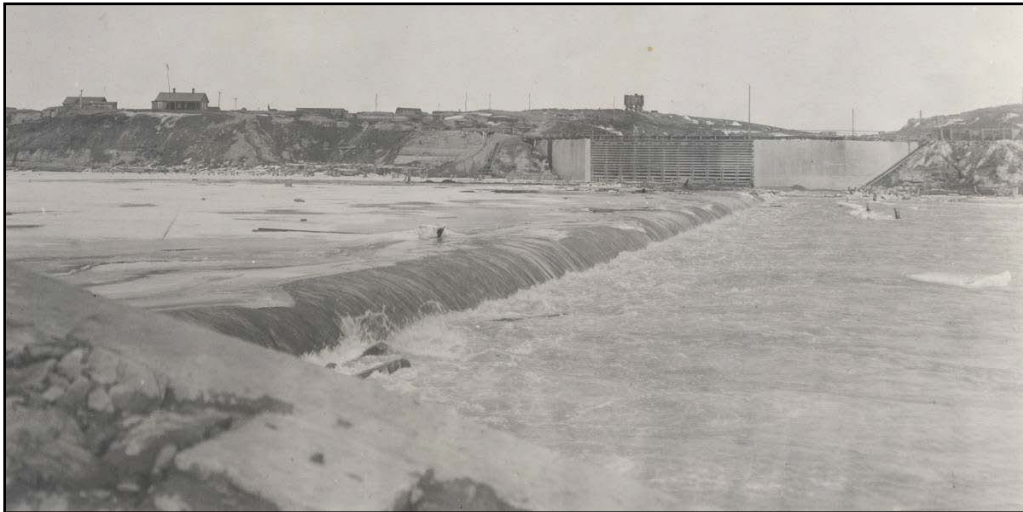
Figure 1. Lower Yellowstone Diversion Dam shortly after completion in 1920.

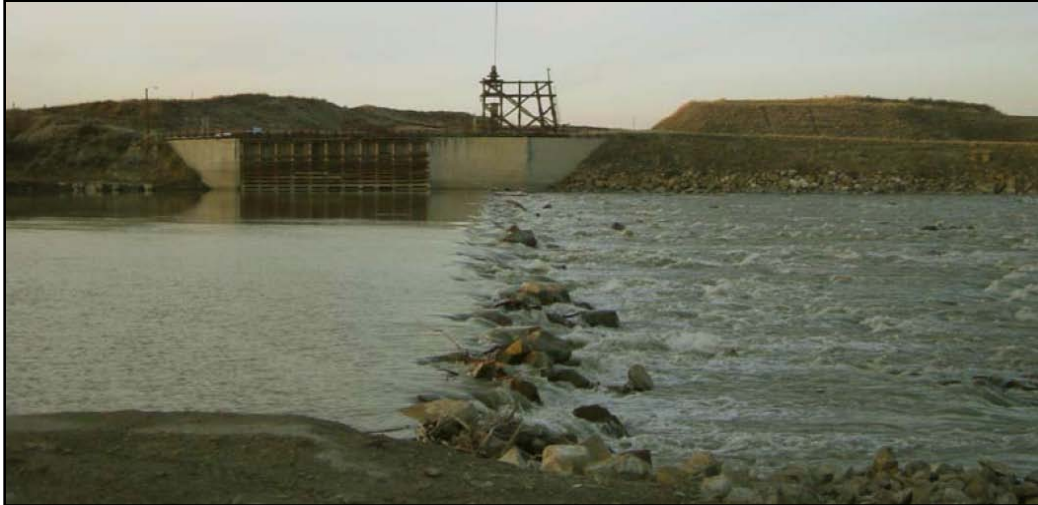
Figure 2. Lower Yellowstone Diversion Dam today with large rock dumped along the dam crest that has migrated downstream over the years preventing fish passage.

The dam has been damaged by large ice flows many times over the years. Damage is typically repaired by dumping rock on the dam crest using an overhead cableway. Every few years the irrigation district adds more rock to the dam to recover the upstream water surface elevation required to divert water into the Main Canal. The hydraulic drop across the structure combined with turbulent flow conditions on the dam prevent upstream passage of pallid sturgeon, a listed species. In addition, the canal entrance is not screened, allowing all life stages of fish to be entrained into the canal. Figure 2 shows a recent view of flow over the dam crest. Dumped rock across the dam crest forms a highly irregular crest with turbulent flow extending well downstream.

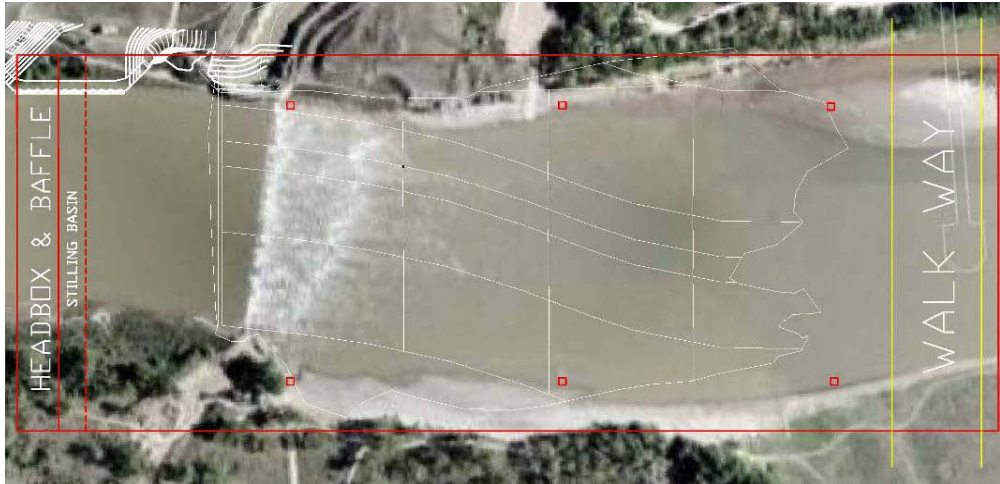
Figure 3. Extent of the 1:25 scale model of the diversion weir and rock ramp

ramp and sufficient downstream river channel for evaluating scour development at the ramp toe. Figure 3 shows the outline of the proposed ramp design from the COE numerical modeling with the model box outline overlaid onto an aerial photo of the existing diversion facility.

The model included approximately 2,300 ft of the river and rock ramp with 500 ft upstream of the diversion weir, 1,600 ft rock ramp and 300 ft downstream of the ramp. The 1600 ft long rock ramp is herein referred to as the Concept 1 (C1) design. The upstream length provided optimum approach conditions to the weir crest and minimized the influence of laboratory support columns within the rock ramp and slope. Slopes were maintained in the model by placing vertical plywood templates at slope break-lines specified in the ramp design (blue lines in Figure 4). The relative roughness of the rock ramp was modeled using geometrically scaled angular rock which was placed to grade using the plywood break-lines. A rock gradation was provided by the COE ($D_{100} = 3$ ft) that was used in the majority of the ramp. A larger gradation of rock was used for the thalweg section ($D_{100} = 4$ ft). A detailed discussion of the rock gradations and roughness is provided in the Testing Procedure section.

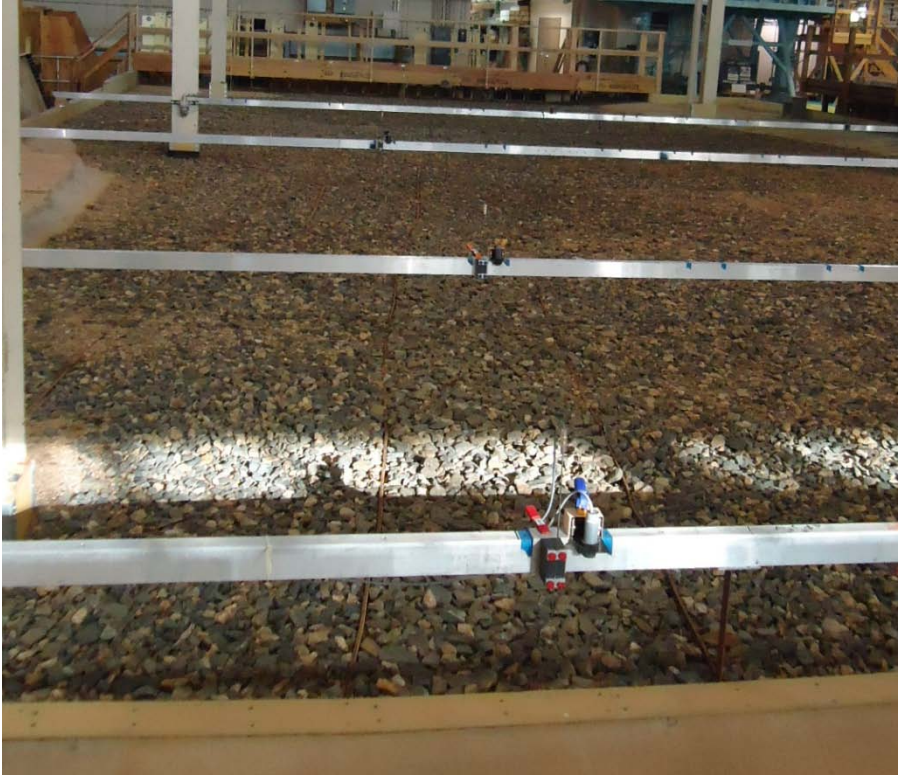
Figure 11. MassaSonic sensors placed next to Nixon meters to record depth and velocity simultaneously at the same location.

Water surface elevation, flow depth, and velocity data were collected simultaneously using an IOtech Personal Daq/3000 Series data acquisition unit. This unit collected voltage data from each sensor and meter that were connected through cables that ran along the channels. The voltage data was then transferred to a Lap Top computer with version 9 of Data Acquisition System Laboratory (DasyLab). Within this program the data was manipulated using coefficients and calibrations specific to each instrument to display and record prototype scale data. The data was then imported into a spreadsheet where they were formatted for analysis and presentation.

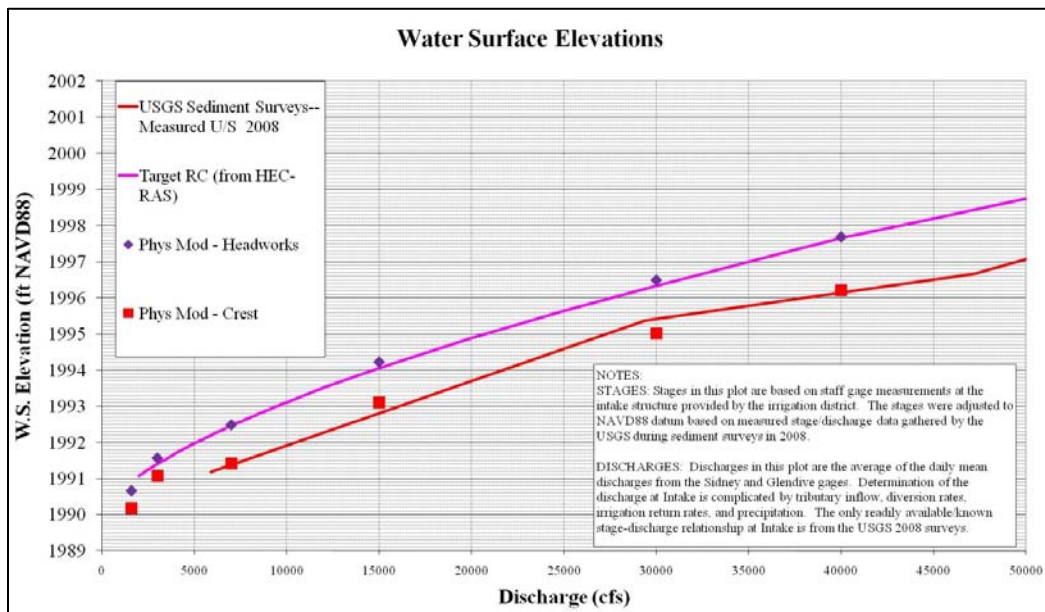
Figure 20. Comparison of water surface elevations measured in physical model to rating curves for new headworks and diversion weir.

Comparisons of water surface elevations measured in the physical model to target rating curves are shown in Figure 20. Rating curves for the new canal headworks and weir crest were established from COE's HEC-RAS modeling simulations and field surveys conducted by the U.S. Geological Survey. Water surface elevations measured in the model near the new diversion headworks closely matched the design rating curve. Physical model results also closely matched the design rating at the weir crest with about 0.4 ft difference noted at 30,000 ft³/s where a break-in-slope is indicated in the 2008 USGS water surface survey data.

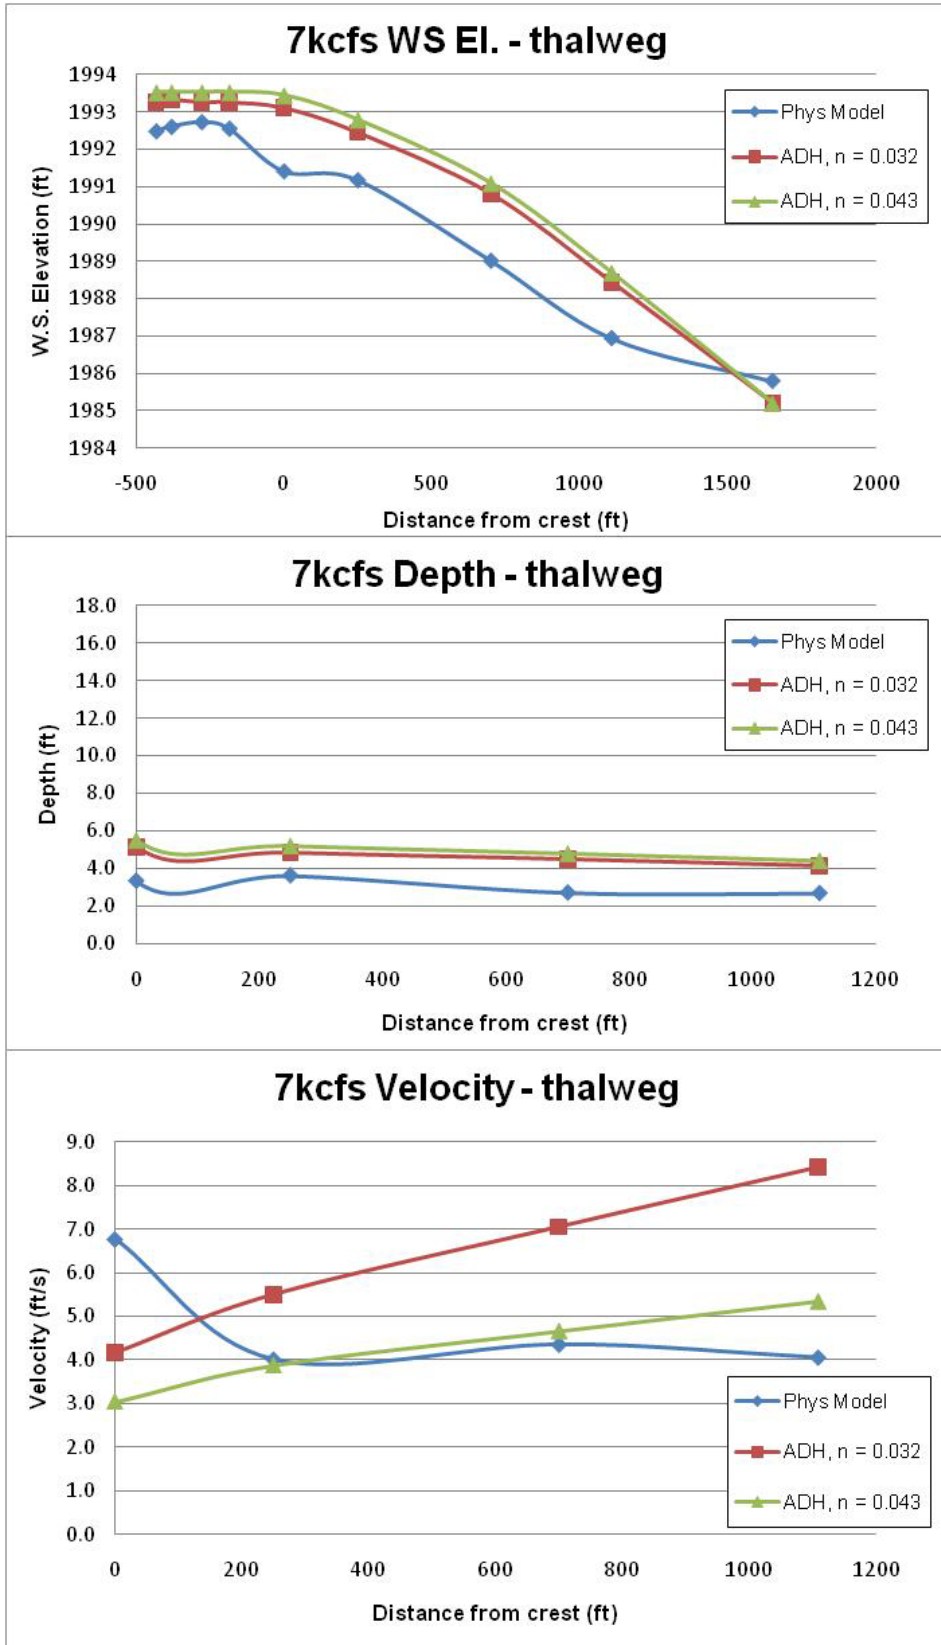
Figure 21. Water surface elevation, depth, and velocity results from physical and ADH numerical model over the rock ramp for 7,000 ft³/s.

derived using the HEC-RAS model. Data from the physical model shown here were taken in the thalweg of the ramp before any choke material was applied. Comparisons of physical and numerical data at other choke conditions are in Appendix A. Water surface elevations from the physical model were generally lower than simulation results for both numerical models. This was especially the case at the first break in slope, 250 ft downstream of the weir crest (distance “0” indicates location of crest in figures with flow going left to right). Physical model water surface elevations most closely compared to numerical model results for a Manning’s “n” value of 0.032 with increased similarity with increased river flow.

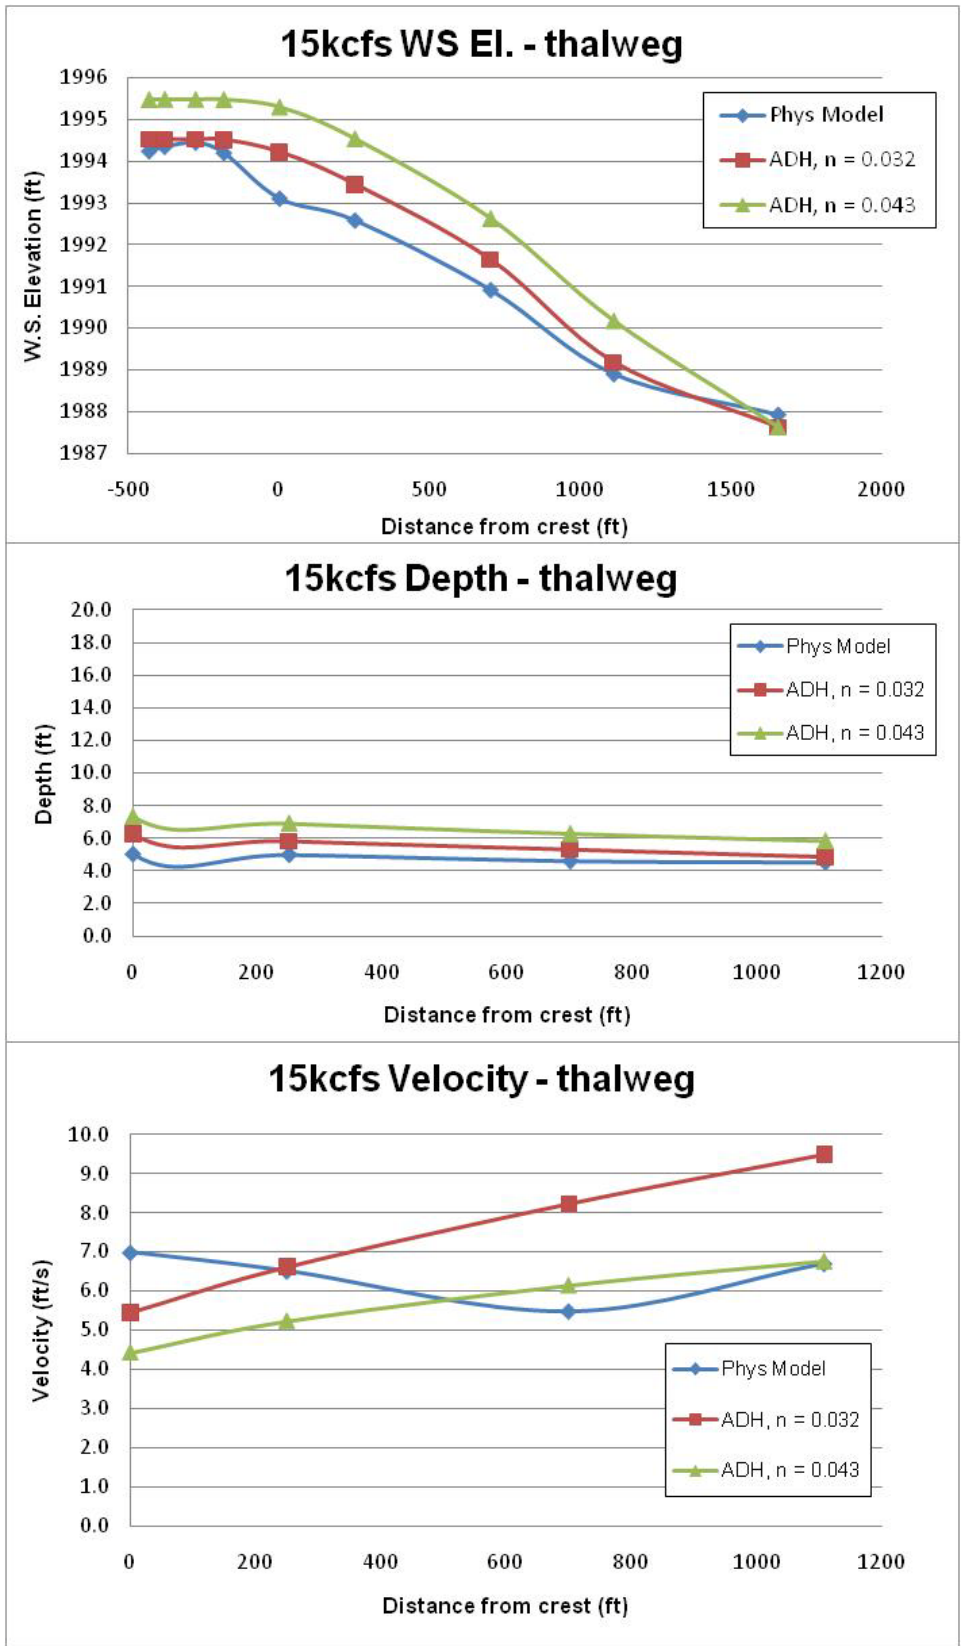
Figure 22. Water surface elevation, depth, and velocity results from physical and ADH numerical model over the rock ramp for 15,000 ft³/s.

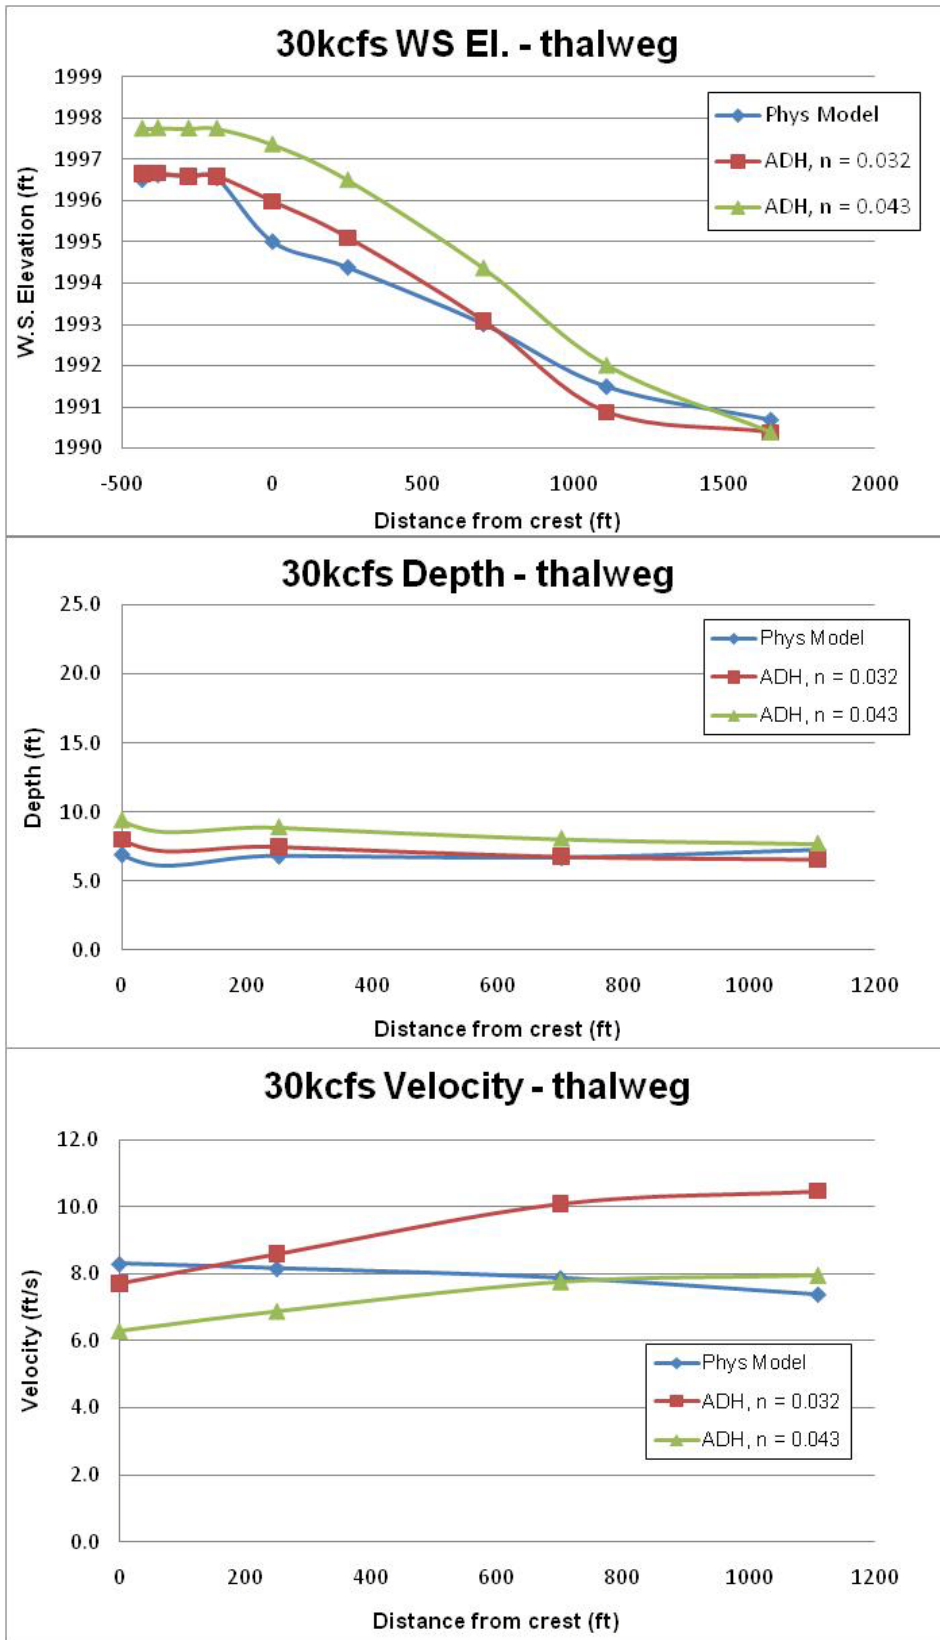
Figure 23. Water surface elevation, depth, and velocity results from physical and ADH numerical model over the rock ramp for 30,000 ft³/s.

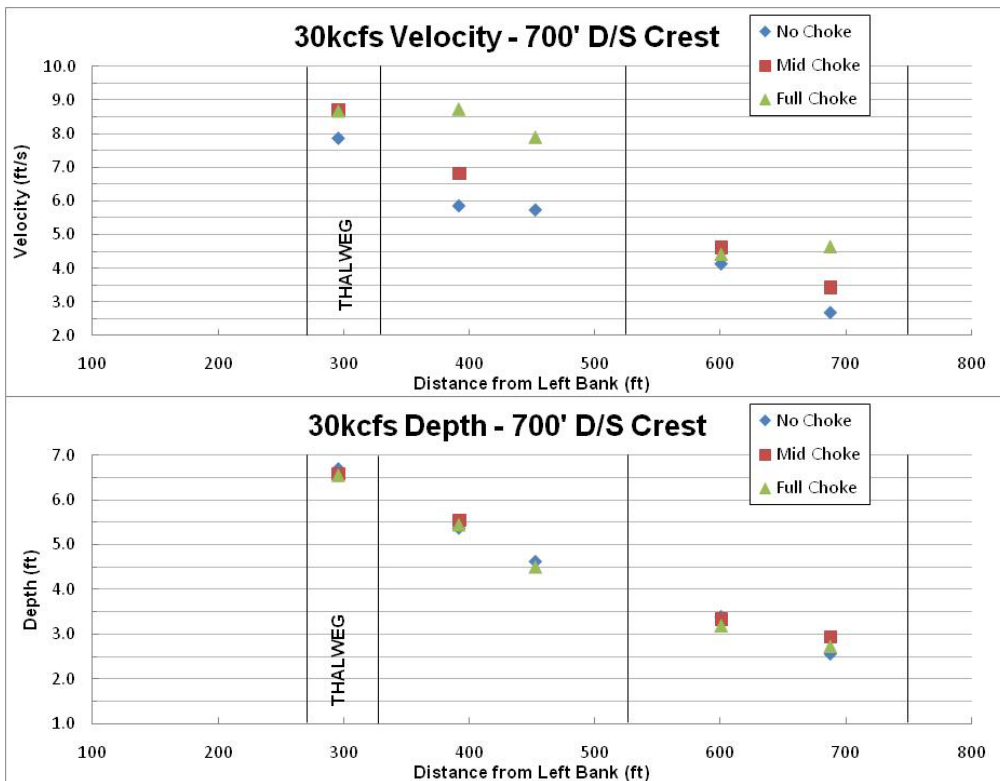
Figure 32 Comparison of velocity and depth data 700 ft downstream of the crest with different choked conditions at 30,000 ft³/s; thalweg was not fully choked.

The trends observed at 15,000 ft³/s were also found for higher flows of 30,000 ft³/s and 40,000 ft³/s (Figures 31 through 34). At the crest, velocities decreased and depth increased as choke material was added to the ramp. However, these differences became less significant as river flow increased. Crest velocities from the fully choked condition decreased by an average of 8 percent for 30,000 ft³/s and only about 4.5 percent for 40,000 ft³/s. Velocities on the downstream ramp surface increased significantly for both 30,000 and 40,000 ft³/s (Figures 32 and 34). Mid and full choke results were similar in the thalweg, probably because the thalweg was never fully choked. Flow depths over most of the downstream ramp surface were similar for all choke conditions for both of these river flows.

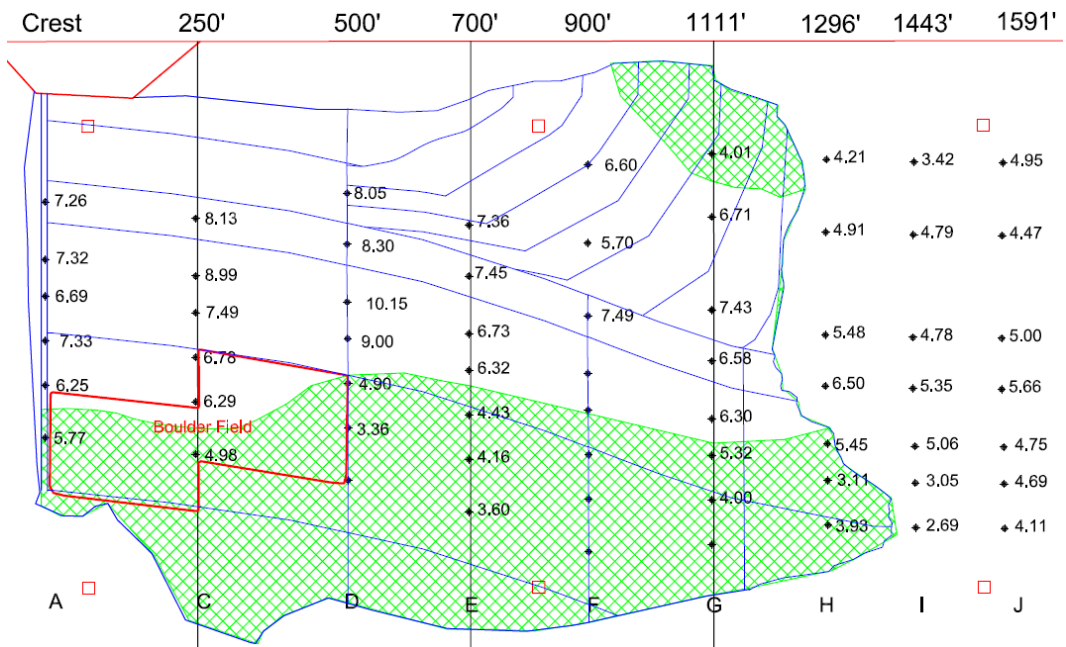
Figure B- 3. Planview velocity data with boulder field at 30,000 cfs.

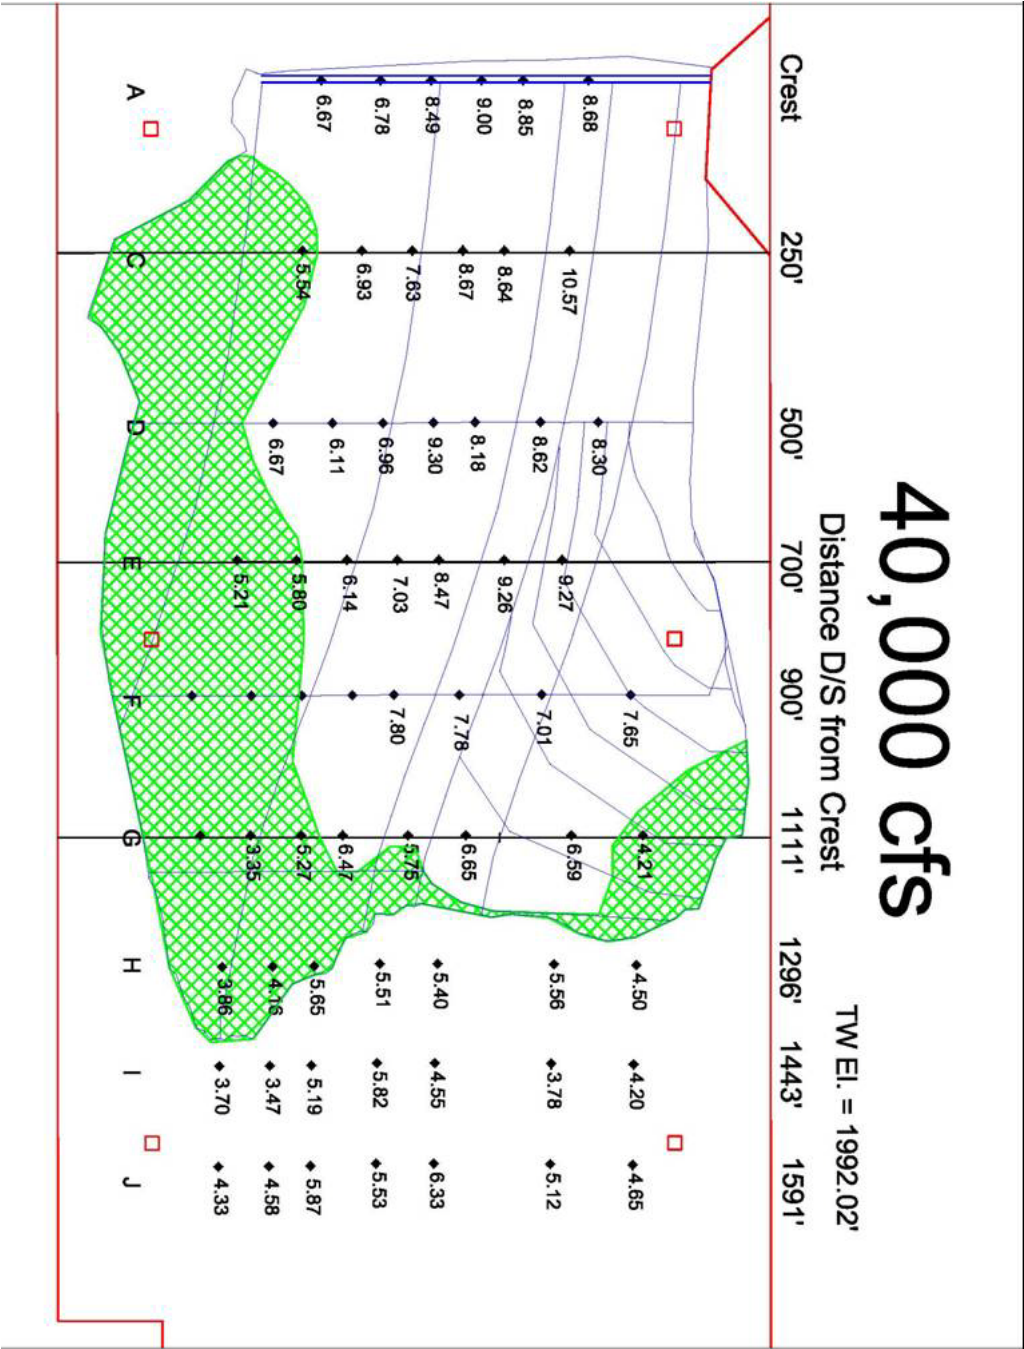
Figure C- 4. Planview velocity data of shortened ramp geometry without a boulder field at 40,000 cfs.

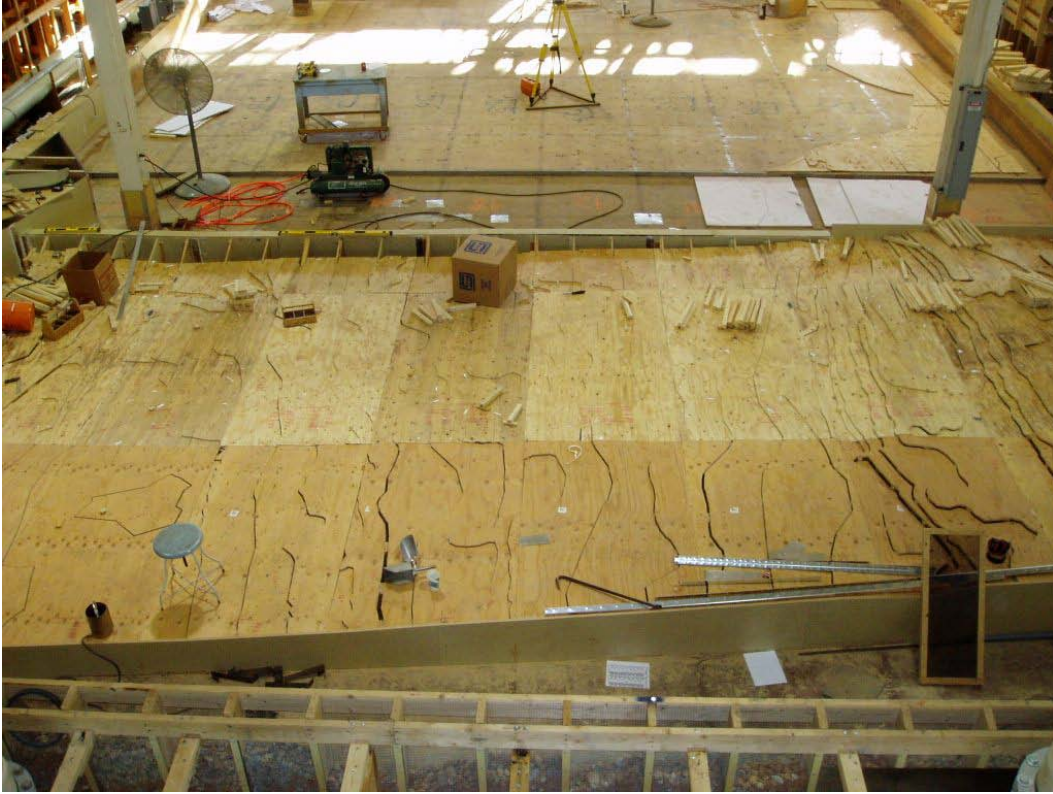
Figure D- 2. Upstream topography meeting diversion weir.

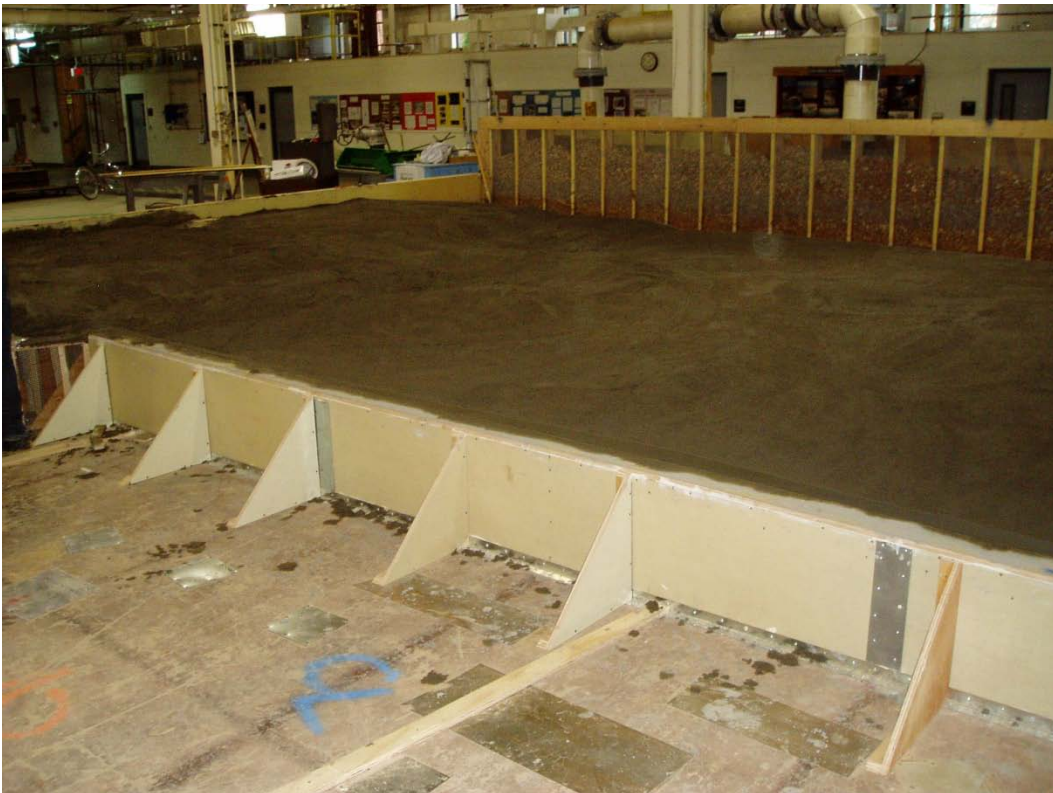
Figure D- 3. Concrete layer over upstream topography.

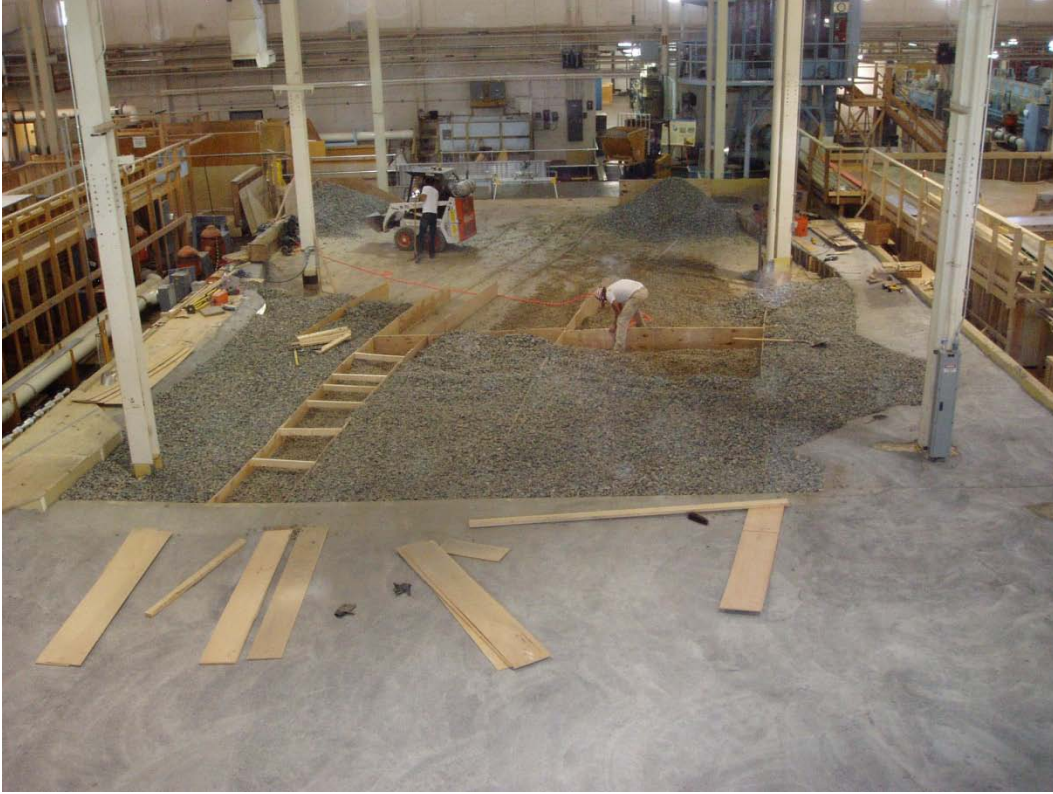
Figure D- 4. Installation of angular rock and breakline templates for model rock ramp.

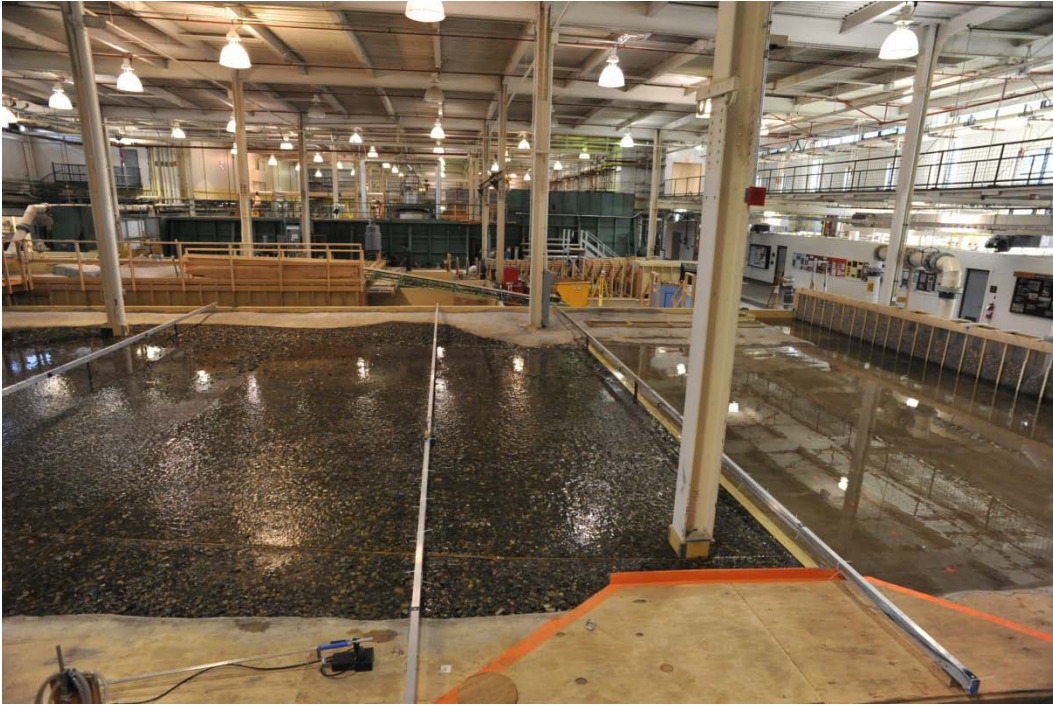
Figure D- 5. 7,000 ft³/s flow setting, flowing right to left.

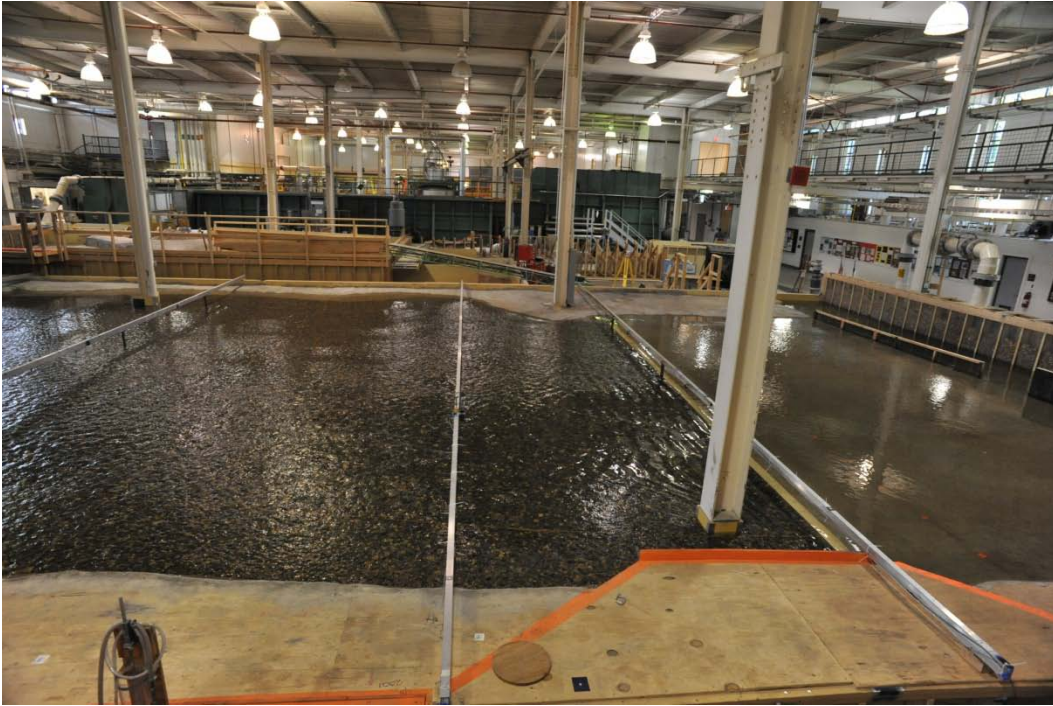
Figure D- 7. 30,000 ft³/s flow setting, flowing right to left.

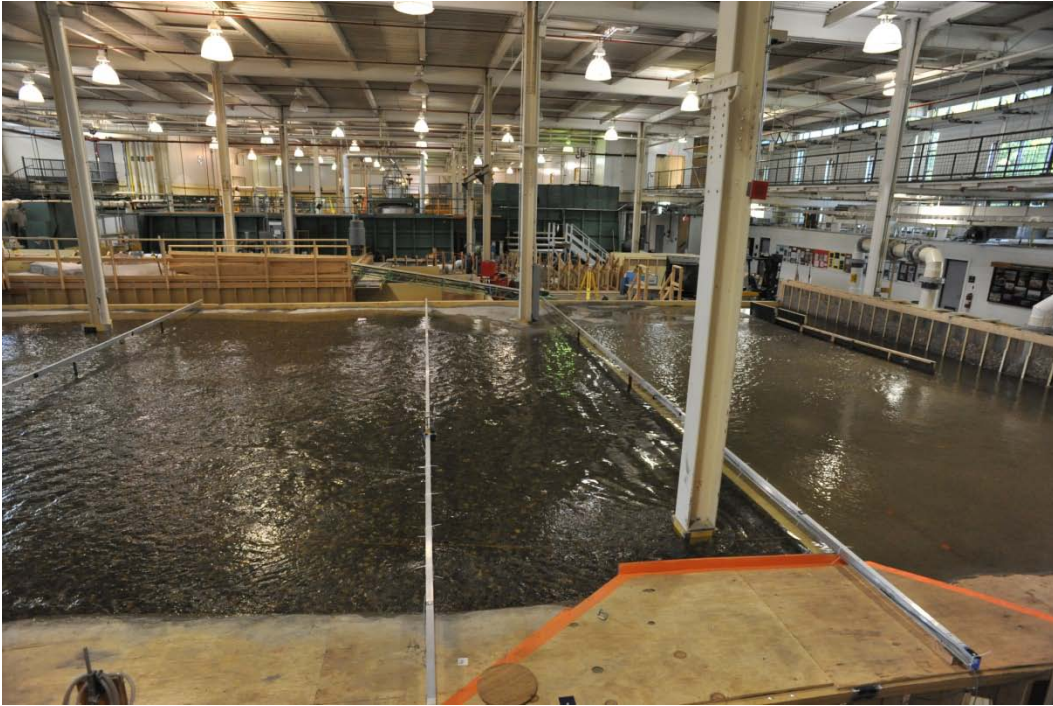
Figure D- 9. 70,000 ft³/s flow setting, flowing right to left.
