### Use of Occupancy Sensors in LED Parking Lot and Garage Applications: Early Experiences

Pacific Northwest National  
Laboratory

# **Use of Occupancy Sensors in LED Parking Lot and Garage Applications: Early Experiences**

Final Report Prepared in Support of the U.S. DOE  
GATEWAY Solid-State Lighting Technology  
Demonstration Program

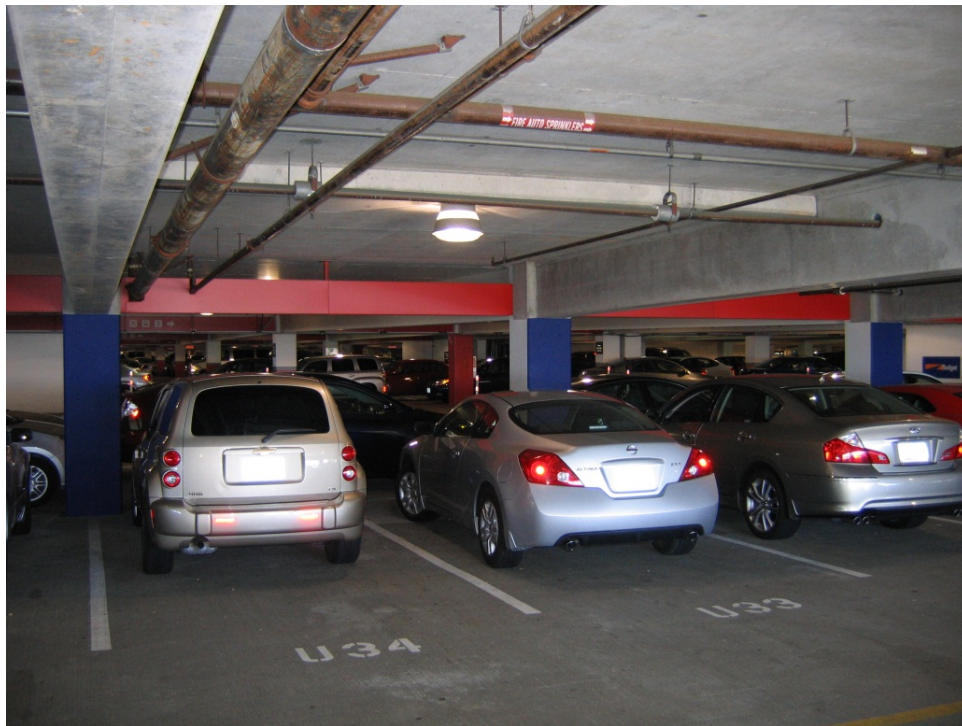
**Figure 1.2.** Line of sight can be challenged by a variety of obstructions

A challenge for PIR sensors in parking structures is that they require line of sight for detection. Structural and utility elements in both above- and below-ground applications can inhibit line of sight (Figure 1.2) and so require special design. Intermittent blockage from large parked vehicles can present similar issues, with the added complication of being transitory and relatively unpredictable.

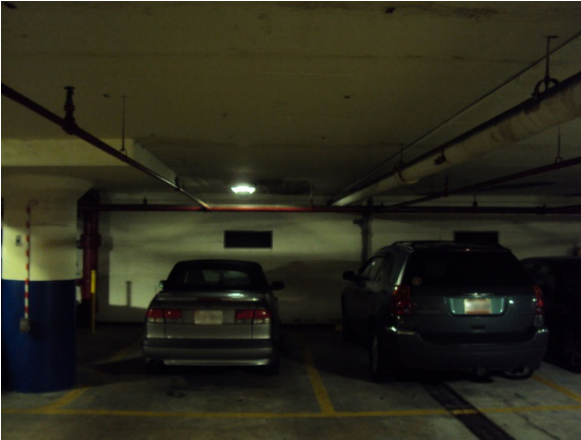
**Figure 2.1.** Occupied parking space with LED luminaire in low state (10% full power)

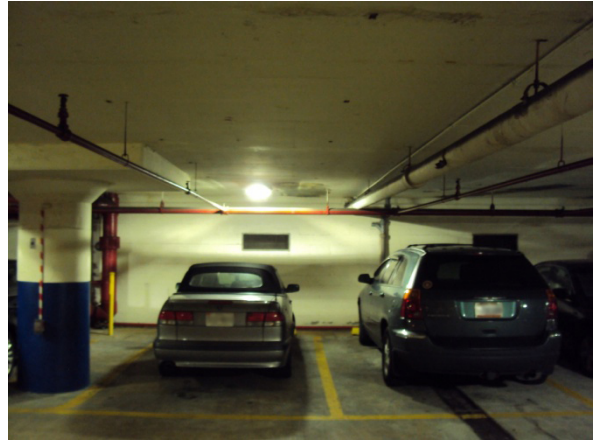
**Figure 2.2.** Occupied parking space with LED luminaire in high state (100% full power)

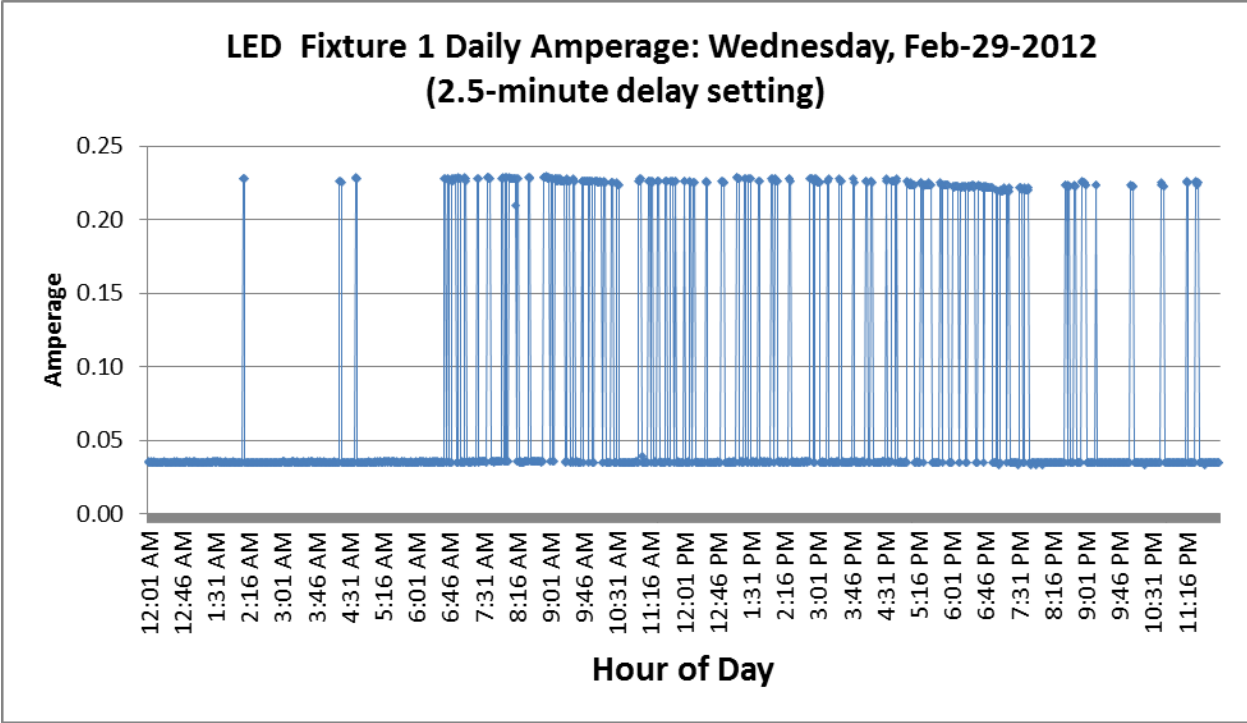
**Figure 2.5.** LED luminaire daily amperage profile (2.5-minute delay) Wednesday, February 29, 2012, for the office underground parking structure

To investigate, facilities staff manually reduced the delay setting to 2.5 minutes to increase the percentage of time the luminaires spent in the low setting. Figure 2.4 and Figure 2.5 display the behavior

for the same luminaire, identified as Fixture 1, on the same day of the week, but on different dates corresponding to the separate delay settings. Although the patterns appear quite similar in aggregate, the more frequent switching between high and low states resulting from the shorter delay setting makes the latter much more active.

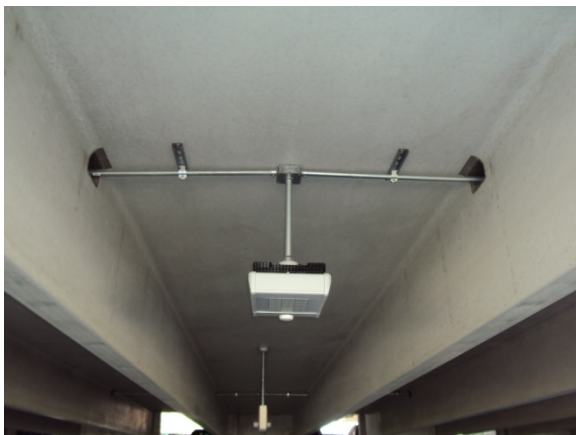
**Figure 2.8.** LED luminaire and pendant installation

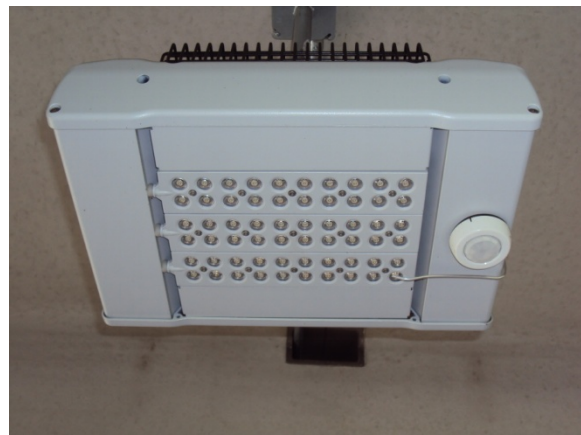
**Figure 2.9.** Close-up of LED luminaire and integral motion sensor (metering light pipe also shown)

At this project site, a non-intrusive metering method was accomplished using a standard time-series lighting logger coupled with a custom-made fiber optic light pipe. Rather than measuring input current or power level directly, the system records the luminaire's state (i.e., off, low, or high) by evaluating relative illuminance from the luminaire. The fiber optic light pipe is visible at lower right in Figure 2.9.

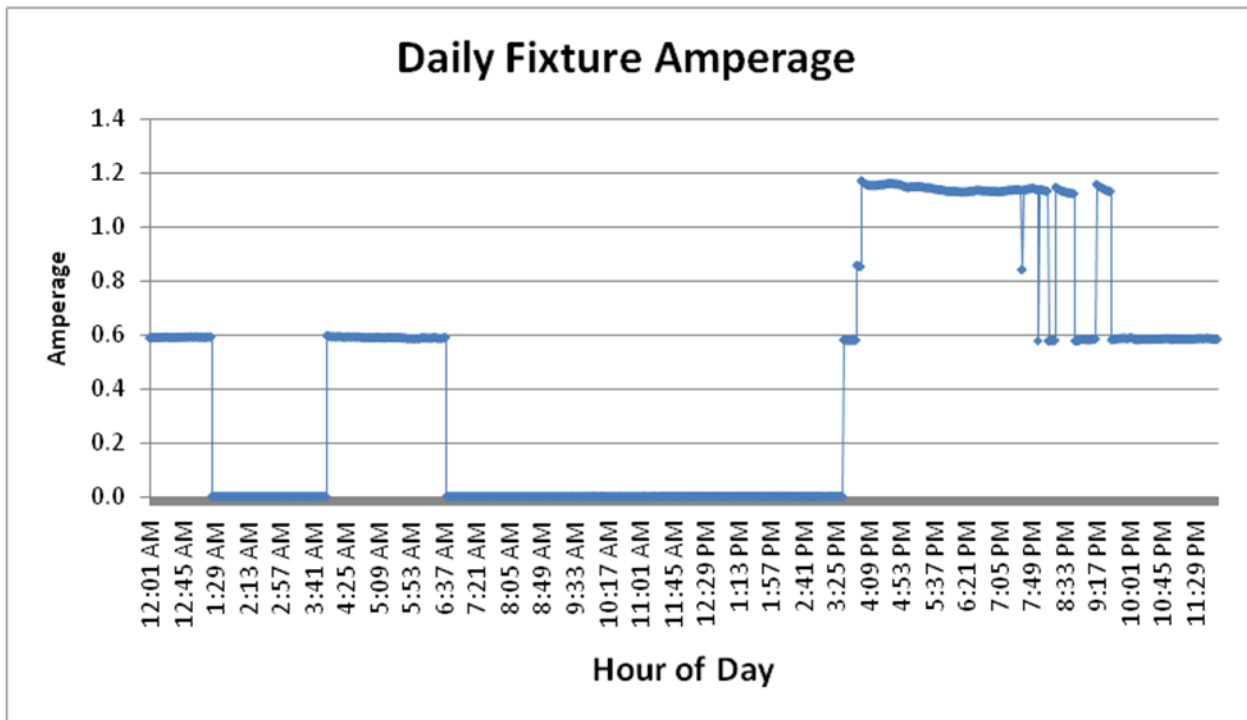
**Figure 3.3.** Operating profile of luminaires located elsewhere in the parking lot on Friday, 12-3-2010. Two luminaires are mounted on this pole.

Two graphics generated from the metered data in this installation serve to illustrate some of the issues discussed. Figure 3.2 displays the erroneous operation of the luminaire noted above, clearly showing the influence of the neighboring road traffic. With few exceptions, this luminaire was spending the vast majority of operating time in the high state. In contrast, Figure 3.3 shows the operating profile for a more typical set of luminaires located on a pole elsewhere in the parking lot. Note in this graphic that there are only two brief instances in the displayed 24-hour period where only one luminaire went to high state and not the other (at about 4:00 pm and 7:30 pm); tripping the sensor on one luminaire almost invariably tripped the other luminaire on the same pole due to the overlap in sensor coverage. Also evident is the fact that while these luminaires appear to be adequately detecting movement during normal business hours when vehicles are staying within the prescribed driving lanes, after hours the situation may be different. The drop-off in detected activity appears quite abrupt; while there is no way to determine whether lot activity was missed from this graphic alone, certainly the complete cessation starting at about 9:30 pm is questionable. Data from other poles around the lot (not included here) do show occasional random activity during these after-hour periods, revealing in fact the lot is not as entirely deserted as this graphic might imply. One plausible explanation is that once the parking lot has largely emptied, cars moving through the lot begin to traverse across the painted spaces rather than following the lanes, and thus escape detection.

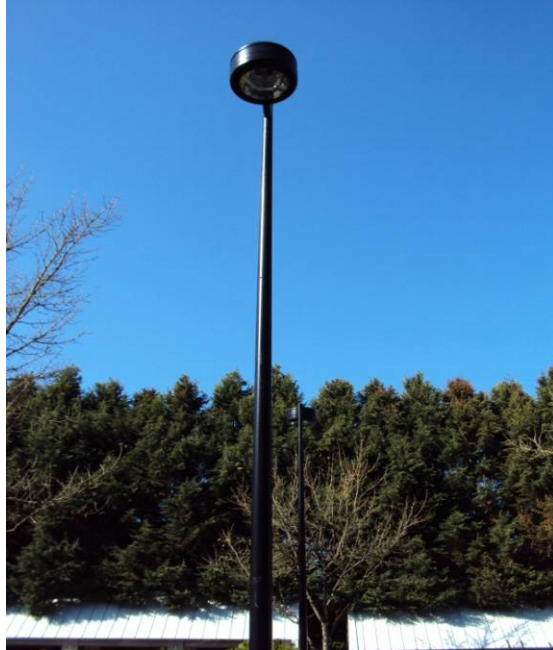
**Figure 3.4.** Original 400 W metal halide luminaire

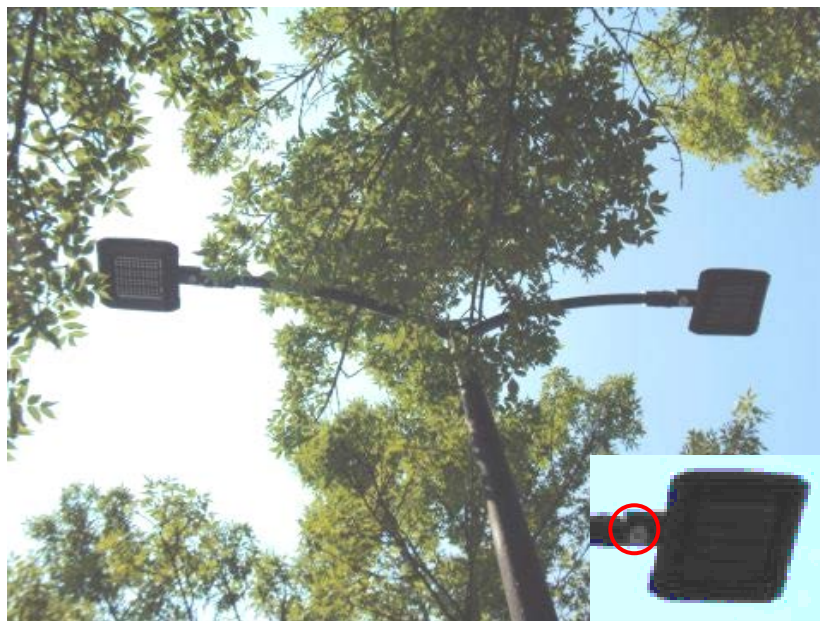
**Figure 3.5.** Replacement LED luminaires on extended arms and inset highlighting occupancy sensor

This corporate campus parking lot project involved the installation of LED luminaires, among a variety of other attempted fixes, to remedy numerous illumination issues being reported by employees. The original 400 W nominal MH luminaires had been installed without arms (Figure 3.4) several years earlier, at about 22 feet mounting height on variable pole spacing between 125 by 75 feet to 125 by 135 feet. Since then, vegetation growth had partially obscured the luminaires, and illumination levels around the parking lot had become inadequate. The client was unwilling to pursue aggressive pruning of the vegetation, so among the alternatives attempted was installation of supplemental 200 and 250 W nominal MH luminaires at points around the site. At the time of this demonstration, LED lamps on extended arms with integrated occupancy sensors had recently been installed in a few sections of the parking lot, as shown in Figure 3.5. This figure also includes an inset close-up of one luminaire to highlight its integrated motion detector, visible as a white circular disk at the base of the luminaire.
