## Emergency Watershed Protection Program McGrath Project

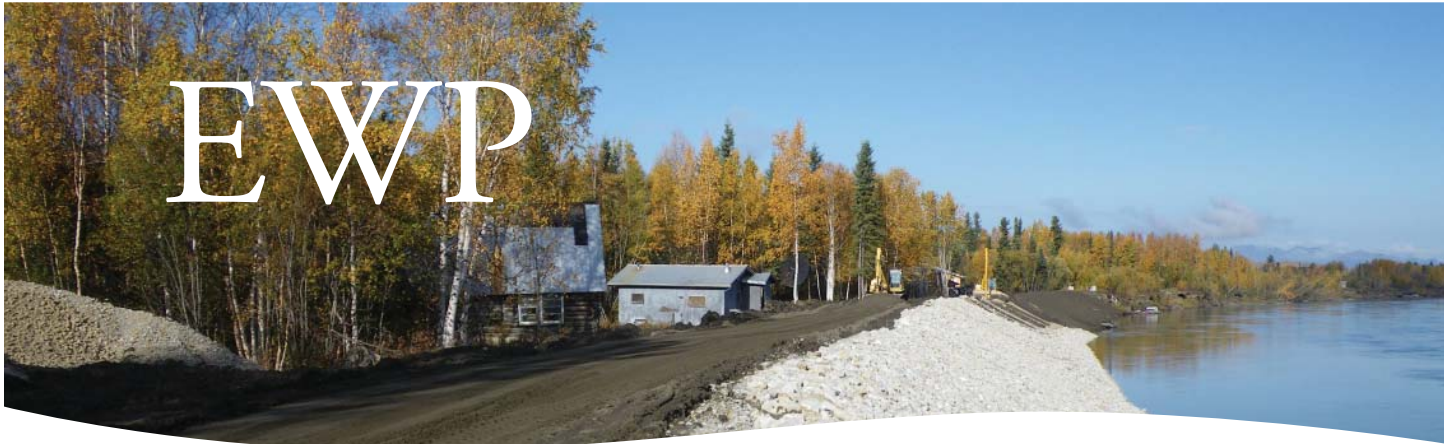
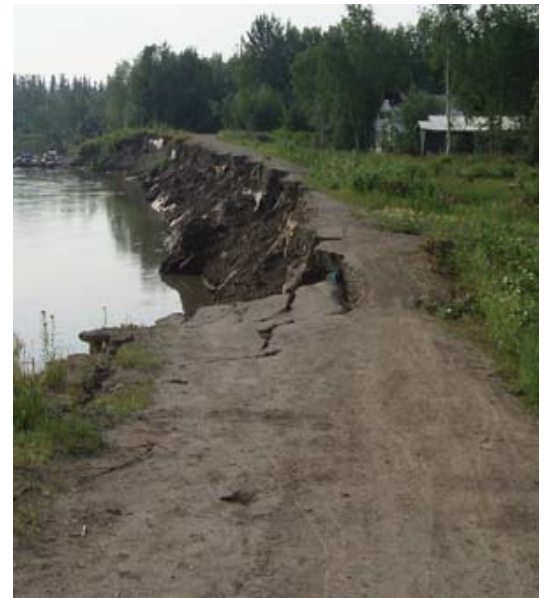
Top and bottom photos: The project in process with the levee bank partially stabilized with rock armor.

The Natural Resources Conservation Service in Alaska repaired a flood control levee along the Kuskokwim River in the off-road village of McGrath. The original levee was compromised by erosion, at one place only a foot wide, and the village was subject to flooding. Following levee repairs, the bank was stabilized with rock armor. The equipment had to be barged to the work site.
