Wisconsin Dam Rehabilitation Project October 2003

Bad Axe Watershed

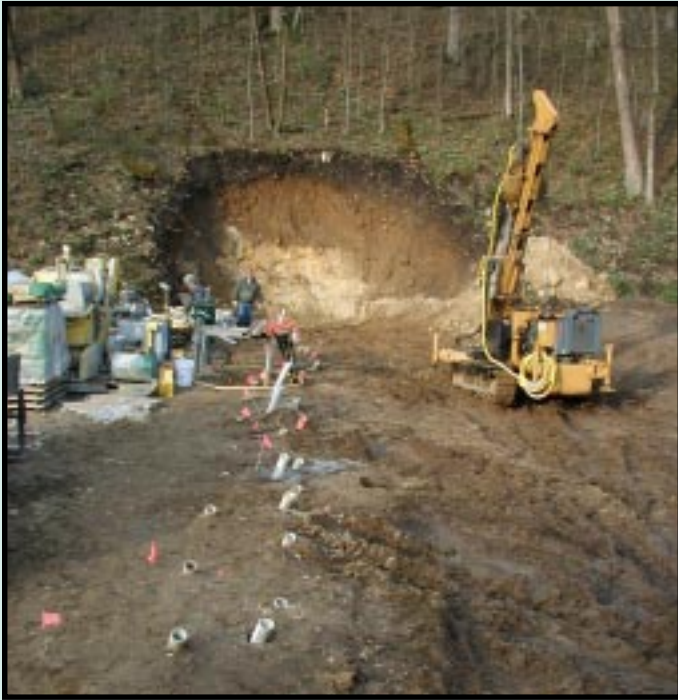
Grout, a mixture of cement, water and clay, is injected through boreholes into voids in the rock. The grout curtain reduces water flow through rock in the dam foundation.

Rehabilitation has extended the life of Bad Axe Dam No. 24 for 50 years. Necessary repairs to the dam included grouting to reduce seepage flow through the left abutment, repair of the principal spillway pipe and enlargement of the plunge pool.

The USDA Natural Resources Conservation Service developed a supplement to the watershed plan recommending repairs to the site. The principal spillway pipe was repaired, the plunge pool was enlarged and high rates of seepage were reduced by implementing a grouting program. These repairs ensure that the dam will continue to provide benefits for another 50 years.
