# **Millstone River Basin, New Jersey**

## **Flood Risk Management Feasibility Study**

### **Final Feasibility Report**

November 2016

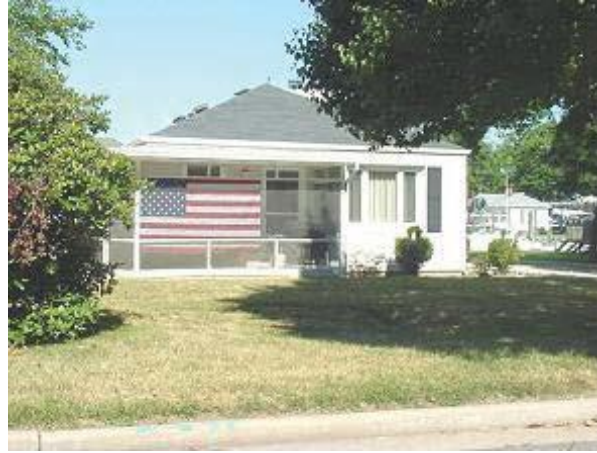
Figure 2: Typical Slab-on-Grade Foundation Type

This structure is constructed on a slab foundation at grade (Figure 2).

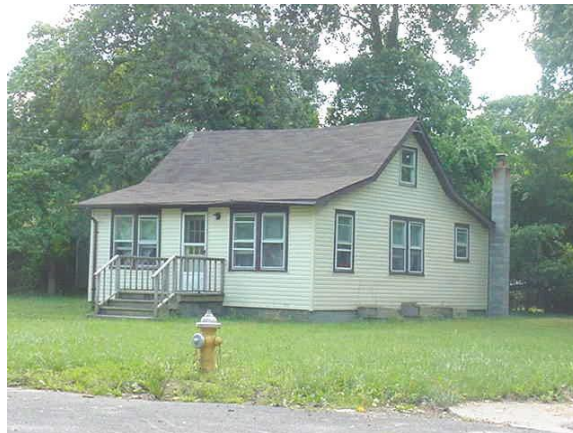
Figure 3: Typical Raised (Crawlspace) Foundation Type

This structure is on a raised foundation, typically concrete masonry, not high enough for a basement (Figure 3).

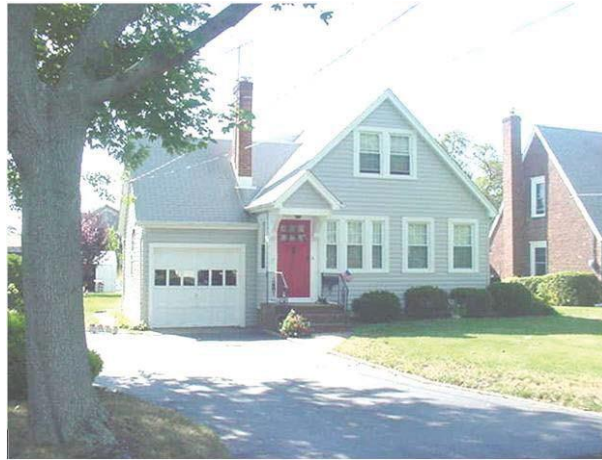
Figure 4: Typical Subgrade Basement Foundation Type

poured concrete or concrete masonry. The basement may be finished or unfinished. The subgrade basement slab is completely below grade on all four sides (Figure 4).

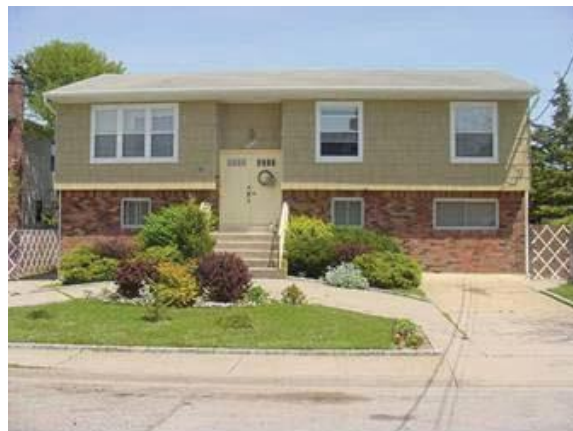
The bi-level structure consists of two stories. In most cases, the first story is partially below grade, consisting of living space or a garage or both. The main floor of the bi-level tends to be above the first story of the structure, with the main entrance located between the lower and main floor (Figure 5).

Figure 5: Typical Bi-Level Structure Type

Due to the similarities between the characteristics of bi-levels and raised ranches, these structure types were considered identical for flood proofing alternatives screening. Elevation methodology and costs are generally similar to structures with basements.

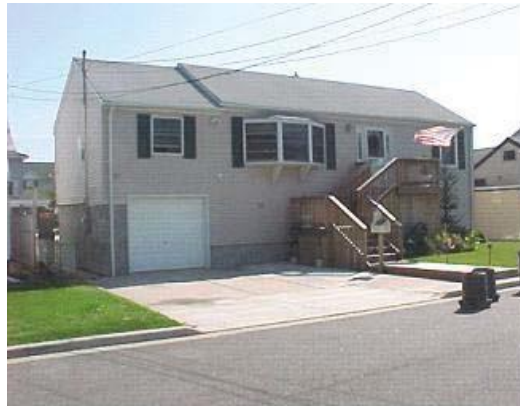
The Raised Ranch Structure Type is similar to a Bi-Level. The lower level is built slab-on-grade and the main entrance is usually at the main floor or second level (Figure 6).

Figure 6: Typical Raised Ranch Structure Type

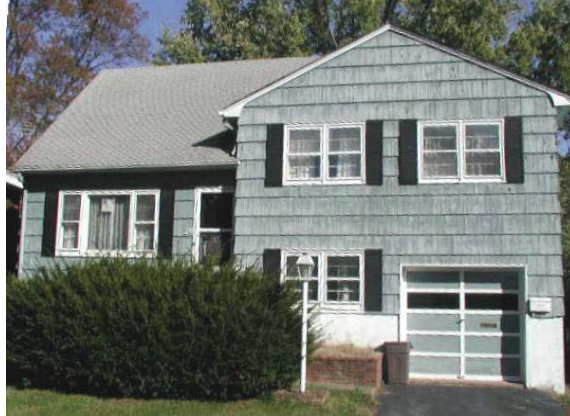
This structure consists of three levels: a stacked lower and upper level, with an adjacent main floor between the upper and lower floor levels. Each floor (lower, main, and upper) has a different elevation, and is connected by short stairways. The lower level is generally on a slab foundation and the main floor is usually raised. The lower level may be living space and/or a garage (Figure 7). The main entrance is at the main floor level. There was assumed to be no basement below the main level.

Figure 7: Typical Split Level Structure Type

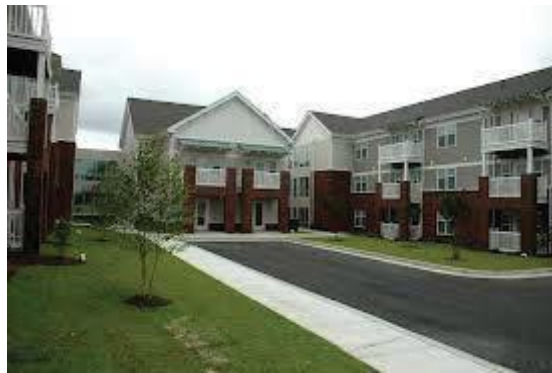
Figure 8: Typical multi-family units

This category included multi-family units (>2 families), garden apartments, and townhouses. Foundation types for this category included slab-on-grade, raised crawlspace, or subgrade basement (Figure 8).

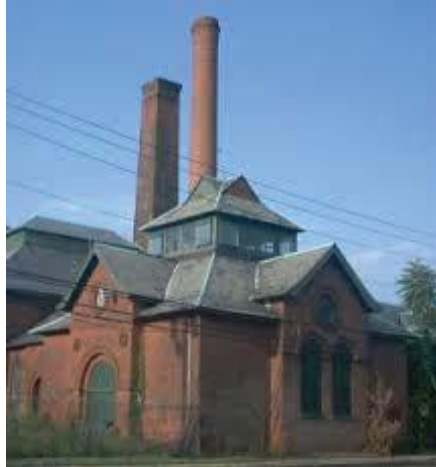
This category includes commercial, industrial, and municipal structures, where persons would not reasonably be expected to sleep (Figure 9).

Figure 9: Typical *Non-Residential unit*

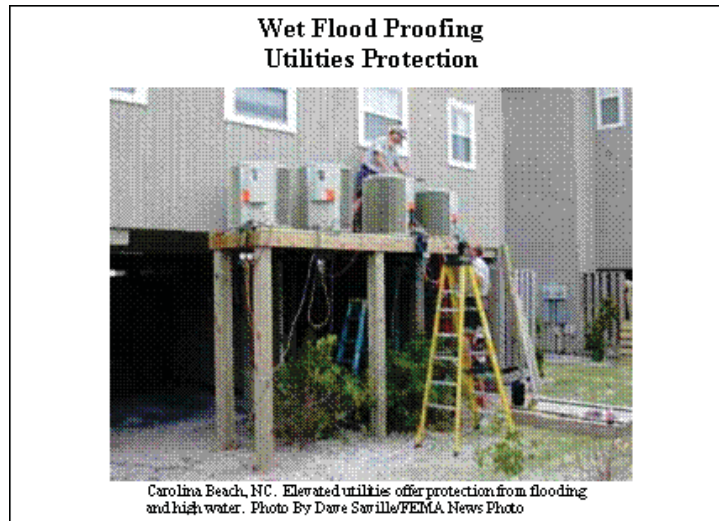
Wet flood proofing measures (Figure 11) involves elevating and/or protecting vulnerable utilities (Figure 12) and other contents allowing flood water to get inside lower, non-living space areas of the structure via vents and openings in order to reduce interior damages and the effects of hydrostatic pressure and, in turn, reduce flood-related damages to the structure's foundation.

Figure 12: Wet Flood Proofing Utilities Protection

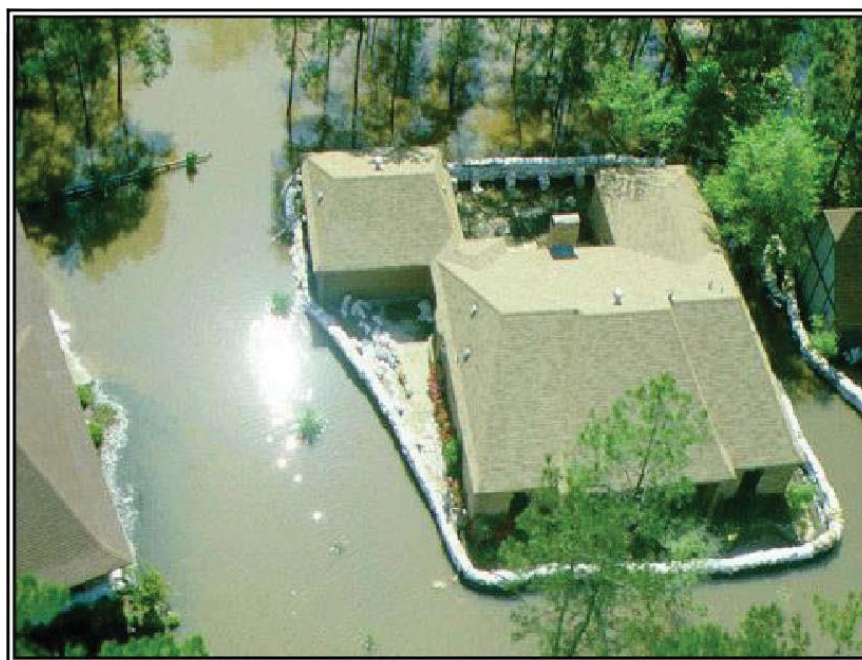
Figure 14: Example of a ringwall arrangement built around a structure

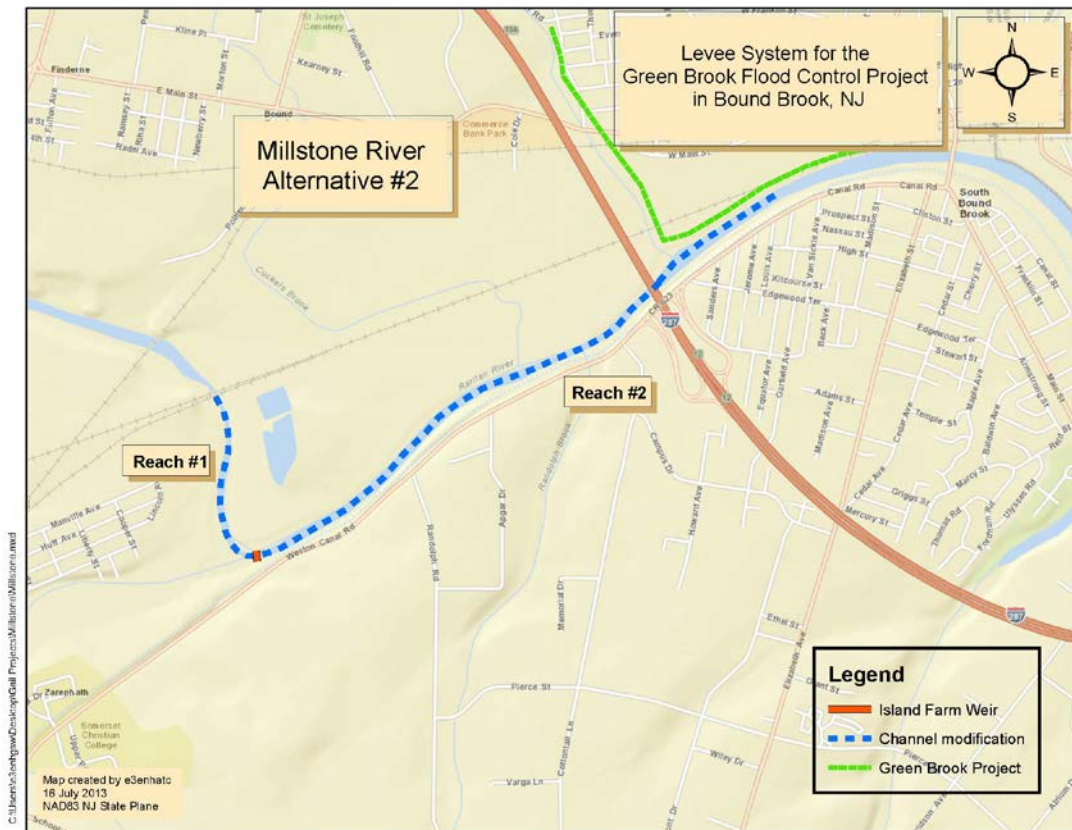
*Figure 2: Alternative 2 – Channel Modifications*

The channel modification alternative provides \$1,317,000 in equivalent annual benefits. The total first cost of the channel modification alternative is \$125,588,000 with a total investment cost of \$130,347,000, including construction, planning, engineering and design and construction management. The equivalent annual cost for the channel alternative, including annualized OMRR&R, is \$6,510,000. The BCR of the channel alternative is 0.2. Lands, damages and environmental mitigation costs were not calculated, since there are insufficient benefits to support this plan even without the inclusion of additional costs.
