PARISH PRIORITY ECOSYSTEM RESTORATION PROJECTS

CALCASIEU PARISH PRIORITY ECOSYSTEM RESTORATION PROJECTS

Rabbit Island Restoration Project

Cameron Parish Master Plan

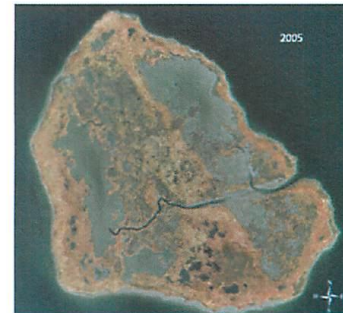
2005 aerial photograph of Rabbit Island Note in 2005 photograph the extent of interior ponds; the ponds are fed by a shallow channel approximately 100 feet wide; the channel mouth is located on the southeastern quarter of the island.

Tidal channels, and open ponds dissect the interior portion of Rabbit Island and fully cover approximately ½ of the island. There is only 1 main channel located in the southeast quarter of the island that feeds the 3 interior ponds, 2 of which are north and 1 south of the main channel. At its mouth the channel is approximately 2 feet deep but in the interior portions of the island the channel narrows and deepens to approximately 4 feet deep. The 2 ponds north of the main channel are approximately 1 ½ feet deep. The eastern pond on the north side has only a narrow rim, approximately 20 feet wide protecting the pond from the open waters of West Cove. The pond on the south side of the main channel is less well defined and shallower than the northern ponds. The edges of the south pond are formed by broken, deteriorating marsh.

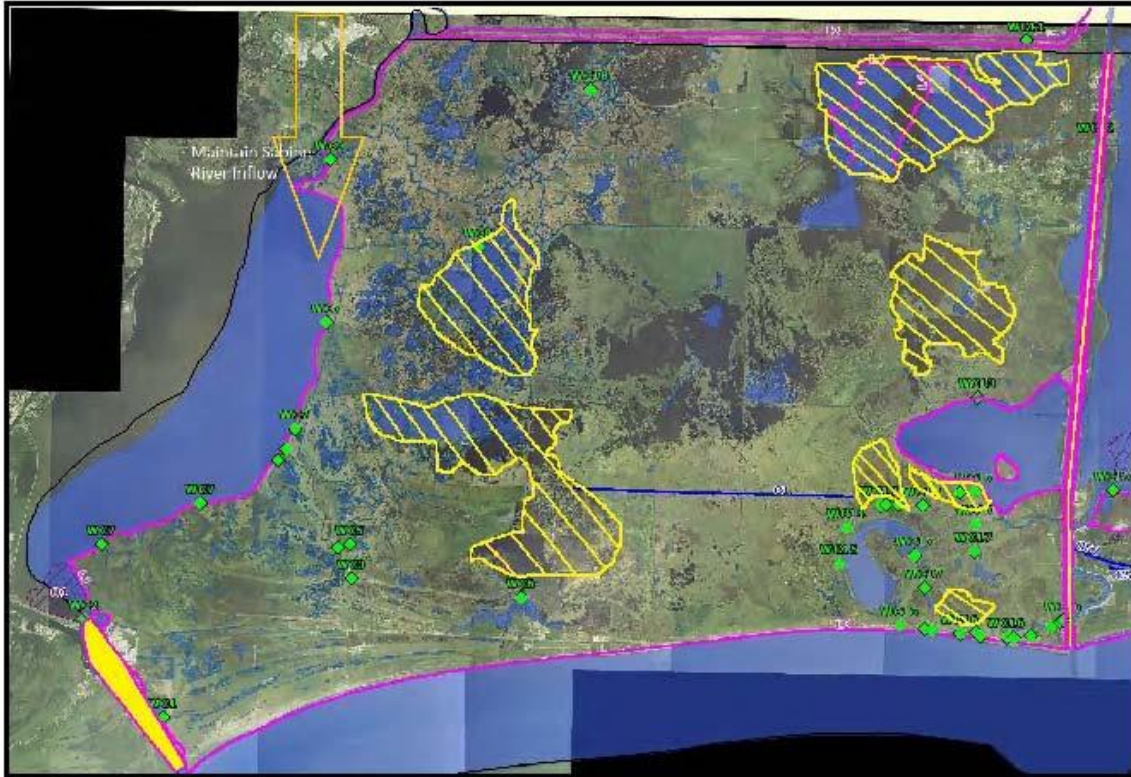
<p>LEGEND</p> <ul style="list-style-type: none">Shoreline Protection/StabilizationDrainage LateralsRock Jetty InstallationMarsh Creation/Beneficial Use AreaWater Control Structure AreaWater Control StructureOyster Reef	<p>Cameron Parish Master Plan Proposal</p> <p>Western Cameron Parish</p>

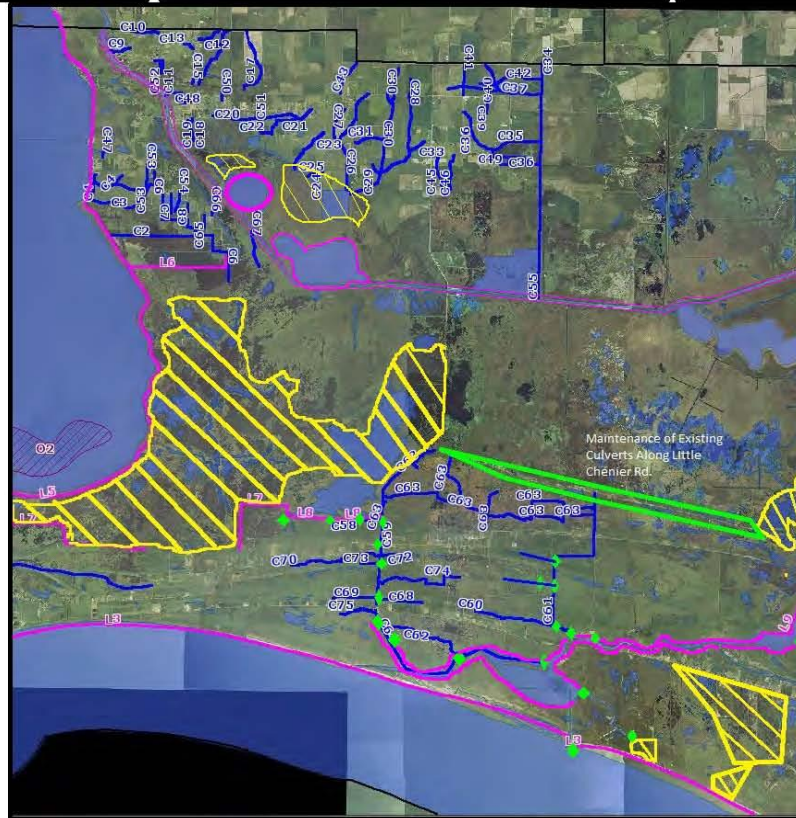
Oyster Reef 	<p>Cameron Parish Master Plan Proposal</p> <p>Central Cameron Parish</p>
