Elkhorn Slough Tidal Marsh Restoration Project, Phase 1 Request for Incidental Harassment Authorization

Elkhorn Slough Tidal Marsh Restoration Project . D120505.00 Figure 1-2 Restoration Plan Overview

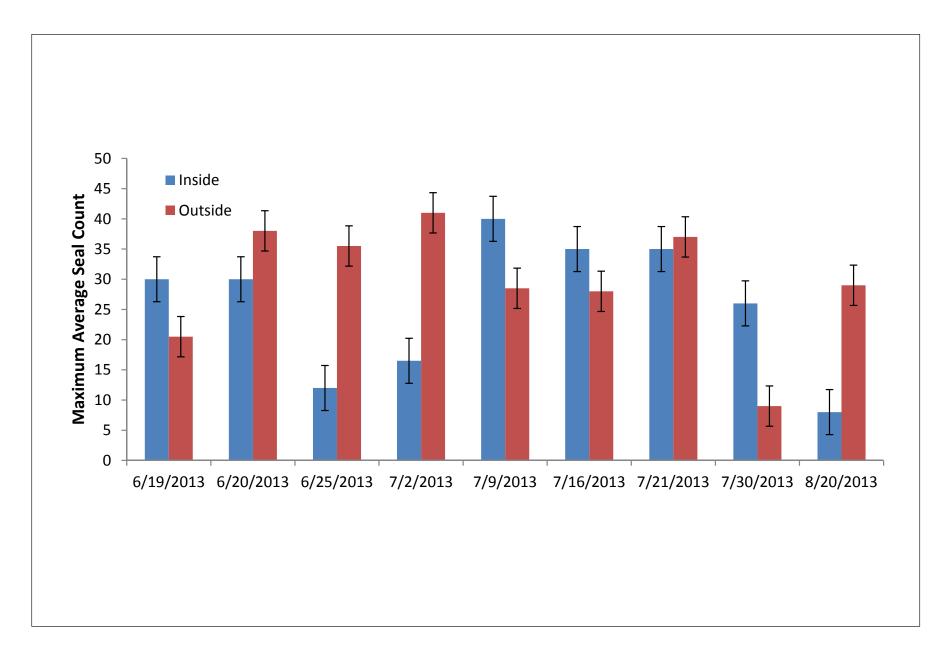
Elkhorn Slough Tidal Marsh Restoration Project Request for Incidental Harassment Authorization . 120505.00 Figure 6-1 Maximum Daily Average Number of Seals Hauled-out at Minhoto Marsh During Each Sampling Day

Figure 6-1 shows the average number of seals hauled out, by location (either inside or outside of the marsh), during each of the 2013 survey days. The maximum daily average number of seals observed inside was 40, and the maximum daily average observed outside was 41.

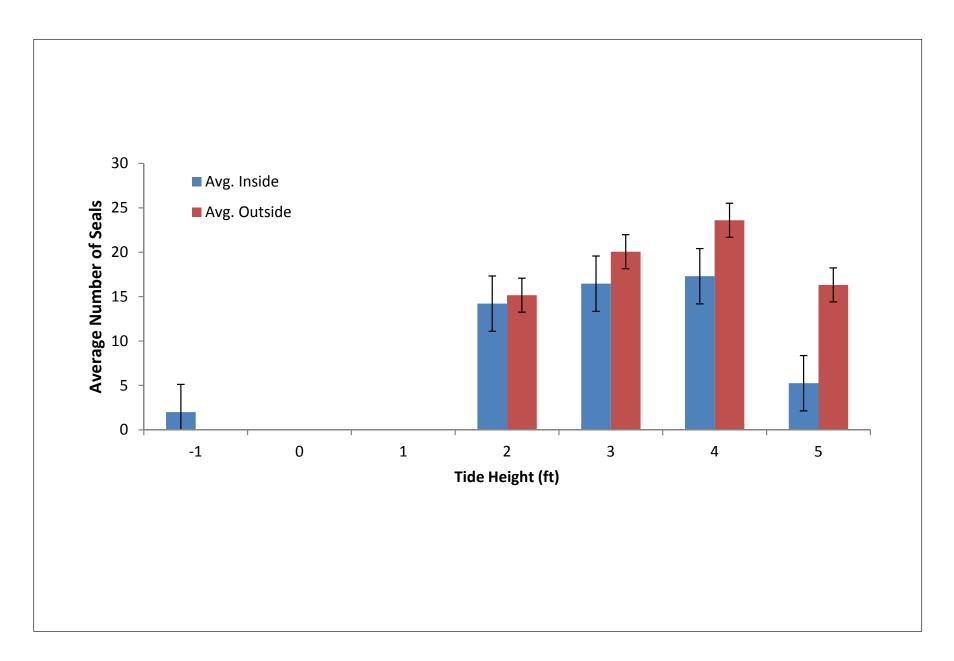
Elkhorn Slough Tidal Marsh Restoration Project Request for Incidental Harassment Authorization . 120505.00 Figure 6-2 Average Number of Seals Hauled-out by Tide Height

Figure 6-2 shows the average number of seals hauled out by tide height. The average number of seals hauled out showed an increasing trend starting in the two to four foot range when analyzed by tide height. **Figure 6-3** shows the average number of seals hauled out by time of day. The average count increased progressively throughout the morning and peaked in the afternoon, with counts declining toward sunset. These results are consistent with several previous studies (Ainley et al, 1977, Fancher 1979, Allen et al. 1984), including the published results from marine mammal monitoring competed for the Parsons Slough Complex in 2009-2010 (Maldini et. al. 2010). The decline in numbers toward sunset is in line with findings that harbors leave the Slough in the evening to forage in Monterey Bay (Oxman, 1995).

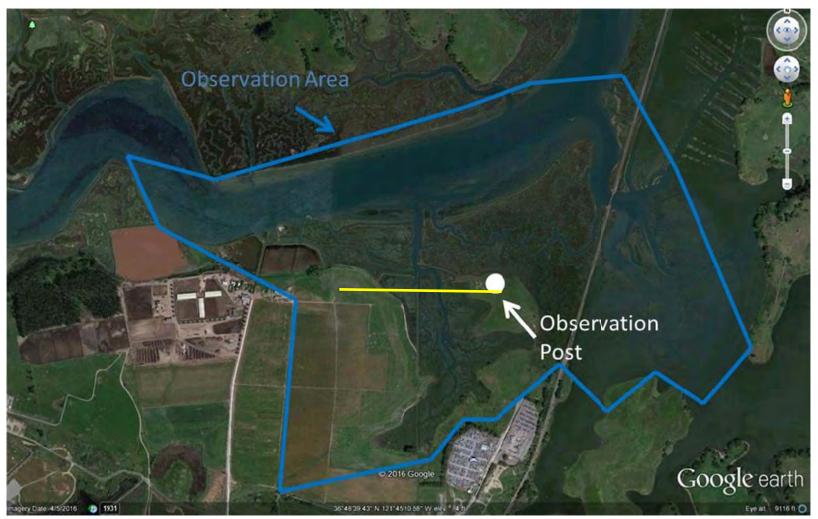
Figure 1. Observation post and observation area. Note: Some areas around the railroad tracks and within the healthy marsh just north of the post cannot be seen at low tides. All work north of the yellow line will be monitored continuously.
