# Common ADA Problems at Newly Constructed Lodging Facilities

## Introduction

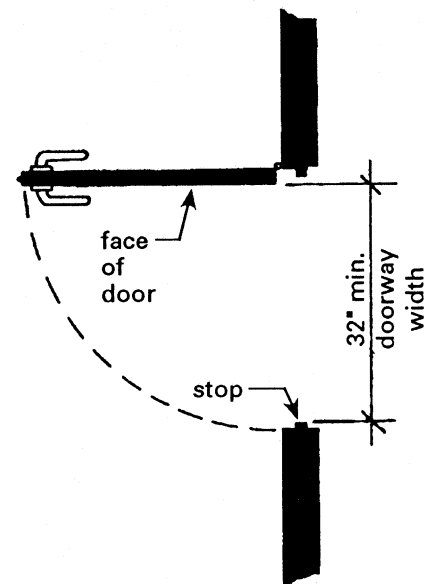
**Measuring Clear Width**

All doors and doorways (except shallow closets) into and within all guestrooms and suites (including guestroom bathrooms, kitchens, and connecting room doors) shall provide 32 inches of clear opening width measured when a hinged door is open 90 degrees or a sliding door is fully opened.

ADA Standards 9.4; 4.13.5.

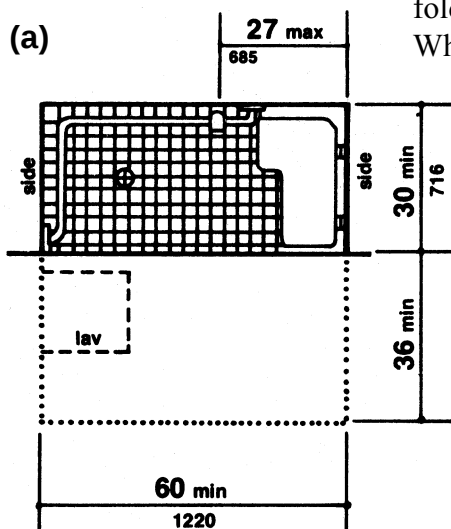
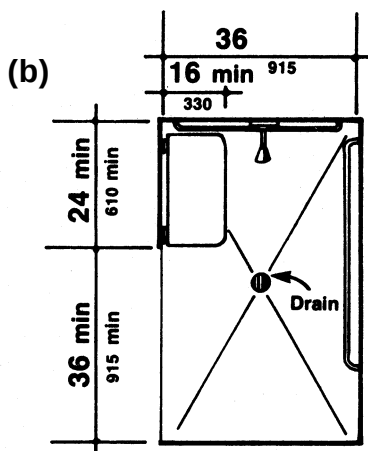
Fig. 57  
Roll-in Shower  
with Folding Seat

Lodging facilities must provide a specific number of accessible guest rooms based on the table provided below. Bathing facilities in these rooms must comply with the Standards. In addition, in lodging facilities with more than 50 guestrooms or suites, the facility must provide a specified number of accessible guestrooms that have a roll-in shower with a permanently attached fold-down seat. The roll-in shower in these rooms must comply with specific requirements contained in Figure 57 of the Standards, shown on this page.

ADA Standards 9.1.2; 9.2; 4.21; Figure 57(a) or (b).

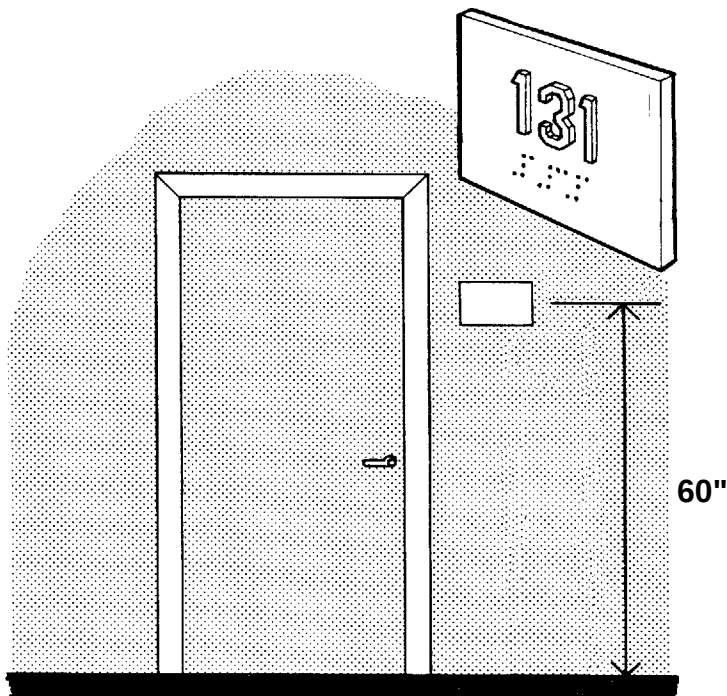
Signs that are provided for all permanent rooms and spaces in the lodging facility must be mounted on the wall (not the door) adjacent to the latch side of the door and centered 60 inches above the floor so that they can be easily located by persons who are blind or who have low vision. Signs must include the same information in Braille, with raised lettering that forms a high contrast with the background of the sign. Signs should not be made of reflective materials such as brass, silver, gold, glass, or mirrored surfaces unless there is an additional properly located sign that complies with the Standards. ADA Standards 4.1.3(16)(a); 4.30.4; 4.30.5.

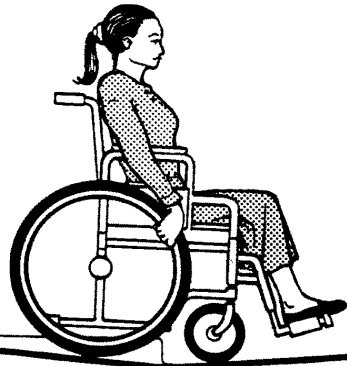
At least one route that is a minimum of 36 inches wide without steps, stairs, or other abrupt level changes must be provided within the boundary of the lodging facility's property from an accessible entrance to the building to public transportation stops, accessible parking spaces, accessible passenger pick-up/drop-off areas, if provided, and public streets or sidewalks. Once inside the facility, an accessible route must be provided between an accessible entrance, lobby and the various accessible elements and spaces in the lodging facility. ADA Standards 4.1.2 (1); 4.1.3(1); 4.3.

At least one route that is a minimum of 36 inches wide without steps, stairs, or other abrupt level changes must be provided
