## Case Study 5: Strategic Planning and Responsible Investments for Threatened Historic Structures, *Dry Tortugas National Park, Florida*

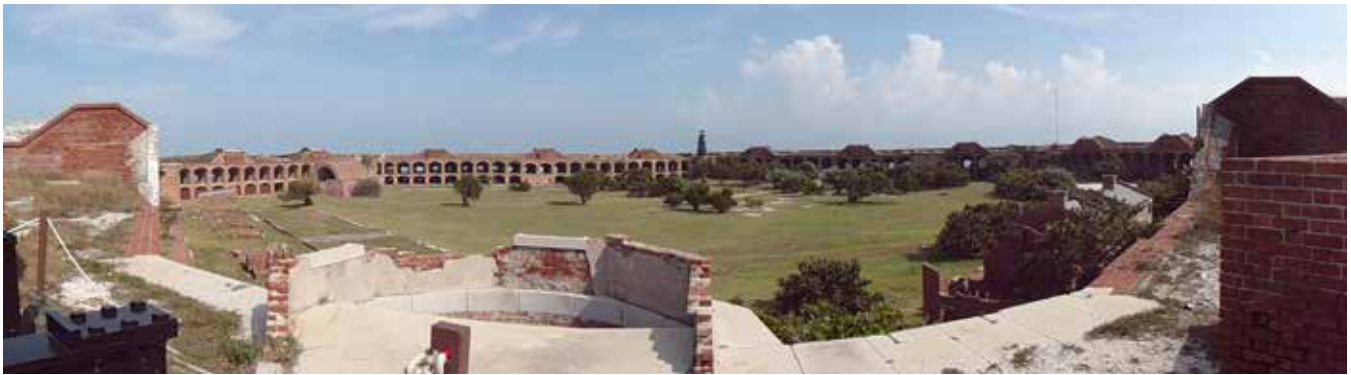
Historic Fort Jefferson is a six-sided structure built on a landform that is impacted by coastal processes.  
Image credit: Marcy Rockman, NPS.

brick, with six sides and three tiers. It is surrounded by a 21 m (70 ft) wide wet moat that is separated from the open waters of the Gulf of Mexico by a masonry wall, formally called the counterscarp. The counterscarp sits approximately 2 m (6 ft) above the low water line and 1 m (3 ft) above high tide. The moat and counterscarp were designed to keep would-be attackers at bay and to provide a structural first line of defense for the fort against the sea.

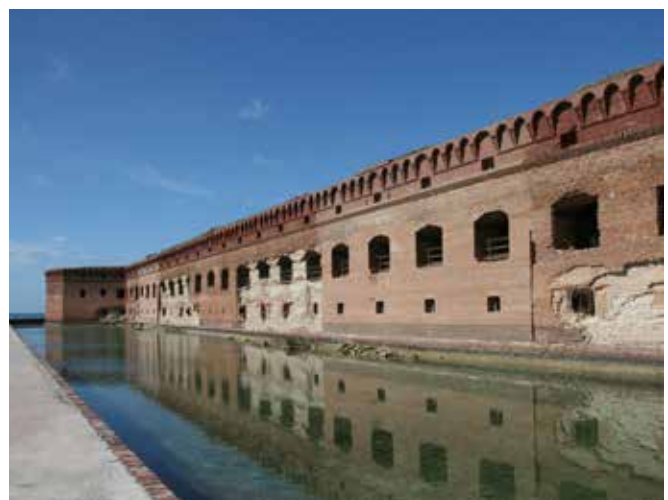
Fort Jefferson needs repairs to its front and moat wall.  
Image credit: Kelly Clark, NPS.

Throughout the architecture of the fort, there are iron components embedded within the masonry that served various functions, including water collection, supports for catwalks, and, most importantly, protection against enemy fire. In this salt water environment, the wrought-iron has rusted and expanded, pushing the brick apart and causing serious structural damage to Fort Jefferson's exterior scarp walls; large sections of the fort walls have collapsed into the moat.

The moat wall surrounding the fort also needs repairs in many places. Because it is an integral part of the site design and protects the fort from wave forces, it also protects the investment in stabilization of the fronts.

Through strategic planning, informed decision making, and responsible investments, the park is trying to mitigate the effects of the environment over time. This approach has resulted in removing the corroded iron shutter assembly components and stabilizing the exterior masonry walls. Preservation and stabilization work on the fort has occurred on an intermittent basis since the 1990s. The moat wall has been worked on intermittently since the 1960s. For both structures, the scope of work has been guided by the amount of available funding. At this point in time, all six sides of Fort Jefferson have received some form of stabilization, but the work is not complete. The main priority for the park is to complete the removal of the remaining iron shutter components embedded in the exterior scarp wall (fronts 3 and 2) and to stabilize as much of the brick work from the top of the parapet to the low water line with selective brick replacement and repointing. The estimated cost to finish these stabilizing measures by 2018 is just under \$12 million.
